Inspection Report

77 E. State St.
1A
Chicago IL

Domicile Consulting

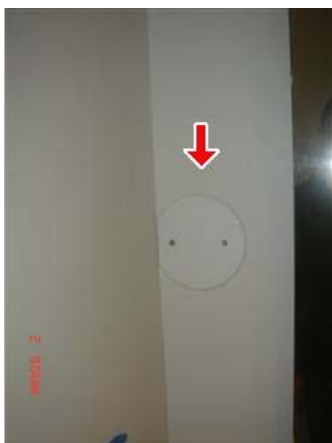
E. Picture 1

(Picture 1) The wall bracket light fixture junction boxes in the powder room are not equidistant from the adjacent parallel walls. This may not allow the light fixtures to be installed in a neat, workmanlike manner. Further review of the junction box installation by a qualified electrician is recommended.

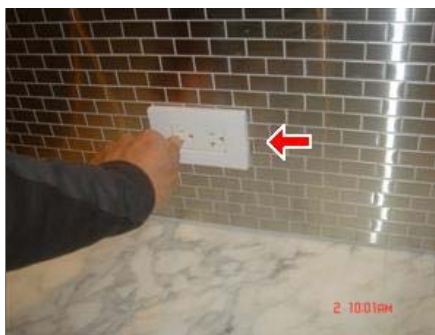
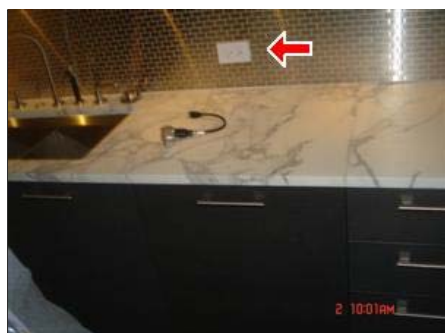
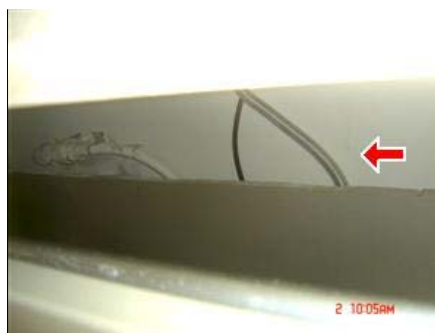
E. Picture 2

(Picture 2)(Picture 3) Excess motion was noted at the electrical receptacle on the right hand side of the kitchen sink. The receptacle should be properly secured to it's junction box in order to reduce the risk of arcing/sparking and damage.

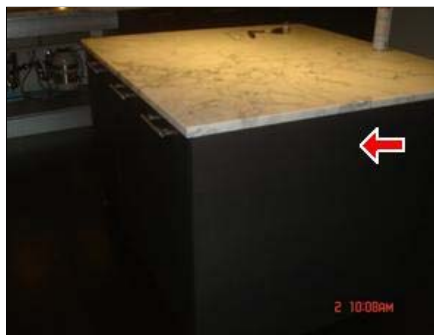
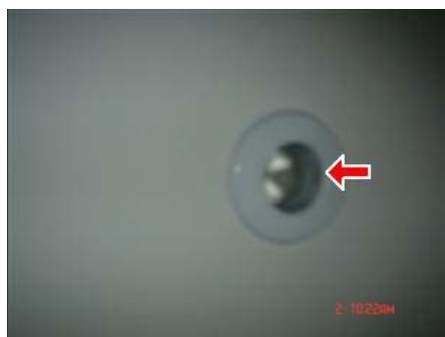
E. Picture 5

(Picture 5)(Picture 6) The national electrical code requires the installation of GFCI protected receptacles at every four linear feet of kitchen countertop. This requirement stems from the fact that the typical appliance power cord is approximately 2 feet long. It is recommended that additional GFCI protected electrical receptacle be installed at the opposite side panel of the kitchen island in order to increase it's food preparation functionality.

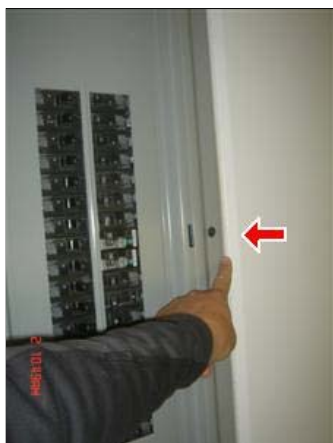
E. Picture 8

(Picture 8) The missing screw should be furnished and installed at the electrical panel's dead front cover.

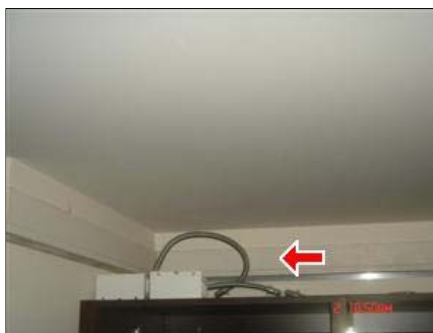
(Picture 9) The right hand side of the electrical panel wall opening does not have the same finished depth as the left-hand side, the top, and the bottom. It is recommended that the missing wall finish be installed at this location so that the dead front cover fits uniformly around the electrical panel.

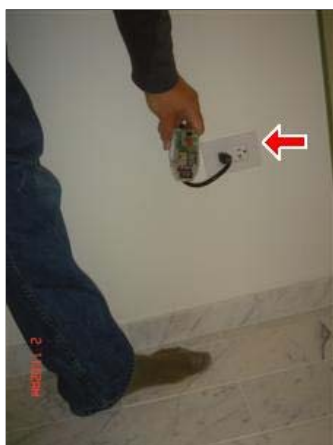
E. Picture 12

(Picture 12) All of the electrical receptacle and light switch covers should be checked for proper plumb and level positioning and repaired as necessary.

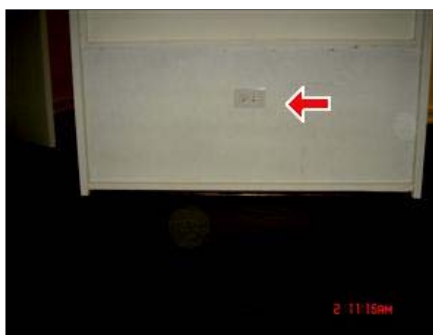
E. Picture 11

(Picture 11) Multiple 'dead' electrical receptacles were noted in the master bathroom. These should be repaired by a qualified electrician.

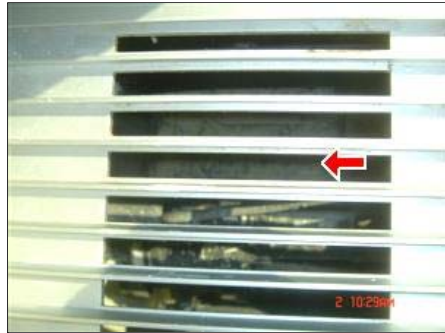
F. Picture 1

(Picture 1) Dust and debris were noted below the upper grating of the baseboard convectors. The grates should be removed and these areas thoroughly and professionally cleaned prior to closing.

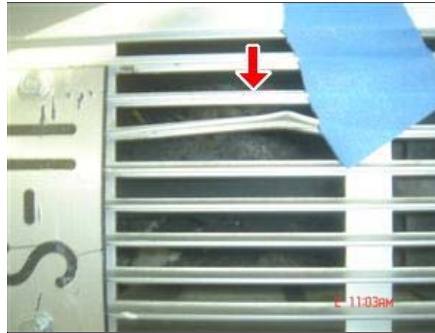
F. Picture 2

(Picture 2) The damaged convector grille at the S-11 baseboard unit should be repaired or replaced.

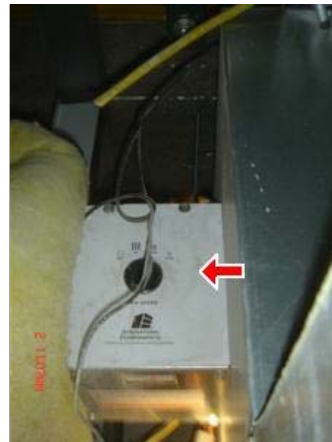
F. Picture 3

(Picture 3) The air handler fan speed controls are located inside their ceiling alcoves. This makes adjustment of the HVAC airflow difficult and potentially dangerous. It is recommended that the fan speed controls be moved to a readily accessible location.

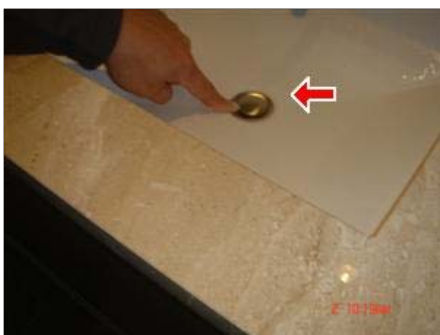
G. Picture 1

(Picture 1) The guest bath lavatory sink drains slowly and should be repaired by a qualified plumber.

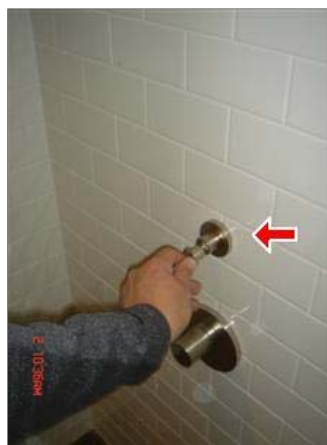
G. Picture 2

(Picture 2) The master bath shower diverter handle is loose and should be secured.

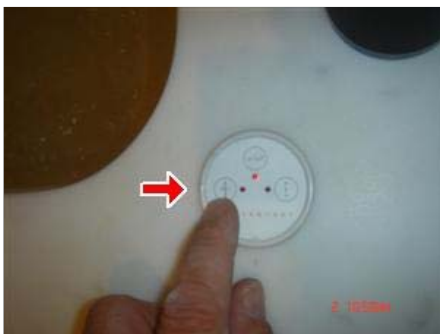
G. Picture 3

(Picture 3) The left-hand control button at the hydromassage bathtub did not operate at the time of the inspection. Evaluation by a qualified appliance specialist is recommended.

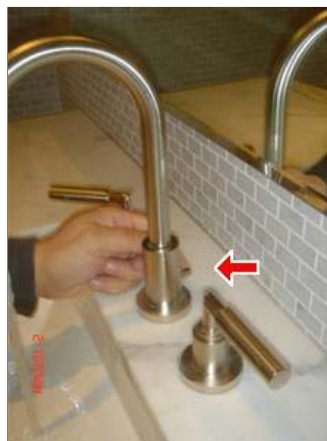
G. Picture 4

(Picture 4) The pop-up drain lever at the left-hand master bath lavatory sink is not operational and should be repaired or replaced.

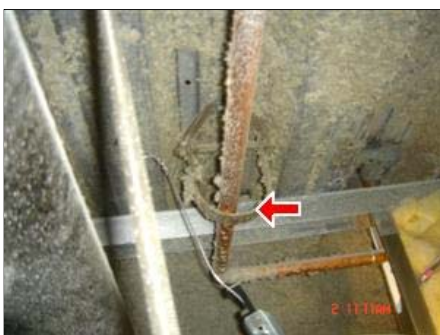
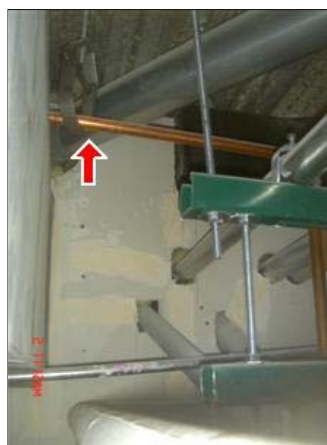
G. Picture 5

(Picture 5)(Picture 6) Areas of contact between copper water supply piping and iron-based metals were noted at the ceiling alcove. this type of contact can result in piping corrosion, leaking, and water damage. Further evaluation by a qualified mechanical contractor is recommended in order to determine if remedial action is required.

(Picture 5)(Picture 6) Areas of contact between copper water supply piping and iron-based metals were noted at the ceiling alcove. This type of contact can result in piping corrosion, leaking, and water damage. Further evaluation by a qualified mechanical contractor is recommended in order to determine if remedial action is required.

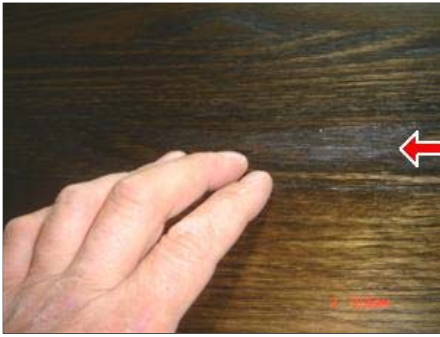
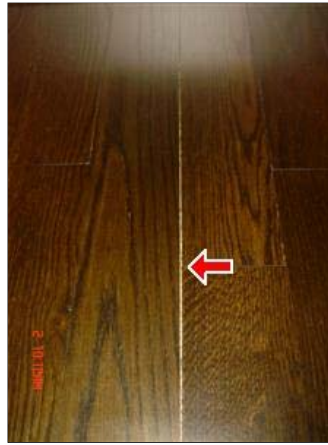
H. Picture 1

(1) (Picture 1)(Picture 2) Obvious gaps and multiple surface imperfections were noted in the hardwood flooring. This may indicate that the flooring was installed with an elevated moisture content. The indoor relative humidity inside the condominium unit appeared to be within normal limits and the commercial quality humidifier was operating at the time of the inspection. It is recommended that the hardwood flooring in the home be evaluated and repaired by a qualified flooring specialty contractor in order to reduce or eliminate the gaps between floor boards and to eliminate all other obvious flooring or finish defects.

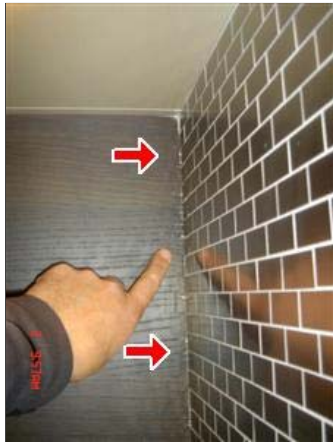
H. Picture 3

(Picture 3) The porous wood grain of the kitchen cabinet side panels has absorbed some of the backsplash tile grout. Repair of the kitchen cabinet finishes by a qualified specialty contractor is recommended.

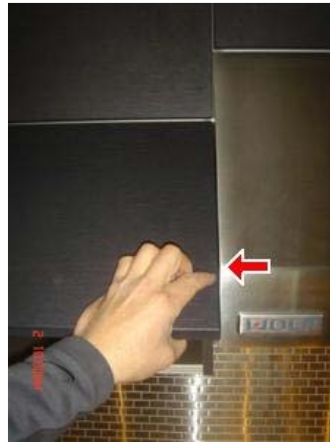
H. Picture 4

(Picture 4) The awning style wall cabinet door at the left-hand side of the exhaust hood rubs on the hood when opened. Repair or adjustment of the door or hood is recommended in order to prevent marring of the finishes.

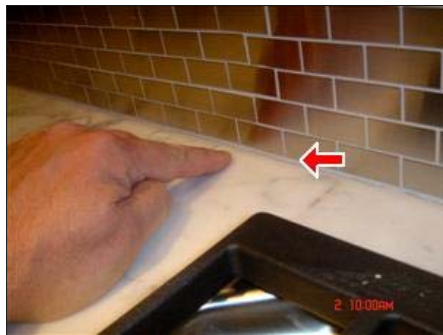
H. Picture 5

(Picture 5) The National Tile Contractor's Association recommends the use of color matched and mildew resistant caulking at all areas where dissimilar material meets a grouted tile surface. These locations are inherently prone to motion which the brittle grout cannot absorb. This inevitably leads to grout cracking. It is recommended that all such locations in the home, whether it be kitchen or bathroom, have the existing grout joints raked out and replaced with the color matched and mildew resistant caulking marketed by the grout manufacturer expressly for this purpose.

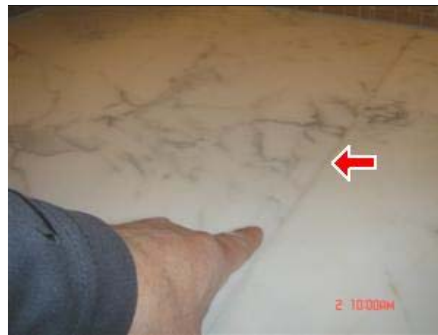
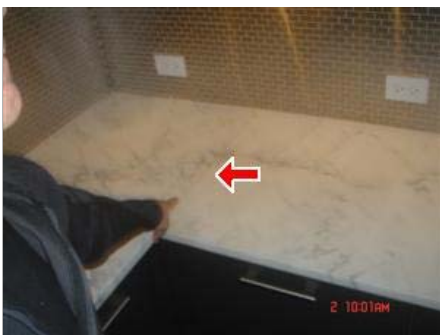
H. Picture 6

(Picture 6)(Picture 7) A scratch was noted at the Northwest corner of the stone kitchen countertop. The scratch should be repaired by a qualified specialty contractor.

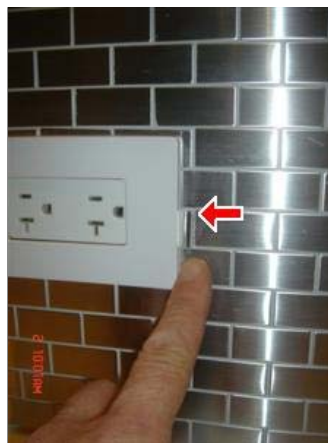
H. Picture 8

(Picture 8) Missing grout was noted at the backsplash tile near the electrical receptacle at the right hand side of the kitchen sink.

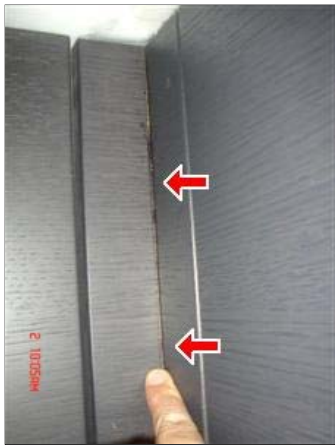
H. Picture 9

(Picture 9) The inside base cabinet trim at the Northwest corner of the kitchen has a rough and unsightly finish. It should be repaired by a qualified cabinet specialty contractor.

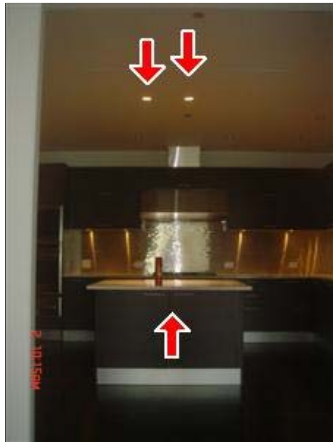
H. Picture 11

(Picture 11) The two can lights above the kitchen island are not centered directly above the island. It appears that the buyer would be well within his rights to demand at the lights be centered over the island. Further evaluation of this electrical installation, and review of the approved electrical plan, by a qualified electrical contractor is recommended.

(Picture 11) The two can lights above the kitchen island are not centered directly above the island. It appears that the buyer would be well within his rights to demand that the lights be centered over the island. Further evaluation of this electrical installation, and review of the approved electrical plan, by a qualified electrical contractor is recommended.

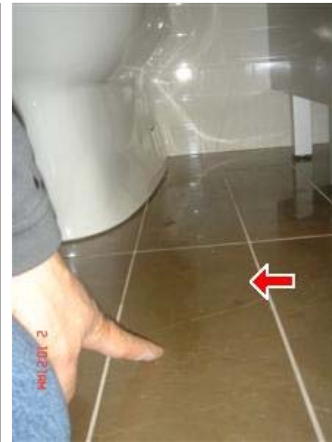
H. Picture 12

(Picture 12) An oily residue was noted on the natural stone flooring in the guest bathroom. The flooring should be cleaned and, if necessary sealed by a qualified specialty flooring contractor.

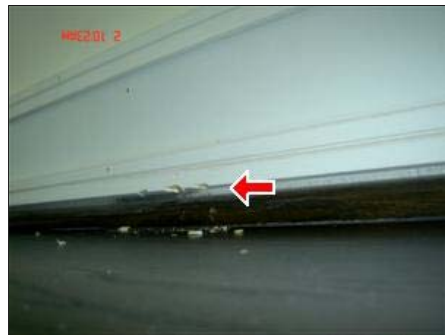
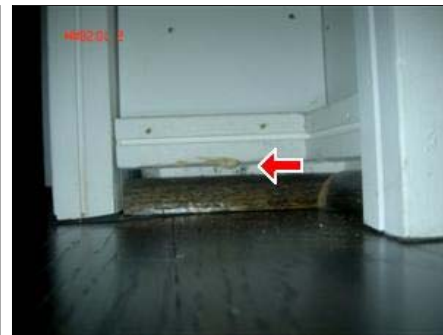
H. Picture 13

(Picture 13)(Picture 14) Multiple areas of damage were noted at the bottom edge of the raised baseboard trim. All such damage should be repaired to like new condition.

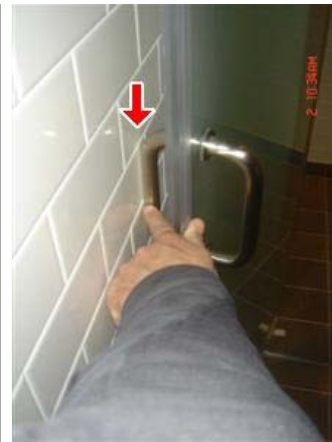
H. Picture 16

(Picture 16) The heavy glass shower doors are at risk of causing damage and at risk of being damaged from contact with the adjacent tile walls. Installation of wall-mounted bumpers is recommended.

(Picture 16) The heavy glass shower doors are at risk of causing damage and at risk of being damaged from contact with the adjacent tile walls.

Installation of wall-mounted bumpers is recommended.

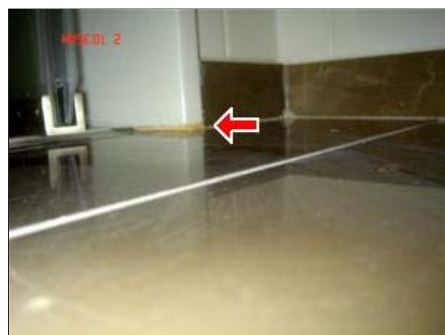
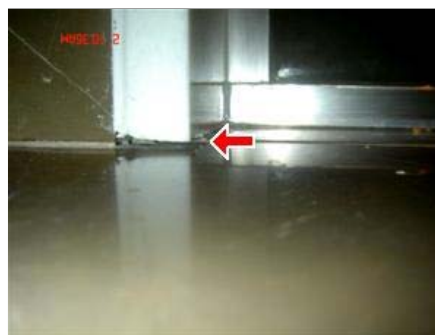
H. Picture 17

(Picture 17)(Picture 18) Wood shimming and gaps were noted at the base of the shower door jambs in the master bath. The wood shims should be removed, and if needed, replaced with plastic shims. The bottom of the shower door jambs should be neatly and professionally caulked with the appropriate compounds.

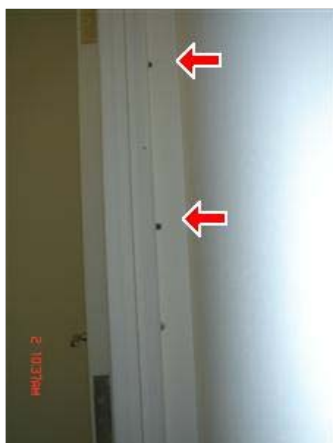
H. Picture 19

(Picture 19) Unconcealed drywall screws were noted inside the central double door closet. Repair by a qualified drywall contractor is recommended.

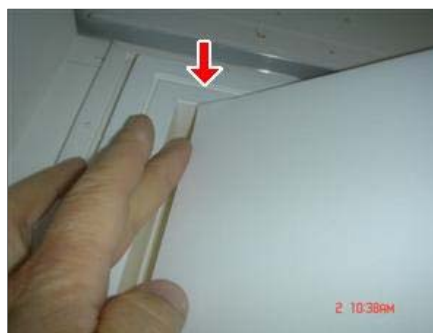
H. Picture 20

(Picture 20) The upper left corner of the left-hand door at the central double door closet is damaged and should be repaired or replaced.

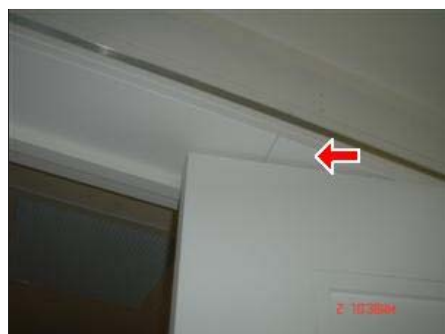
H. Picture 21

(Picture 21) Both of the doors at the central double door closet rub on the adjoining door jambs when opened. The doors should be repaired or adjusted to prevent such contact.

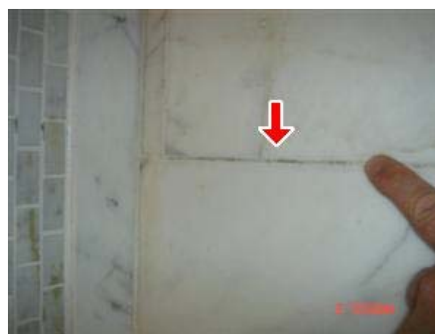
H. Picture 22

(Picture 22) Stained grout was already noted at the master bathroom floor tile. The tile should be professionally cleaned and then sealed with multiple coats of high quality grout sealer.

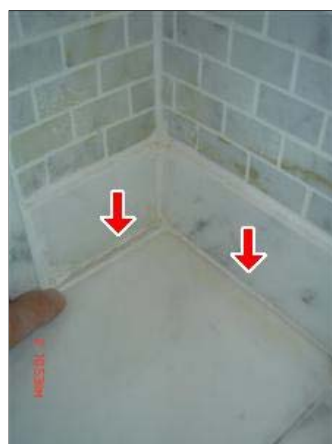
H. Picture 23

(Picture 23) All inside tile corners should be sealed not with grout, but with a color matched, mildew resistant, caulking compound. It is recommended that the existing grout be raked free from these locations and that a be sealed with high-quality caulked joints.

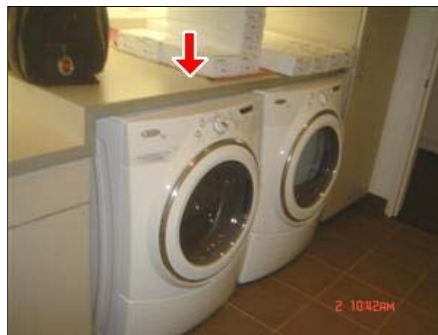
I. Picture 1

(Picture 1) The built-in installation of the washer and dryer prevented a full inspection of these units and their mechanical components. The built-in installation presents the following concerns: the inspector was unable to determine if the appropriate materials and methods were utilized in the installation of the dryer venting; the washer hoses are hidden from view and cannot be routinely inspected by the homeowner for leaking or damage; no floor drain was noted underneath the clothes washer and the clothes washer was not installed in a drain pan; routine maintenance of the clothes dryer requires access to the vent hose and vent outlets. It is recommended that the laundry units be made readily removable and their components readily accessible in order to reduce the risk of moisture damage. Also, the use of braided stainless steel water supply hoses is recommended to reduce the risk of bursting and leaking. Further evaluation by a qualified appliance specialist is recommended and it is also recommended that the laundry unit manufacturer's instructions be followed completely.

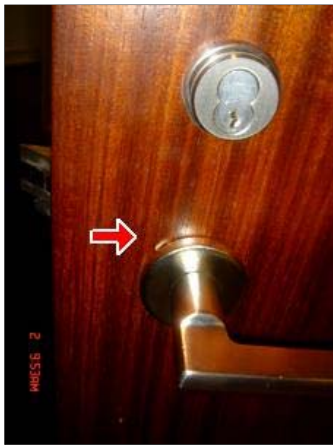
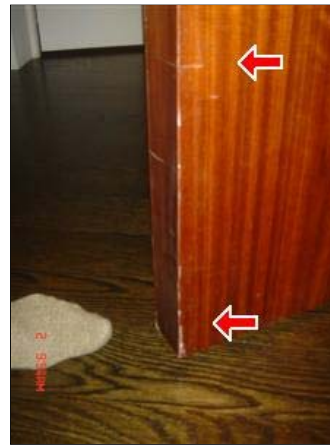
J. Picture 1

(Picture 1)(Picture 2) The hole that was cut for the Main entry door latch handle is too large and is visible outside the escutcheon. Also, a number of scratches, dents, and other surface imperfections were noted on the door. The door should be repaired to 'like new' condition or replaced.

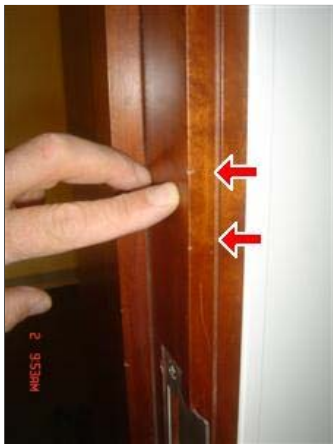
J. Picture 3

(Picture 3) Damage was also noted at the front door jamb and trim. They should also be returned to 'like new' condition.

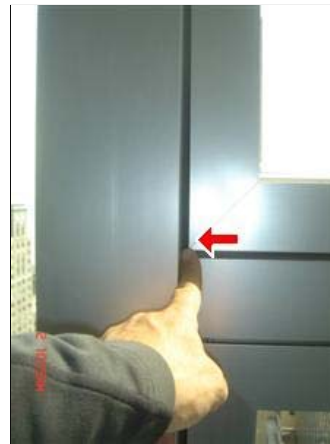
J. Picture 4

(Picture 4) The aluminum frame windows in this condominium unit may be prone to condensation formation, dripping, and associated moisture issues. Further information regarding these windows including their NFRC ratings, air infiltration, U value, and their installation instructions should be provided to the buyer or his agent/s for further review.

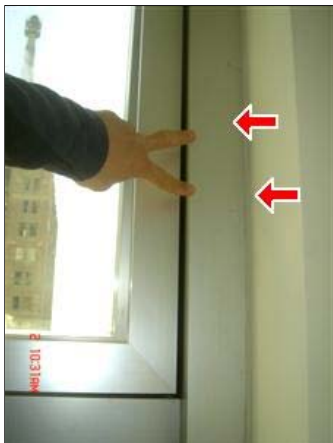
J. Picture 5

(Picture 5) Multiple scratches were noted on the aluminum interior window finishes. The windows should be returned to like new condition.

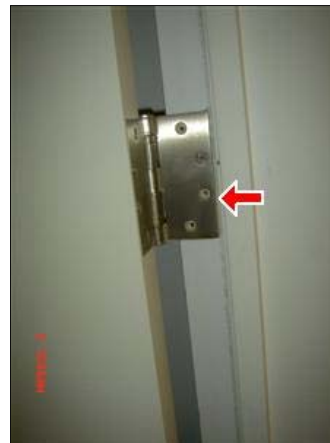
J. Picture 6

(Picture 6) Several hinged screws are missing from the secondary unit entry door, these should be furnished and installed.
