Inspection Report for Property at:
Chicago, IL

Private Home Inspection for:

Date:
November 13, 2009

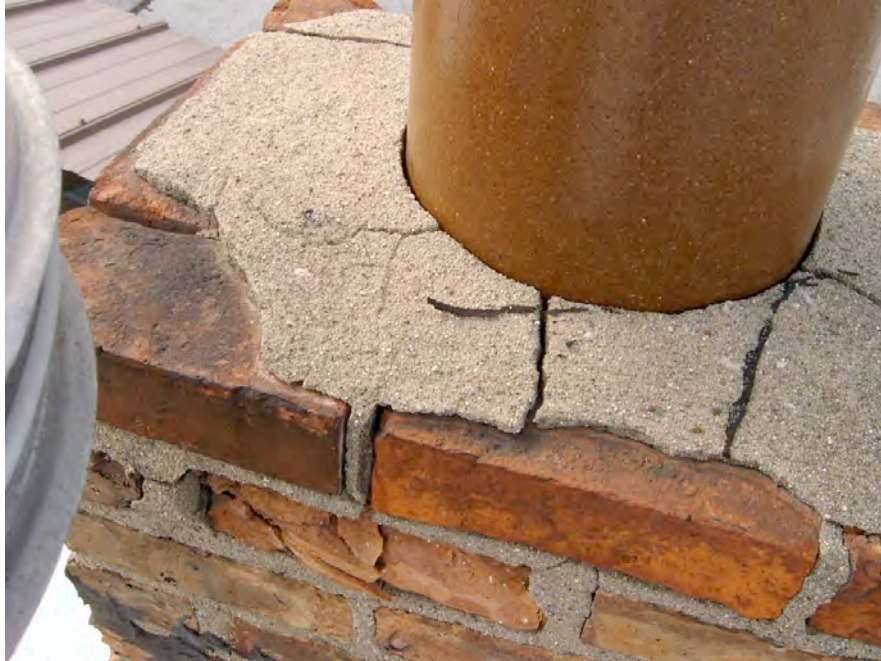
Chimney material: Metal, PVC & Masonry. Sections of the north masonry chimney have cracked bricks and deteriorating mortar. The south fireplace chimneys are not lined. Recommend this be corrected as necessary (see photos).

Figure 3 North chimney. Note deterioration of brick & cap

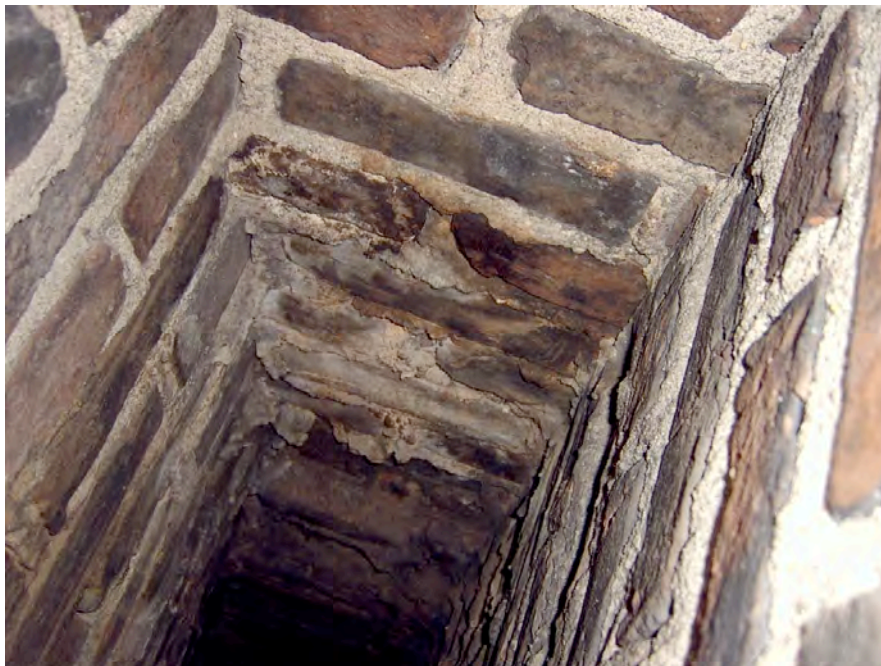
Figure 4 Unlined fireplace chimney

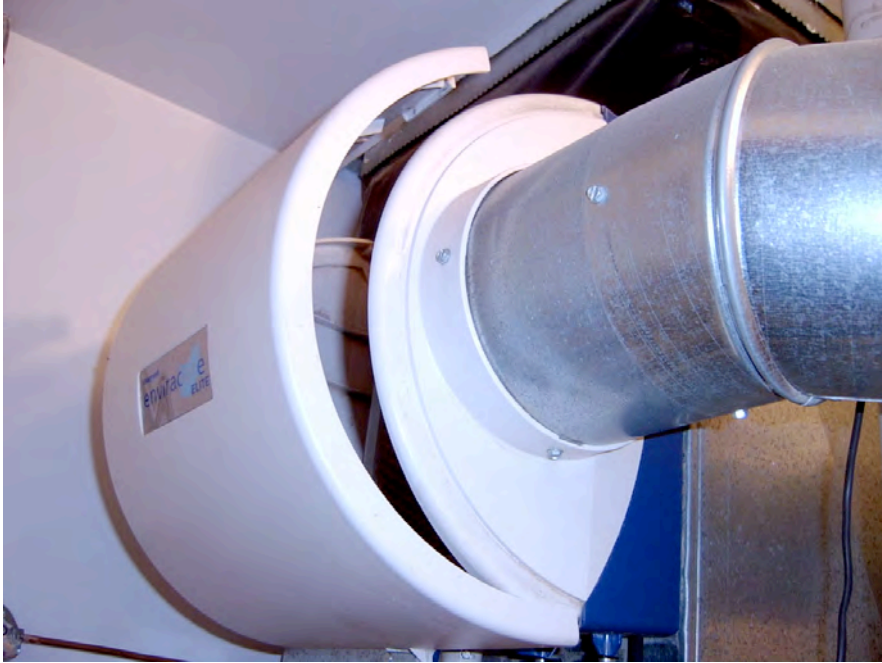
Replace humidifier evaporator pads annually. The cover for lower level humidifier is not in place properly at time of the inspection. Remember to open humidifier damper in winter. The lower level unit needs a damper.

Figure 9 Loose cover on lower humidifier

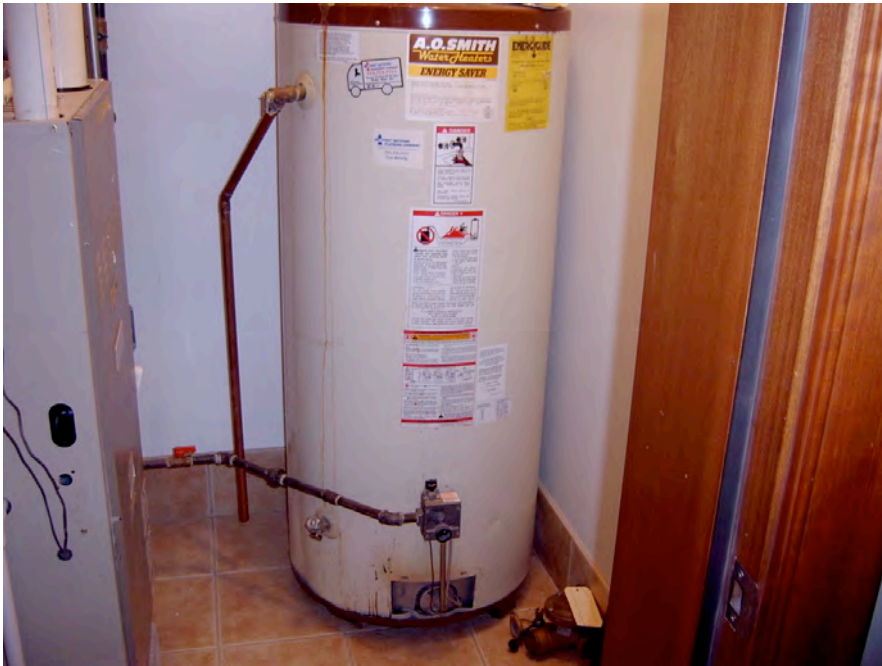
Comments: A. O. Smith®. The front burner cover is missing. There is no visible source of fresh air into the furnace area for water heater (75,000 BTU). Adequate air supply is necessary for proper operation of gas appliances. The unit is near the end of its useful life expectancy.

Figure 10 Water heater. Note missing burner cover.

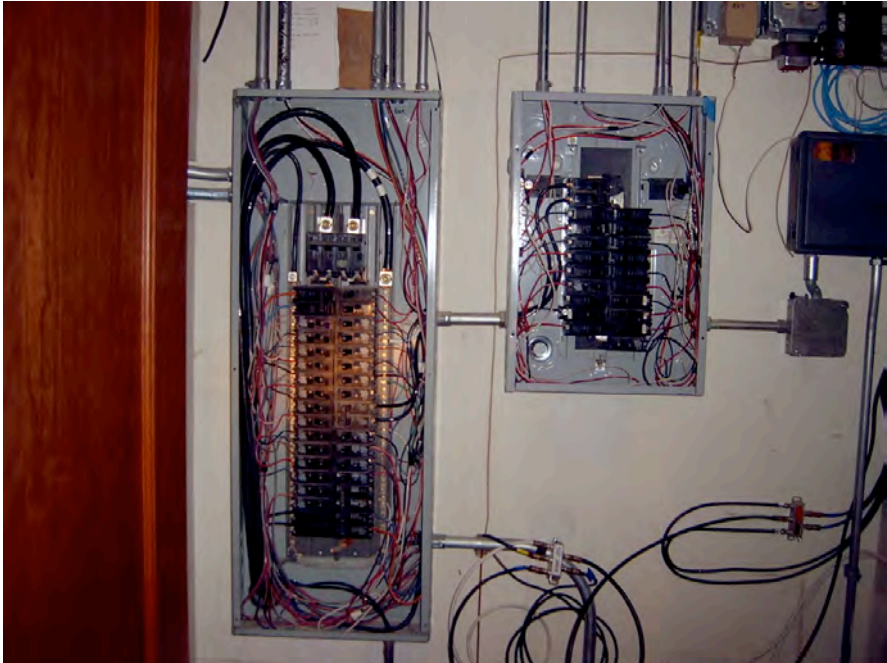
Figure 11 Main electric panels (covers removed for inspection)
