# domicile consulting

Property, Energy & Moisture Intrusion Inspections

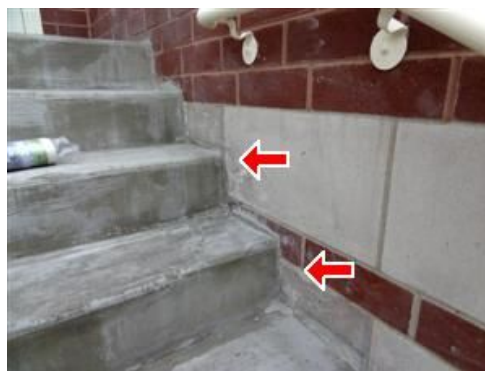
A. Picture 1 Front Exterior Stairs

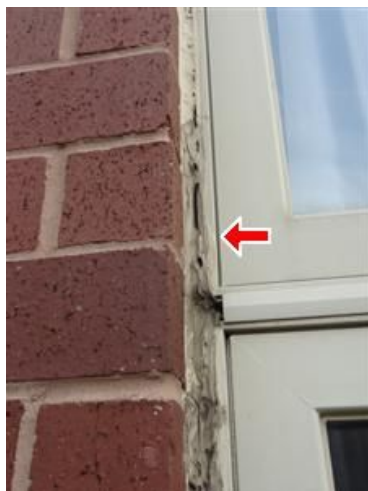
A. Picture 2 Aged and Deteriorated Caulking

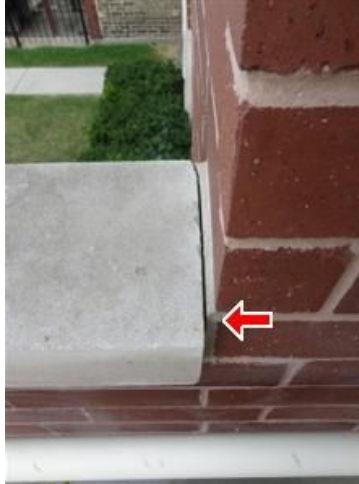
A. Picture 4 Limestone Mortar Joint

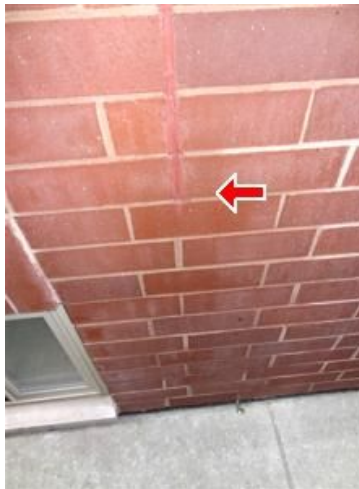
A. Picture 5 Incomplete Movement Joint

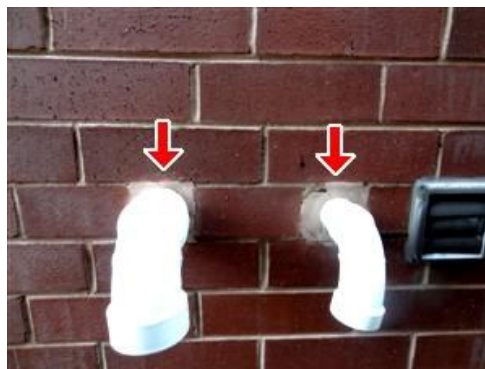
A. Picture 6 Improperly Configured Wall Penetrations

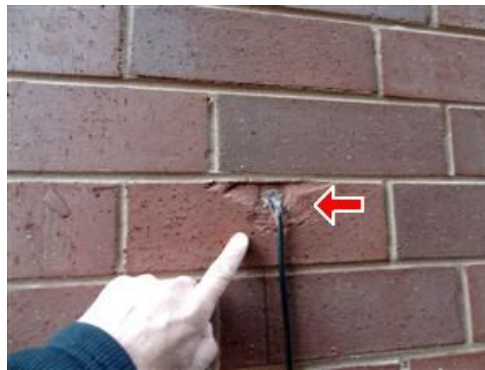
A. Picture 7 Wanton and Willful Negligence

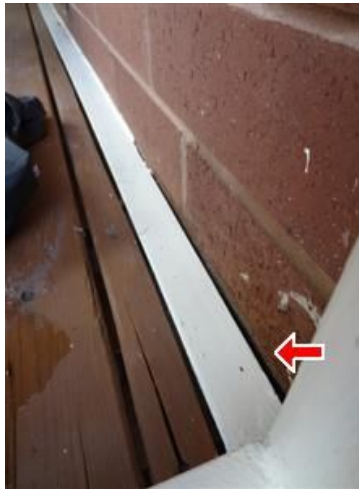
A. Picture 8 Incomplete Sealant Joint

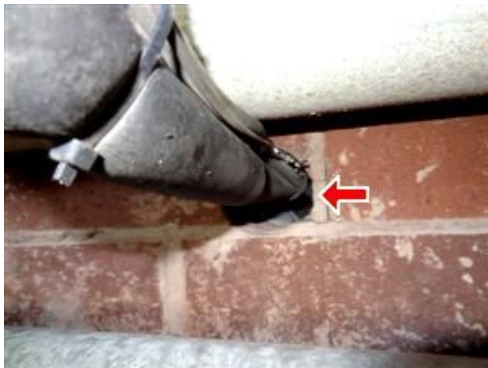
A. Picture 9 Unsealed Air-Conditioning Refrigerant Line Penetration

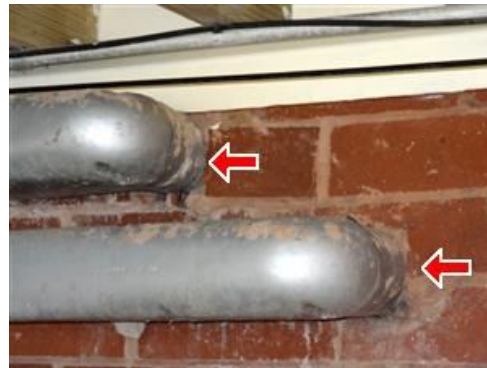
A. Picture 10 Feeder Conduit

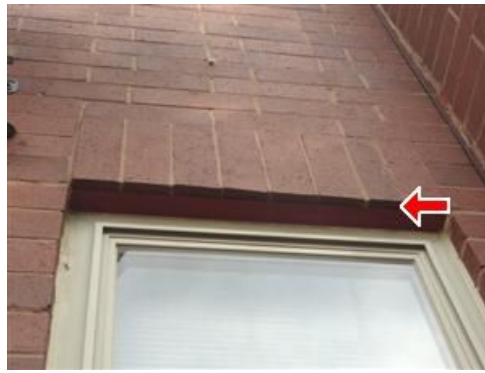
A. Picture 11 Missing Flashing

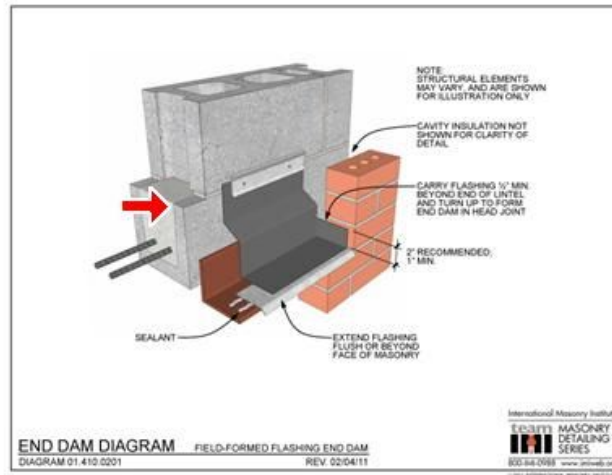
A. Picture 12 Proper Flashing Detail

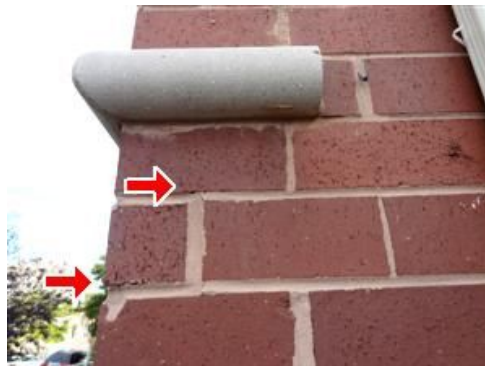
A. Picture 13 Substandard Cement Mortar

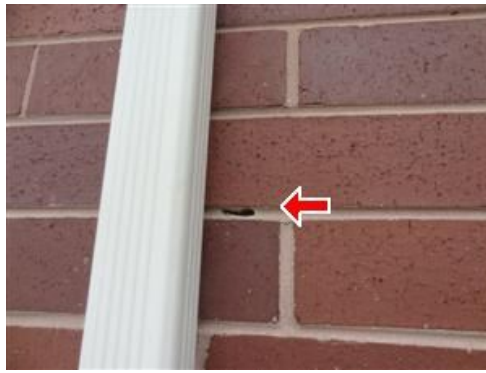
A. Picture 14 Mortar Gap

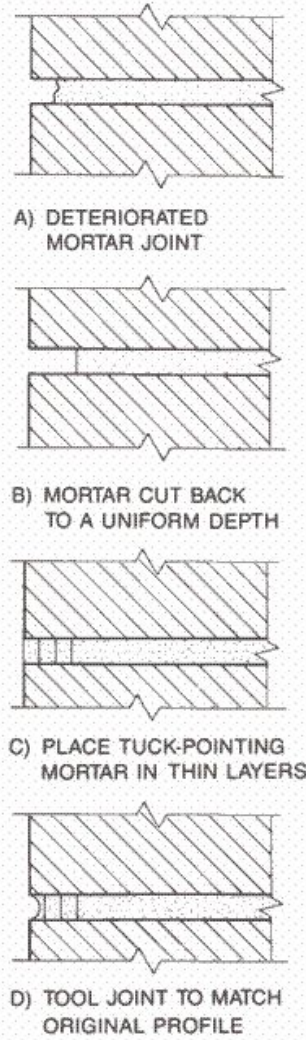
A. Picture 15 Re-Pointing Sequence

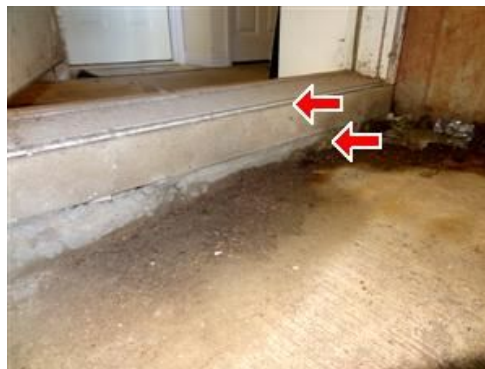
A. Picture 16 Rear Basement Entry Door

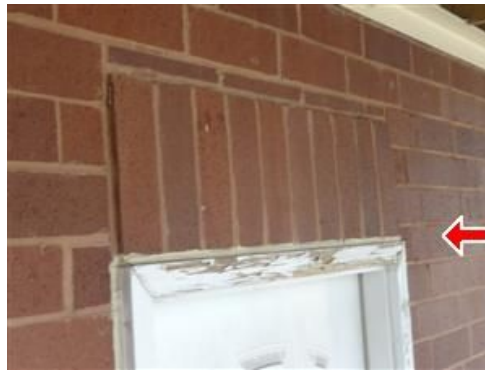
A. Picture 17 Improper Door Installation

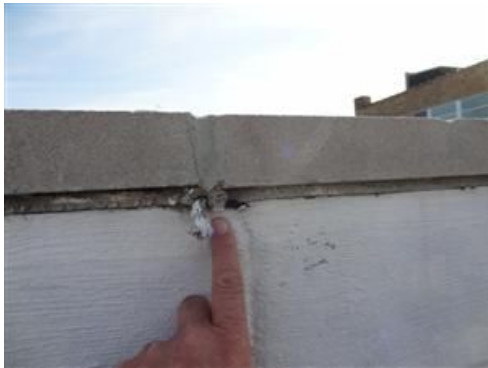
A. Picture 18 Improper Limestone Coping And Flashing Details

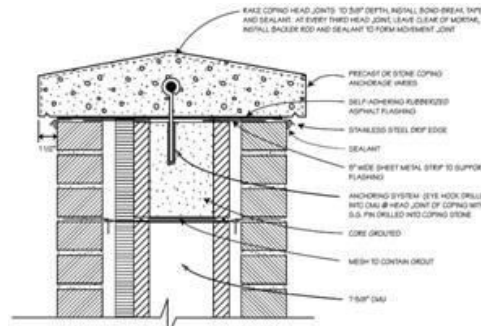
A. Picture 19 Correctly Configured/Installed Coping

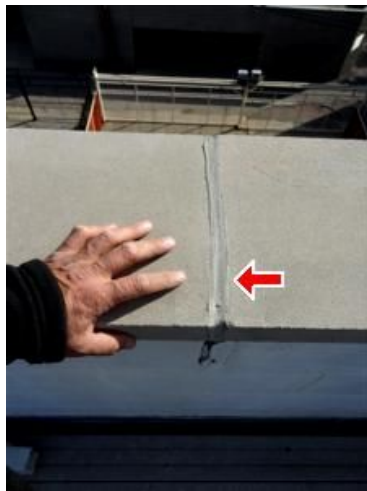
A. Picture 20 Caulk Smear

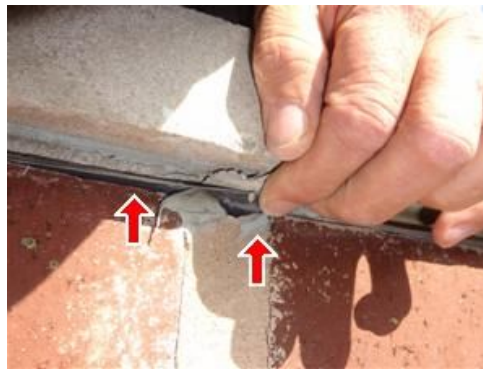
A. Picture 21 Improper Parapet Capping Detail

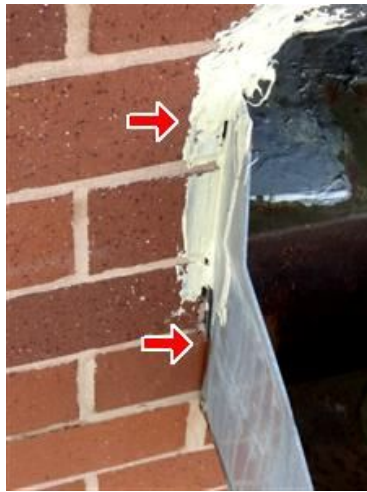
A. Picture 22 Missing and Smeared  
Caulk at Scupper Opening

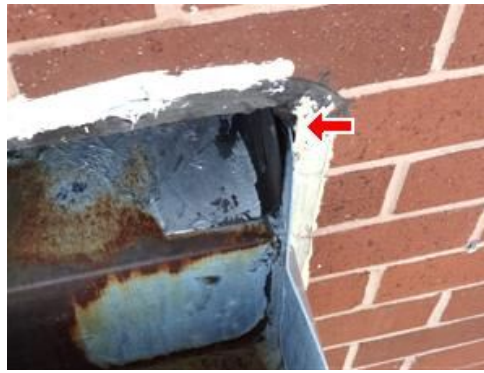
A. Picture 23 Loose Flap of Roofing Membrane At  
Scupper Opening

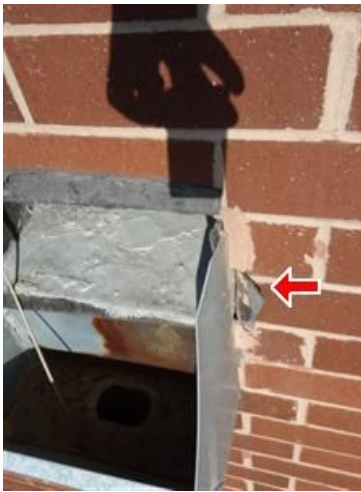
A. Picture 25 Risk for Moisture Penetration at Scupper

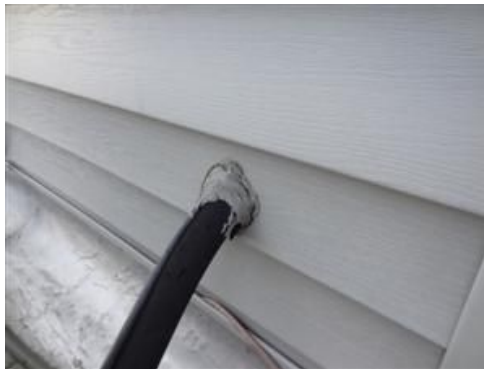
A. Picture 26 Improper Vinyl Siding Penetration

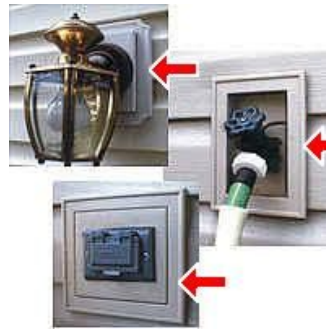
A. Picture 27 Vinyl Siding Mounting Blocks

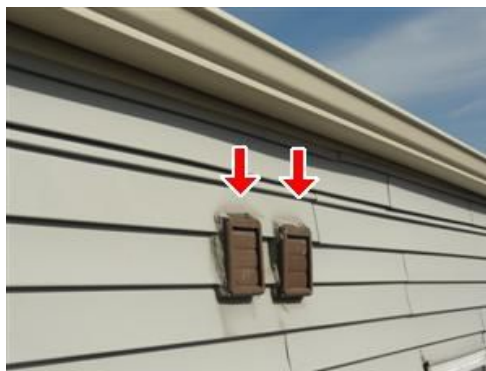
A. Picture 28 Improper Vinyl Siding Penetrations

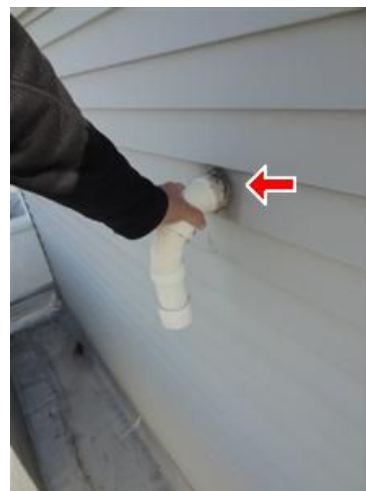
A. Picture 29 Installation of Vinyl Siding Mounting Blocks Recommended  
e pre-formed vinyl siding mounting blocks that are risk for moisture intrusion. They also allow the siding to amage, sealant failure, etc. Repair by a qualified siding

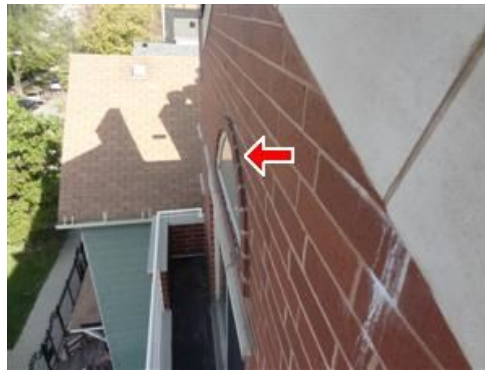
A. Picture 30 Projecting Soldier Course at Arch Top Window

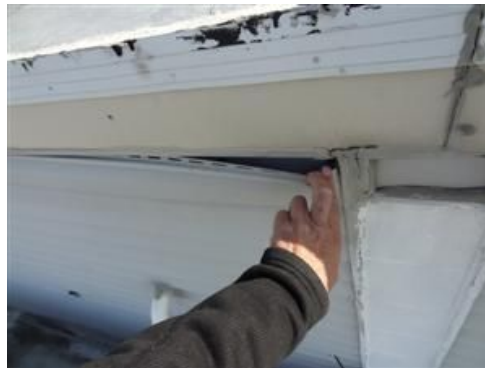
A. Picture 31 Loose Siding

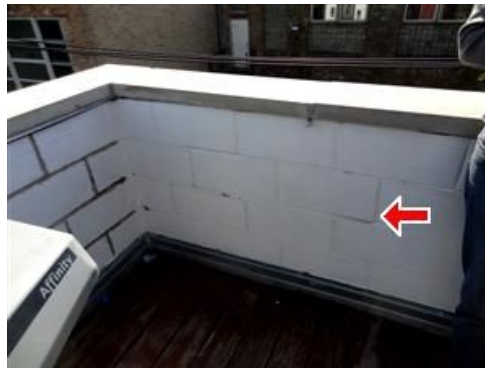
A. Picture 32 Mortar Cracking at Concrete Masonry Units Of the Inner Parapet

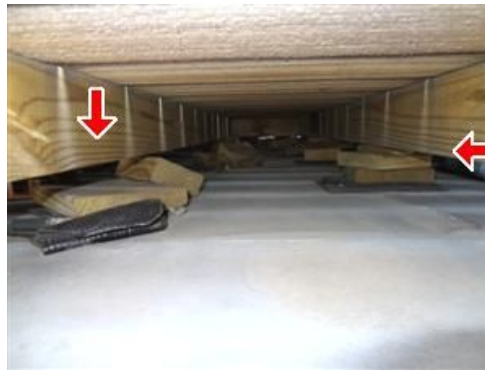
B. Picture 1 "Deck of Card"

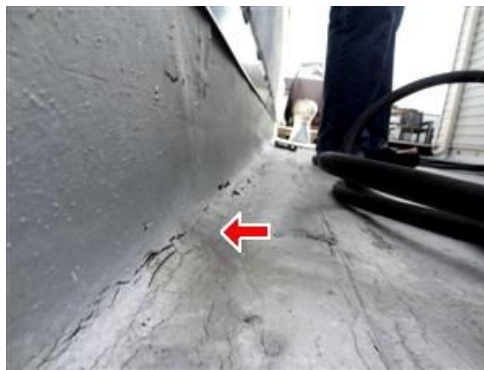
B. Picture 2 Creates That Roofing Material

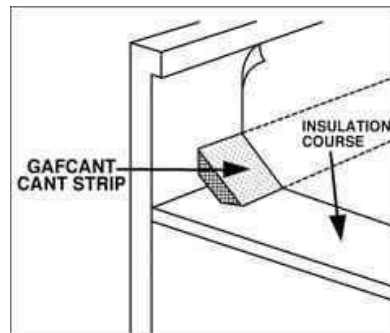
B. Picture 3 Cant Strip at Roof Crease

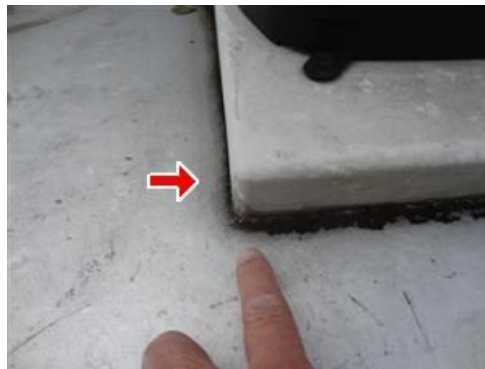
B. Picture 4 Risk for Damage to Roof Covering

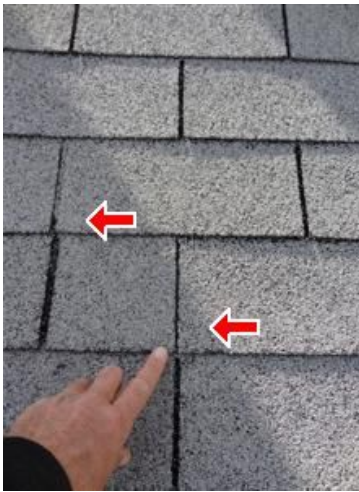
B. Picture 5 Improper Shingle Application

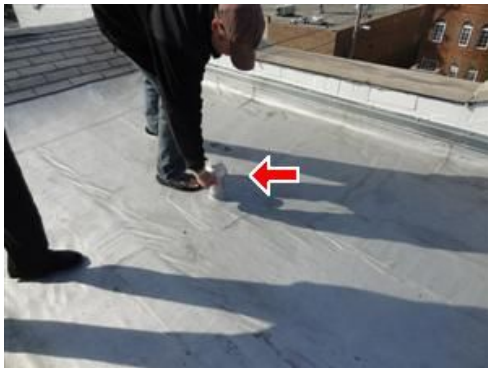
B. Picture 6 Inappropriate Installation

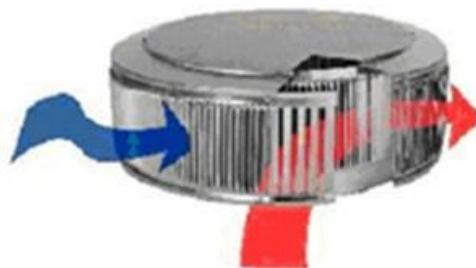
B. Picture 7 Low Slope Roof Vent

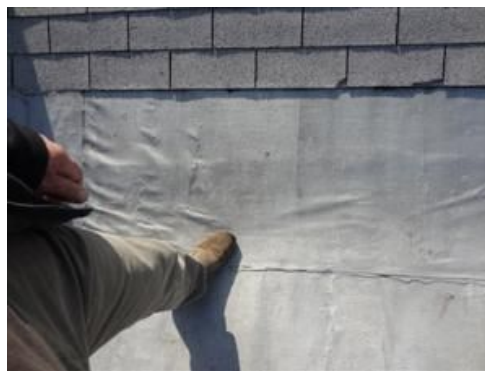
B. Picture 8 Spongy Roof Sheathing

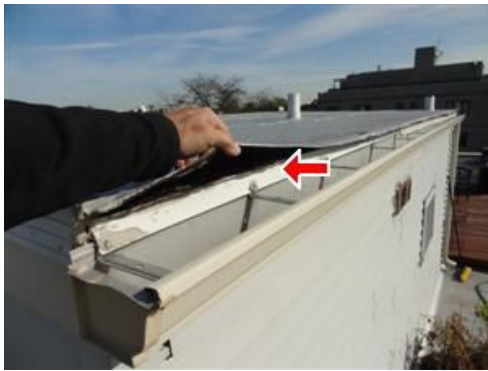
B. Picture 9 Unsealed Roof Membrane

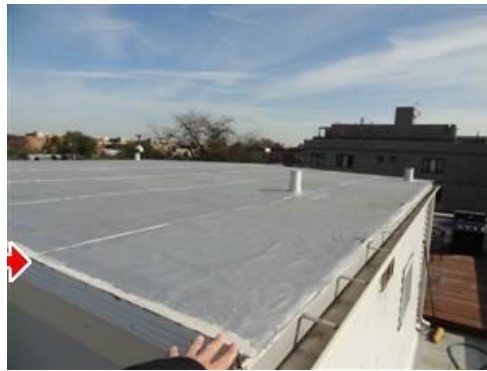
B. Picture 10 Improperly Detailed Edge Metal Flashing

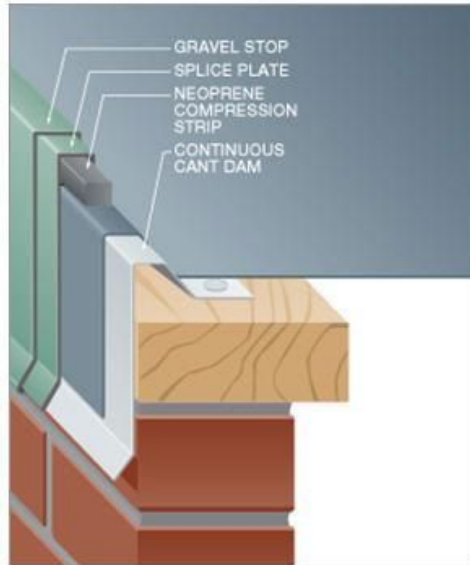
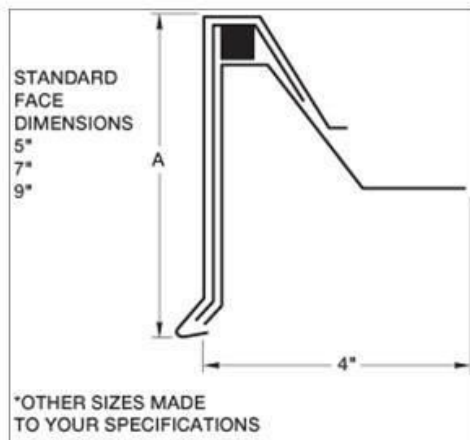
B. Picture 11 Proper Edge Metal Flashing Detail

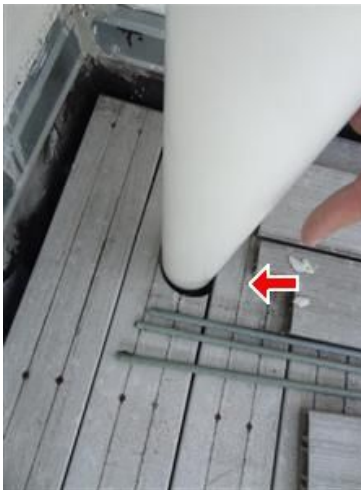
B. Picture 12 Loose Vent Pipe

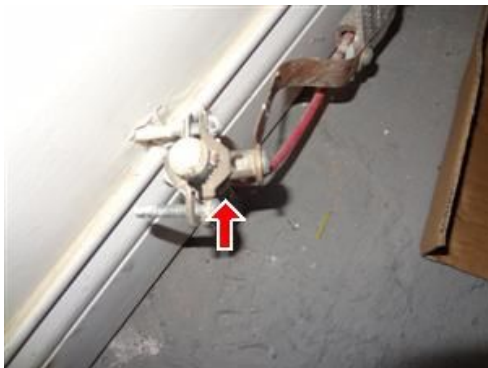
C. Picture 1 Improper Electrical Connection

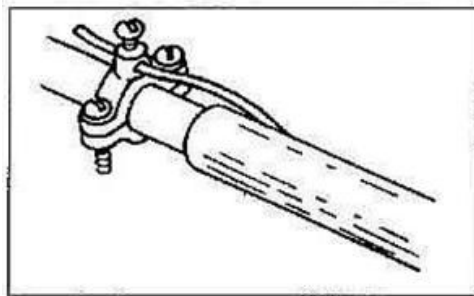
C. Picture 2 Correct Way to Secure Grounding Electrode Conductor

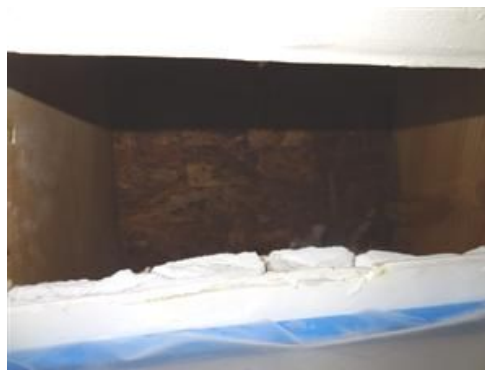
D. Picture 1 Mold-like Substances on Underside of Roof Sheathing

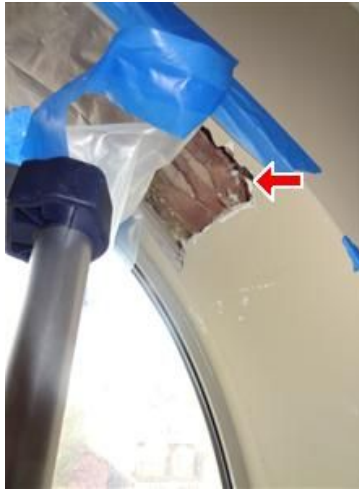
E. Picture 1 Round Top Window

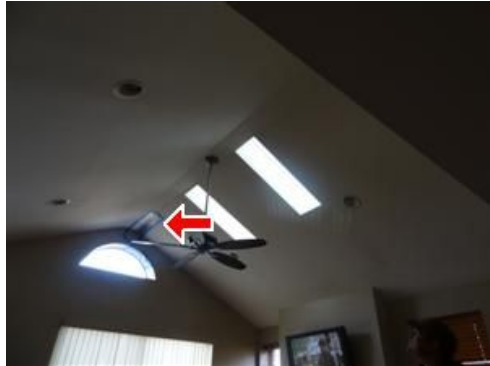
E. Picture 2 Cathedral ceiling at Unit 3N

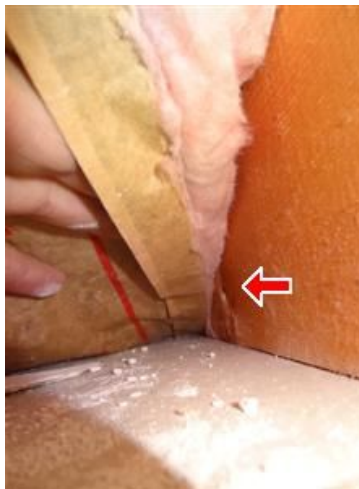
E. Picture 4 Improper Insulation

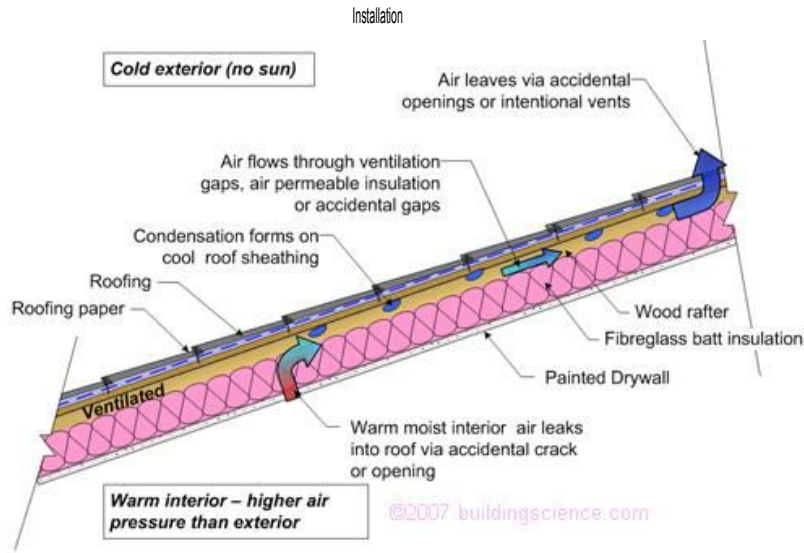
E. Picture 5 Faulty Insulation/Ventilation at Cathedral Ceiling Diagram

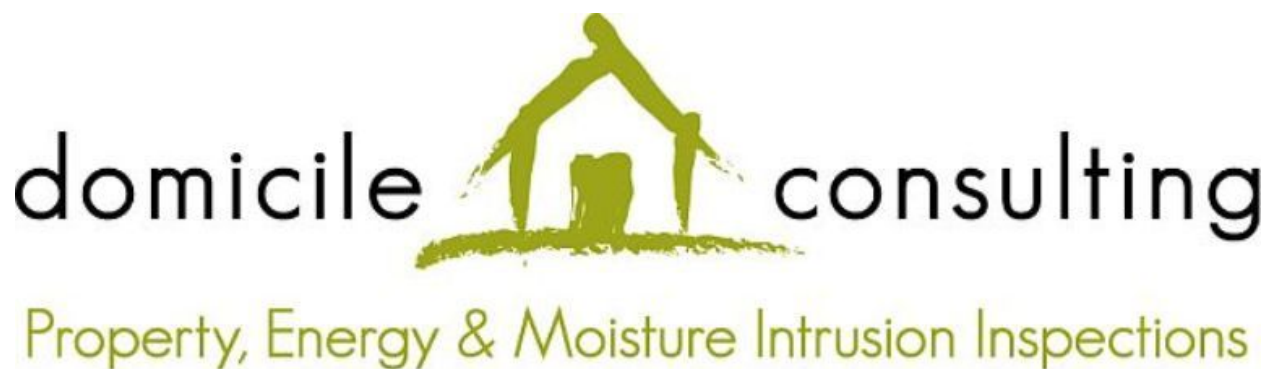
### PROTECTING YOUR PROPERTY INVESTMENT
