Property, Energy & Moisture Intrusion Inspect

Inspection Report

Domicile Consulting

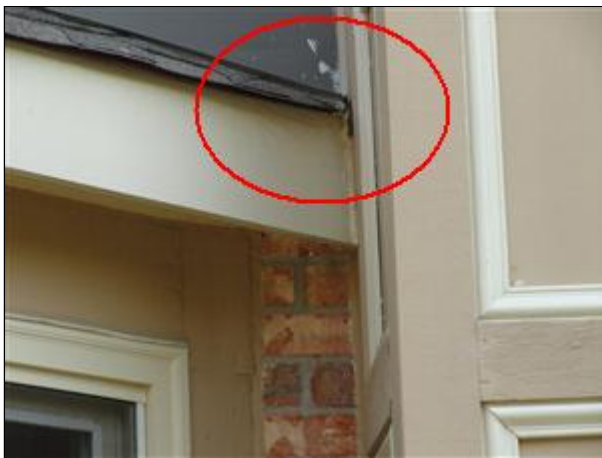
A. Picture 2 avoid flat surfaces when possible

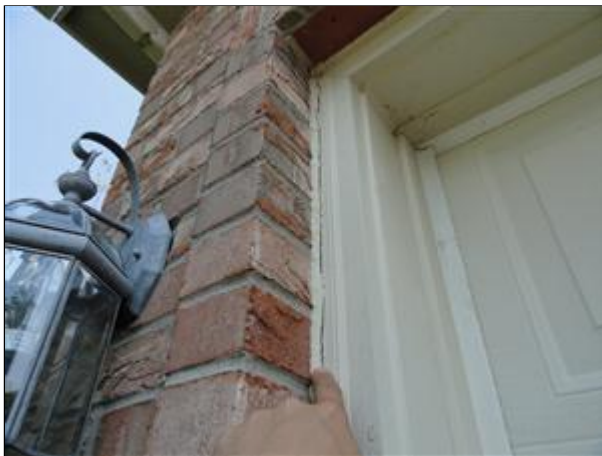
A. Picture 4 trim collections areas prone to moisture

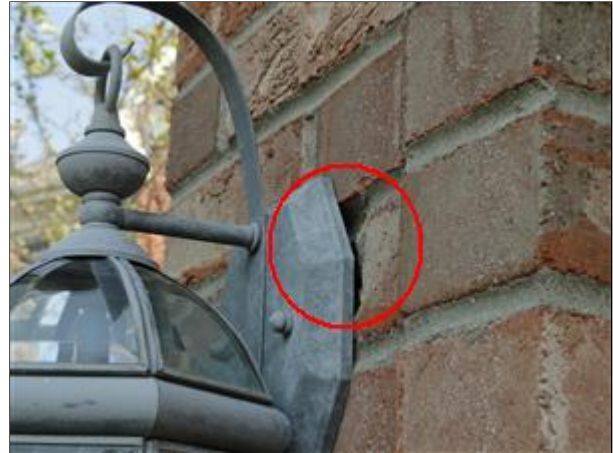
(2) Caulking is recommended at the top and sides of the exterior electrical lighting fixtures, equipment and outlets in order to prevent moisture penetration into the home and/or moisture contact with energized electrical equipment.

A. Picture 8 seal exterior electrical fixtures

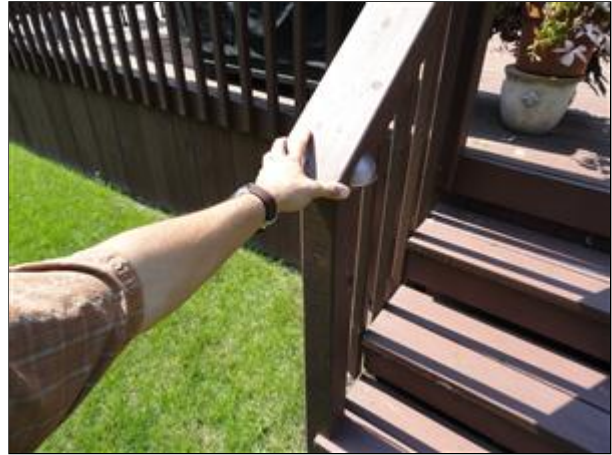
(7) Several areas of the decking require repairs or adjustments for continued service and safety. No access was available beneath the deck to view the ledger connection to the home (please see following comment regarding flashing, Sect D.). A qualified carpentry contractor is recommended for these repairs.

A. Picture 14 stringer/post/tread soil contact

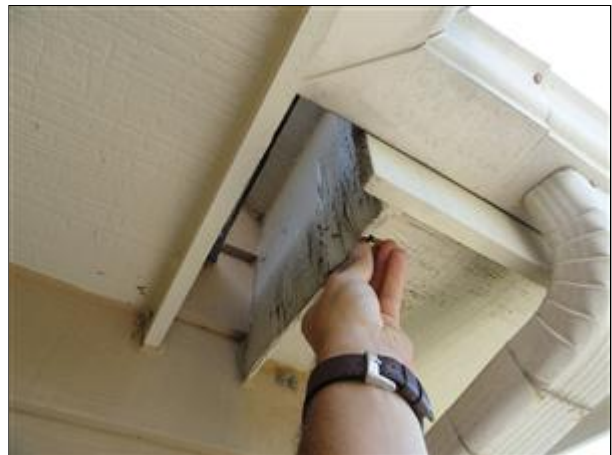
A. Picture 18

(8) Rotted trim was noted at the SW corner soffit and mid West above gutter line and will require replacement.

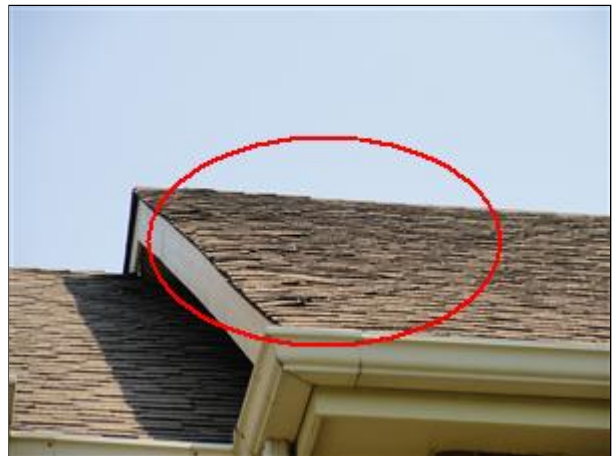
(1) Heavy granular erosion/loss and fiberglass composition exposure of the composition shingles indicates they are at their useful service life's end and will require very near future replacement. The Client should budget for approximately \$10-12k for a tear off and re-roof, preferably with the lightest color acceptable for extended service and solar load reduction.

C. Picture 3 note shingle wear

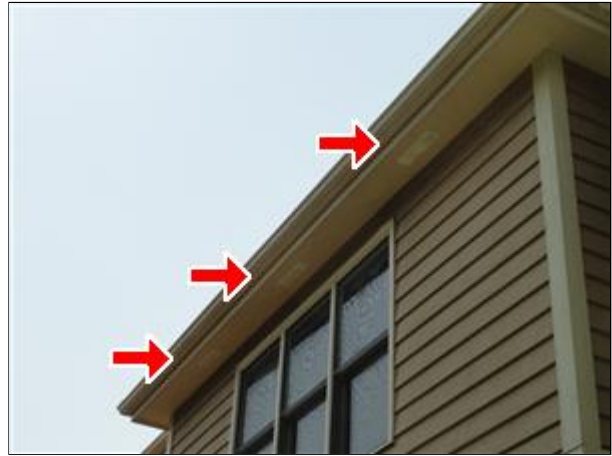
(4) The attic spaces are not properly insulated or ventilated. Therefore the following recommendations are made: The eave ends of **all** the rafters channels should have insulation baffles installed in them in order to promote low-to-high attic ventilation and to reduce the tendency for ice damming and condensation to occur at this location. All ceiling penetrations through the attic floor should be sealed to maintain a pressure boundary. Attic insulation installed against sidewalls, kneewalls or skylight shafts should have an air barrier (housewrap, drywall, rigid foam board w/flame suppression, etc.) to reduce 'washing' of fibrous insulation which does not resist airflow. The attic insulation should be increased to a minimum of R-49 and the attic scuttle(s) should be weather stripped and insulated (typically 3 layers of rigid foam board glued to hatch). **Also, additional low ventilation points should be added preferably at the soffit.** Evaluation and repair by a licensed and competent specialty contractor is recommended in order to promote effective attic ventilation and reduce energy losses. Balanced airflow between high and low positions in the roof is paramount for proper performance.

C. Picture 7 increase ventilation

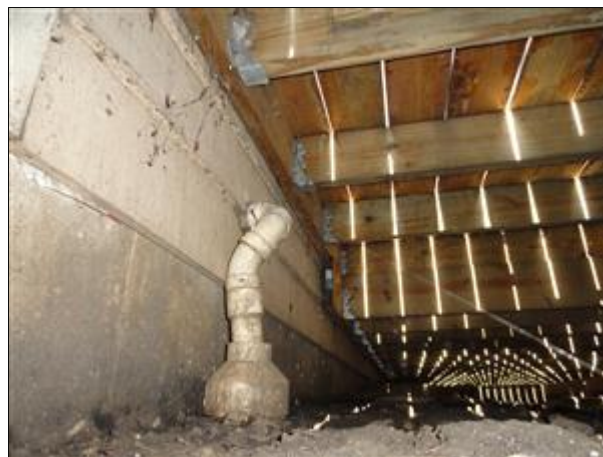
(1) INFORMATIONAL (no access beneath deck): The deck ledger is not properly flashed and should be repaired. This critical flashing should be installed in order to prevent moisture from entering the wall cavity and loosening or weakening the structural connection between the ledger board and wall framing--essentially the most important connection in the deck structure for safety as the vast majority of deck failures occur at this location according to several construction and safety organizations. [North American Deck and Railing Association](#)

D. Picture 1 inconclusive view from gap at South

In addition, ledger spacing can also increase the performance and service life of the ledger/deck system and building wall cladding through the use of spacers such as these [Ledger Wall Spacer](#). This does not remove the need for a ledger flashing or properly detailed deck attachment to the structure.

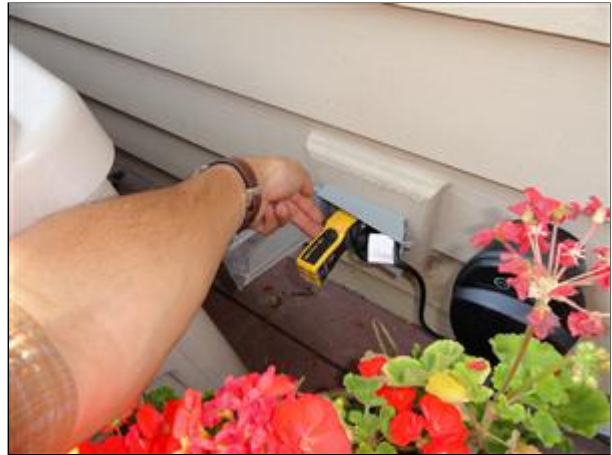
The exterior GFCI receptacles are aged and did not respond to instrument or manual trip functions. They should be replaced for safe and proper function.

E. Picture 1 replace aged receptacles

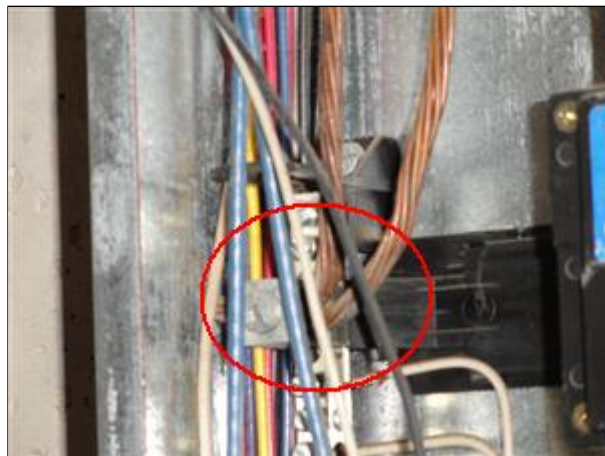
(2) The main grounding and bonding electrodes must terminate on individual lugs for proper performance in the event that if one should become loose, so would the other. A qualified electrician should repair as soon as possible.

E. Picture 4 install second lug

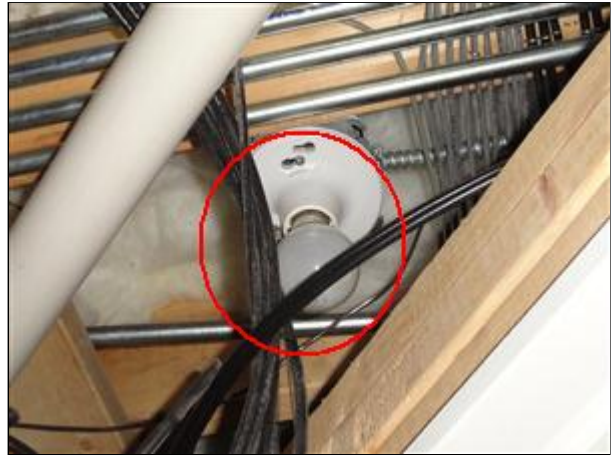
E. Picture 6 avoid bare bulb fixtures, risk of fire-- upgrade to covered or low profile fluorescent (sump closet here)

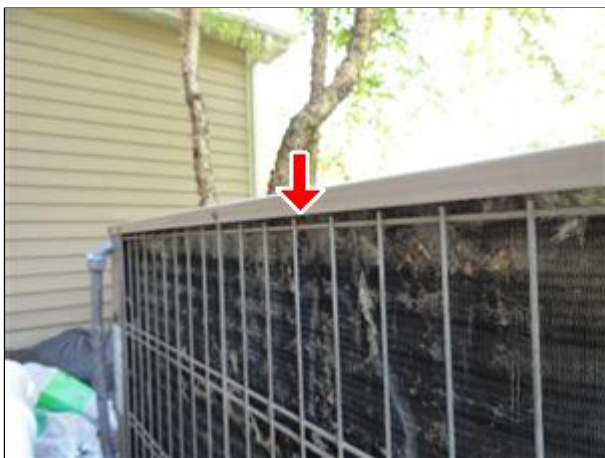
(1) The condensing unit is 13 years old and nearing its useful service life's end. Budgeting for its near future replacement is recommended and may require slightly reduced sizing if energy improvements are implemented. A cooling load calculation is recommended prior to this replacement.

Moderate cooling temperatures were recorded at the time of inspection; recommend a servicing of unit.

F. Picture 1 clean exterior of unit

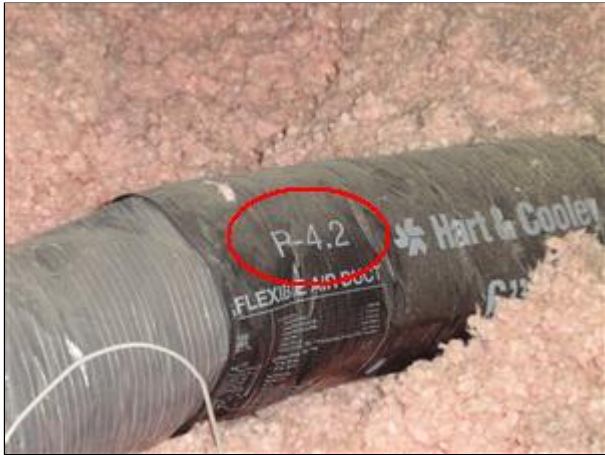
(4) The Department of Energy recommends insulating ductwork in unconditioned spaces to a level of at least R-8 for maximum delivered comfort and efficiency.

F. Picture 6 increased insulation and LESS flex duct use is recommended

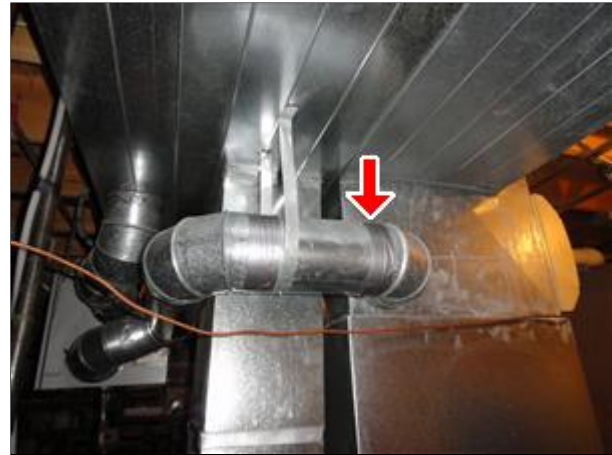
The cloth tape duct sealing should be removed and replaced with proper UL approved foil tape or duct mastic for extended service life and performance. Cloth duct tape fails 100% of the time in laboratory tests.

F. Picture 7 upgrade material

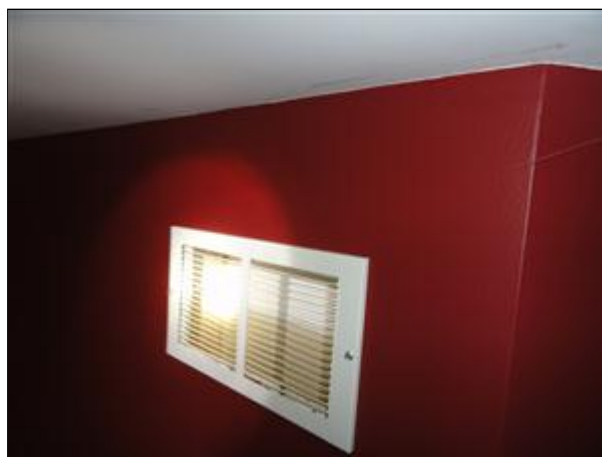
(8) Some of the return ductwork in the home is "panned". While allowable by some codes, panned ductwork is not ideal as it uses the framing cavities instead of dedicated ductwork for its return or supply path. This can introduce allergens and particulates as well as unconditioned air from adjoining interstitial spaces into the conditioned airstream and increase energy costs. The use of dedicated ductwork is recommended and should be evaluated by a qualified HVAC contractor.

F. Picture 10 panned ductwork

NOTE for those return ducts at 2nd floor that ARE NOT routed through attic-- a simple, but not perfect, repair is to remove the existing grille and install a piece of rigid foam cut neatly to size and wedged/sealed in the wall cavity ABOVE the return as the routing of these returns are below the grille back to the furnace.

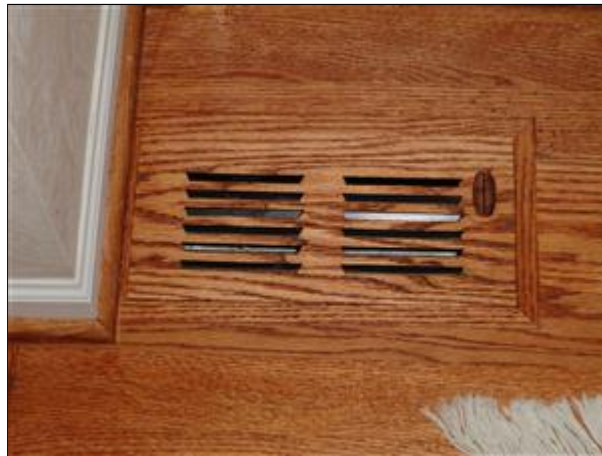
(9) The decorative wooden HVAC registers are known to restrict airflow in the 25-40% range. This can pressurize the HVAC system and shorten critical components' life while reducing the system's efficiency and delivered comfort. The registers should be replaced with those of the highest net free area to allow as much airflow as possible to maximize comfort and energy savings and prolong mechanical equipment service life.

F. Picture 11 upgrade registers

Additionally, the registers should be pointed toward the outside wall for maximum energy savings and comfort so as to dilute the hot/cold outer wall as well as prevent short circuiting the heating cycle by blowing directly towards return air grilles, if present.

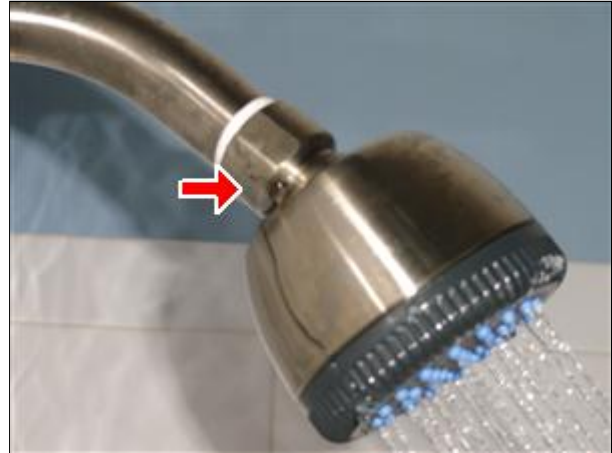
G. Picture 2 low master water volume, shower

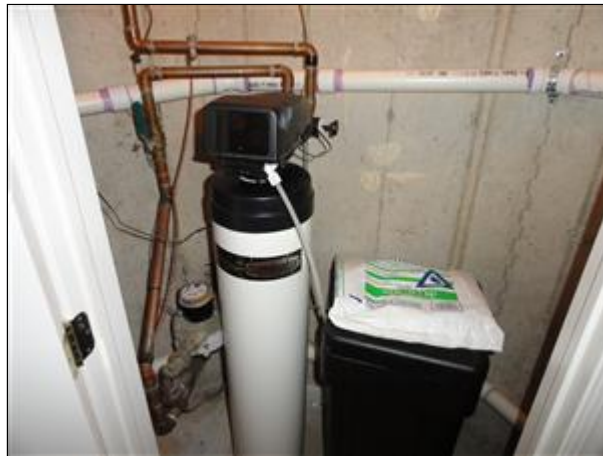
(5) Any operating instructions (tips, nuances) regarding the water conditioning equipment should be made available by the Seller to Buyer for reduced risk of malfunction.

G. Picture 11 water softener

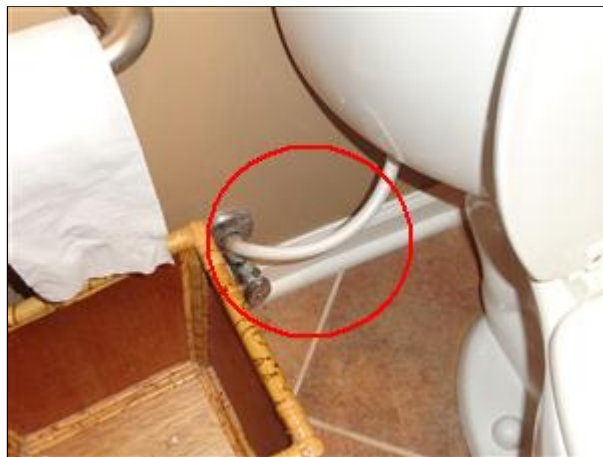
(6) The installation of stainless braided supply lines is recommended for each fixture to increase abrasion, puncture and bursting resistance levels.

G. Picture 12 basement toilet line

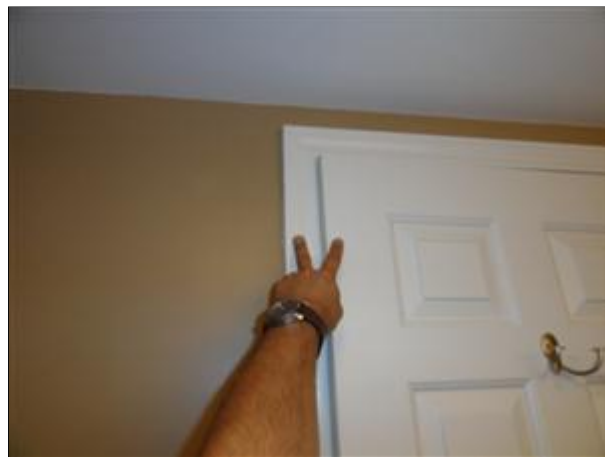
H. Picture 4 install button caps for appearance

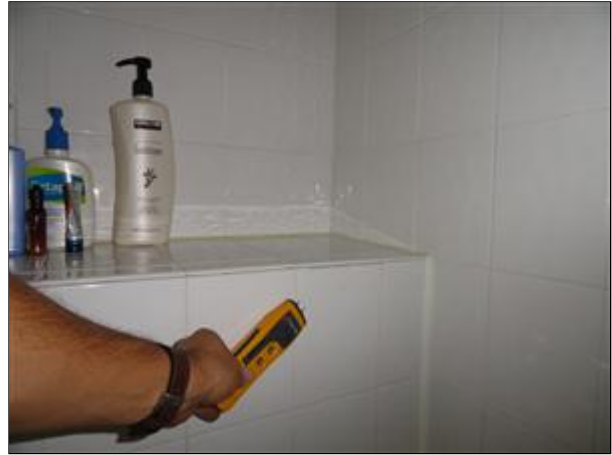
H. Picture 6 baseline moisture reading

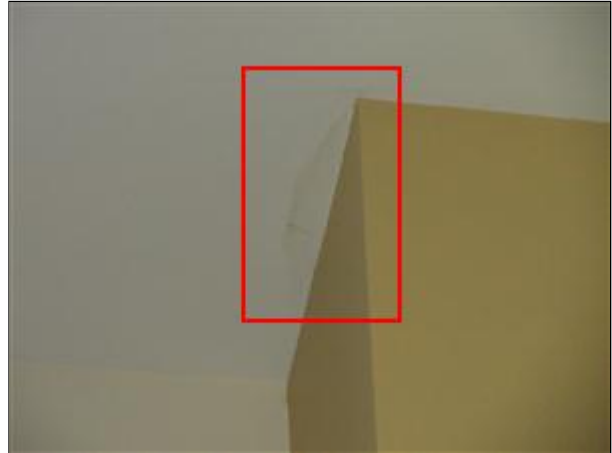
H. Picture 10 flashings may have degraded

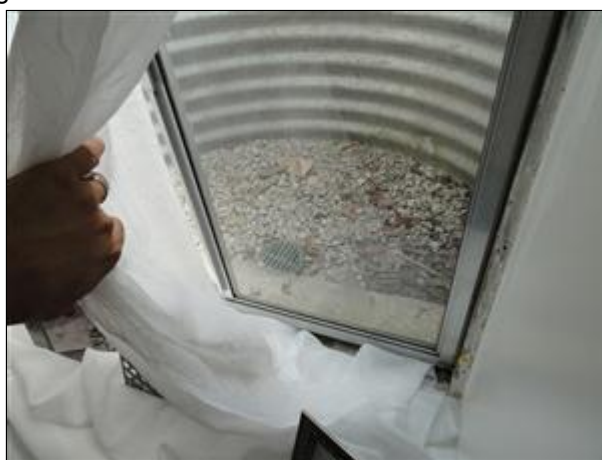
(4) The single pane, metal frame basement windows are poor performers in terms of energy savings. The Client is recommended to upgrade to at least a double pane, thermally glazed window. Care should be taken to follow all local fire and egress codes in terms of sizing and window construction.

J. Picture 4 inefficient windows

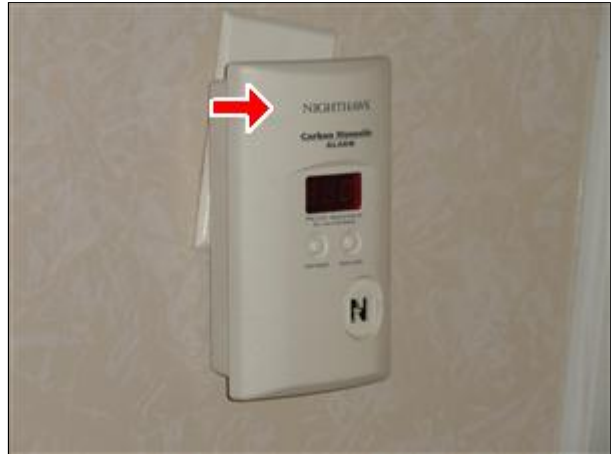
L. Picture 1 aged detectors, replace due to low cost vs critical function

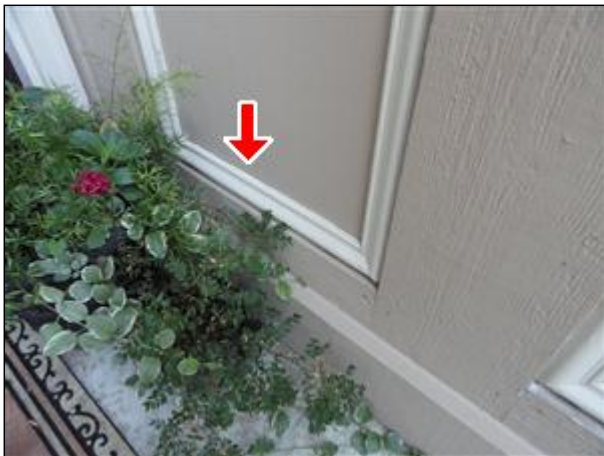
Item 1 - Picture 1 periodically inspect inset trim for water collection

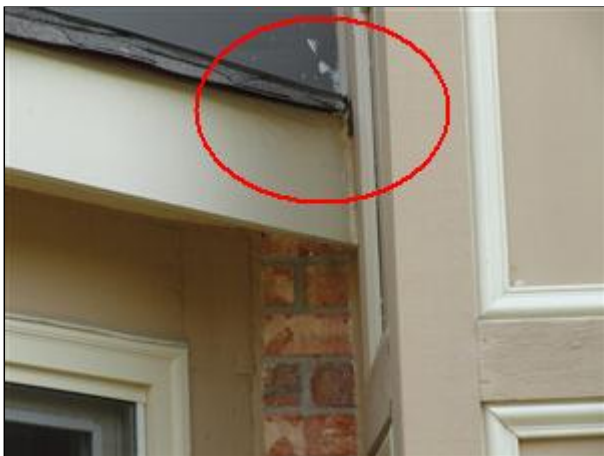
Item 1 - Picture 3 recommend diverter flashing and/or modified gutter and downspout to avoid splashing/saturation at front bay

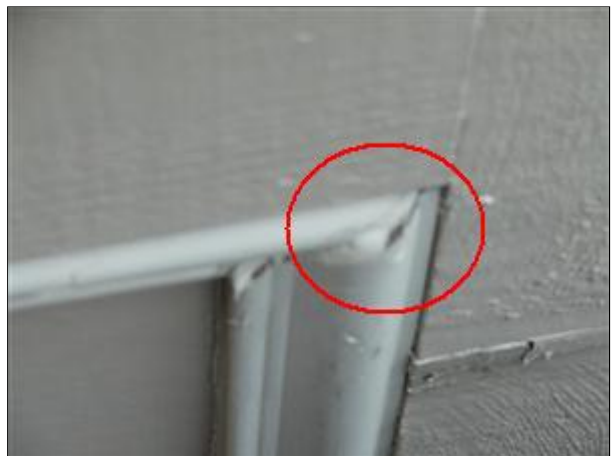
Item 1 - Picture 4 trim collections areas prone to moisture

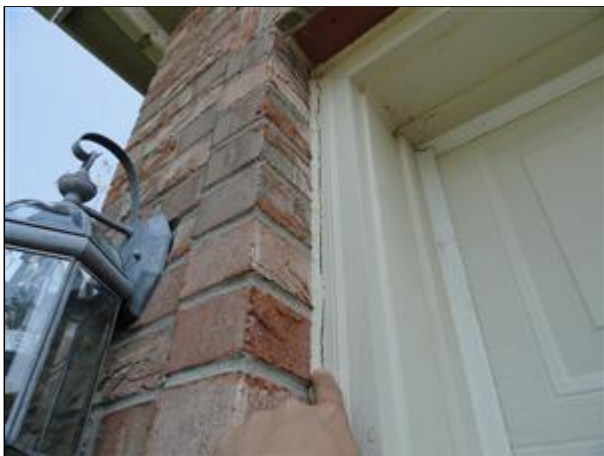
Item 1 - Picture 5 aged sealant, garage i.e.

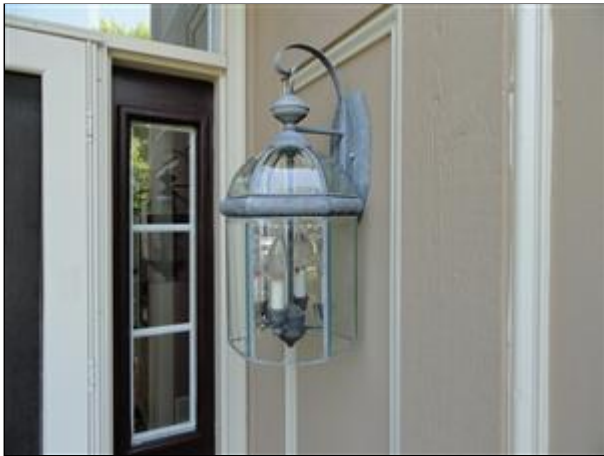
2. (2) Caulking is recommended at the top and sides of the exterior electrical lighting fixtures, equipment and outlets in order to prevent moisture penetration into the home and/or moisture contact with energized electrical equipment.

Item 2 - Picture 1 seal exterior electrical fixtures

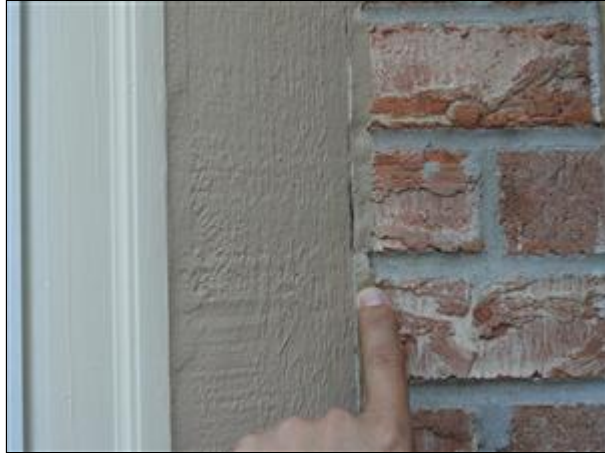
3. (3) All dissimilar elements at the exterior walls of the home such as: brick-to-stone; brick-to-concrete block; concrete block-to-glass block, etc. should be joined one to the other and sealed against moisture through the use of backer rod and urethane caulk or its equivalent. These dissimilar elements have differing coefficients of expansion and contraction in relation to temperature and moisture. This can lead to cracking of the cladding material and/or of the mortar joints. The existing cement mortar joints should be ground out and replaced with the appropriate backer rod and ASTM approved caulking. This procedure is in keeping with the standards set forth by the Brick Industry Association. Further information is available at www.bia.org

Item 3 - Picture 1 repair sealant joints as needed

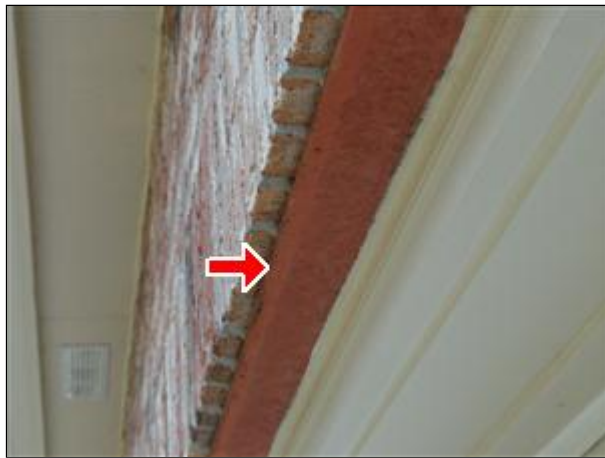
- 4. (4) All of the steel window and door lintels should be finish painted in order to provide protection against corrosion and also for proper appearance.

Item 4 - Picture 1 prep and finish paint lintels

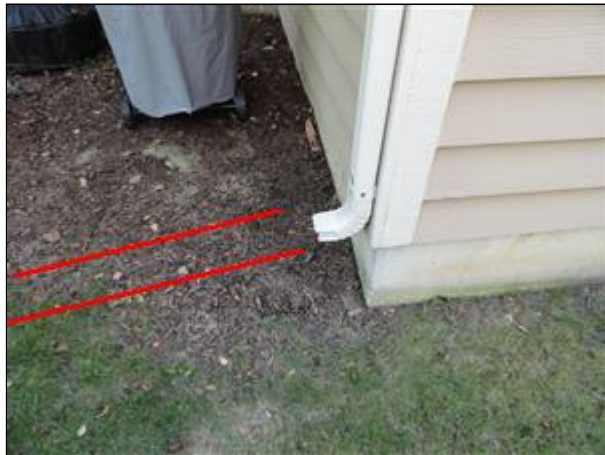
Item 5 - Picture 1

- 5. (5) The downspouts around the home should extend approximately 6 feet away from the basement foundation walls to well-drained areas in order to reduce the risk of soil saturation and basement seepage.

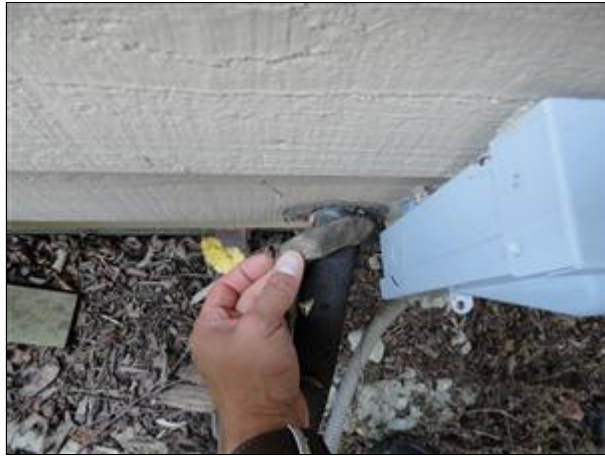
- 6. (6) **ALL** exterior wall penetrations such as: piping, conduit, vent caps, etc. should be sealed against moisture intrusion through the use of the appropriate caulking methods and materials.

Item 6 - Picture 1 loose putty at a/c lineset

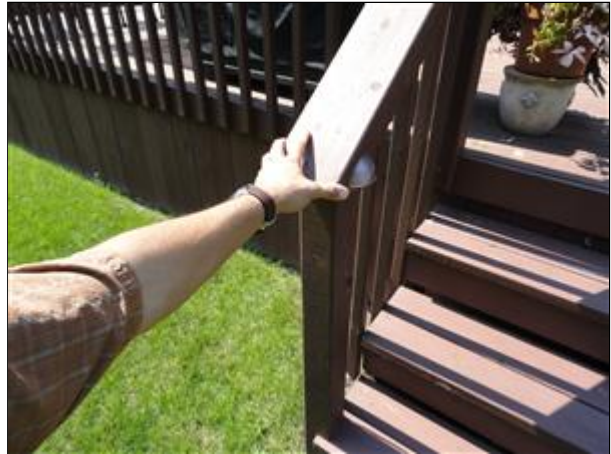
Item 7 - Picture 2 loose handrail

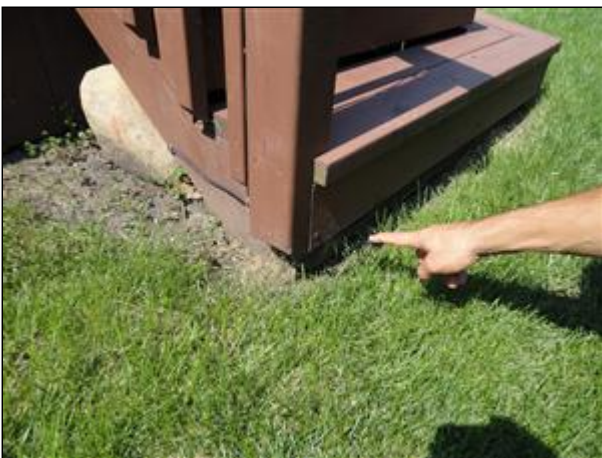
Item 7 - Picture 3 stringer termination not on concrete or stable surface

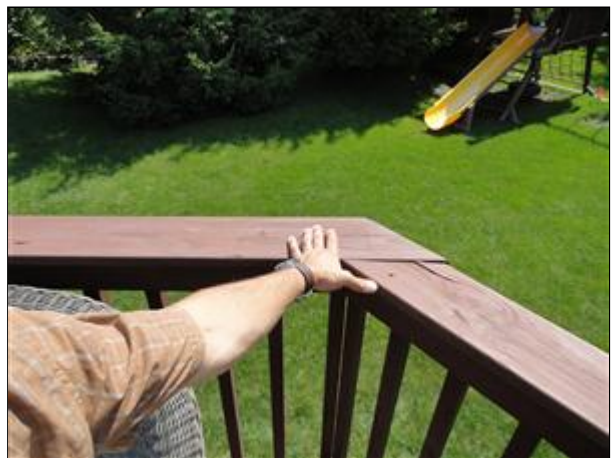
Item 7 - Picture 4 improve lateral load resistance

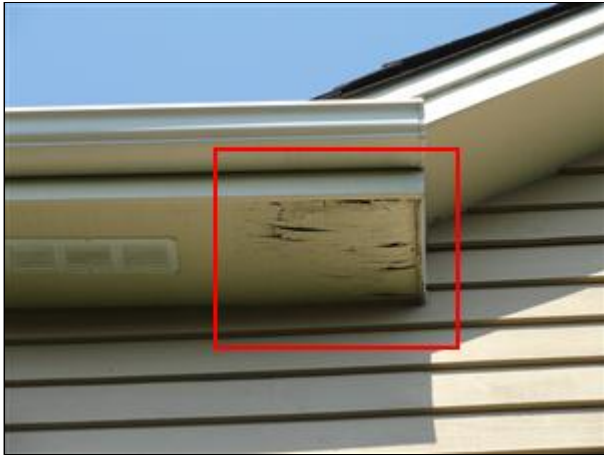
Item 8 - Picture 1

8. (8) Rotted trim was noted at the SW corner soffit and mid West above gutter line and will require replacement.

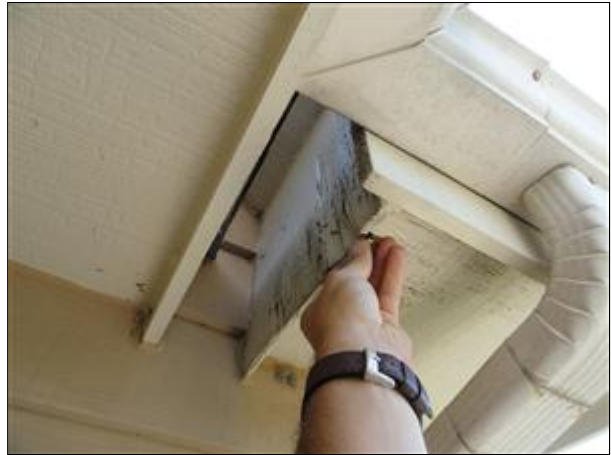
Item 8 - Picture 2 awkward routing of roof drainage

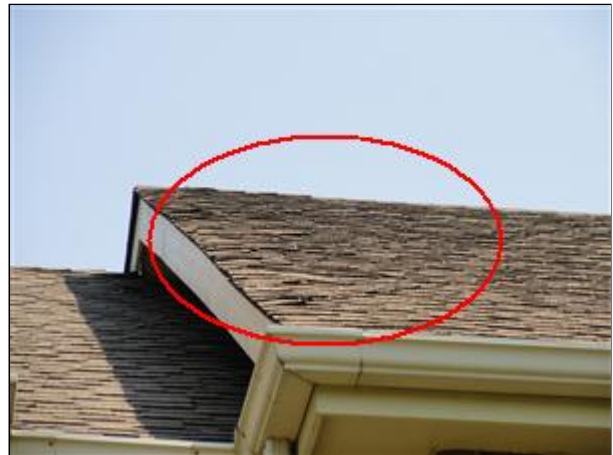
Item 13 - Picture 4 beginning shingle curling, indication of 'dying' shingle

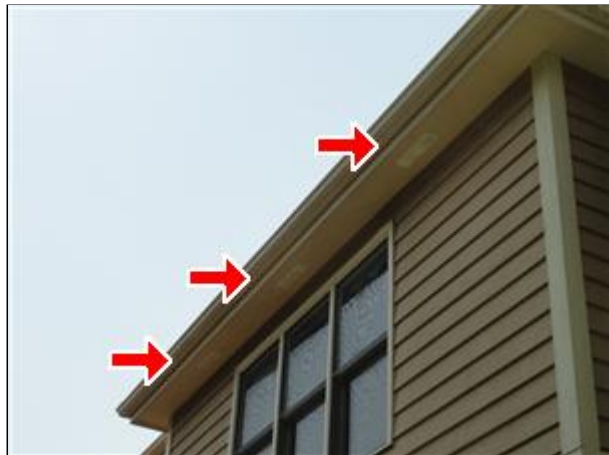
Item 16 - Picture 2 recommend increased soffit ventilation

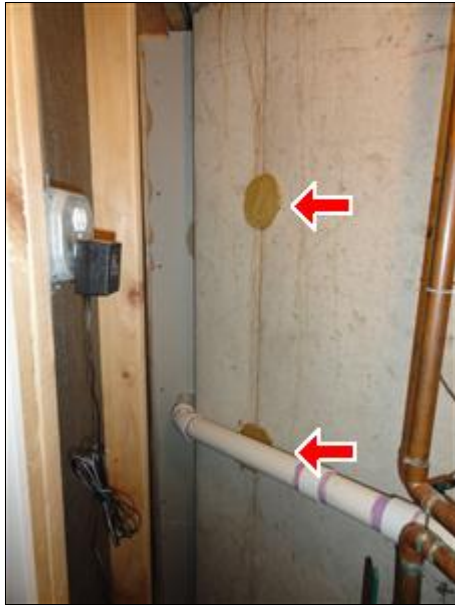
Item 19 - Picture 1 West basement

19. (3) Any information or warranty status of the foundation epoxy repairs is recommended to be presented to the Buyers for evaluation. The repairs and foundation at this area appear to be stable and functioning properly.

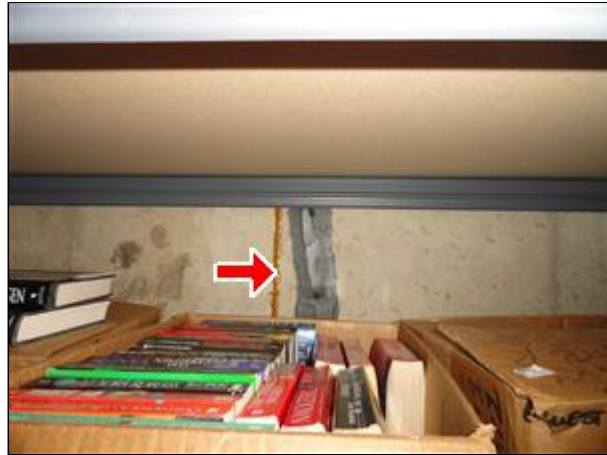
Item 19 - Picture 2 East basement foundation repairs

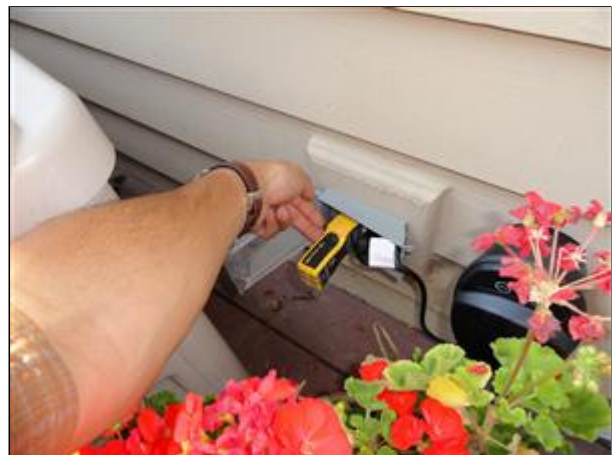
Item 20 - Picture 2 deck, improper horizontal cover orientation

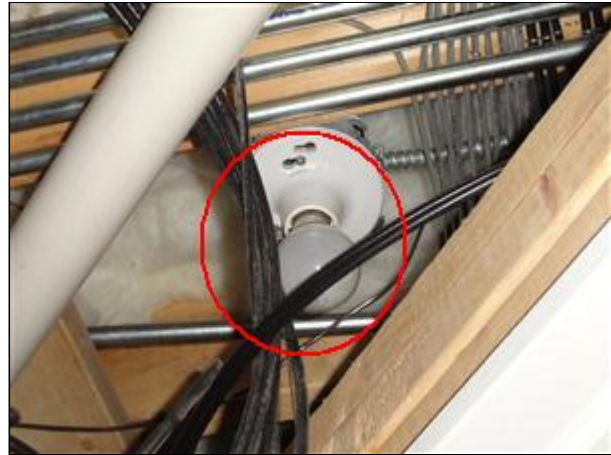
Item 22 - Picture 2 avoid bare bulb fixtures, risk of fire--upgrade to covered or low profile fluorescent (sump closet here)

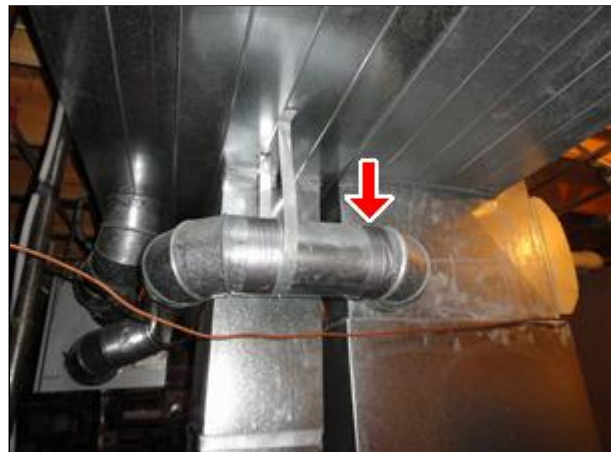
Item 26 - Picture 2 upgrade material

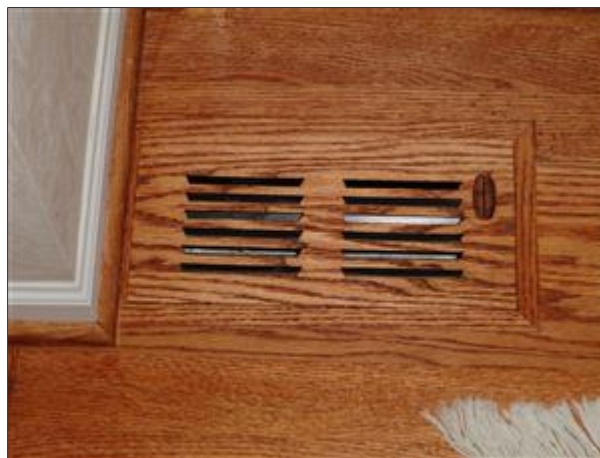
Additionally, the registers should be pointed toward the outside wall for maximum energy savings and comfort so as to dilute the hot/cold outer wall as well as prevent short circuiting the heating cycle by blowing directly towards return air grilles, if present.

Item 31 - Picture 1 upgrade registers

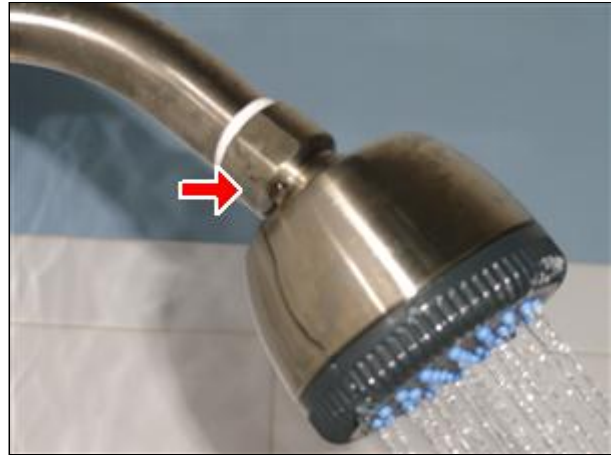
Item 36 - Picture 2 small leak, guest bath 2nd fl

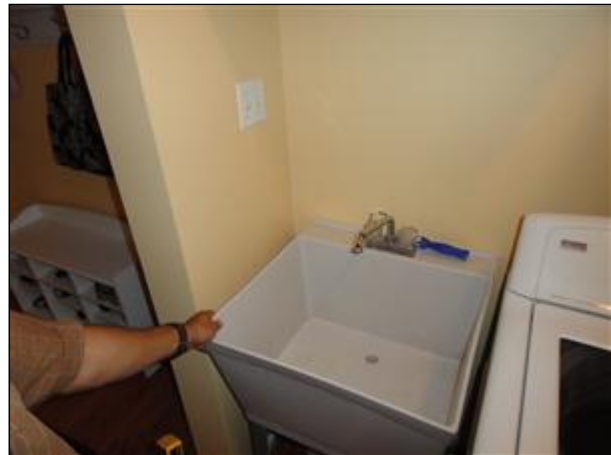
Item 36 - Picture 4 loose utility tub

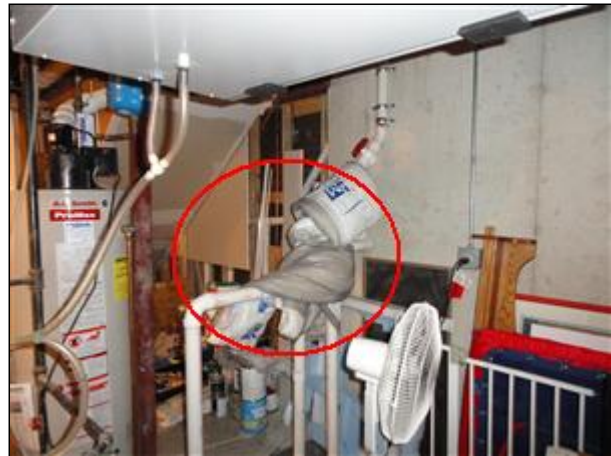
Item 36 - Picture 6 install add'l supports for ejector pit piping to avoid 'hammer' and risk of leaking

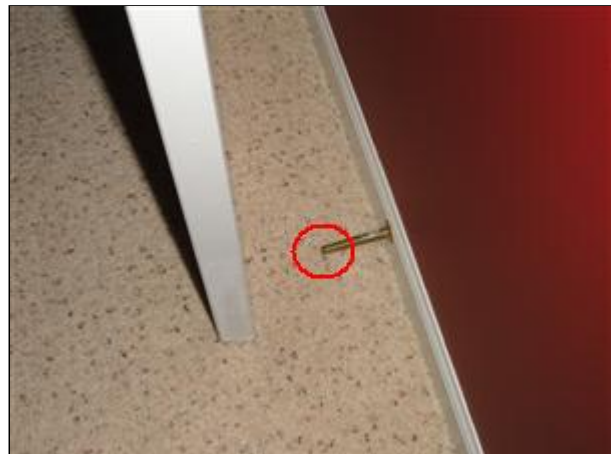
Item 42 - Picture 2 add rubber caps to avoid door damage

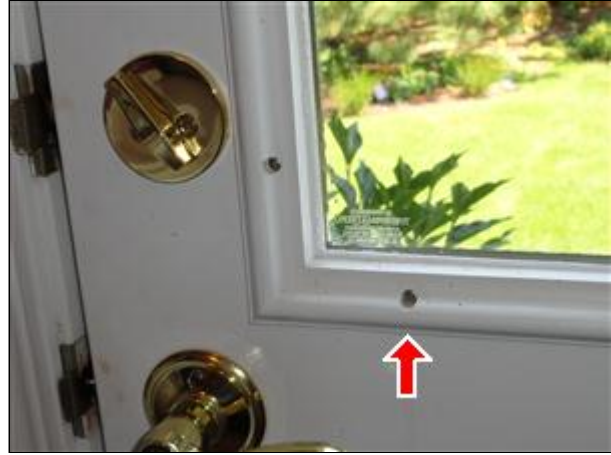
Item 42 - Picture 4 install button caps for appearance

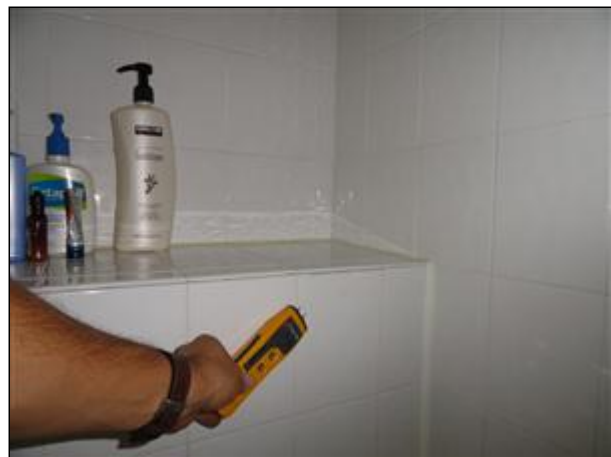
Item 43 - Picture 2 buried meter indicating saturation

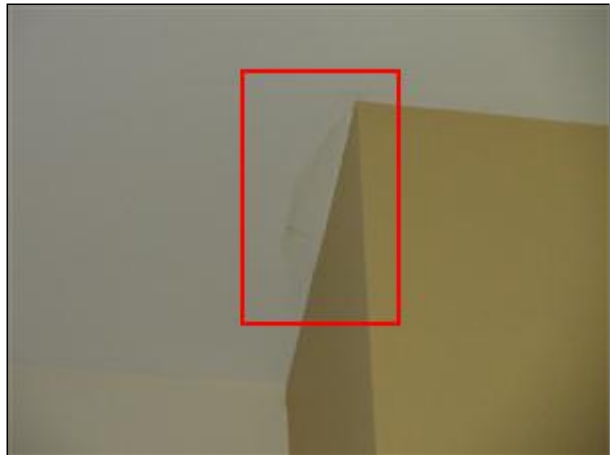
Item 45 - Picture 2 ceiling stain

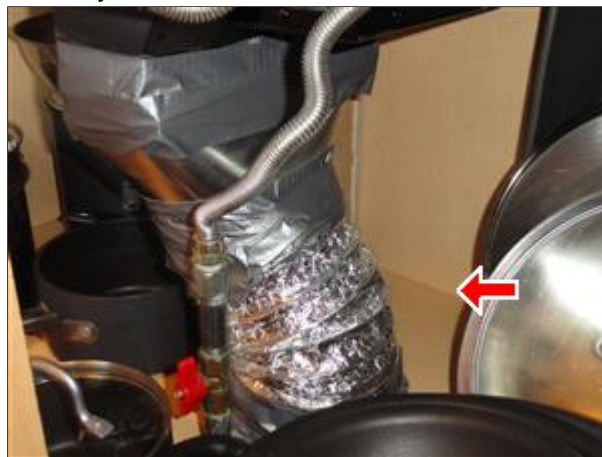
48. (1) The use of smooth wall metal venting is recommended for the kitchen exhaust to avoid grease collection within the corrugations of the existing vent which may cause odor or health issues over time as well as reduce performance.

Item 48 - Picture 1 upgrade venting

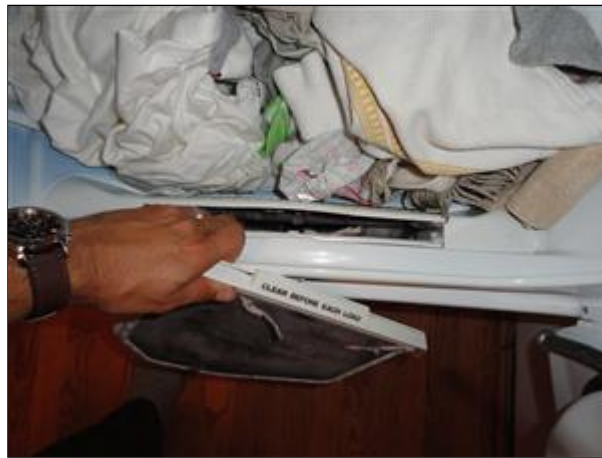
50. (3) Lint build-up was noted inside the vent passages of the clothes dryer. These passages and any vent piping should be cleaned in order to reduce the risk of dryer fire, reduce drying times, and to maximize the service life of the clothes dryer.

Item 50 - Picture 1 clean lint passages

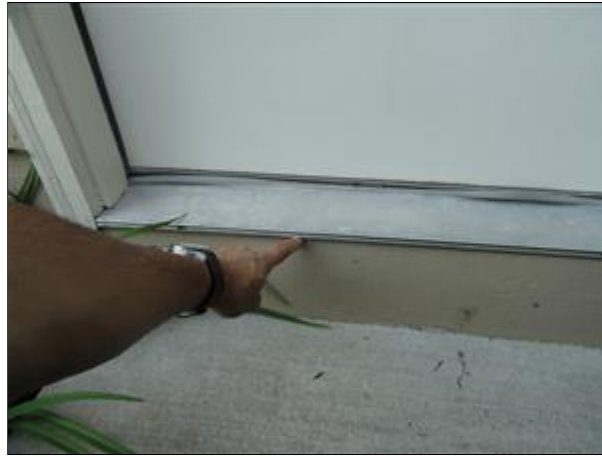
Item 52 - Picture 1 laundry door

52. (1) A drip edge flashing is recommended (preferably end dammed) at the rear laundry door to reduce the risk of moisture entry beneath the door sill and apron.

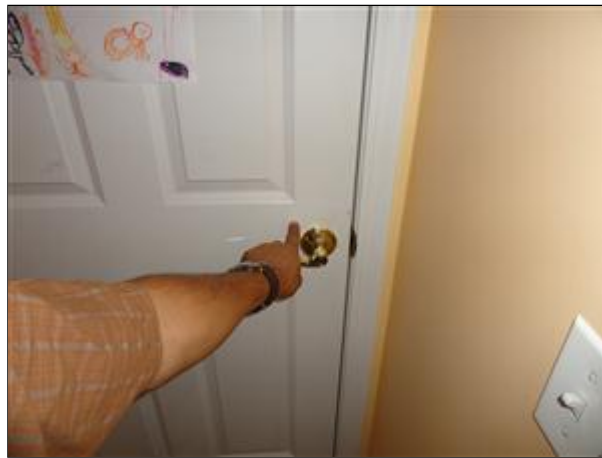
Item 53 - Picture 1 SW bedroom

53. (2) All doors should be adjusted so that they fit snugly in the strikeplates and don't rattle or have excess movement when shut.

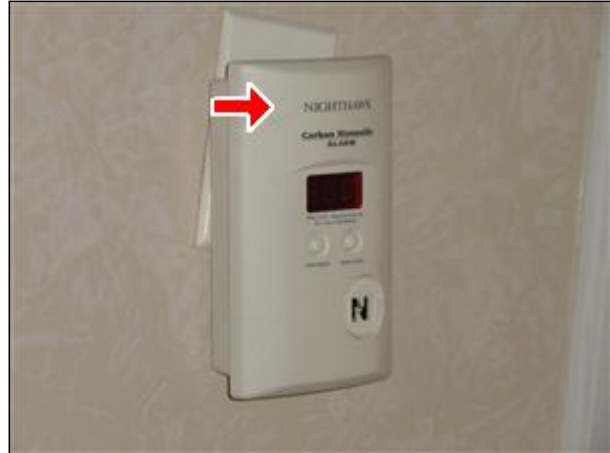
Item 57 - Picture 2 manufacturer/model with high rate of failure
