Property, Energy & Moisture Intrusion Inspections

Inspection Report

Property Address:
4455 West Waverly Place
Anytown IL 60000

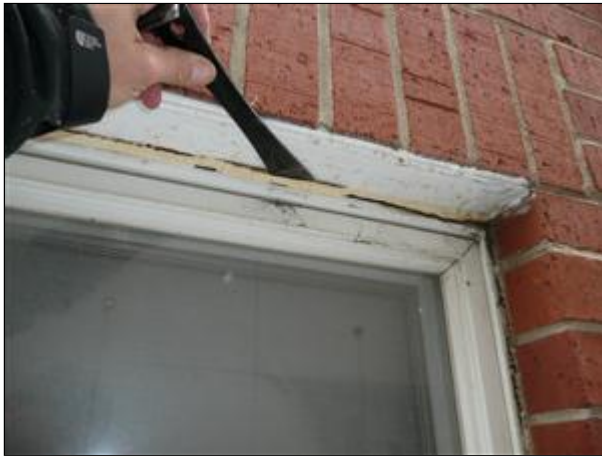
(1) Exterior sealant has an approximate lifespan of 3-7 years in our climate. The use of ASTM C 920 compliant exterior rated sealants of good quality and joint preparation is recommended for increased service life, performance, and aesthetics. Several sources regarding caulking preparation can be found online, especially here: [Caulking 101](#).

A. Picture 1 multiple, if not all windows, require sealant replacement

All caulk joints should be inspected annually and repaired as needed.

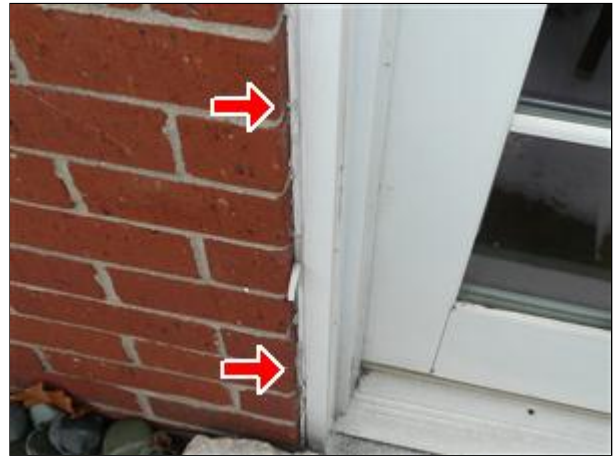
A. Picture 2 east door trim

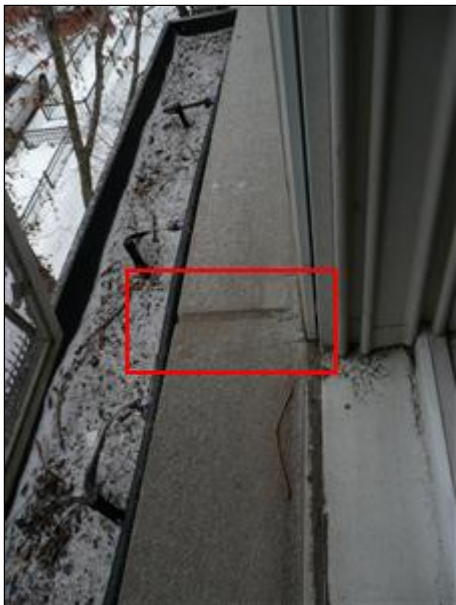
(2) The mortar joints between the stone window/door sills should be sealed with a high-quality masonry caulking compound to reduce the risk of moisture saturation and damage to the brick masonry below.

A. Picture 3 master BR window, i.e.

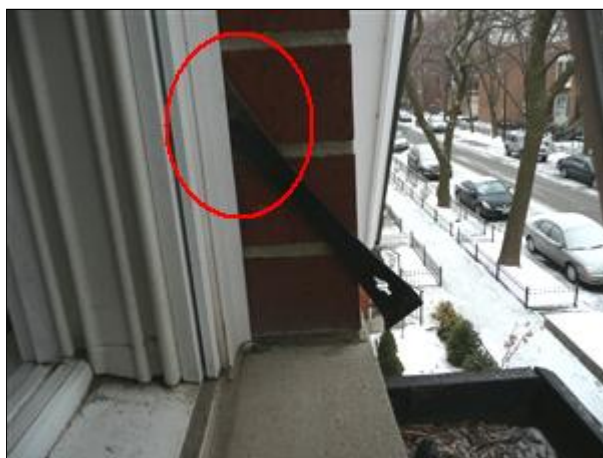
A. Picture 5 seal window trim gaps

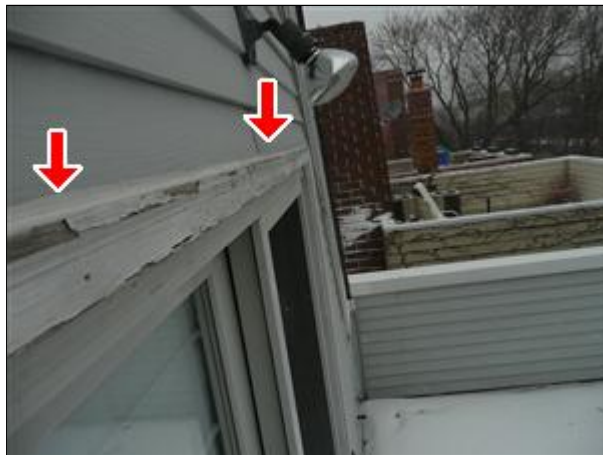
A. Picture 6 install head flashing, replace/repair aged trim

(4) The use of a head flashing versus relying on sealant is recommended at the office door head casing for maximum protection.

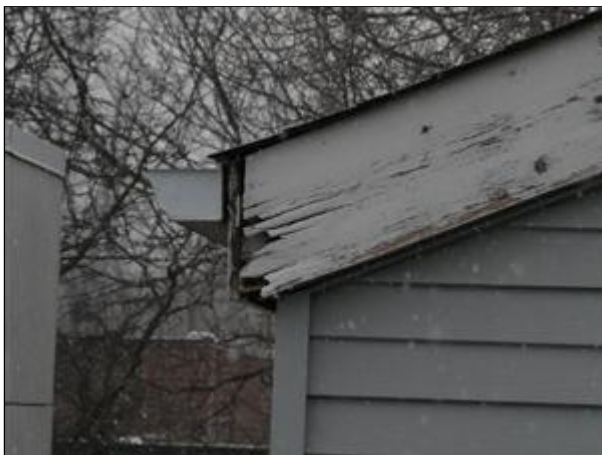
(5) The aged wood rake trim should be replaced, preferably with a composite type of material for prolonged service life.

A. Picture 7 replace rake fascia

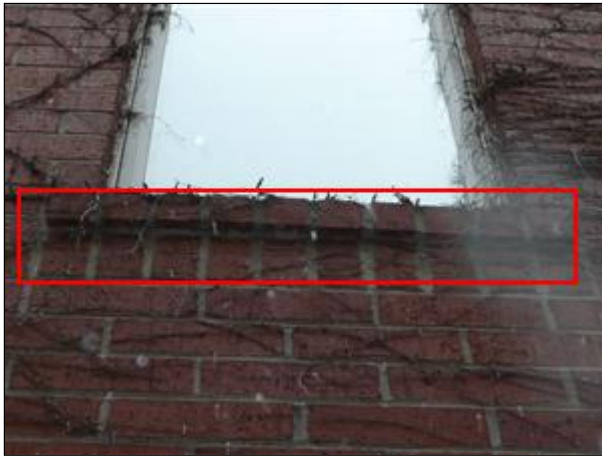
(6) The masonry wall flashings are either missing or improperly installed. The flashings should protrude from the wall by at least 1/4" at the following locations: the top of the foundation wall; above the masonry pockets where the floor joists are set into the concrete block; tops of parapet walls and decorative capstones; and **above and below every window and door**. Missing or improperly installed wall flashing can allow moisture to enter the home and cause rot, mold growth, and structural damage. If replacement of the flashings is to commence, the use of copper or similar metal flashing or high quality rubberized/elastomeric material and stainless steel drip edge is highly recommended to prevent UV degradation of the flashing material and to prolong its service life as well as keep water from saturating the masonry walls and contributing to excess moisture loads. The exterior masonry walls of this structure should be evaluated and repaired by a licensed and competent masonry contractor.

From Brick Industry Association, Technical Notes #7: "**Flashing Extension Through Wall:** When possible, flashing should extend beyond the face of the wall to form a drip edge. When using a flashing that deteriorates with UV exposure, a metal or stainless steel drip edge can accomplish this. It is imperative that flashing be extended at least to the face of the brickwork."

A. Picture 9 no flashing evidence below sills

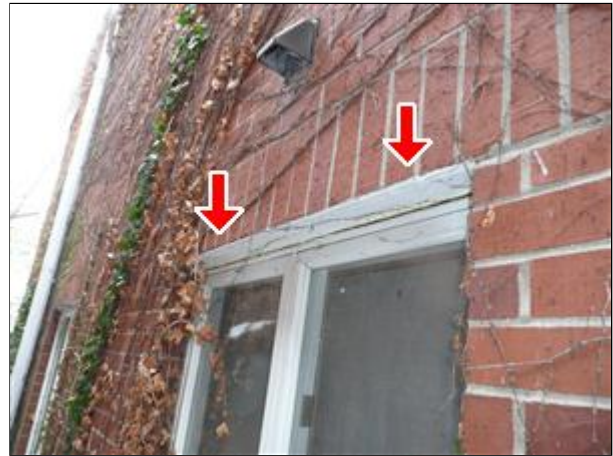
A. Picture 10 sealed lintels increase risk of moisture retention, structural damage

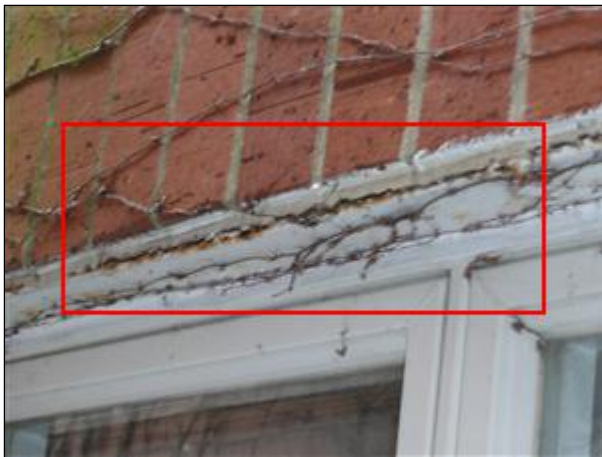
A. Picture 11 rusting lintel, north kitchen window

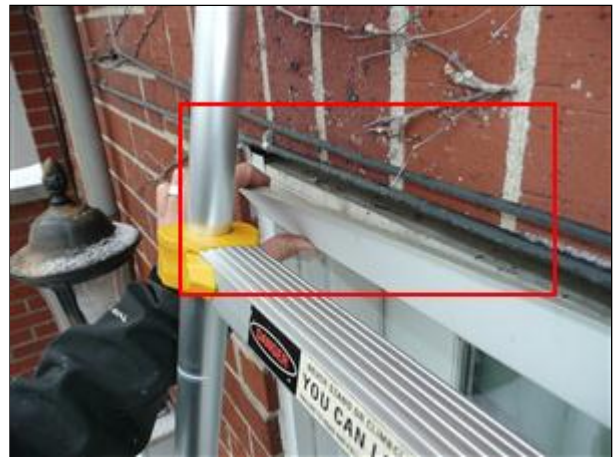
A. Picture 12 east door system header improperly installed/flashed; repair

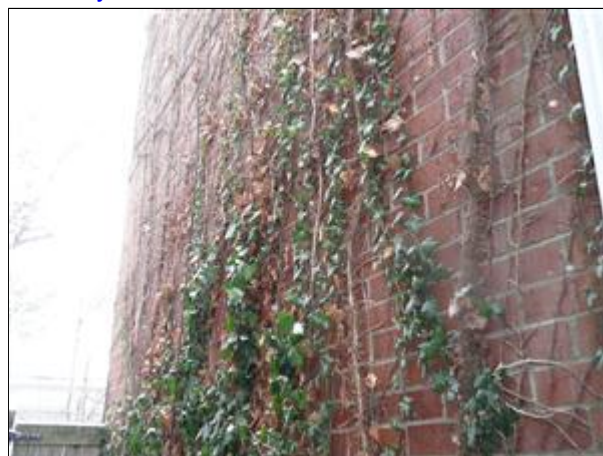
(7) The following article by the Brick Industry Association should be reviewed in consideration of the existing ivy presence at the subject home. Differing opinions exist as to its acceptance or removal. Further evaluation by a qualified masonry contractor may be desired by the Client. [Ivy Growth](#)

A. Picture 13 ivy presence

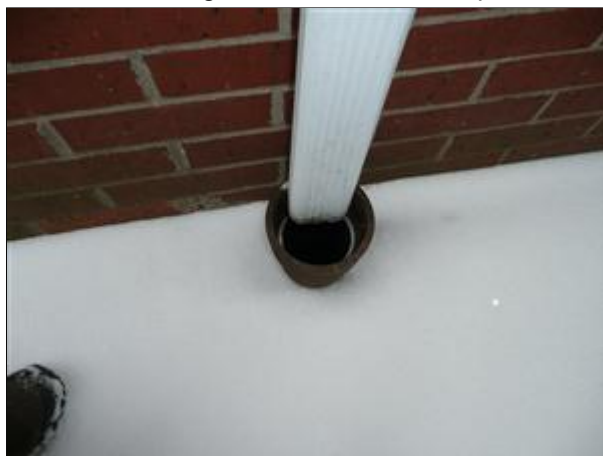
(8) The downspout connection to subsurface drainage should be sealed to prevent foreign object entry and clogging.

A. Picture 14 seal connection

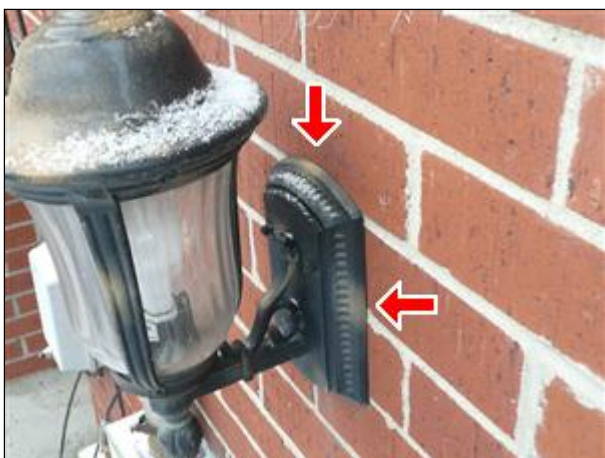
A. Picture 15

(9) Caulking is recommended at the top and sides of the exterior electrical lighting fixtures, equipment and outlets in order to prevent moisture penetration into the home and/or moisture contact with energized electrical equipment.

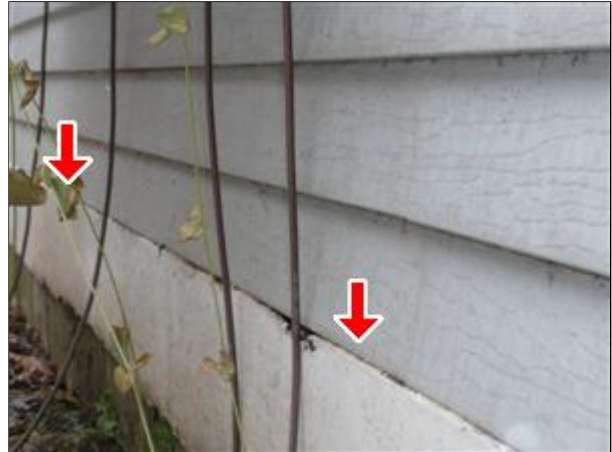
(1) The base garage trim is missing a z-type flashing between it and the aluminum siding above for proper moisture management and should be repaired by a qualified contractor. The base trim should be replaced at that time, preferably with composite material for longer service life and rot resistance.

B. Picture 2 missing flashing or projection of siding over trim

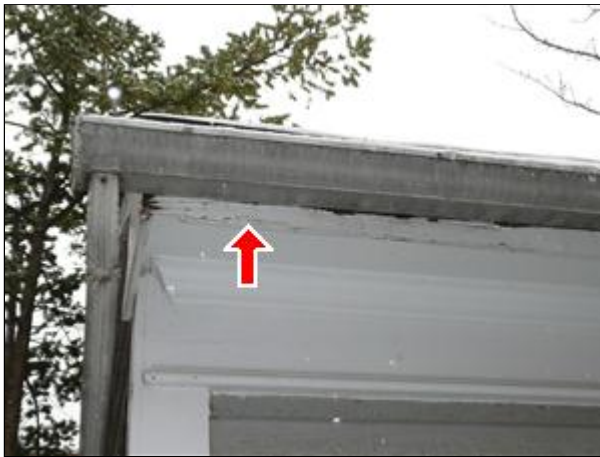
B. Picture 3 aged alley side fascia board

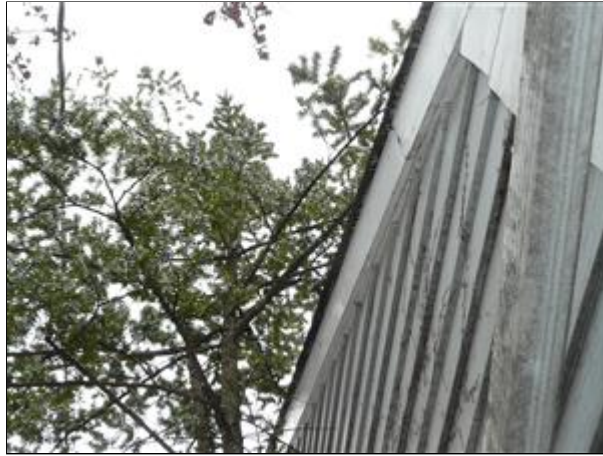
(2) All tree limbs should be kept at least 3 feet from garage surfaces to avoid abrasion as well as pest access.

B. Picture 6 trim branches

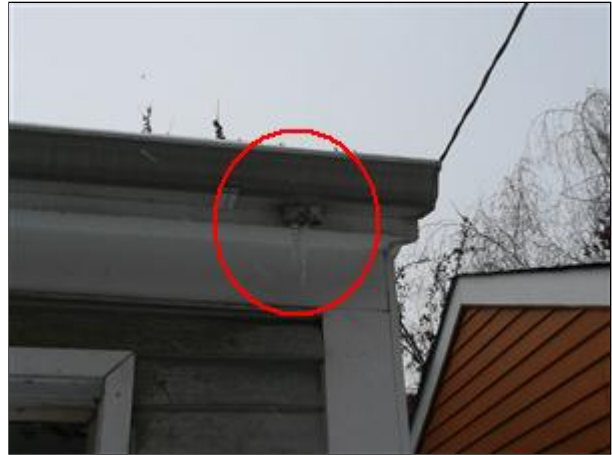
(3) The north downspout should be connected to an additional downspout and routed away from the garage slab where accessible to avoid unnecessary soil saturation and risk of damage to garage framing.

B. Picture 8 missing east downspout(s)

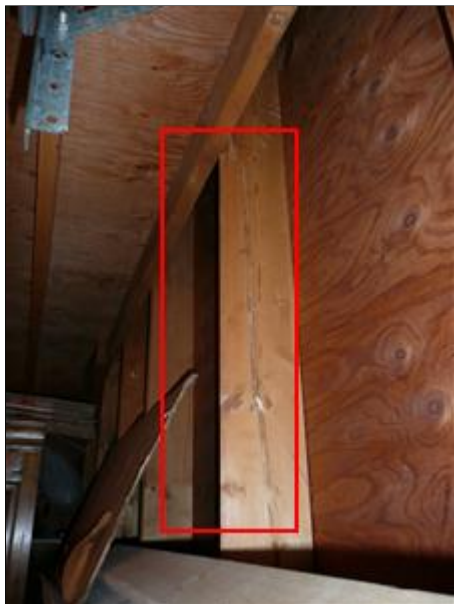
(5) The split wall stud at the north wall should be repaired or replaced for proper wall support and function.

B. Picture 10 split and rotated stud,
north wall

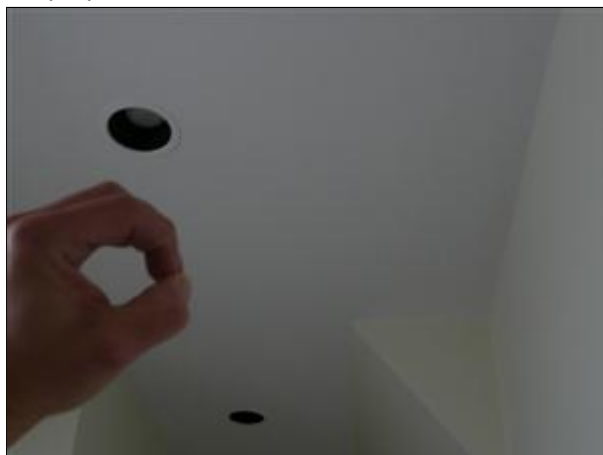
(1) No access to the attic plenum was located at the time of inspection. Recommend installing attic/plenum access for periodic inspections and maintenance purposes.

C. Picture 1 no attic access

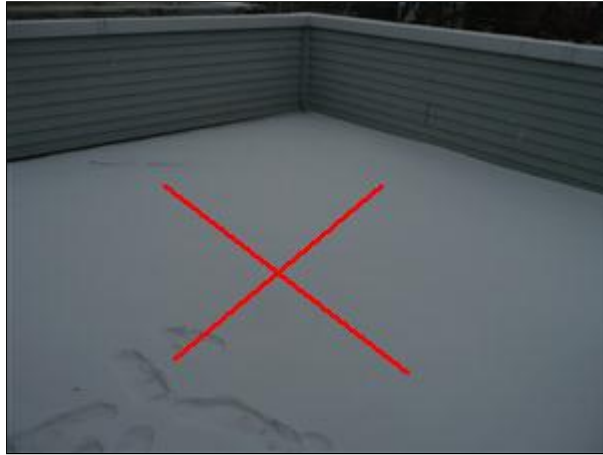
(2) A covering of snow on the roof prevented a thorough evaluation of its condition. It is recommended that a complete inspection be performed when weather permits. It may be advisable to have an escrow holdback agreed to at closing if a full evaluation is not practical before the property changes hands.

C. Picture 2 snow covered roof

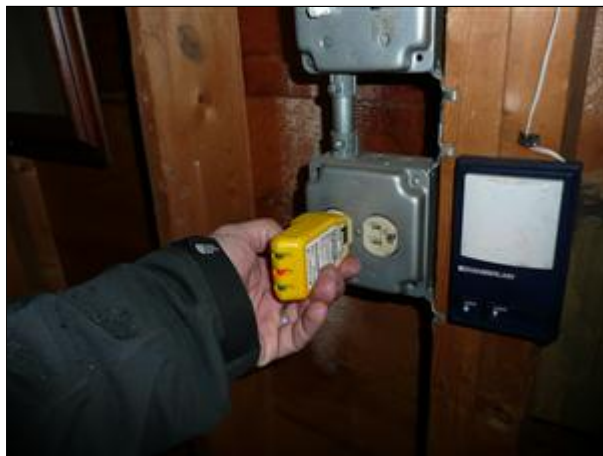
It is recommended that **ALL** electrical receptacles in the bathrooms, wet bars, kitchen and food service counters, garage, and all exterior locations be upgraded to GFCI protected receptacles by a licensed and electrician in order to reduce the risk of electrical shock and injury.

D. Picture 3 upgrade garage outlet(s)

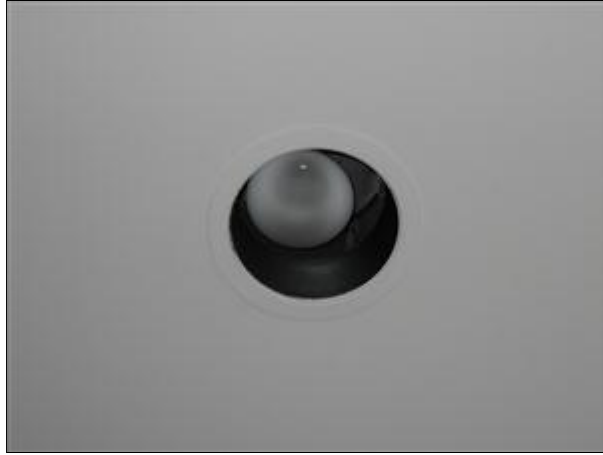
(2) NOTE- Many can lights were noted in the units that were not air-tight. These can provide a pathway for conditioned (heated or cooled) air to escape and possibly condense against non-conditioned building surfaces, raise energy costs and decrease indoor comfort as well as air quality. It is recommended that the Client replace these can light inserts with the appropriate compatible air tight inserts to reduce these conditions. The Inspector may be reached for further comment.

D. Picture 4 recommend air tight inserts

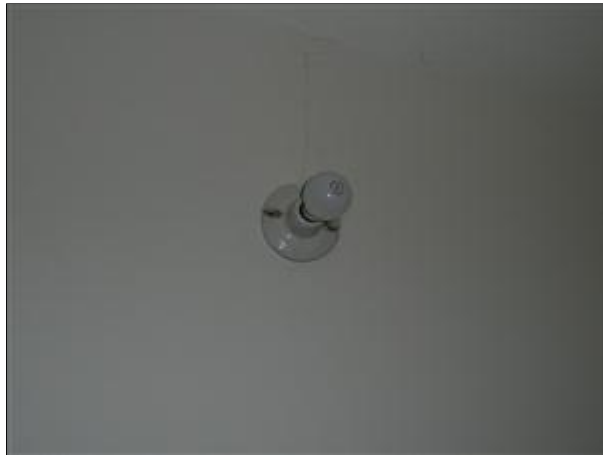
(3) The bare bulb light fixtures in the closets should be replaced with low-profile fluorescent fixtures in order to reduce the fire hazard associated with their hot surfaces and also in order to reduce the risk of bulb breakage.

D. Picture 5 upgrade bare bulb fixtures @ closets

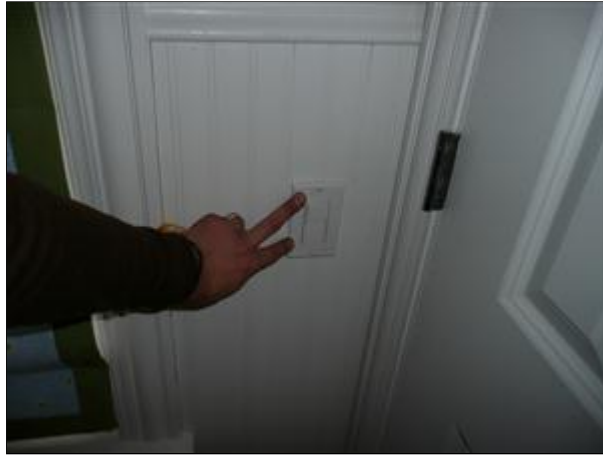
D. Picture 8 reverse switch in child's bedroom

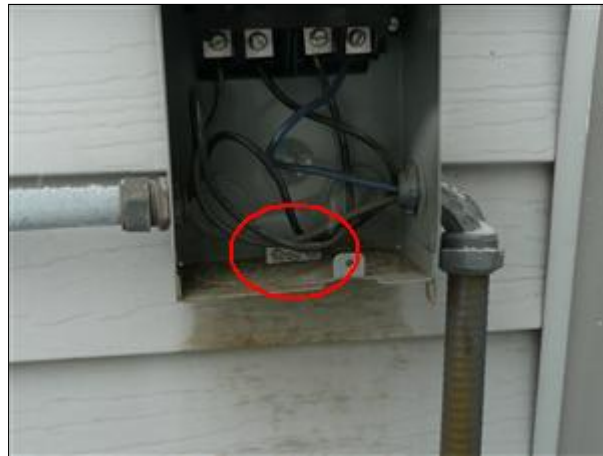
(5) Missing grounding conductors were noted at the a/c disconnect boxes. The grounding conductors should be installed for proper operation in the event of an electrical fault.

NOTE- 240 volt appliances do not require a separate grounding conductor but it is considered best practice due to the vibration and stresses that a/c condensing units experience while in operation which can loosen electrical bonding connections, especially flexible metallic conduit.

D. Picture 9 recommend grounding conductor

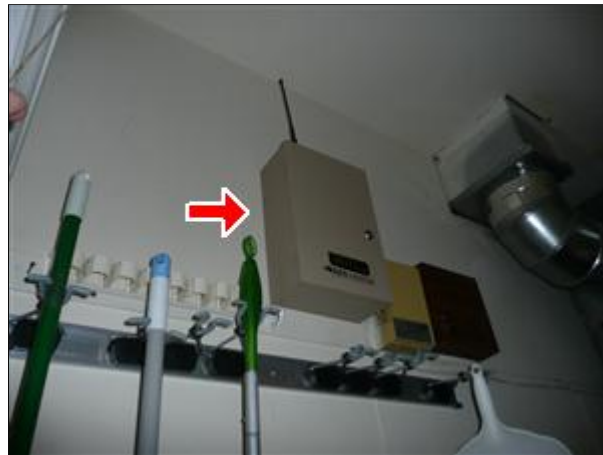
(6) The alarm company information should be made available to the new owner in order to avoid delayed activation of the system if service is transferred.

D. Picture 10 provide alarm info, manual

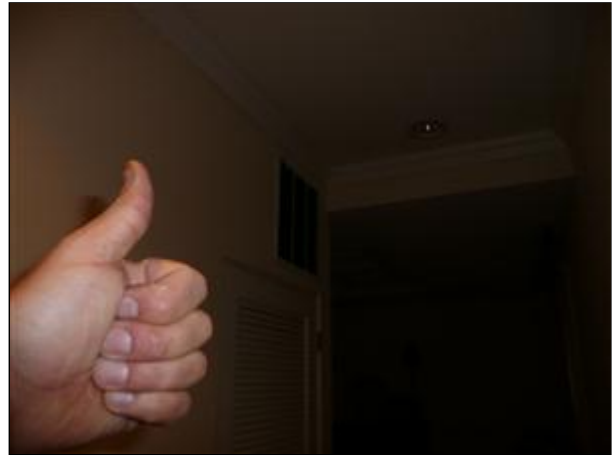
The first floor furnace is also excessively loud while in operation, typically an indication of poorly designed/installed ductwork, oversized air handler, leaks and general lack of care in installation. The distribution and return ductwork should be evaluated for repairs and balancing by a qualified HVAC contractor.

E. Picture 4 high noise from 1st fl furnace

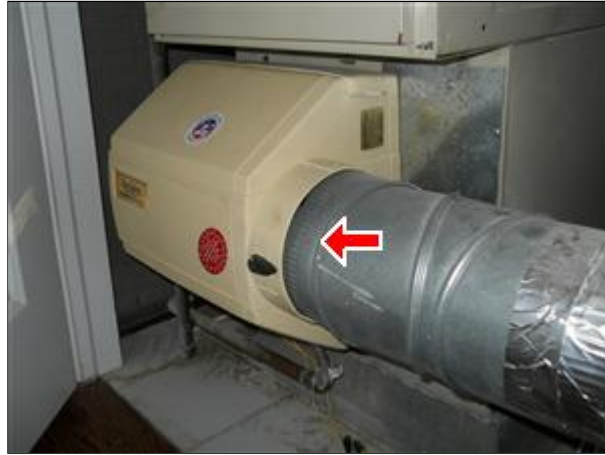
E. Picture 5 large gap at 2nd fl furnace

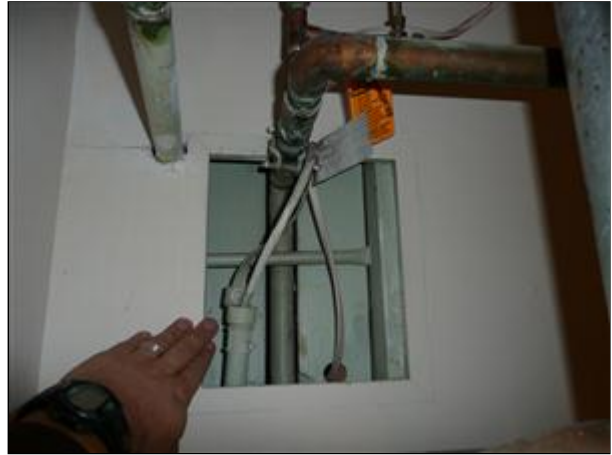
(4) The furnace closet is not adequately protected from fire spread. The combustion closet and penetrations should have 5/8" fire rated drywall or equivalent, taped at all edges, installed and/or intumescent foam or caulking to prevent flame spread to the framing members which abut attic framing members. A qualified contractor should repair.

E. Picture 10 seal opening in HWH closet

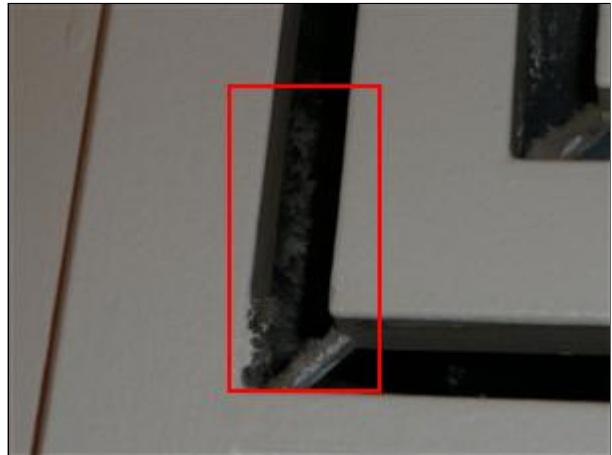
E. Picture 12 dirty fan interior, clean for increased fan performance

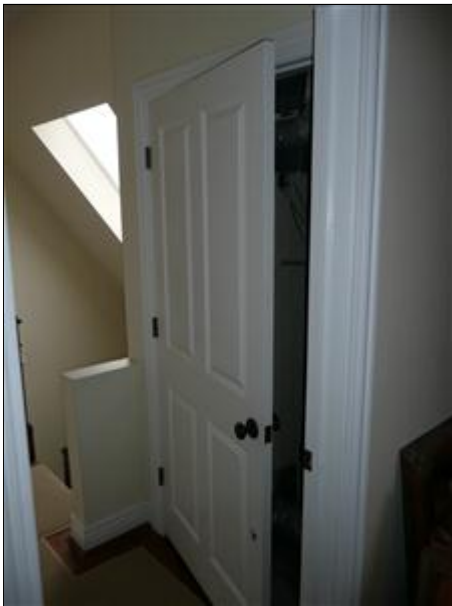
(6) The mechanical closets have insufficient access to combustion/dilution air for the gas-fired appliances that are located inside. Evaluation and repair by a licensed and competent HVAC contractor is recommended in order to reduce the risk of equipment damage, inefficient combustion, and infiltration of carbon monoxide to the living space.

E. Picture 13 2nd fl furnace closet

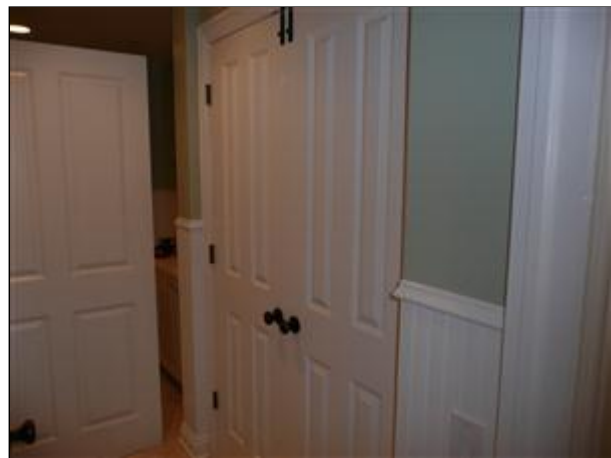
E. Picture 16 hot water heater closet

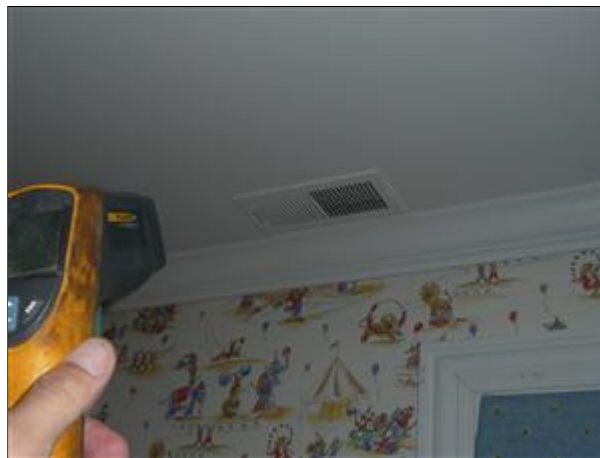
(7) The 2nd floor furnace is approximately 27 years old and beyond its statistical life. Very high supply temperatures in excess of 150F were noted at several supply registers indicating unbalanced distribution and improper performance. The furnace should be replaced with a properly sized unit of the highest efficiency affordable (preferably sealed combustion, 90% AFUE or greater) and the airflow balanced by a qualified HVAC contractor certified or educated in air balancing.

E. Picture 19 very high supply temps, child's BR

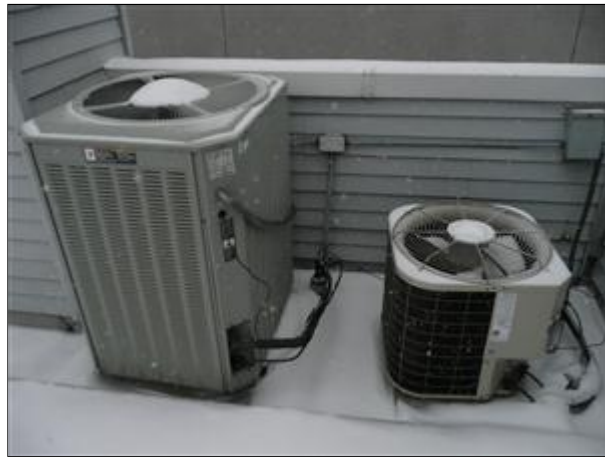
(8) Since the ambient temperature did not allow for the safe operation of the air-conditioning system, it is recommended that an escrow holdback be provided at closing in order to protect the purchaser in the event that the air-conditioning system is defective or inoperative. Further evaluation of the air-conditioning system by a licensed and competent HVAC contractor is recommended when weather permits.

It is good practice to cover condensing units when not in use (Fall-Spring). The cooling fins were full of dust and debris and should be thoroughly cleaned prior to cooling season. It is recommended that the service disconnect be pulled and stored to prevent accidental operation of a covered unit and potential damage.

E. Picture 20 unable to test air conditioning; cover units when not in use

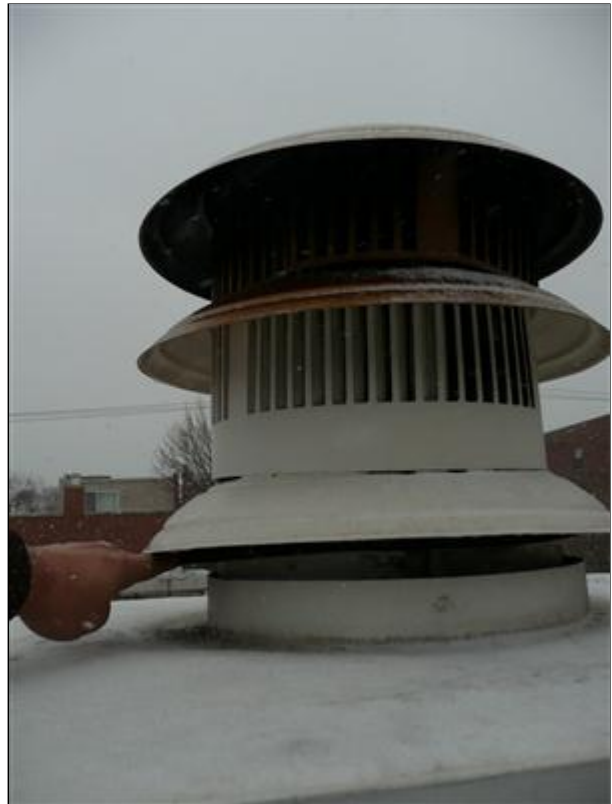
(9) The 2nd floor furnace (and kitchen fireplace chimney) exhaust vent does not meet the 2, 3, 10 rule which requires chimneys to terminate at least 3 feet higher than its roof penetration or be 2' higher than any building horizontal surface within 10'. If the furnace is to be replaced the proper clearances should be adhered to. Recommend repair of existing furnace vent.

E. Picture 22 kitchen chimney prone to downdrafts but may be within acceptable installation limits

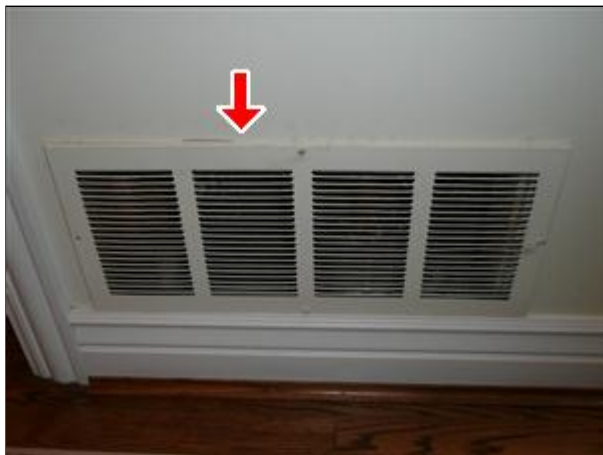
(10) Some of the return ductwork in the home is "panned". While allowable by some codes, panned ductwork is not ideal as it uses the framing cavities instead of dedicated ductwork for its return or supply path. This can introduce allergens and particulates as well as unconditioned air from adjoining interstitial spaces into the conditioned airstream and increase energy costs. The use of dedicated ductwork is recommended and should be evaluated by a qualified HVAC contractor.

E. Picture 23 central hallway, 1st fl

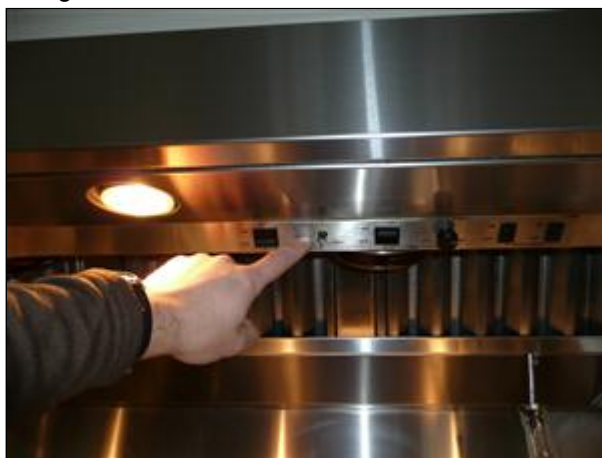
E. Picture 25 repair dimmer switch

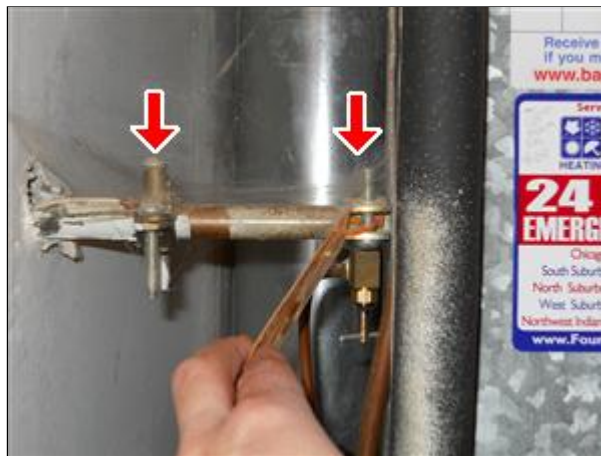
(1) The inexpensive, unreliable and illegal saddle valve that supplies water to the furnace-mounted humidifier should be replaced with a high-quality fixture valve in order to reduce the risk of leaking and damage. Any other remaining needle valves in operation should be upgraded as stated above.

G. Picture 1 upgrade needle valves

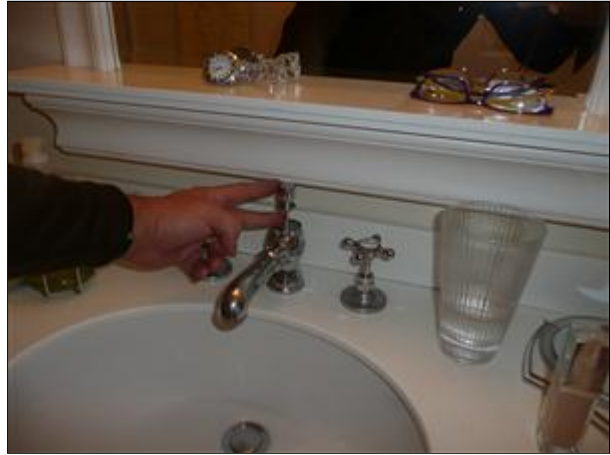
G. Picture 3 adjust 2nd fl pop up and drain assembly

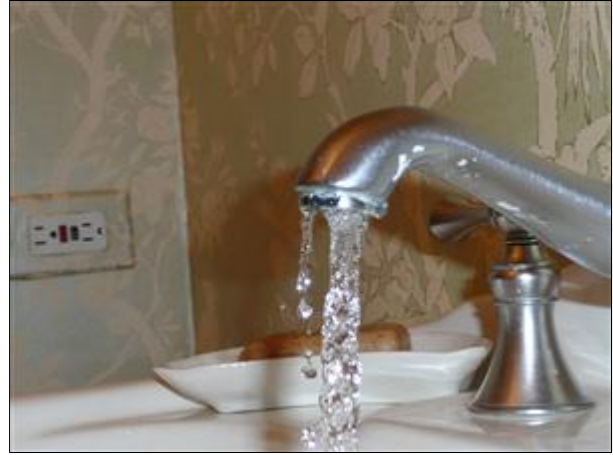
G. Picture 8 adjust childrens' bath pop-up and drain G. Picture 9 clean powder room aerator or replace

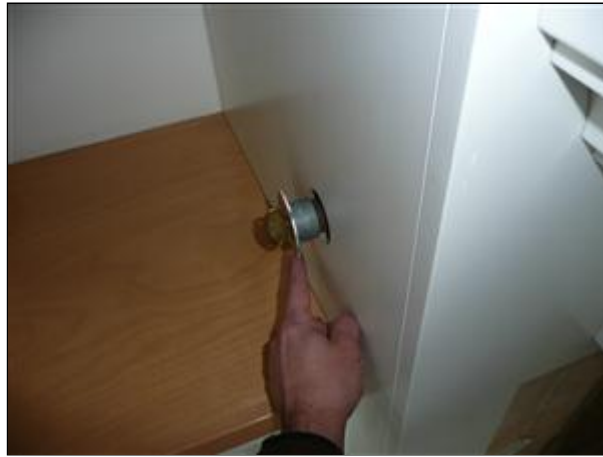
G. Picture 10 repair kitchen fireplace gas escutcheon

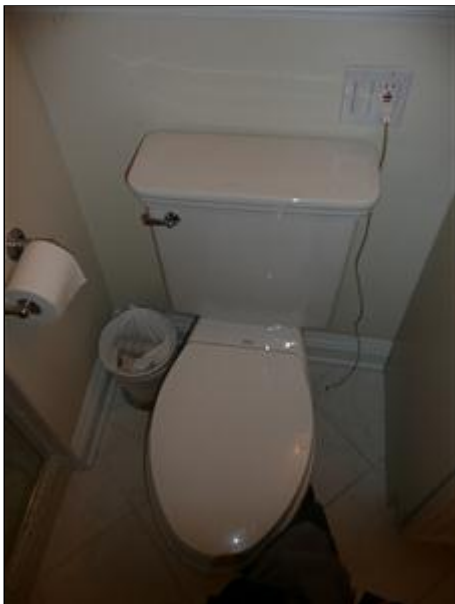
(3) The toilet is not adequately secured to the floor. This can result in deformation of the wax ring seal, leaking, and other damage. The toilet should be evaluated by a licensed and competent plumber in order to determine if removal and reinstallation as necessary.

G. Picture 11 2nd fl toilet

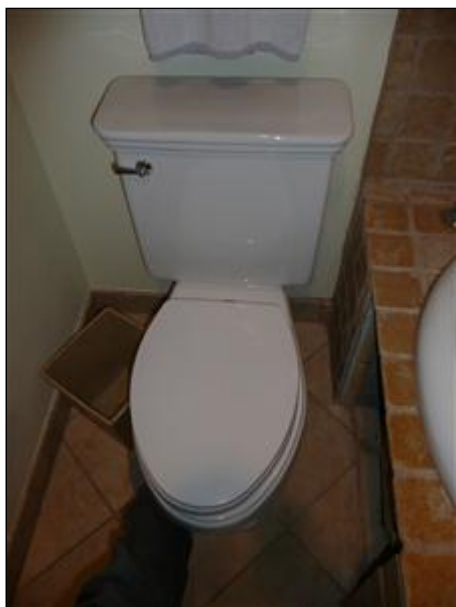
G. Picture 13 master toilet loose

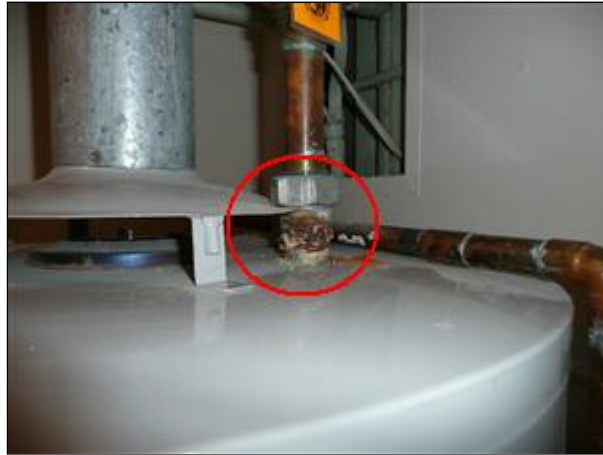
(6) The house has copper supply piping throughout. This increases the potential early failure of the hot water heater dielectric unions (they become 'sacrificial') which separate iron based pipe from copper. Conversations with several reputable plumbers in the Chicago area have yielded a proactive approach and the Inspection Firm recommends replacing the unions with a quality full port brass union for maximum safety and performance.

G. Picture 17 corroded union; may also be larger indication of poor draft due to lack of combustion air

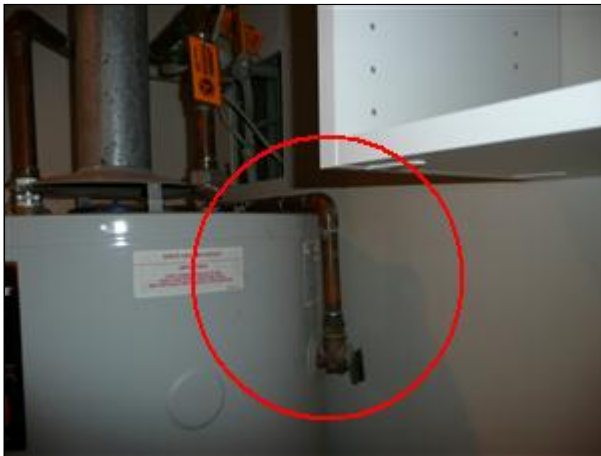
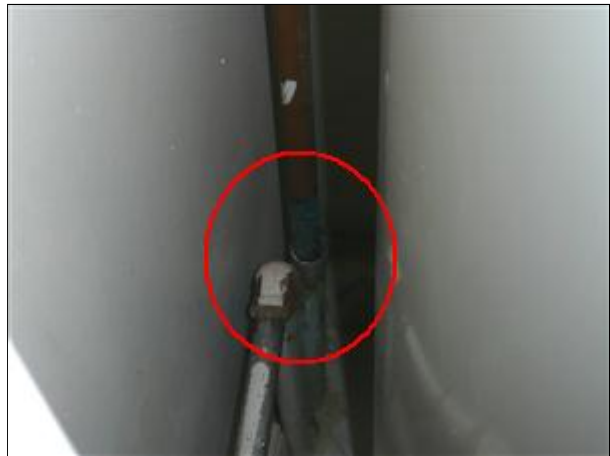
(7) The termination point of the extension piping for the water heater's Temperature and Pressure Relief Valve (TPR) is hidden from view. The end of the extension piping should be visible so the leaks in the TPR valve can be repaired before the leak leads to mineral buildup inside the valve which can prevent it from releasing pressure in an emergency. It is recommended that the extension piping be removed from the existing drain and that it be altered so that it terminates within 6 inches of the floor directly below the TPR valve.

G. Picture 18 TPR piping should NOT route upward G. Picture 19 hidden TPR termination at south side of heater

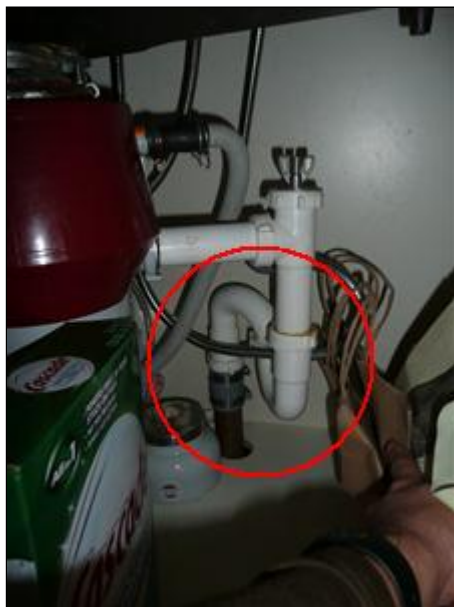
(9) The illegal S trap should be replaced with proper P trap to avoid self siphoning and potential sewer gas entry into living spaces.

G. Picture 22 kitchen sink s trap

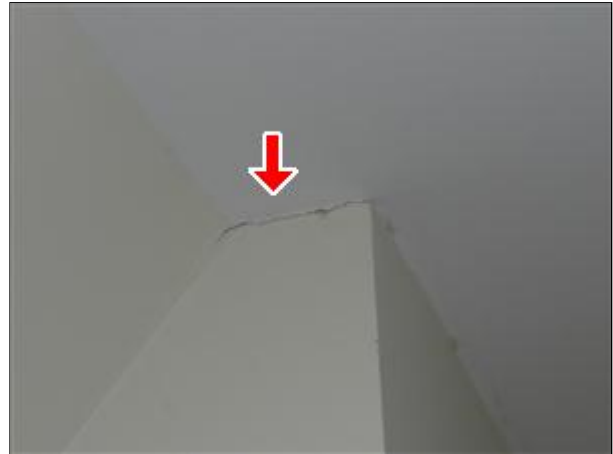
H. Picture 2 top floor drywall junction repairs required

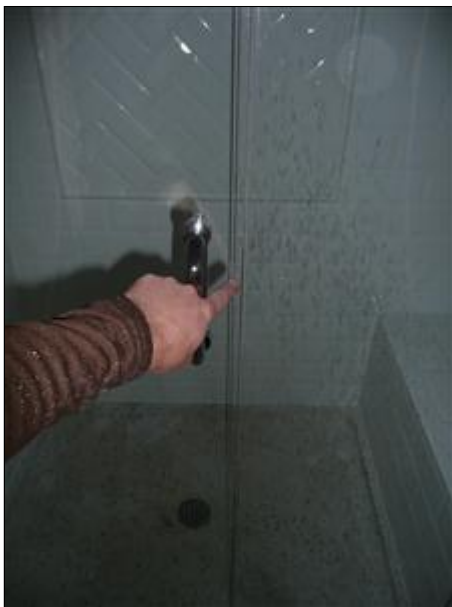
H. Picture 3 install astragal gasket at 2nd fl shower

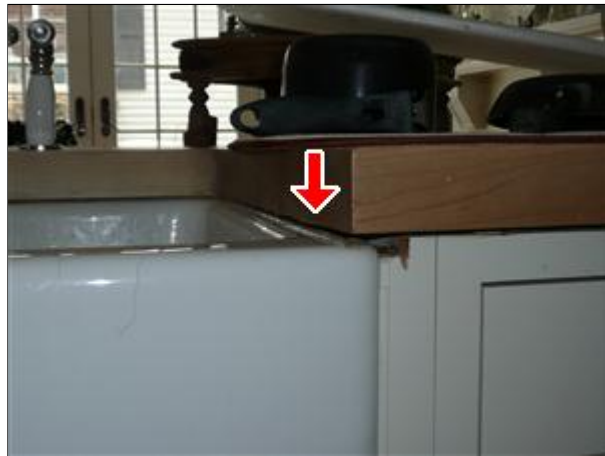
H. Picture 8 seal kitchen sink to counter gaps

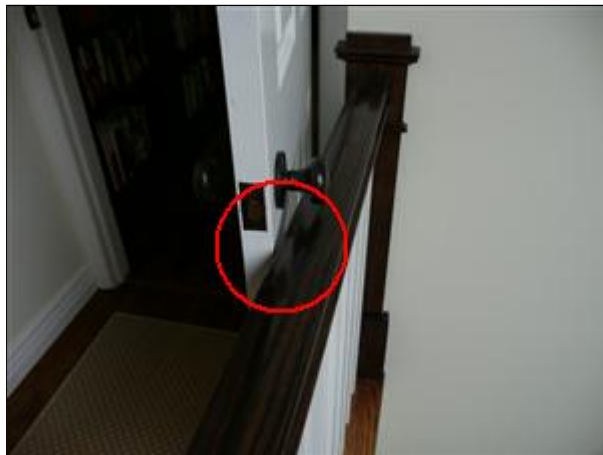
(2) Rubber bump stops or stop hinges should be installed in any location where door to door, door to wall or door to object contact exists and may cause unneeded damage to the finishes.

H. Picture 9 door to railing, i.e.

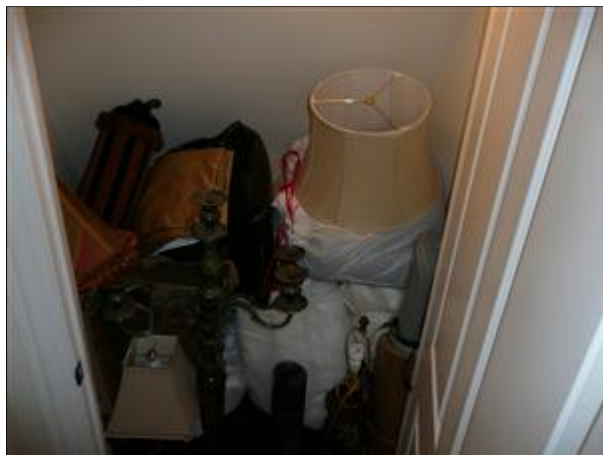
(4) Stored items throughout the entire building prevent the Inspector from evaluating all finishes and components of the building. Not all deficiencies or safety items may have been discovered and should be reviewed by the Client at final walk through prior to closing.

H. Picture 12 stored items

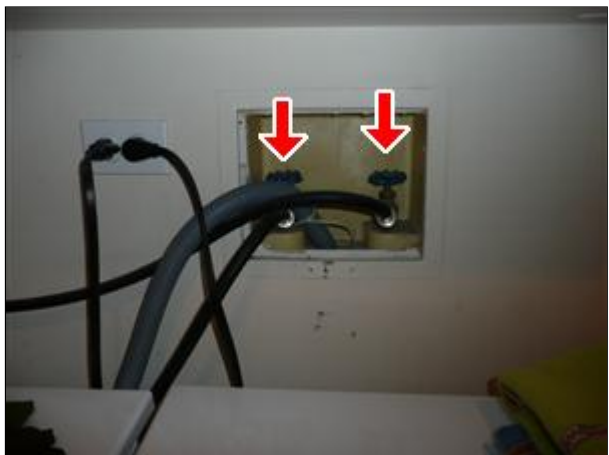
I. Picture 2 upgrade hoses

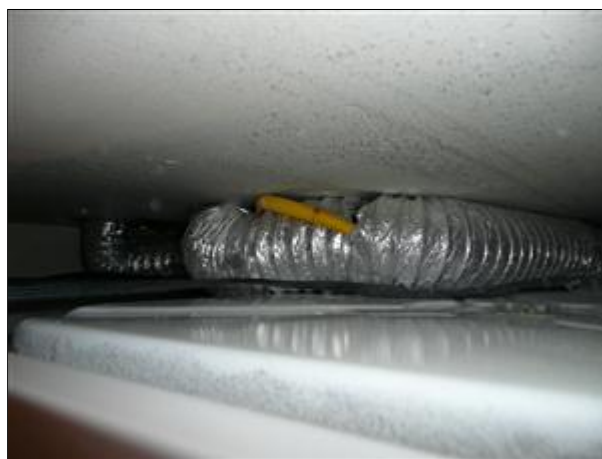
The gas supply routing penetrates the dryer venting and is unsafe and should be repaired as soon as possible for safe operation of the dryer and gas supply.

I. Picture 4 replace venting and gas supply routing

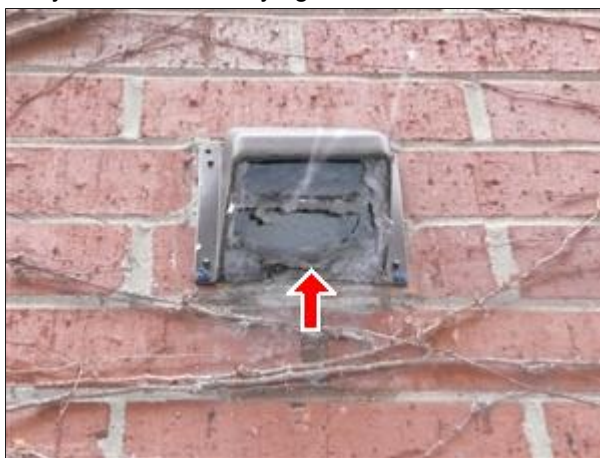
(6) Lint build-up was noted inside the vent passages of the clothes dryer. These passages and any vent piping should be cleaned in order to reduce the risk of dryer fire, reduce drying times, and to maximize the service life of the clothes dryer.

I. Picture 7 clean lint passages

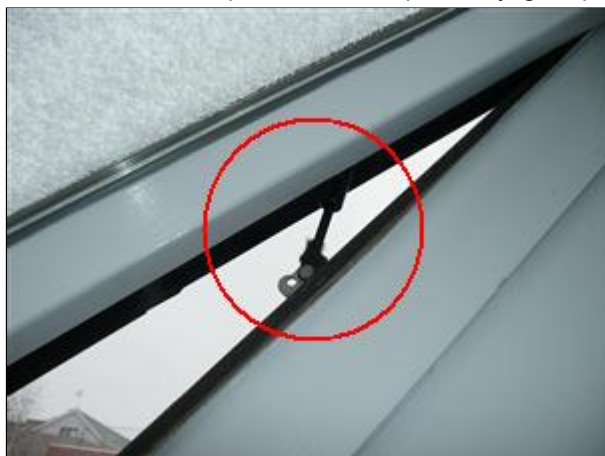
J. Picture 1

(1) The east skylight hinges are shot and should be replaced for adequate skylight operation and elevation during use.

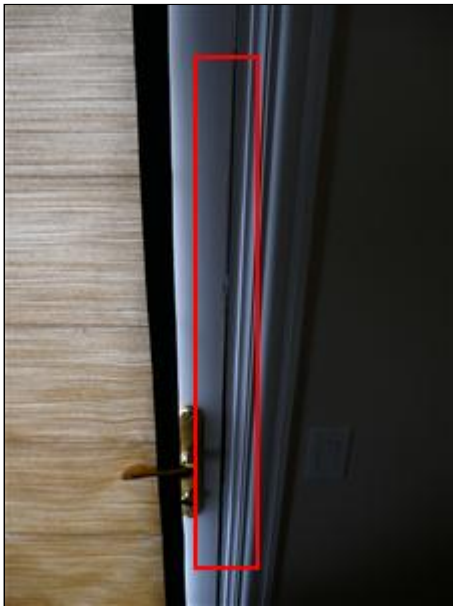
J. Picture 2 gaps at 2nd fl office door

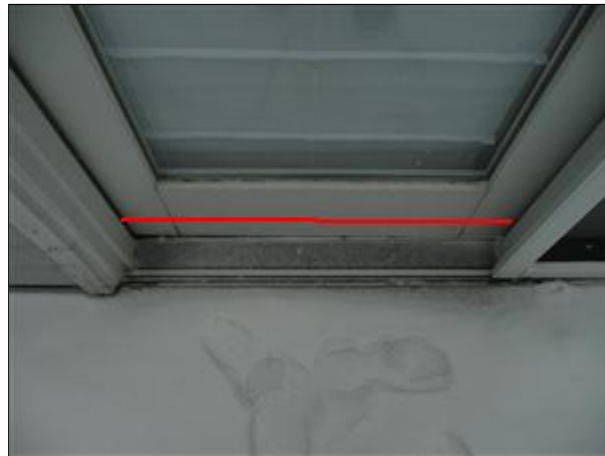
The addition of a rain or drip cap is recommended for the office exterior door to reduce moisture loads and convey to the exterior. Similar items such as this are found at better building material stores or online. [Drip Cap](#) This is generally recommended for any exterior door without a storm door or large overhang.

J. Picture 3 recommend drip caps

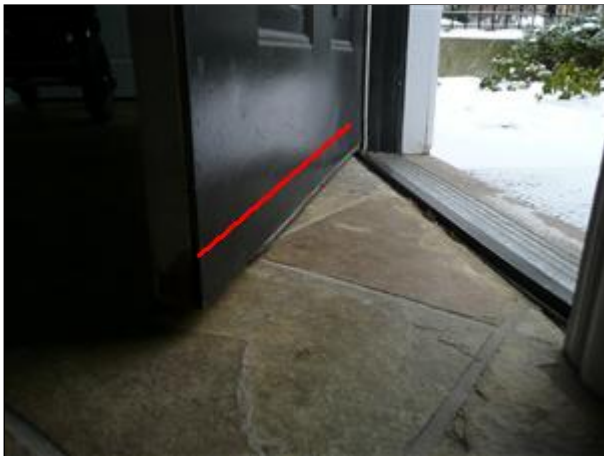
J. Picture 4 front entry door, install drip cap

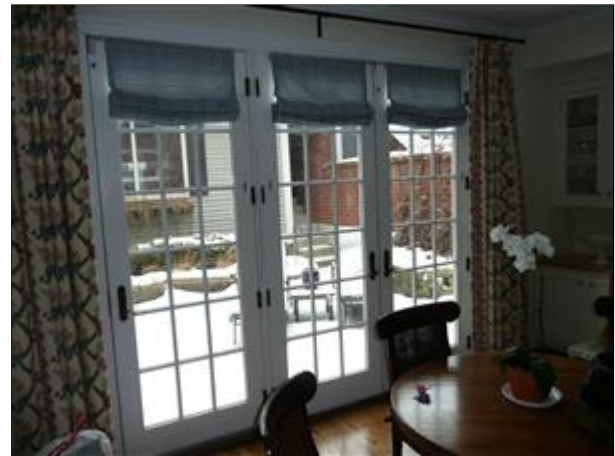
J. Picture 5 loose weatherstripping and fitment 1st fl rear

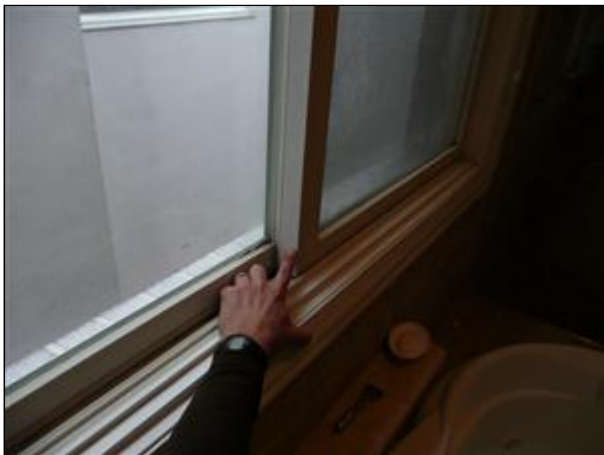
(3) Multiple windows require adjustment, repairs to hardware or glass, and overall maintenance to ensure easy operation and performance. A qualified repair contractor should evaluate.

J. Picture 6 stiff and 'swollen' master bath slider

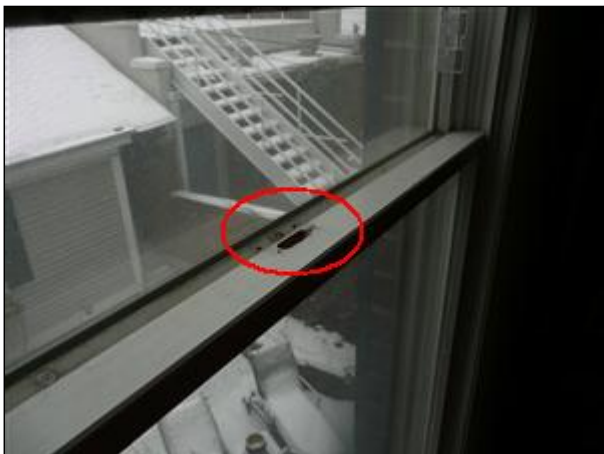
J. Picture 8 missing hardware, east BR

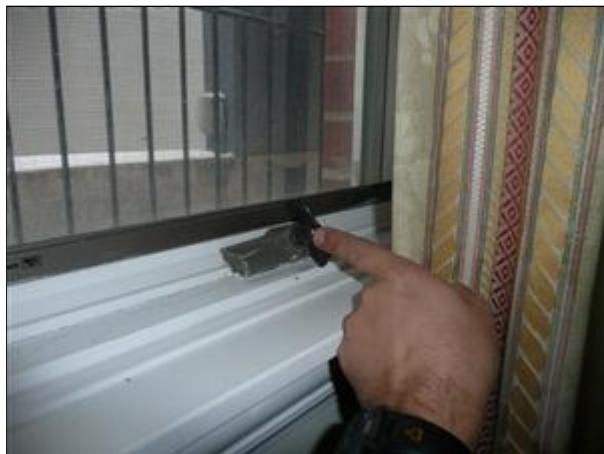
J. Picture 9 stripped casement operators

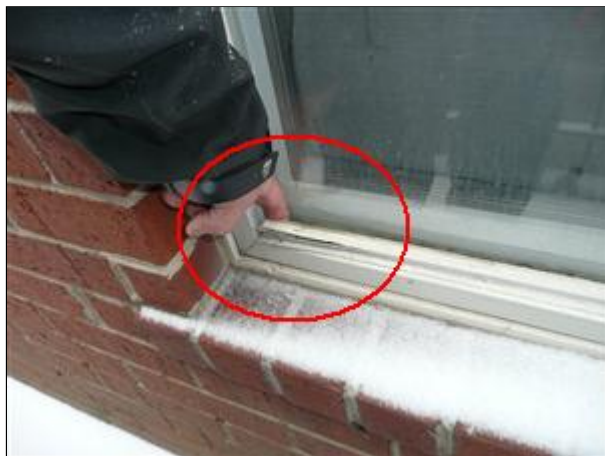
J. Picture 10 loose trim, south window @ gangway

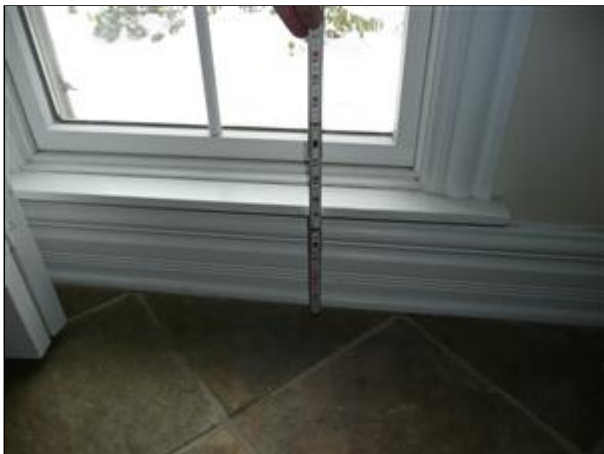
(4) Multiple windows in the home terminate less than 18" from the floor and are not of tempered glass which greatly increases the risk of laceration injuries, especially for children. All of the windows at these areas should be upgraded to tempered safety glass for safety purposes.

J. Picture 11 repair glass for safety purposes

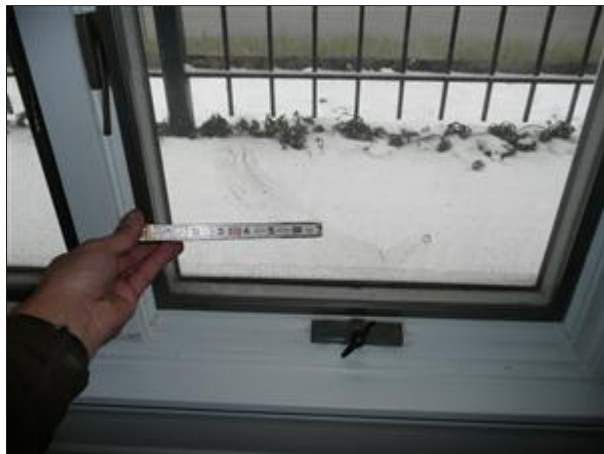
J. Picture 12 south windows along gangway
