Property, Energy & Moisture Intrusion Inspections

Inspection Report

Property Address:
4455 West Waverly Place
Anytown IL 60000

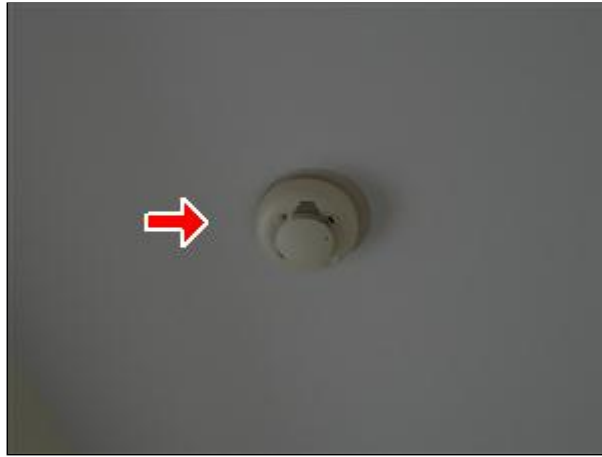
(2) Some of the smoke detectors noted in the home appeared to be at or beyond the end of their service lives, typically taken to be 10 years. It is recommended that the smoke detector and carbon monoxide detector systems be upgraded to reflect current life safety codes which include; smoke detectors on each level of living space and in each sleeping room, hard-wired 120 V smoke detectors that are interconnected in order to alarm simultaneously when any individual smoke detector responds, and low level carbon monoxide detectors on every level of living space and within 15 feet of a sleeping room. The installation of these critical life safety devices by a licensed and competent electrician is recommended.

L. Picture 5 upgrade safety detectors
