Inspection Report

Condominium Association

Property Address:
2468 Moldy Row
Chicago IL

This report reflects the findings of a limited scope moisture intrusion investigation performed at the request of the client named herein. The purpose of the investigation was to determine the cause of the moisture intrusion that has become evident in several areas of the interior condominium spaces. The inspection used only non-invasive techniques and therefore the concealed areas of the exterior wall assembly (wall cavities, wall framing, insulation, vapor retarders, etc.) could not be viewed. Bulk moisture can travel in unpredictable ways inside the space between the exterior wall cladding and the interior wall finishes. For these reasons, it is critically important to follow best construction practices regarding all exterior roof covering and wall cladding details so that the general risk for bulk moisture penetration into the wall assembly is reduced. This report is an attempt to compare the existing exterior wall and roof details against best practices in the industry and to make recommendations for repairs that will reduce the risk for ongoing moisture intrusion.

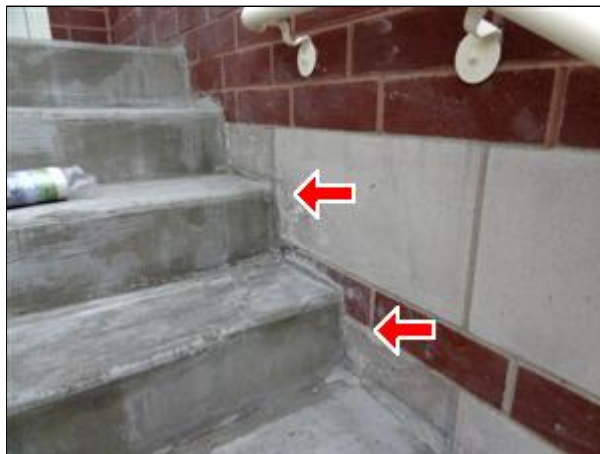
A. Picture 1 Front Exterior Stairs

(1) The joint between the poured concrete front steps and the adjacent masonry piers should be separated by a caulked capillary break so that moisture and melting salts are not drawn into the masonry walls. Failure to provide such a break will result in saturation of the masonry piers and make them subject to freeze/thaw damage. It is further recommended that the masonry piers on either side of the concrete steps be cleaned and then sealed using a high-quality silane or siloxane-based masonry water repellent in order to reduce the rate of moisture absorption as well as the absorption of ice melting compounds which can result in ongoing and accelerating deterioration of the Renaissance stone and the brick masonry units.

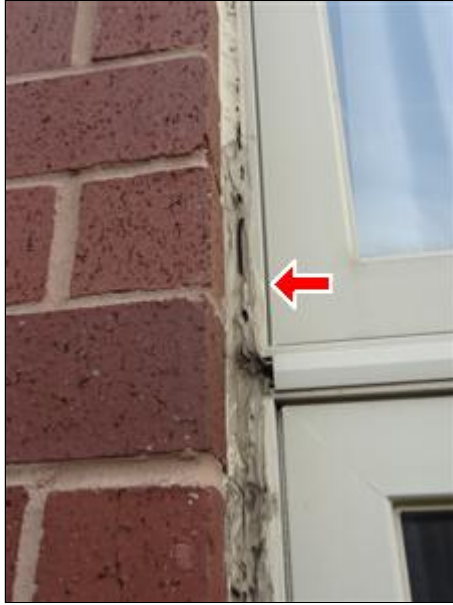
A. Picture 2 Aged and Deteriorated Caulking

(2) The application of the exterior sealants, a.k.a. caulking, was originally improper and is now also deteriorating. It is recommended that plans be made for a near-term removal and replacement of the exterior sealant joints. In order for the sealant joints to prevent drafts, repel moisture, absorb movement, and maintain durability high-quality materials inappropriate methods must be used. Please refer to the referenced article regarding exterior sealants.

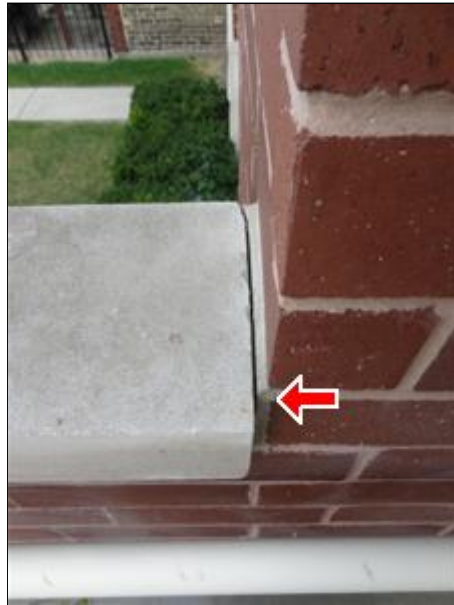
A. Picture 4 Limestone Mortar Joint

(3) The mortar joints at the corners of the stone window sills and between all limestone copings/sills should be raked out and sealed instead with a high-quality masonry caulking compound to reduce the risk of moisture saturation, moisture intrusion to the interior, and damage to the brick masonry below the sill.

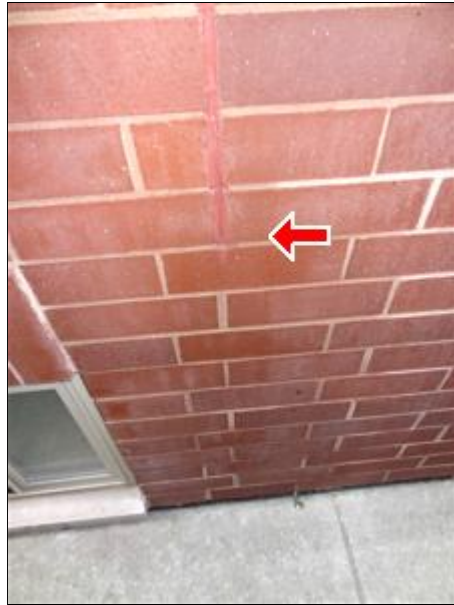
A. Picture 5 Incomplete Movement Joint

(4) The masonry wall movement joints do not extend to the bottom of the foundation wall as is dictated by industry standards. Further review of the exterior wall movement joints by a qualified masonry restoration contractor is recommended in order to determine if completion of the joints is feasible and advisable. No obvious cracking or signs of stress were noted at the lower termination of the incomplete movement joints despite their improper configuration.

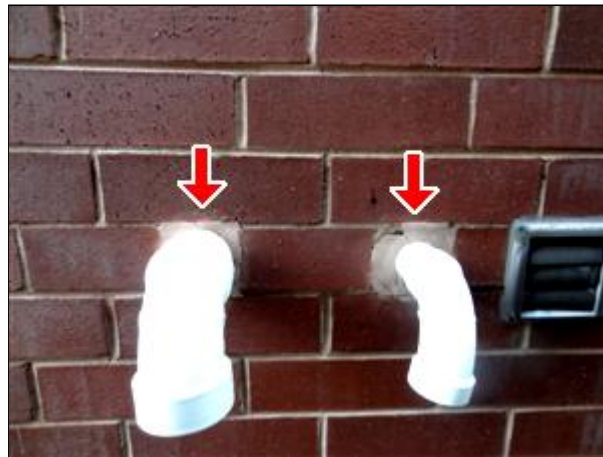
A. Picture 6 Improperly Configured Wall Penetrations

(5) The openings in the masonry wall that allow the passage of the PVC vent piping are improperly configured and are therefore prone to allowing moisture intrusion. The openings are too large and are sealed with relatively brittle cement mortar instead of a flexible and adhesive material such as urethane caulk. Further evaluation and repair of the PVC vent piping wall penetrations by a qualified masonry restoration contractor is recommended; ideally, the vent piping would pass through neatly cored brick masonry units via openings that are slightly larger than the PVC piping themselves. This would allow the application of a properly configured sealant joint.

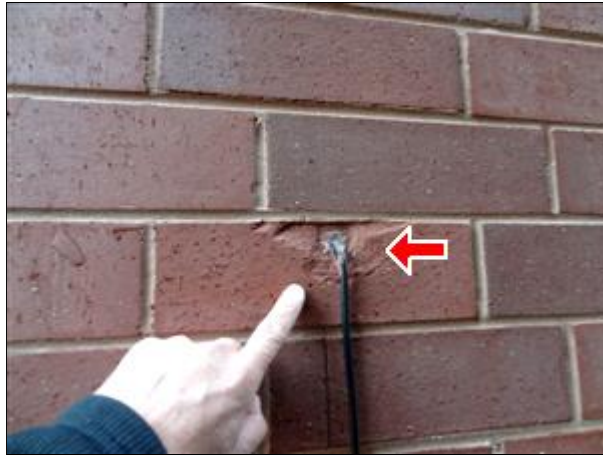
A. Picture 7 Wanton and Willful Negligence

(6) A damaged brick was noted at the lower north exterior masonry wall which is a result of careless drilling. That individual brick should be replaced by a qualified masonry contractor. The penetration through the individual brick masonry unit should be drilled carefully to prevent 'blow-out'.

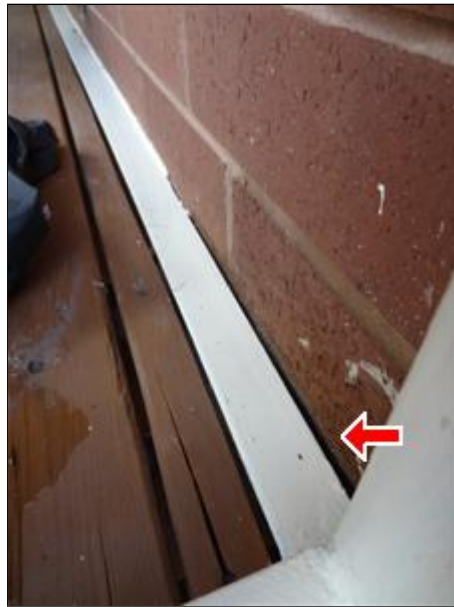
A. Picture 8 Incomplete Sealant Joint

(7) The top edge of the steel deck ledgers should be properly sealed with high-quality caulking compound in order to reduce the risk for moisture entrapment and moisture intrusion through the through-wall ledger bolts.

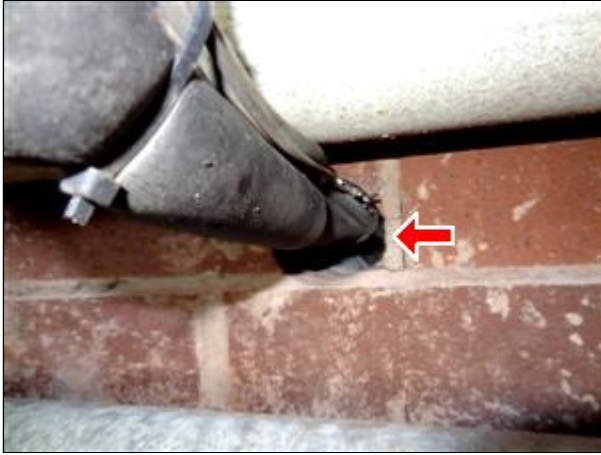
A. Picture 9 Unsealed Air-Conditioning Refrigerant
Line Penetration

(8) The exterior wall penetrations for the air-conditioning refrigerant lines and the electrical feeder conduits should be sealed using backer rod and urethane caulk or the equivalent in order to reduce the risk for drafts, energy losses, moisture intrusion, and pest entry into the structure.

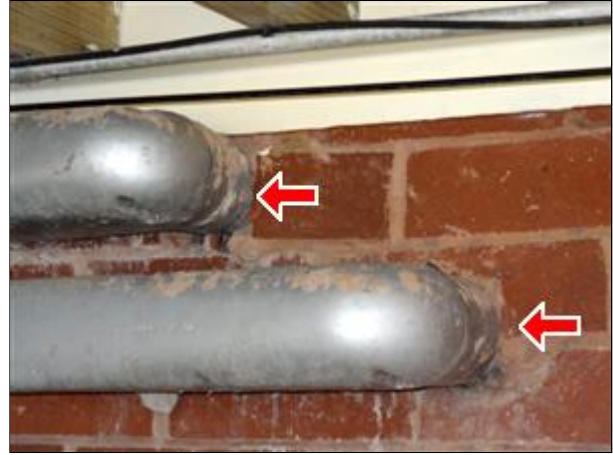
A. Picture 10 Feeder Conduit

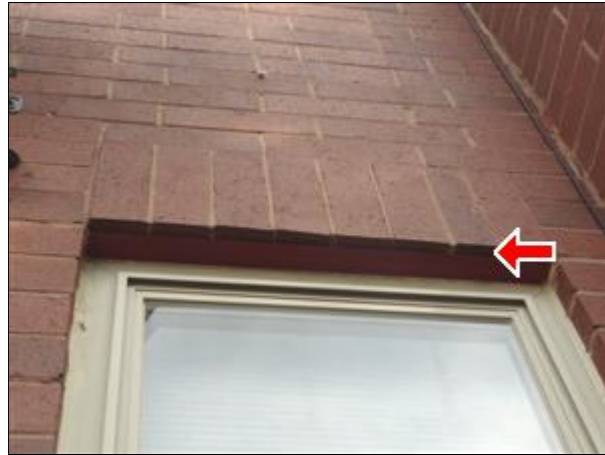
A. Picture 11 Missing Flashing

(9) The masonry wall flashings are either missing or improperly installed. The flashings should protrude from the wall by at least 1/4" at the following locations: the top of the foundation wall; above the masonry pockets where the floor joists are set into the concrete block; above and below every window and door. Missing or improperly installed wall flashing can

allow moisture to enter the home and cause rot, mold growth, and structural damage. The exterior masonry walls of this structure should be evaluated and repaired by a licensed and competent masonry contractor.

Since retrofitting of missing or improperly installed masonry wall flashing is both disruptive and expensive, it may be advisable for the condominium association to deal with this issue on a case-by-case basis. If and when bulk moisture intrusion becomes evident at the top or sides of the interior window openings then retrofitting of the missing flashings should be seriously considered.

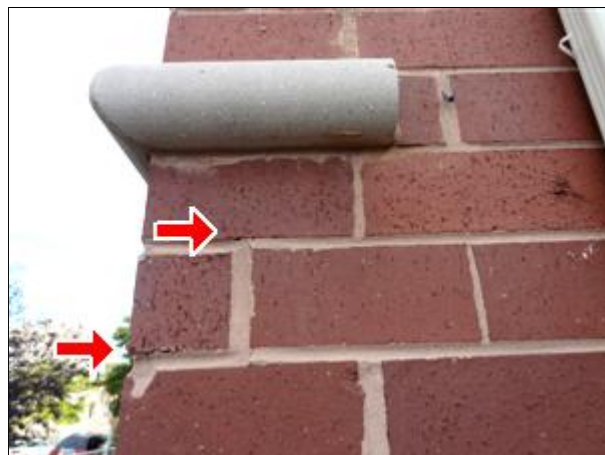
A. Picture 13 Substandard Cement Mortar

(10) The quality of the brick masonry mortar joints is substandard. Areas of the mortar appear to contain excessive amounts of sand and are not properly tooled; improperly or inadequately applied cement mortar in a brick masonry wall often leads to excess moisture saturation by the brick masonry units and, after prolonged or wind driven rains, leads to bulk moisture intrusion to the moisture sensitive interior wall components like insulation, drywall, and wood framing. It is

the inspector's opinion that the masonry walls would benefit greatly from grinding out of the mortar joints and re-pointing. This process is expensive and is disruptive; however, it can be performed on a wall by wall basis in order to allow for easier budgeting.

The application of clear masonry sealants is a poor substitute for properly configured and tooled mortar joints. Further consultation with one or more masonry restoration contractors is recommended so that the condominium association can plan and budget for this process.

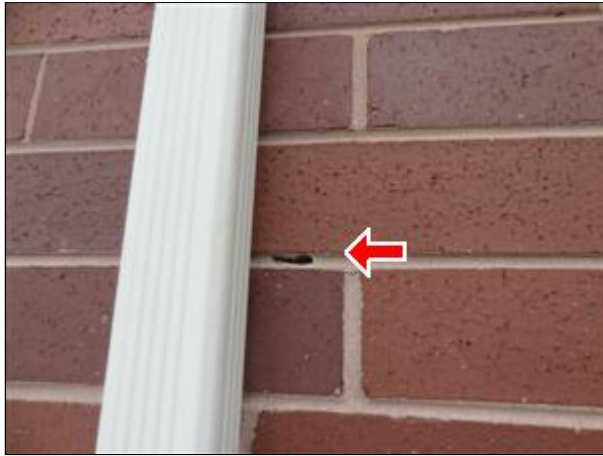
A. Picture 14 Mortar Gap

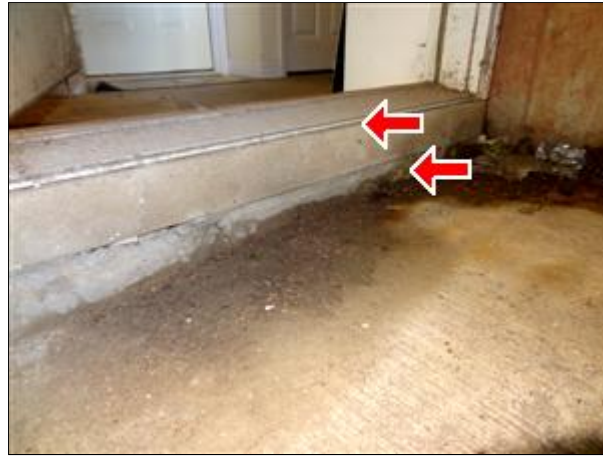
A. Picture 16 Rear Basement Entry Door

(11) Evidence of past moisture intrusion was noted at the rear basement exterior entry doors. It is recommended that the cracked and loose mortar bed below the limestone sills be replaced by a qualified masonry restoration contractor. It is also recommended that the gap between the aluminum door threshold and the limestone sill be neatly and professionally sealed using the appropriate caulking compound.

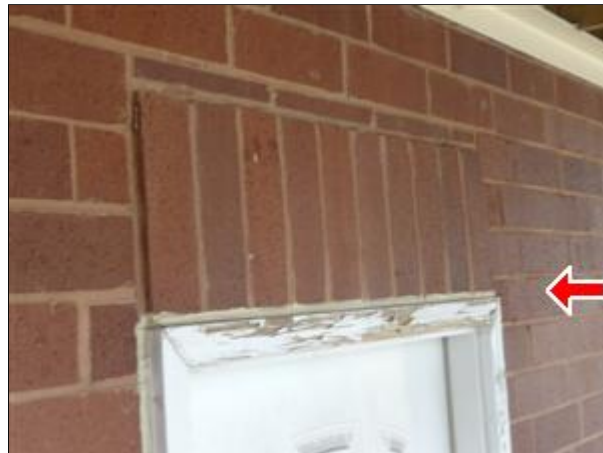
A. Picture 17 Improper Door Installation

(12) Exterior doors and windows in a masonry wall should be recessed approximately 1.5" to 2" in order to protect the wood components from the weather. The exterior rear entry doors at the basement, first floor, and second-floor have been improperly installed and stand outboard of the masonry wall. This puts them at much greater risk for moisture damage. It is recommended that the aluminum flashing be installed over the top of the protruding door trim in order to protect from moisture intrusion and moisture damage.

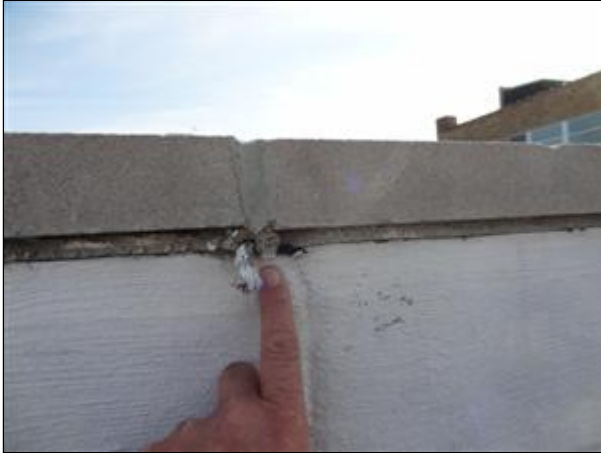
A. Picture 18 Improper Limestone Coping And Flashing Details

(13) A number of defects were noted in the masonry wall flashing details in the area of the limestone parapet capping.

The drip groove at the outside edges of the stone is missing.

The cheap vinyl flashing (not approved for exposure to UV light) has been left exposed at some locations. At other areas the flashing has been cut back flush to the wall and has resulted in gaps/openings that can easily allow both wind-driven rain and capillary suction to draw moisture into the masonry wall below the flashing.

The limestone parapet capping should be removed and reinstalled according to best practices and industry standards and is detailed in the attached Brick Industry Association's Technical Notes #7. Please refer specifically to Figure 18 for a comparison between the 'as built' details and the industry standard.

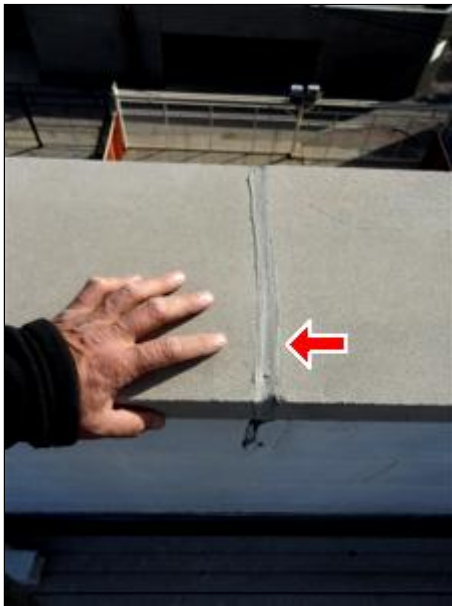
A. Picture 20 Caulk Smear

The urethane sealant between the individual limestone blocks has been smeared over cement mortar and will not perform as intended.

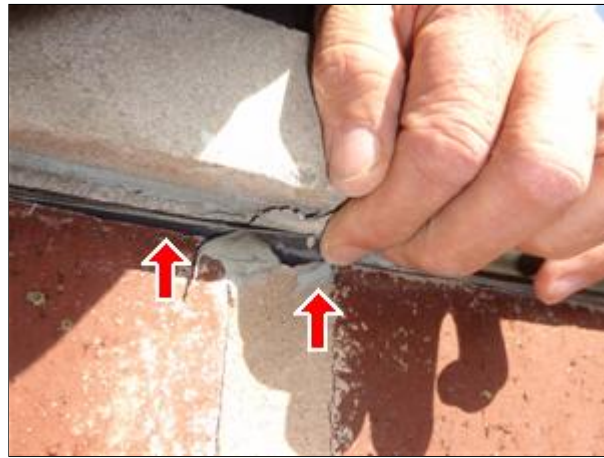
A. Picture 21 Improper Parapet Capping Detail

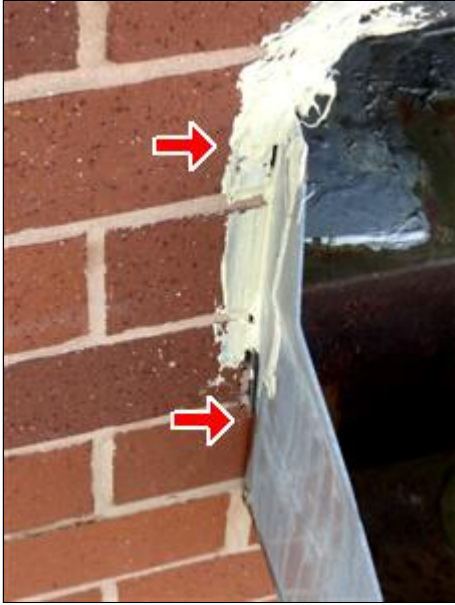
A. Picture 22 Missing and Smeared
Caulk at Scupper Opening

(14) The design and the condition of the through-wall scuppers are inconsistent with best practices and industry standards. The loose roof membrane at the through-wall opening is prone to allowing moisture entrapment, moisture intrusion, and moisture damage. The successively smeared applications of caulking around the brick opening will not perform the intended function of moisture resistance. Each of the through-wall scuppers should be repaired by a qualified roofing contractor. Repair should include removal and replacement of the existing caulk/sealant joints and securing of all roof membranes in and around the scupper. Plans should be made for the eventual reconfiguration of the sheet-metal details around the through-wall scuppers by a qualified contractor.

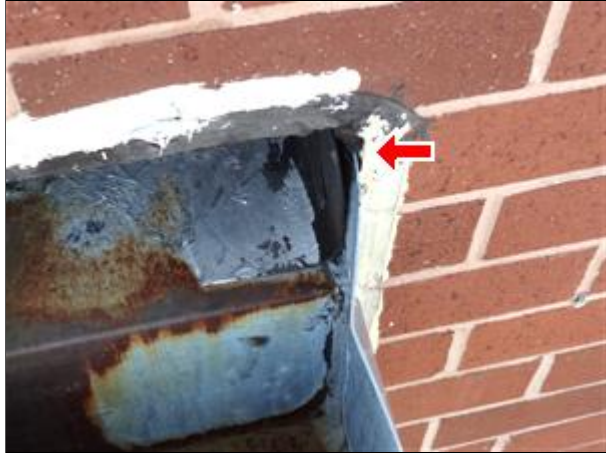
A. Picture 23 Loose Flap of Roofing Membrane At
Scupper Opening

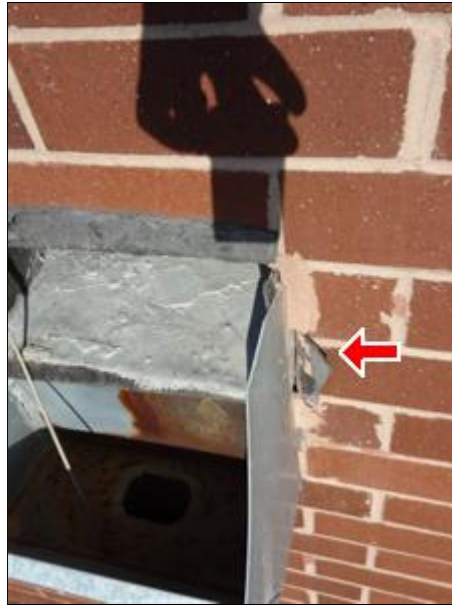
A. Picture 25 Risk for Moisture Penetration at Scupper

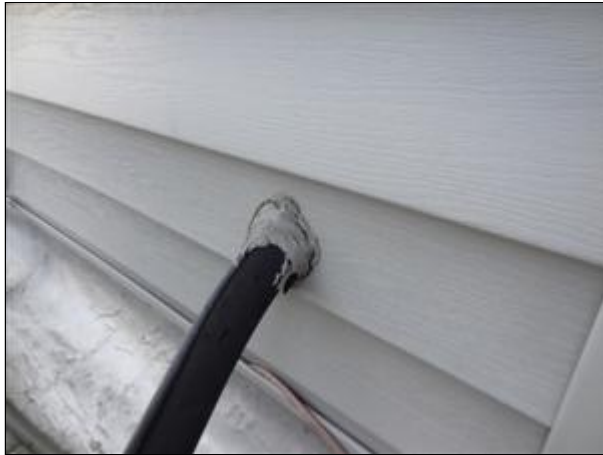
A. Picture 26 Improper Vinyl Siding Penetration

(15) It is recommended that all of the exterior wall penetrations be made through the pre-formed vinyl siding mounting blocks that are manufactured for this purpose. The mounting blocks are self-flashing and reduce the risk for moisture intrusion. They also allow the siding to expand and contract around the mounting block thereby reducing the risk for siding damage, sealant failure, etc. Repair by a qualified siding specialist is recommended.

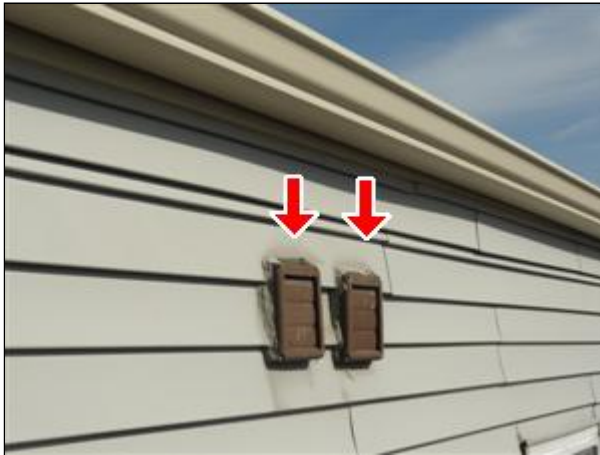
A. Picture 28 Improper Vinyl Siding Penetrations

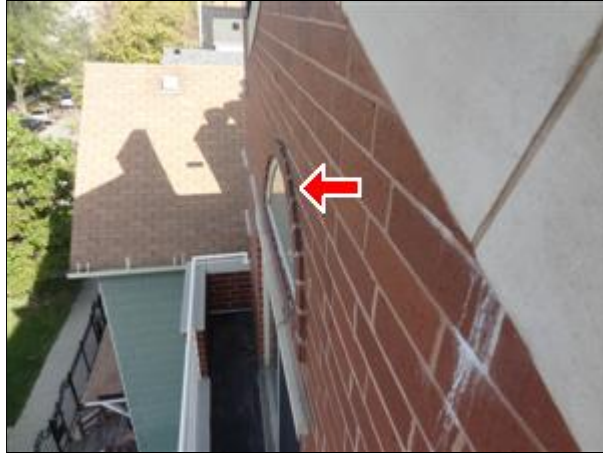
A. Picture 30 Projecting Soldier Course at Arch Top Window

(16) The projecting soldier courses of brick masonry on the exterior walls present an increased risk for moisture intrusion and moisture damage. The flat ledges at the top of the soldier courses result in increased moisture contact time and reduced drainage. Further evaluation by a qualified masonry restoration contractor is recommended however, it is the inspectors opinion that the flat ledge at the masonry soldier courses should be repaired by the application of a cove of either mortar or caulk so that moisture is encouraged to flow away from these flat surfaces.

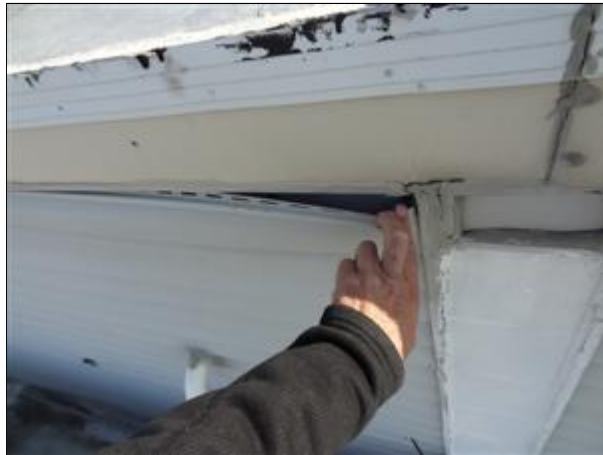
A. Picture 31 Loose Siding

(17) A number of defects were noted regarding the installation of the vinyl siding over the penthouse walls. It is recommended that the condominium association plan for the replacement of the existing vinyl siding in order to ensure the long-term moisture resistant performance of the exterior wall cladding. Cement board siding, Kynar coated metal panels, or similarly weather resistant materials are recommended.

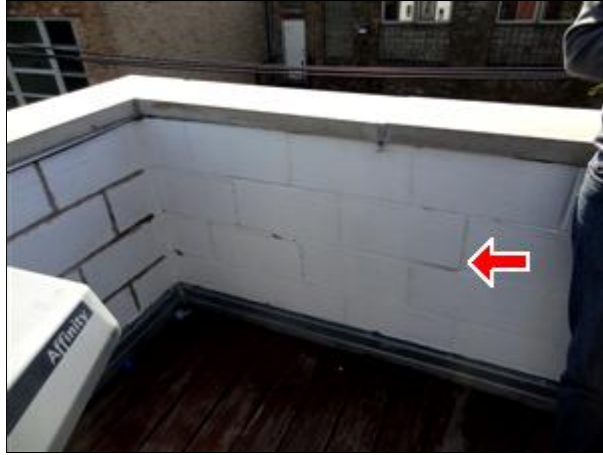
A. Picture 32 Mortar Cracking at Concrete Masonry Units Of the Inner Parapet

(18) It is recommended that the cracking at the mortar joints of the inner parapet be repaired by grinding out and re-pointing. These cracks appear due to moisture saturation and freeze/thaw cycling resulting from improper parapet capping details.

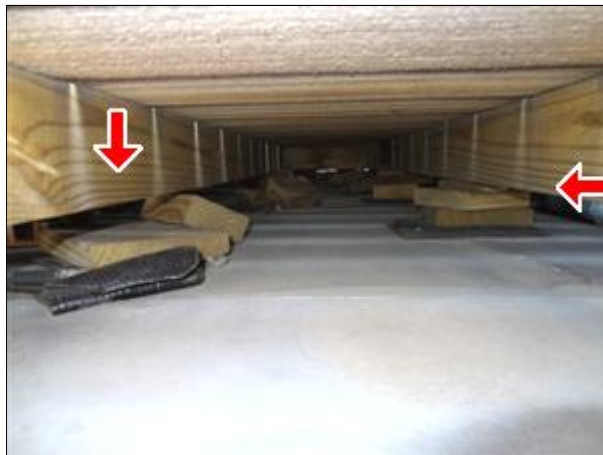
B. Picture 1 "Deck of Card"

(1) The rooftop decks are supported by loose wooden blocks, many of which have become displaced. This creates a risk for damage to both the deck structure as well as to the roof covering. The deck will need to be completely disassembled and reassembled by a qualified contractor in order to reduce the risk for ongoing damage. The deck frame would, ideally, be supported by opposing bearing walls and would not rest directly on the roof covering or roof surface. If space or budget constraints prevent such a support system then the deck bearing points should be lined up directly over and on top of the roof framing trusses below. This will prevent deflection and damage to the plywood roof sheathing. The roof membrane must be protected from keen edges and from heavy loads imposed upon small surface areas. Also, the deck framing should not block the prompt flow of roof run-off from reaching the gutters or scupper drains.

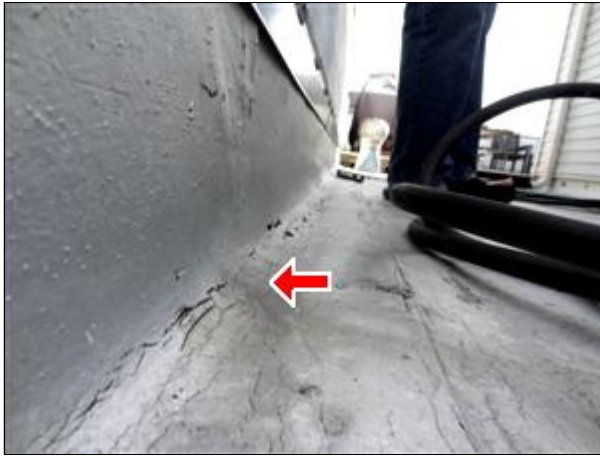
B. Picture 2 Creates That Roofing Material

(2) Modified bitumen roofing membrane should not be creased at a 90° angle due to the risk for cracking, leaking, and damage. The use of cant strips at the roof to sidewall transition is required by both the roofing manufacturer as well as industry standards. It is recommended that the creases at the roof to sidewall transitions be evaluated by a qualified roofing contractor. It is the inspectors opinion that the most cost-effective approach to reducing the risk for ongoing damage and leaking at these locations is to regularly monitor these creases and to apply additional roof coating as needed until the installation of a new roof covering becomes necessary.

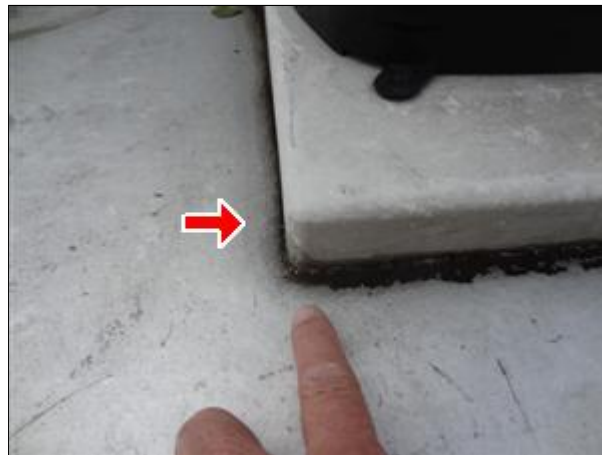
B. Picture 4 Risk for Damage to Roof Covering

(3) The installation of one or more sacrificial layers of roofing material is recommended underneath the rather keen edges of the air-conditioning bases at the rooftop. During hot weather, the modified bitumen roof material will soften and that, combined with the weight and vibration of the condensing unit, can result in scarring, damage and leaking of the roof covering.

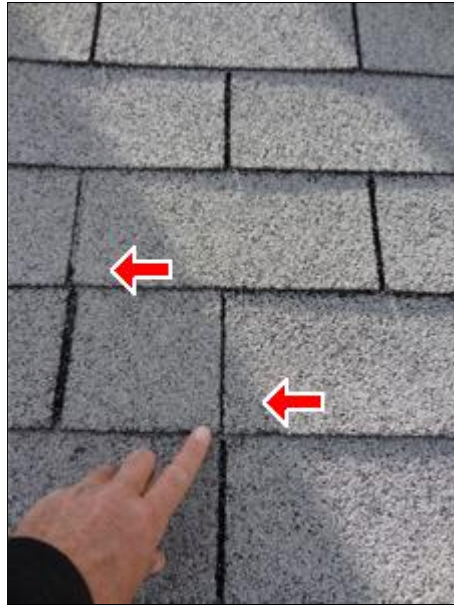
B. Picture 5 Improper Shingle Application

(4) Multiple areas of improper roof shingle application were noted above the sloped cathedral ceilings at units 3S And 3N. The shingle rain guides and the shingle butt joints have been lined up over one another in multiple areas. These defects greatly increase the risk for leaking and damage. Since the existing composition shingle roof covering is at or near the end of its service life, it is recommended that shingle replacement, rather than repair, be performed. Further evaluation by a qualified roofing contractor is recommended.

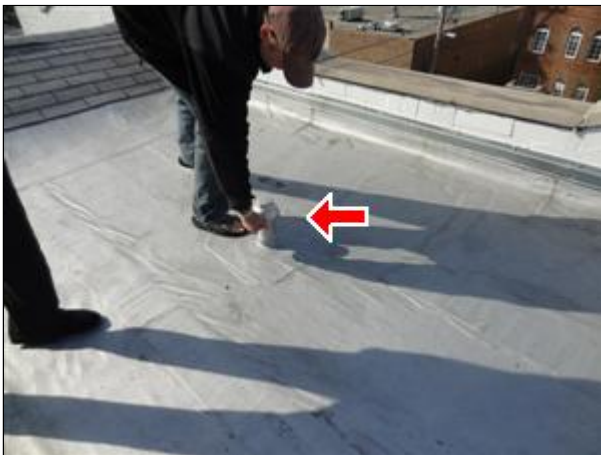
B. Picture 6 Inappropriate Installation

(5) The aluminum breathers noted on this roof are not intended to serve as venting devices for the roof plenum. These devices have very little net free vent area and are incapable of venting the potentially large volumes of trapped heat and moisture inside the roof plenum. Inadequate ventilation of the roof plenum can result in condensation, mold growth, excess energy usage, and reduced indoor air comfort during the cooling season. It is recommended that the existing undersized and inappropriate breathers be replaced with high-quality roof vents designed for low slope roof applications.

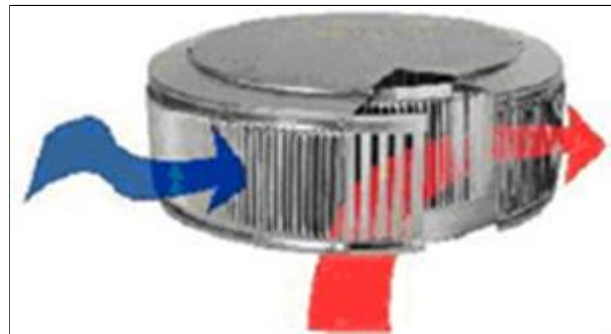
B. Picture 7 Low Slope Roof Vent

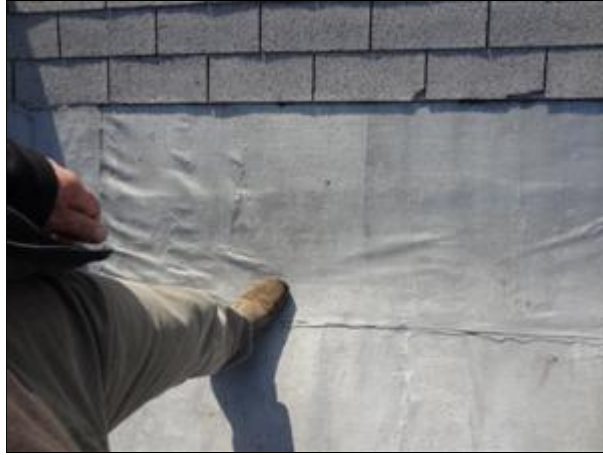
B. Picture 8 Spongy Roof Sheathing

(6) Areas of apparently deteriorated roof sheathing were noted at the low slope roof area between units 3N and 3S. These areas should be further evaluated and repaired as needed in the course of the recommended roof covering replacement.

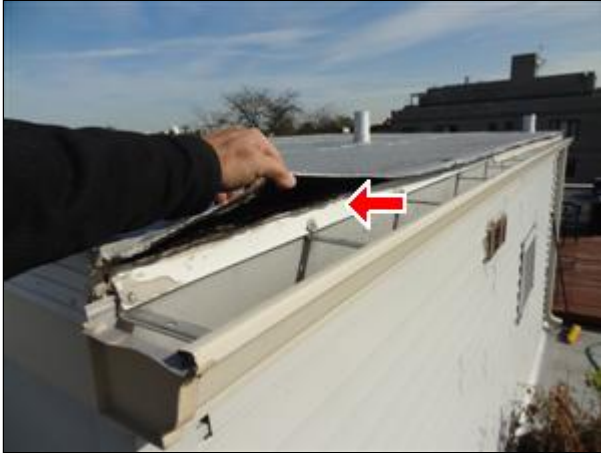
B. Picture 9 Unsealed Roof Membrane

(7) A number of defects were noted at the modified bitumen roof covering over the upper levels of units 3N and 3S. The failure to seal the modified bitumen roof covering at the gutter edge greatly increases the risk for moisture damage from ice damming. The material used as edge metal flashing is not approved for this use and is not properly installed. It is recommended that this roof covering be repaired as soon as possible and replaced as soon as practical.

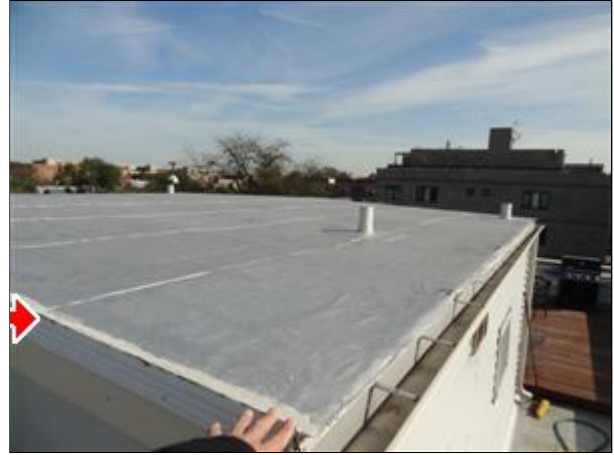
B. Picture 10 Improperly Detailed Edge Metal Flashing

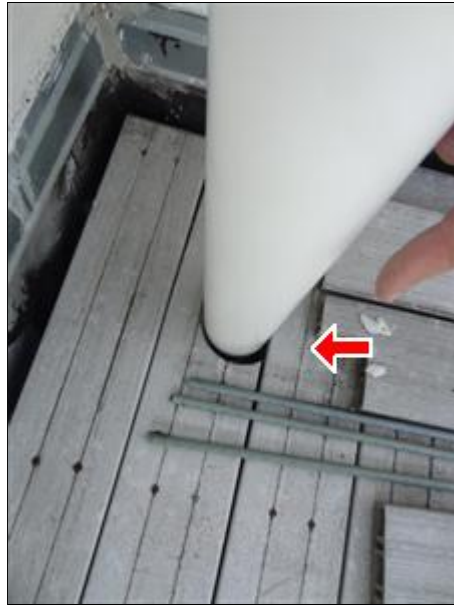
B. Picture 12 Loose Vent Pipe

(8) The PVC vent pipe at the Southeast corner of Unit 3N's rooftop deck is loose and therefore at risk for allowing moisture intrusion. It is recommended that the PVC piping penetration through the roof covering be evaluated and repaired as needed by a qualified roofing contractor.

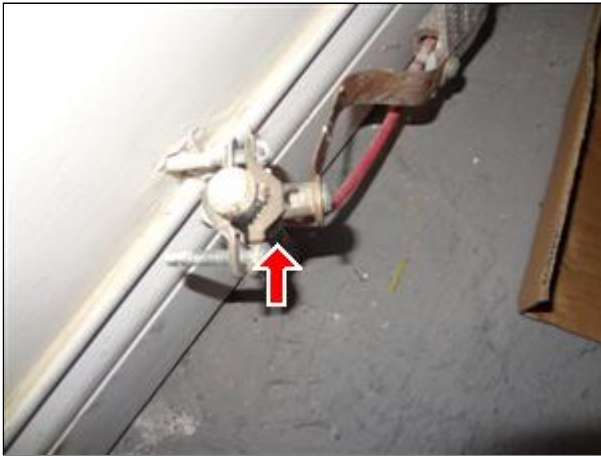
C. Picture 1 Improper Electrical Connection

The connection between the driven ground rod and the grounding electrode conductor at the rear basement is improper and unsafe. The grounding electrode conductor should be secured by the screw terminal and should not be squeezed between the clamp and the rod. Repair by a qualified electrician is recommended in order to help ensure the safe and effective bonding and grounding of the electrical system.

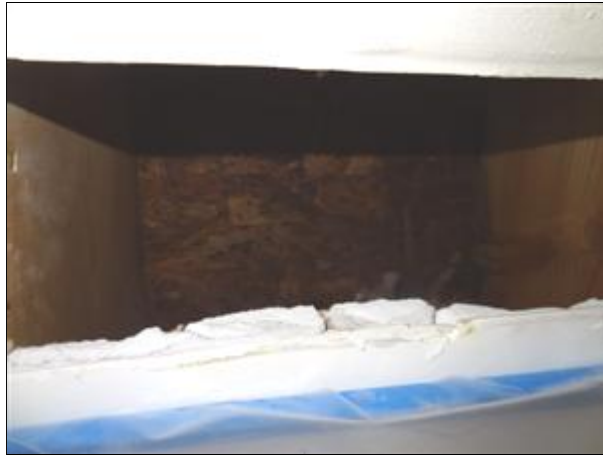
D. Picture 1 Mold-like Substances on Underside of Roof Sheathing

Mold-like substances were noted on surface/s of this home. Mold growth results from moisture on organic strata and is first and foremost a moisture problem. The source of the moisture that is the proximal cause of the mold-growth should be found and eliminated before final remediation is performed. Initial remediative steps may be advisable in order to reduce the release of mold spores, fungal fragments, and mycotoxins during the moisture investigation and repair process. Small areas of mold (10 square feet or less) can be remediated by the homeowner successfully. An EPA approved mildewcide with residual mold inhibiting properties (Concrobium Brand) can be found at major home improvement stores. Relatively non-porous surfaces such as tile, laminate, concrete, etc. should be surface cleaned with this type of product and kept dry. Semi-porous surfaces such as wood framing and sheathing can also be cleaned in this manner if fungal growth hasn't degraded the material significantly. Porous surfaces such as paper-faced gypsum drywall, cellulose insulation, etc. should be removed and replaced.

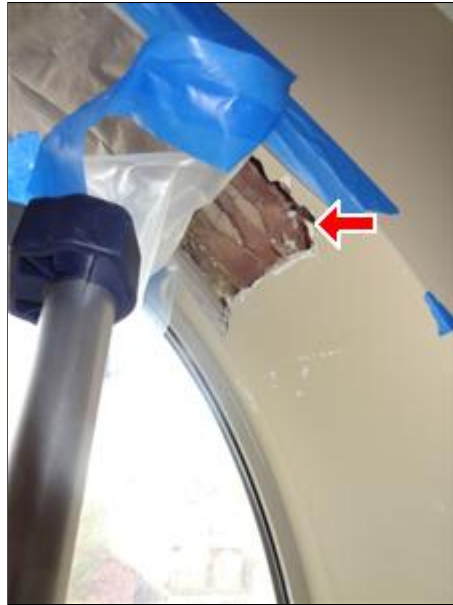
E. Picture 1 Round Top Window

(1) The drywall at the round top interior window returns has been applied directly over the masonry structure. This presents a strong risk for condensation, moisture damage, and mold growth. It is recommended that the drywall finishes at the round top window returns be removed, that all gaps in the arched rough masonry opening be sealed, and that the interior window returns be finished with a non-moisture sensitive material. The use of paper faced or paper backed drywall is not recommended at these locations. Green Board is only marginally more mold resistant than common drywall. The use of non-paper faced gypsum wall board is recommended.

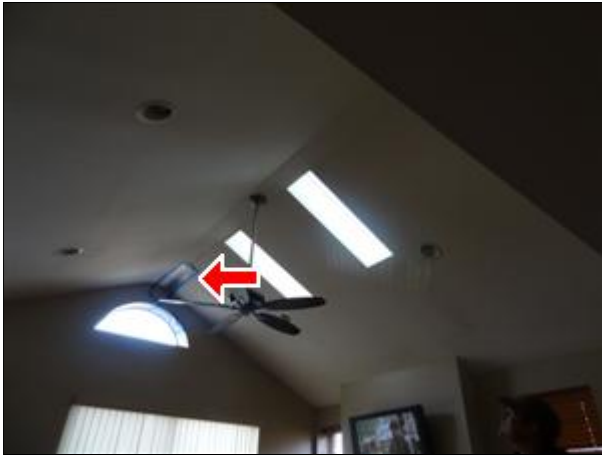
E. Picture 2 Cathedral ceiling at Unit 3N

(2) The cathedral ceilings at units 3N and 3S are not properly ventilated and are prone to recurring condensation events, mold growth, wood rot, etc. The individual framing channels across the cathedral ceiling are lacking adequate air intake openings at the lower termination of the rafters. This omission results in air stagnation and excess contact time between warm and moist interior air leakage and the cold underside of the OSB roof sheathing during the heating season.

Also, the type of roof ridge vent used at this location is prone to allowing wind driven rain to enter the framing voids of the cathedral ceiling. The repeated deterioration of the drywall tape at the peak of the cathedral ceiling is evidence of this process taking place.

These construction defects have combined to create high moisture conditions conducive to mold growth within the individual rafter channels. It is the inspectors opinion that the most cost-effective (both in the long-term and short-term) approach to repairing the defects and remediating the damage at the cathedral ceilings is to remove the existing drywall at the slopes of the cathedral ceilings; remove the fiberglass insulation; remove the continuous ridge vent and perform the required roof patching; apply open cell polyurethane spray foam insulation against the underside of the roof decking and between the individual cathedral ceiling roof rafters; and to install a new drywall ceiling finish.

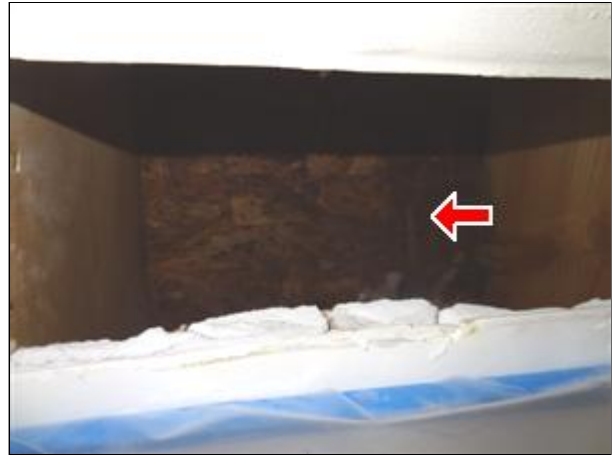
E. Picture 3 Mold Growth at Underside of Roof Sheathing

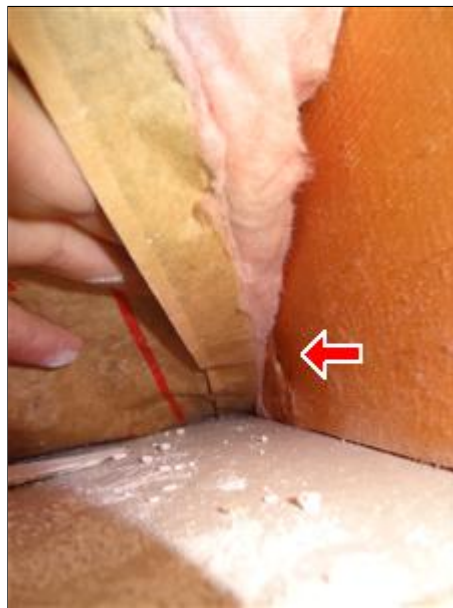
E. Picture 4 Improper Insulation Installation

Also, the fiberglass batt insulation at the cathedral ceiling rafter channels is not been properly installed and is prone to allowing excess warmth and moisture above the insulation layer.

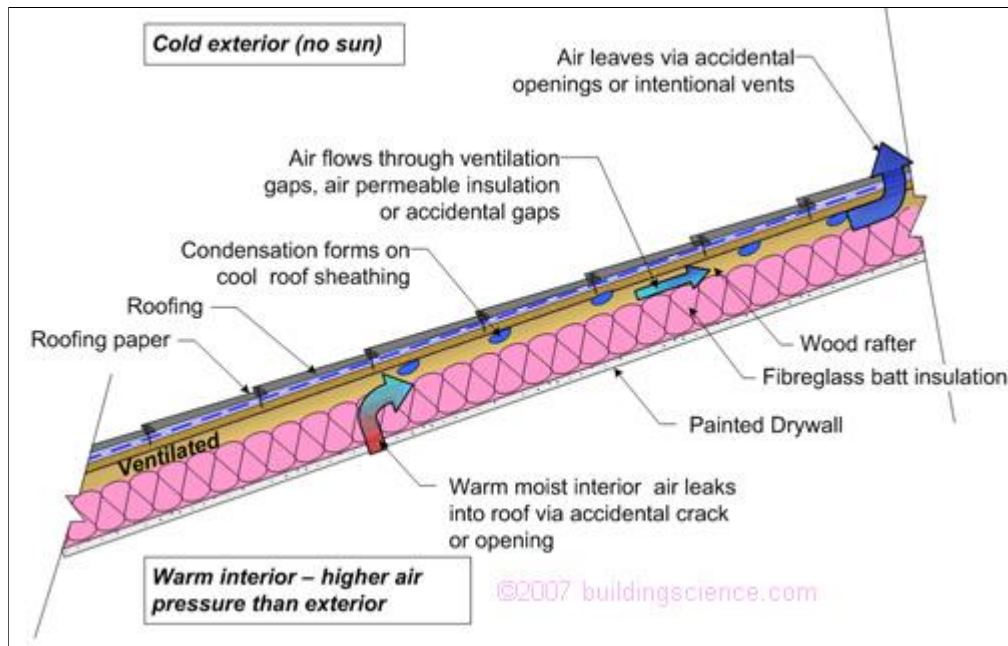
E. Picture 5 Faulty Insulation/Ventilation at Cathedral Ceiling Diagram
