# Inspection Report

**Property Address:**  
1945 W Butterfly Lane  
Chicago IL

**Domicile Consulting**

# I. Domicile Consulting Report

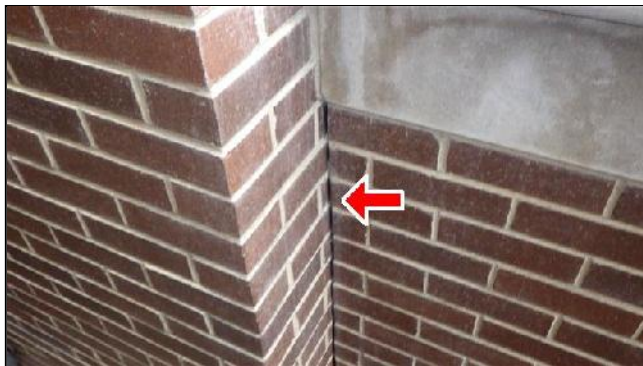
A. Item 1(Picture) Missing Caulking

(1) A number of areas of missing caulking or noted on the exterior of the home. The exterior caulking should be completed once weather permits.

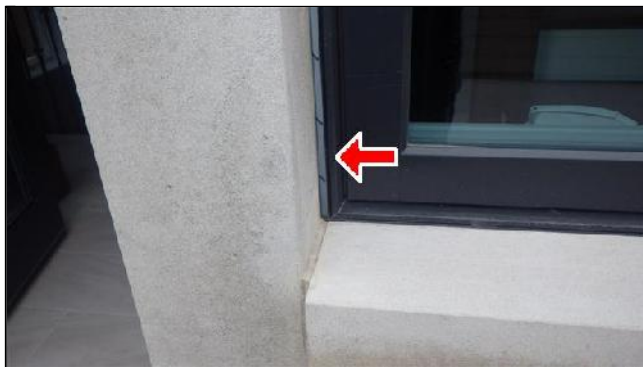
A. Item 2(Picture) Missing Caulking around Window Frame

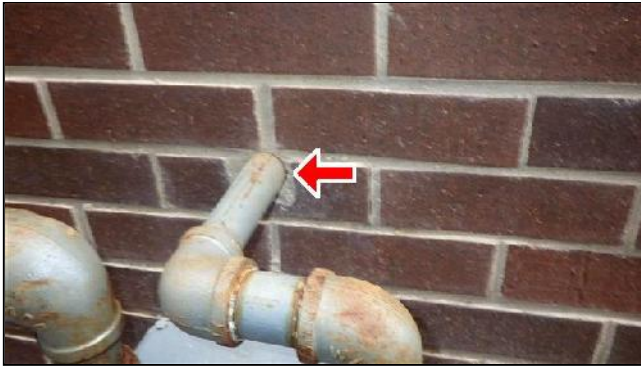
A. Item 3(Picture) Missing Caulking

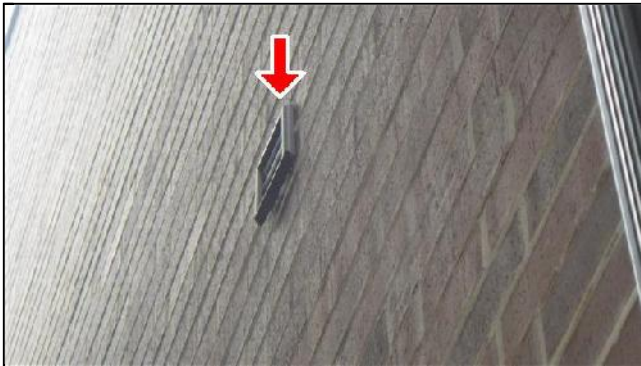
A. Item 4(Picture) Missing Caulking

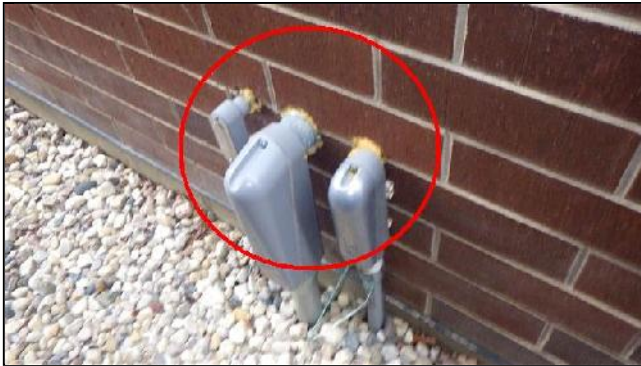
A. Item 5(Picture) Missing Caulking

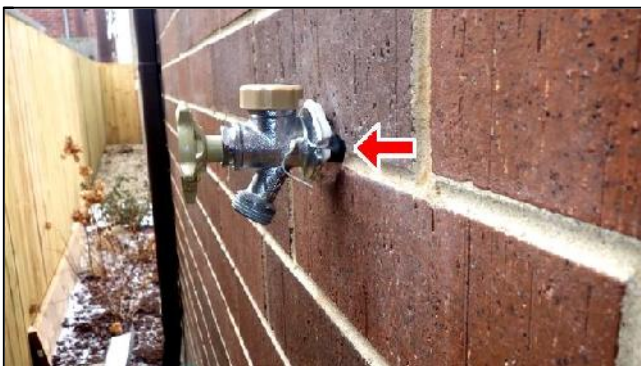
A. Item 6(Picture) Missing Caulking

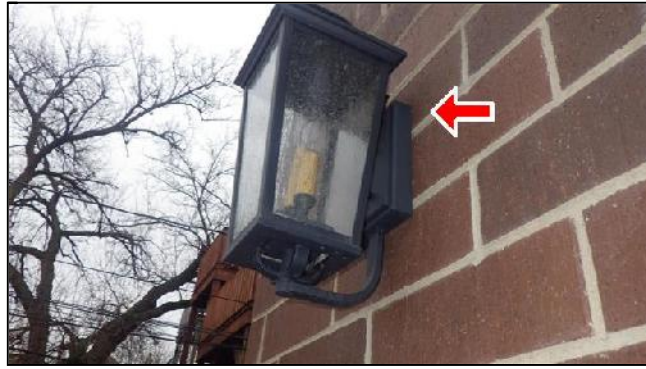
(3) Caulking is recommended at the top and sides of the exterior electrical lighting fixtures in order to prevent moisture penetration into the home and/or moisture contact with energized electrical equipment.

A. Item 7(Picture) Caulking Recommended

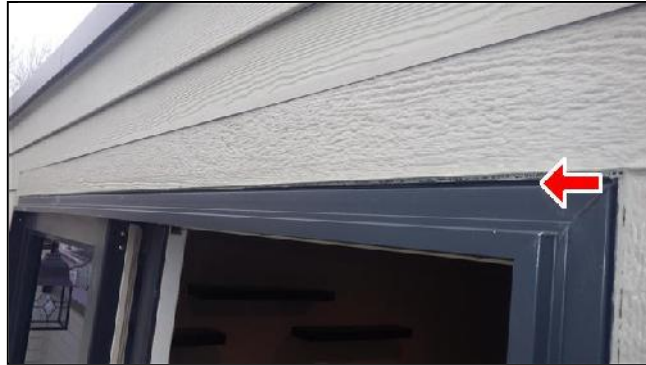
(4) The required drip cap flashing is absent from the top of the penthouse door assembly. This creates a significantly increased risk for moisture penetration and concealed moisture damage. This flashing is required by both the window manufacturer and the siding manufacturer. Repair by a qualified contractor is recommended.

A. Item 8(Picture) Missing Flashing

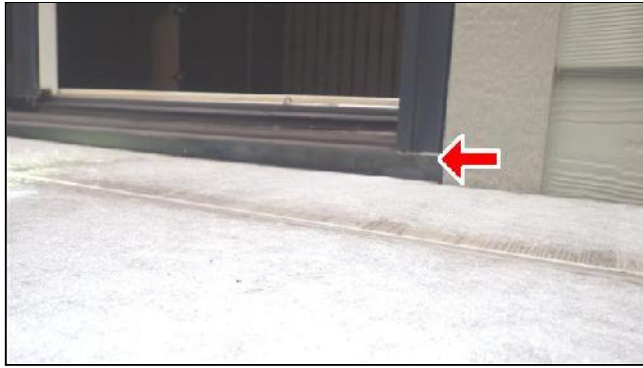
A. Item 9(Picture) Missing Sill Pan Flashing

(5) This exterior door has been installed without the benefit of sill pan flashing. This greatly increases the risk for moisture intrusion and damage at this critical location. It is recommended that the door be removed and that the door opening be protected from moisture intrusion by the application of the appropriate sill pan flashing, head flashing, weather resistant barrier, flashing tape, etc. Repair by a qualified contractor is recommended.

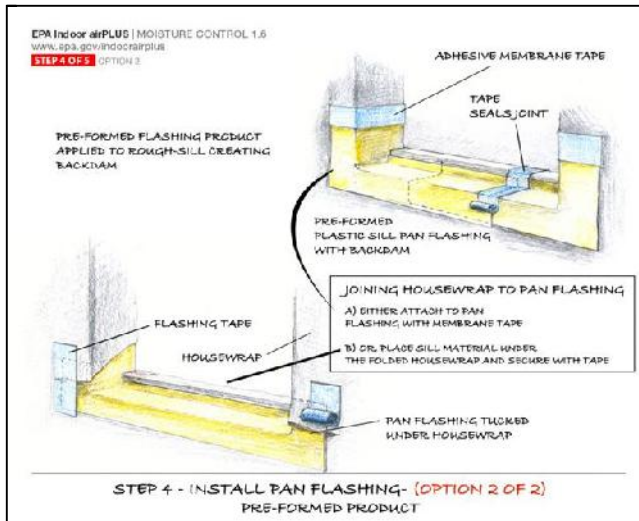
A. Item 10(Picture) Sill Pan Flashing Required

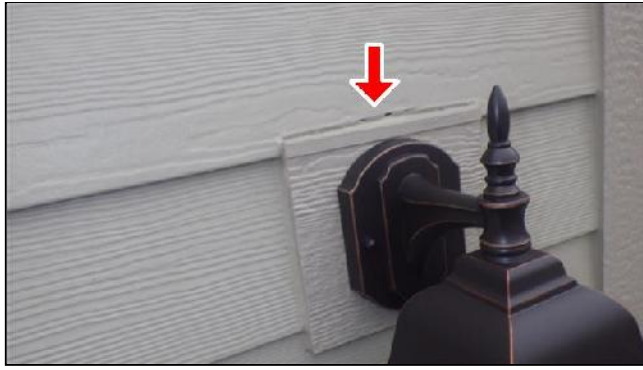
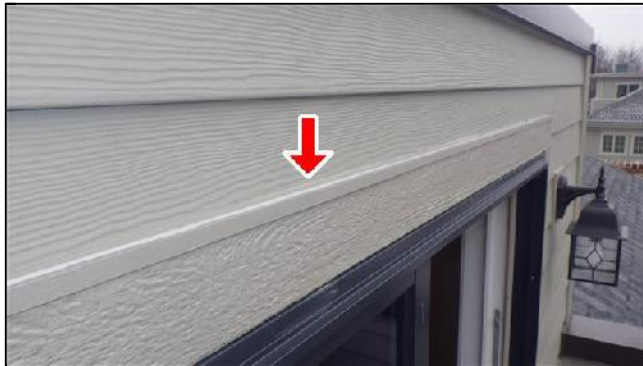
A. Item 11(Picture) Improper Siding Detail

A. Item 12(Picture) Improper Siding Detail

(6) The premier manufacturer of cement composite siding requires that an open space free of caulking be present between the horizontal edge of siding and the adjacent Z flashing. This requirement is intended to allow for moisture release at this location. It is recommended that the seller provide the siding manufacturers information and installation instructions to the buyer for further review.

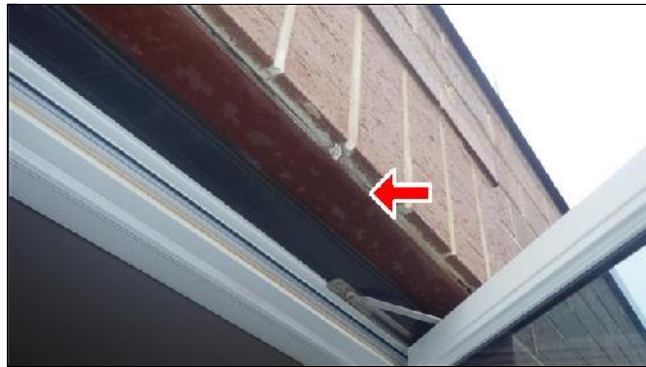
(7) All of the steel window and door lintels should be finish painted in order to provide protection against corrosion and also for proper appearance.

A. Item 13(Picture) Painting Recommended

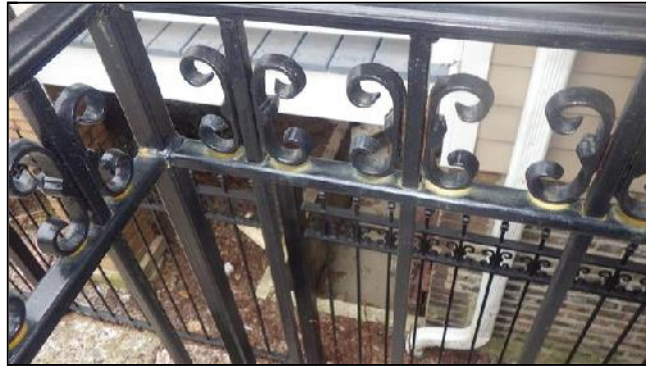
(8) Incipient corrosion was noted at the exterior metal work. A qualified painting contractor should make the necessary repairs to prevent ongoing and accelerating corrosion.

A. Item 14(Picture) Incipient Corrosion

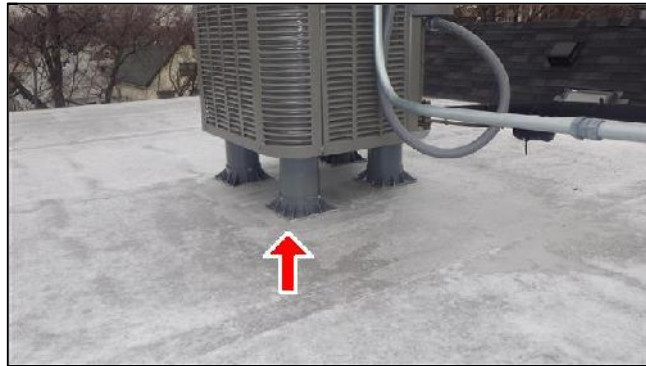
The installation of one or more sacrificial layers of roofing material is recommended underneath the rather keen edges of the air-conditioning bases at the rooftop. During hot weather, the modified bitumen roof material will soften and that, combined with the weight and vibration of the condensing unit, can result in scarring, damage and leaking of the roof covering.

C. Item 1(Picture) Missing Protective Layer

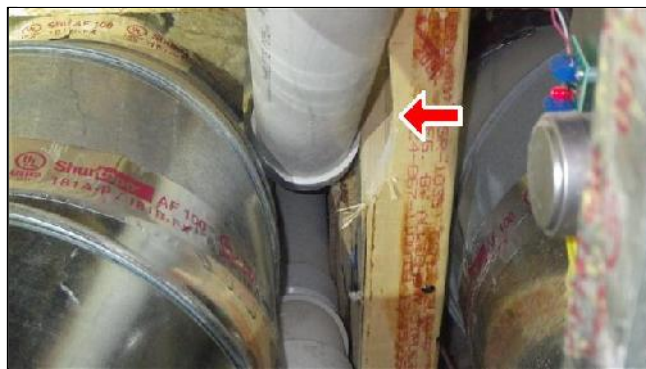
Floor trusses are engineered components which cannot be altered in the field without a stamped drawing by a qualified engineer or architect. It is recommended that the altered and weakened floor truss above the basement furnace be evaluated by a qualified professional and repaired as needed.

D. Item 1(Picture) Damaged Floor Truss

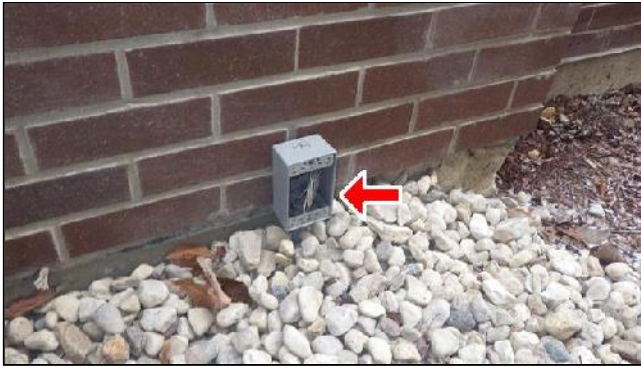
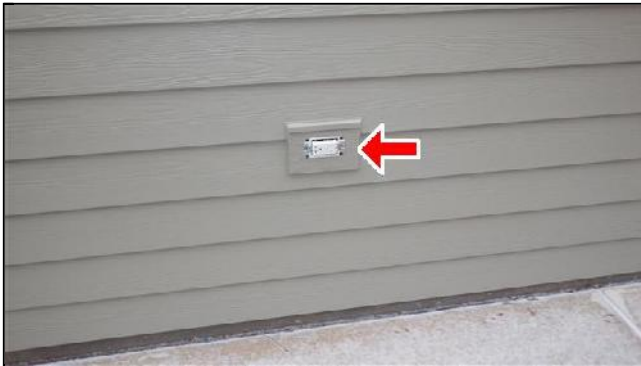
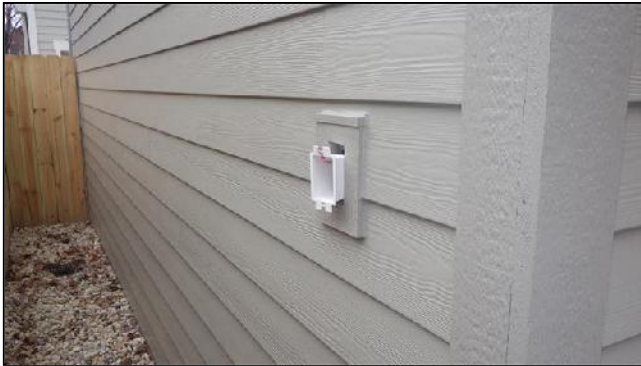
E. Item 1(Picture) Missing Junction Box Cover

E. Item 2(Picture) Missing Cover

E. Item 3(Picture) Incomplete Installation

(1) Several of the exterior electrical junction boxes are lacking covers or other ancillary components. They should be furnished and installed as soon as practical.

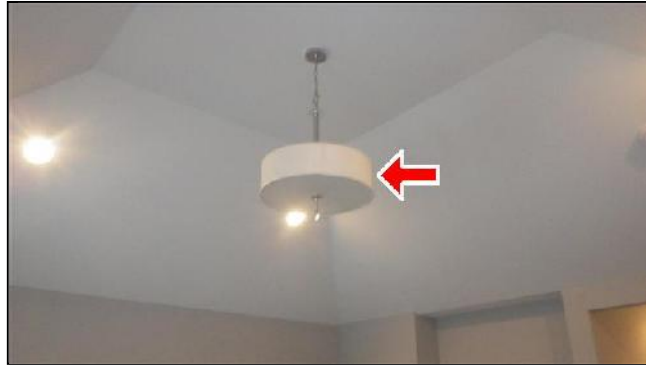
(4) The proper operation of the ceiling mounted pendant light fixture in the master bedroom should be demonstrated to the buyer at the final walk-through.

E. Item 6(Picture) Switch Not Found

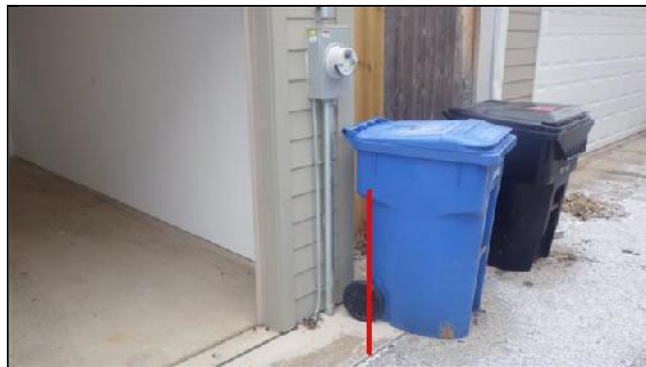
(5) The installation of a protective bollard is recommended in front of the electrical meter socket and service conduit to prevent damage from vehicles.

E. Item 7(Picture) Protection Recommended

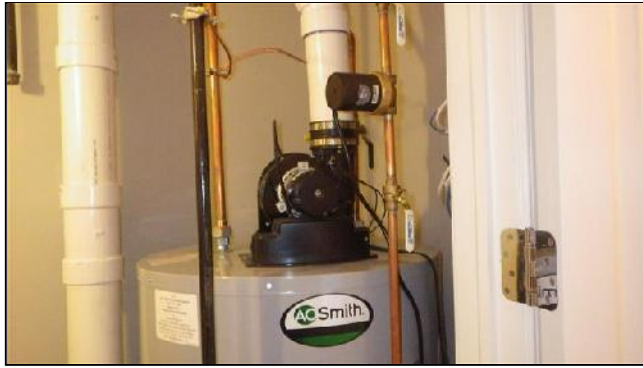
F. Item 1(Picture) Missing Expansion Tank

(1) The plumbing code has long required that an expansion tank be installed adjacent to the water heater in order to prevent excessive piping pressure and leaking. A qualified plumbing contractor should install the required expansion tank.

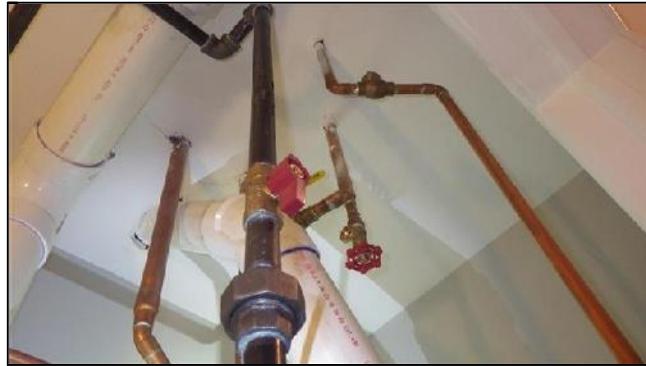
(2) All of the plumbing supply valves and gas valves in the home should be clearly labeled as to their function and areas they serve so that they may be used for emergencies, maintenance, and repairs.

F. Item 3(Picture) Labels Recommended

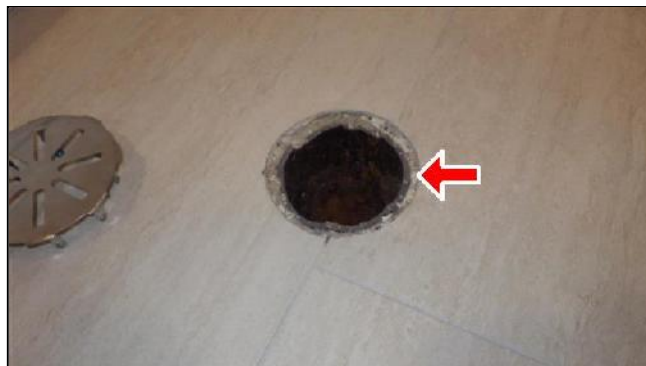
(3) It is recommended that the jagged edges of the cast-iron basement floor drain be ground smooth and made flush with the adjacent concrete slab.

F. Item 4(Picture) Cast-Iron Floor Drain

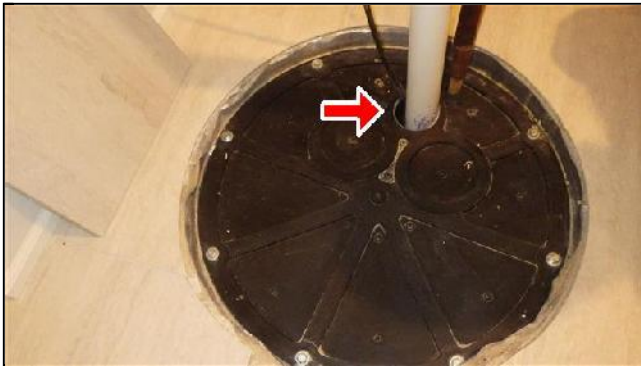
F. Item 6(Picture) Sealing Recommended

(4) It is recommended that the ragged edges of the sump and ejector pit be trimmed and that both pits be sealed to a gas tight level to prevent moisture, pests, and radon gas from entering the home.

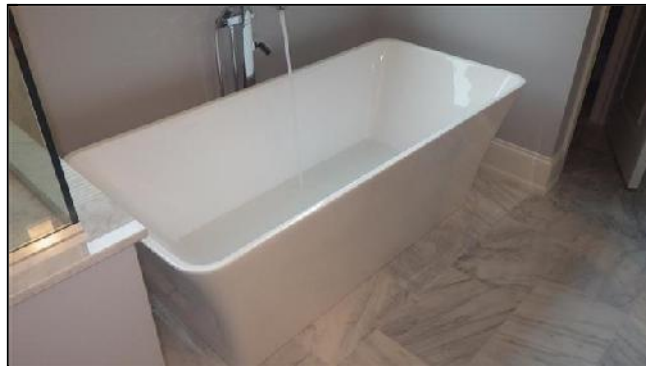
(5) The master bathroom bathtub is not properly secured in position. This presents a risk for excess movement, drain damage, leaking, etc. It is recommended that the bathtub be protected from excess movement according to the manufacturer's installation instructions.

F. Item 7(Picture) Inadequately Secured Bathtub

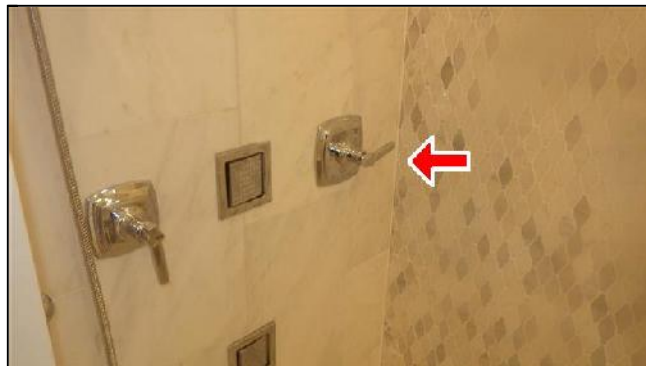
(6) Portions of the master bathroom shower mixer assembly are inadequately secured and at risk for allowing moisture penetration and moisture damage behind the tile. The shower mixer assembly should be repaired as needed by a qualified plumber.

F. Item 8(Picture) Loose Component

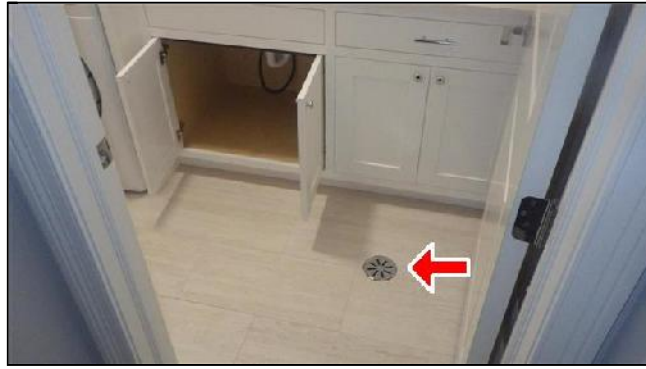
(7) **FYI:** The floor drain/s should be regularly monitored and re-filled with water as needed to prevent the migration of sewer gas into the home. The application of several drops of mineral oil can retard the evaporation of the water 'plug' in the floor drain trap.

F. Item 9(Picture) Regular Maintenance Needed

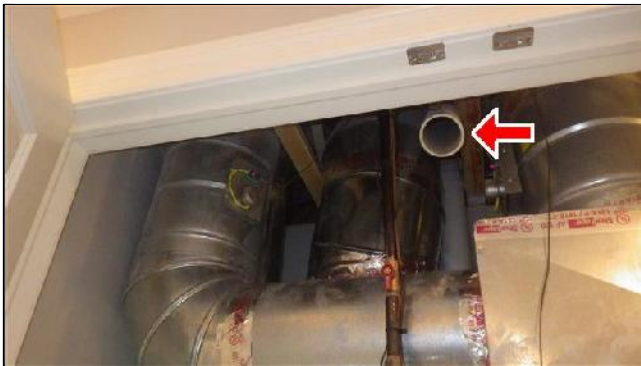
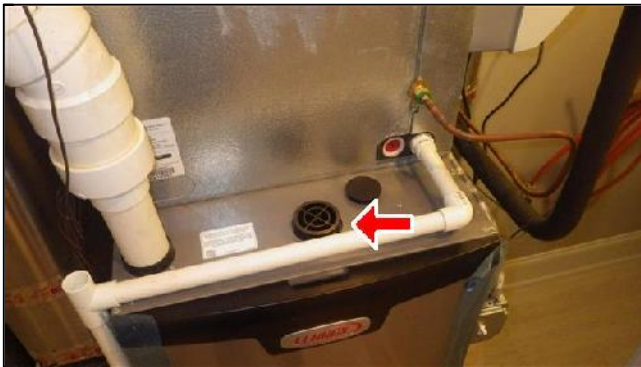
G. Item 1(Picture) Incomplete Furnace Installation

G. Item 2(Picture) Furnace Combustion Air Intake Opening

(1) The high efficiency furnace takes it's combustion/dilution air from the interior of the home. This reduces the fuel efficiency of the furnace. The furnace should be configured so that it's combustion/dilution air is taken directly from outside the home via the appropriate PVC piping. Further evaluation and repair of the furnace by a qualified HVAC contractor is recommended.

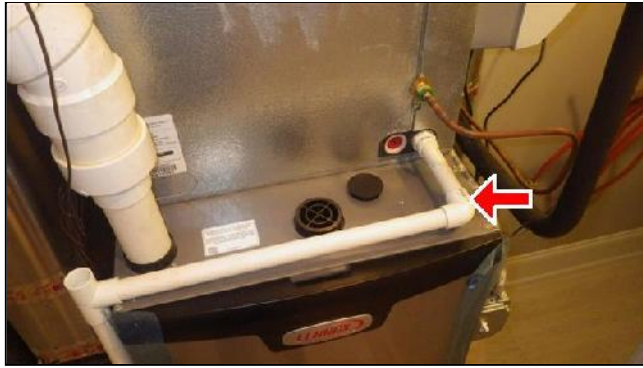
G. Item 3(Picture) Missing Condensate Drain Trap

(2) The installation of a air conditioning condensate trap is recommended in order to reduce the risk for energy losses and for splashing and leaking at the evaporator drain pan. Repair by a qualified HVAC contractor is recommended.

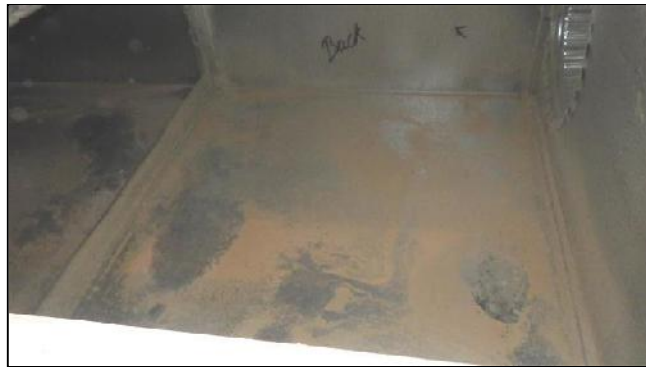
(3) Significant buildup of dust and debris was noted on the interior components of both of the HVAC units that are located inside the structure. The HVAC units should be thoroughly cleaned prior to closing. These cleaning should include evaporator coil, the heat exchanger, and the blower assembly. It appears that these units may have been used during portions of the construction process. This type of use can void the manufacturers warranty. It is also recommended that the units be evaluated by a manufacturer's representative in order to determine their warranty status.

G. Item 5(Picture) Dirty Return Air Plenum

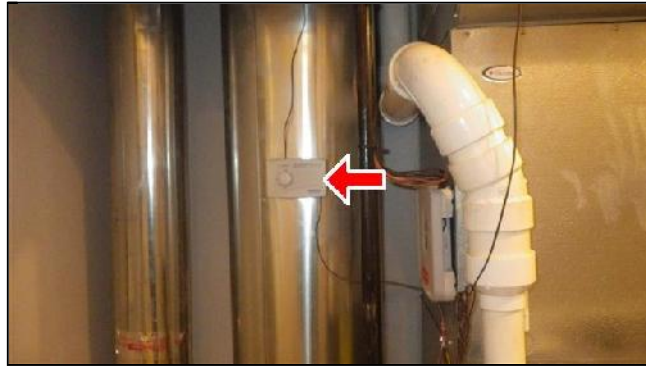
(4) The humidistat control would ideally be placed next to the thermostat control. It's placement in the furnace closet presents an 'out of sight, out of mind' situation for the homeowner. The humidistat requires frequent adjustment during the heating season. Therefore, it is recommended that the humidistat be relocated next to the thermostat.

G. Item 6(Picture) Integrated Controls Recommended

It is recommended that the homeowner purchase a digital hygrometer with which to monitor relative indoor humidity levels during the heating season. The digital hygrometer should be monitored and used as a reference when making adjustments to the furnace mounted humidifier's humidistat. It is recommended that relative indoor humidity levels between 30% and 50% be maintained in the home during the heating season via the careful use and control of the furnace mounted humidifier.

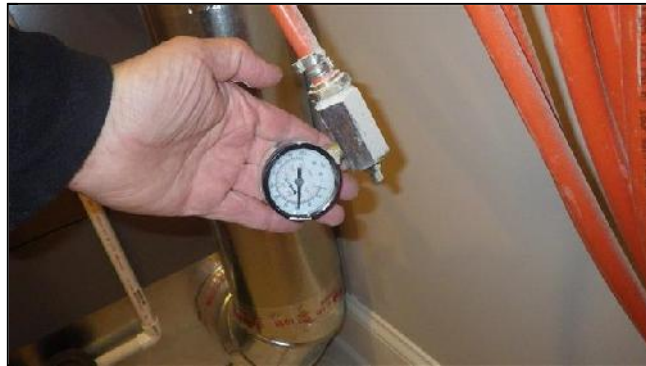
(5) FYI: The hydronic boiler for the radiant slab heating system has not yet been installed.

G. Item 7(Picture) Pressure Tested Hydronic Tubing System

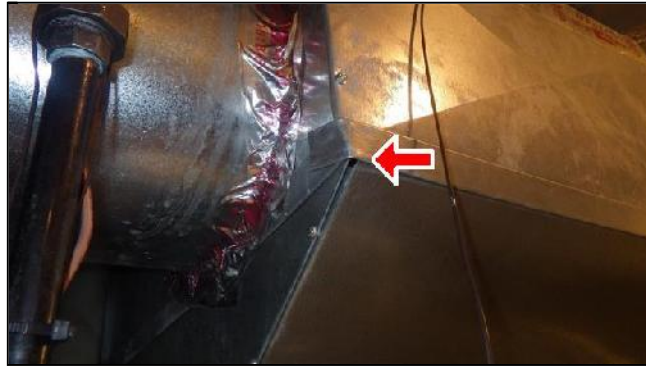
(6) The HVAC air ducts have not been adequately sealed against leakage. It is recommended that a qualified contractor utilize duct mastic to seal all duct joints.

G. Item 8(Picture) Inadequate Duct Sealing

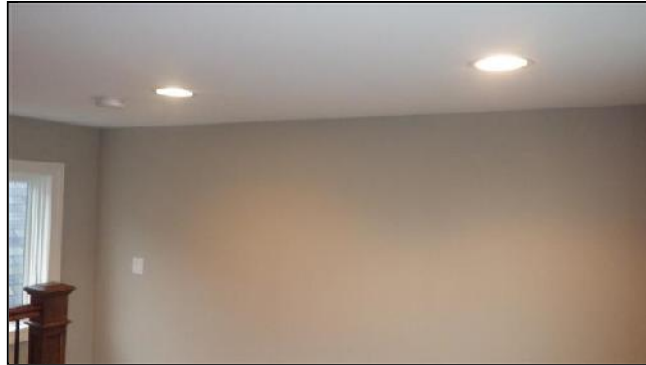
(7) Best practices and industry standards, along with common sense and basic physics, require that return air capability be located at the highest and lowest living areas in the home in order to reduce the risk for temperature stratification. Also, the current International Energy Conservation Code which the city of Chicago subscribes to, requires that HVAC ducts be installed according to established criteria such as that published by the Air-Conditioning Contractors Association in their Manuals 'D', 'J' and 'S'. It is strongly recommended that the seller provide all such documentation to the buyer for further review. It is further recommended that a qualified HVAC contractor provide a plan and budget for the installation of additional return air capability at the upper walls of the penthouse level and at the lower walls of the basement level. In particular, the penthouse level is at risk for becoming untenable during hot weather due to this lack of return air capability coupled with significant areas of unshaded glazing.

G. Item 9(Picture) Missing Return Air

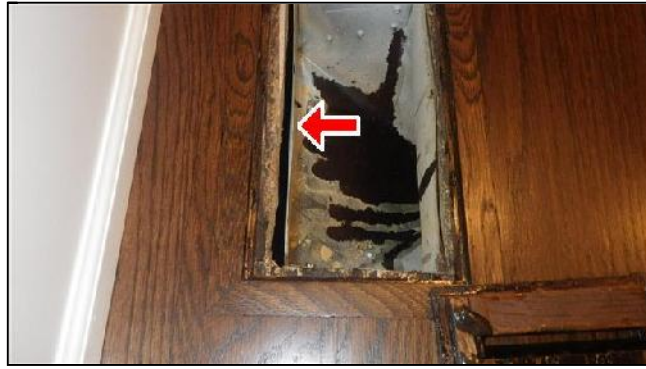
(8) The gaps at the register boots should be sealed to reduce energy losses, to promote optimal HVAC airflow, and to prevent future displacement of the inadequately secured duct boots.

G. Item 10(Picture) Sloppy HVAC Duct Work

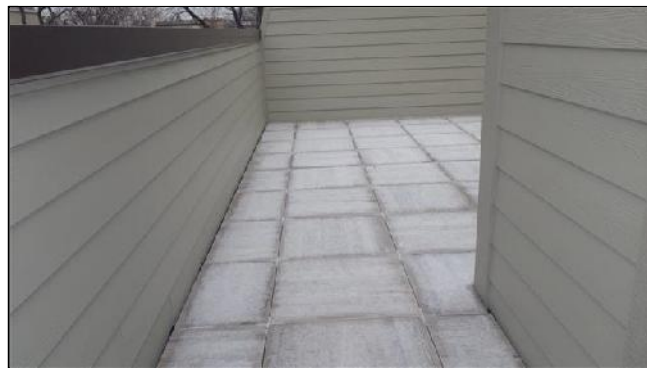
H. Item 2(Picture) No Roof Ventilation Found

(1) The failure to provide ventilation at low slope roof assemblies, a.k.a. flat roofs, can result in wintertime condensation, wood rot, mold growth, etc. It is recommended that high-performance flat roof ventilation be installed by a qualified roofing contractor unless the seller can provide documentation that inappropriately designed and implemented unvented attic assembly is present.

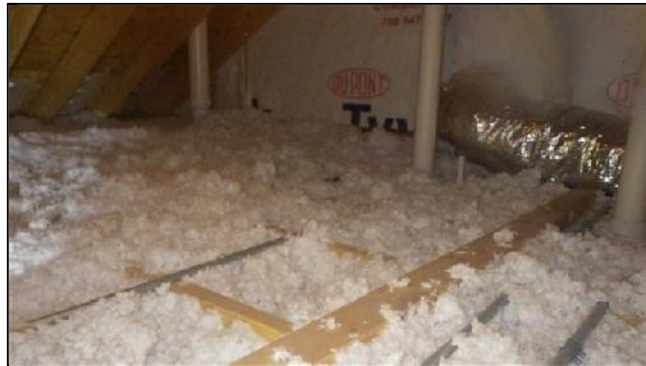
(2) The international energy conservation code requires that the type, amount, and performance value of the thermal insulation throughout the home be stated in a label attached to the electrical panel. In addition, other energy information is required at this location including window performance data. It is strongly recommended that the seller provide proof that the requirements of the existing energy conservation code have been complied with.

H. Item 3(Picture) Missing Insulation Data

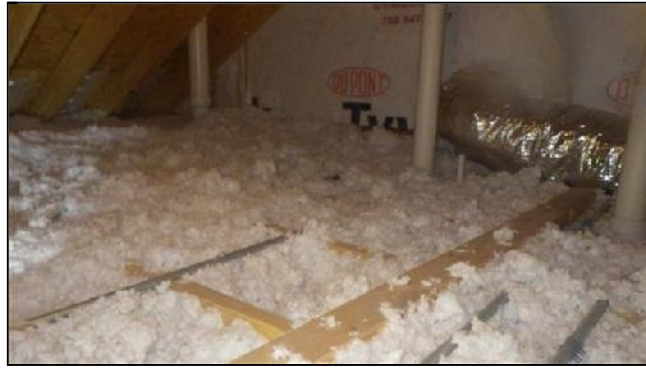
(3) The amount of insulation above the top floor ceiling provide significantly less insulation value than is currently required by the existing energy conservation code. It is most strongly recommended that a qualified third-party installation specialty contractor review the thermal insulation in the home and make all necessary improvements in order to comply with the existing energy conservation code.

H. Item 4(Picture) Inadequate Insulation

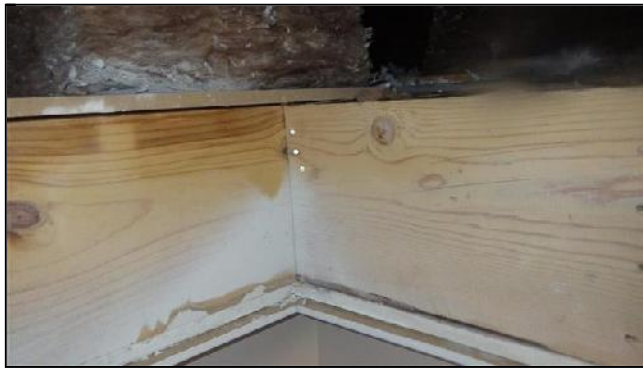
H. Item 5(Picture) Improperly Configured Attic Hatch

(4) The attic hatch should be insulated to the same R-value as the surrounding attic floor and the hatch opening should be weatherstripped in order to reduce drafts and energy losses.

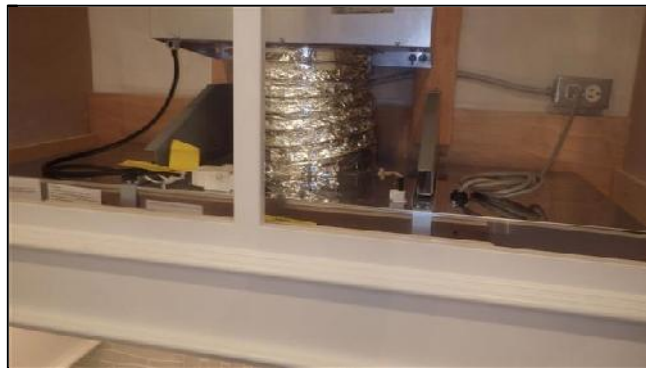
(5) Mylar tubing is generally prohibited from use in kitchen ventilation systems due to its poor airflow characteristics, tendency to accumulate grease, and flammability. It is recommended that the mylar tubing be replaced with rigid, smooth walled, metal vent piping.

H. Item 7(Picture) Forbidden Material

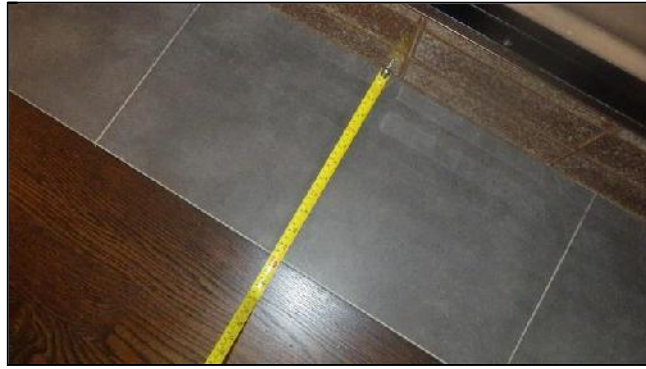
(1) The hearth extension in front of the wood-burning fireplace must be at least 16 inches deep in order to comply with long-standing safety codes. A qualified contractor should make the necessary repairs.

I. Item 1(Picture) Inadequate Hearth Extension Depth

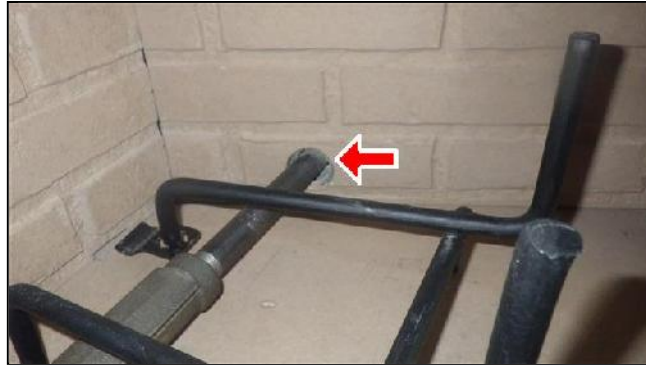
(2) The gaps around the log lighter's penetration into the fireplace should be sealed to prevent flame or super-heated gases from entering the framing voids.

I. Item 2(Picture) Sealant Recommended

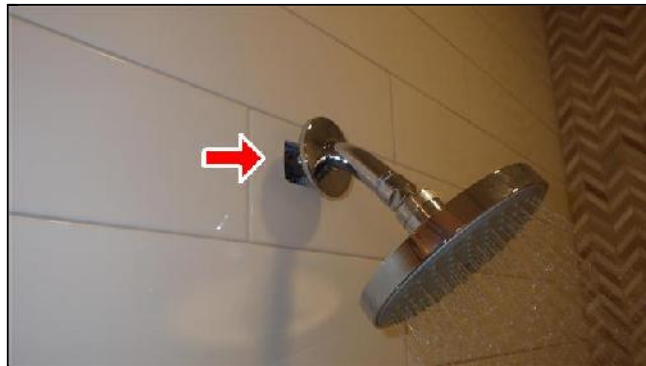
(1) It is recommended that all openings through the basement bathroom tiled shower surround be sealed to prevent steam penetration.

J. Item 1(Picture) Sealant Recommended

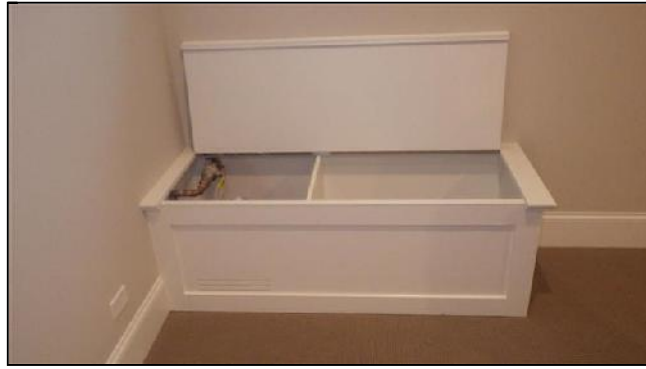
(2) The large lid of the water meter enclosure should be provided with a safety hinged to reduce the risk for injuries to Little fingers.

J. Item 2(Picture) Safety Hinge Recommended

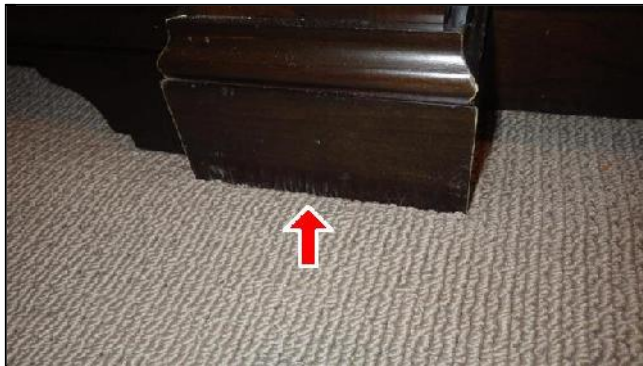
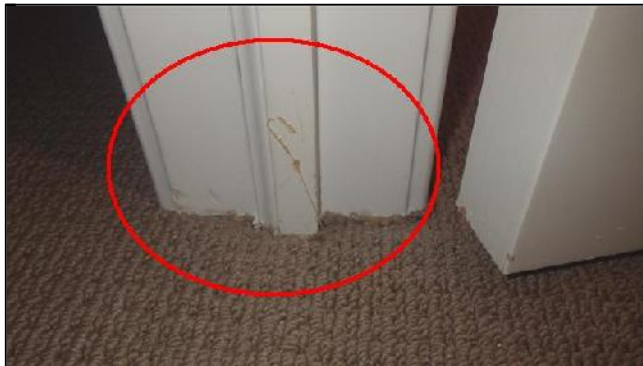
J. Item 3(Picture) Cabinetry Finish Damage

J. Item 4(Picture) Interior Trim Damage

(3) The wall-to-wall carpet installers appear to have caused damage to interior finishes in multiple areas. A qualified contractor should make the necessary repairs.

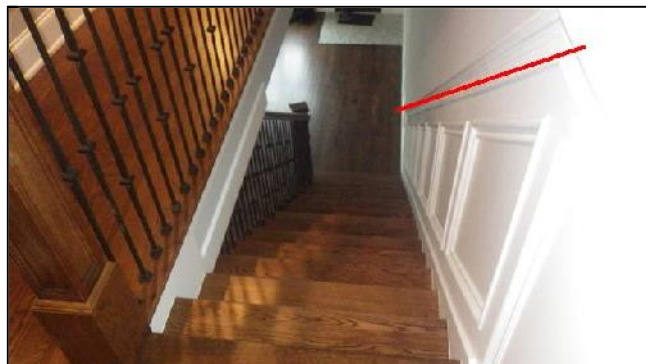
(4) Secure, **continuous**, and graspable handrails should be installed at all of the interior stairs in order to provide for safe stair travel.

J. Item 5(Picture) Missing Railing

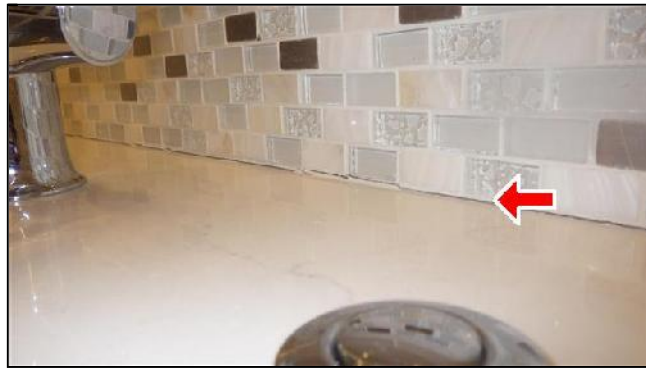
(5) The grout joint at the base of the kitchen backsplash should be raked out and replaced with color matched, mildew resistant caulking.

J. Item 6(Picture) Cracked Grout

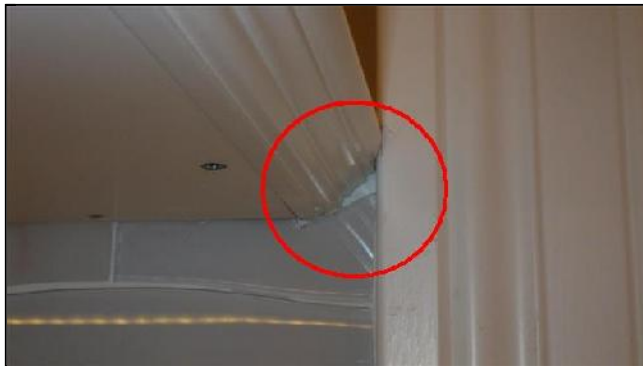
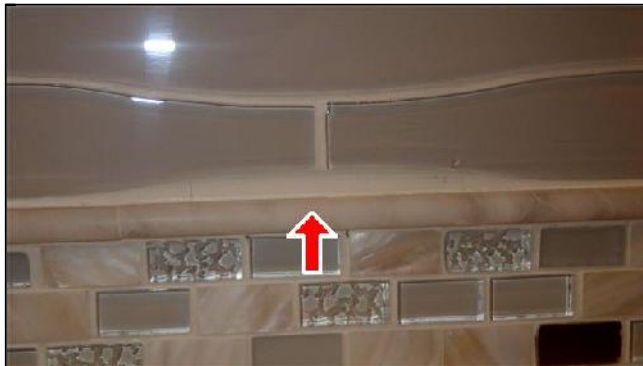
J. Item 7(Picture) Poor Workmanship

J. Item 8(Picture) Poor Workmanship

(6) defects were noted with regard to the installation of the glass tile at the kitchen backsplash. Repair by a qualified tile setting contractor is recommended in order to conform with commonly accepted appearance standards.

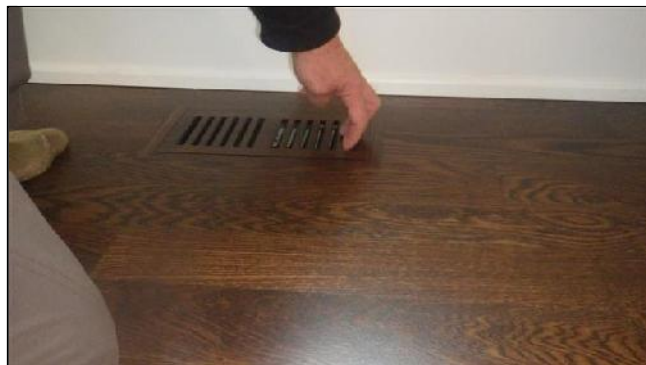
(7) The wooden HVAC diffusers should be made readily removable so that any dropped objects can be easily retrieved.

J. Item 9(Picture) Not Readily Removable

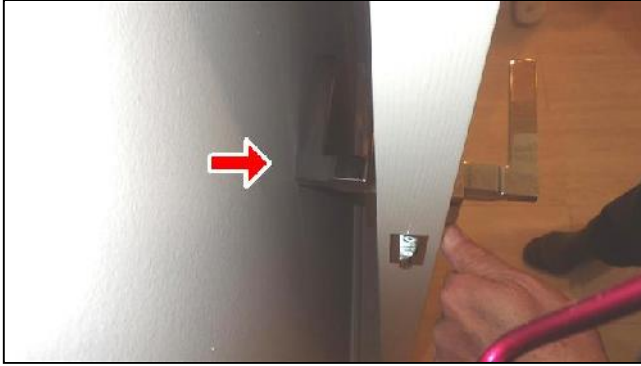
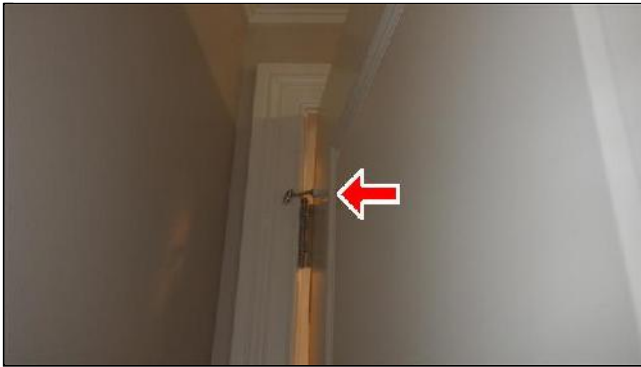
K. Item 1(Picture) Risk for Wall Damage

K. Item 2(Picture) Inadequate Doorstop

(1) The doorstops did not appear to be appropriate or adequate. It may be advisable to install more robust doorstops or to add a second doorstop.

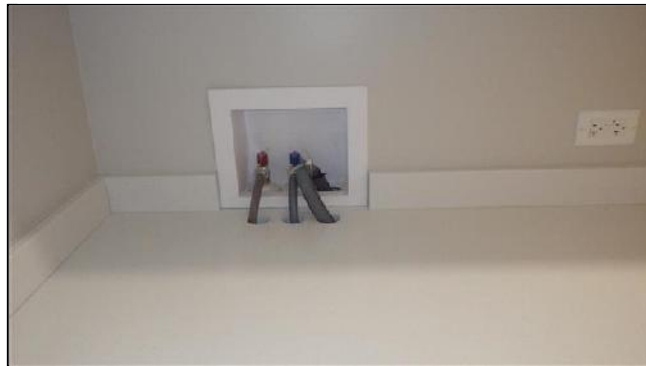
(2) FYI: The built-in nature of the laundry equipment prevented a thorough evaluation of multiple critical components.

K. Item 3(Picture) Concealed Components

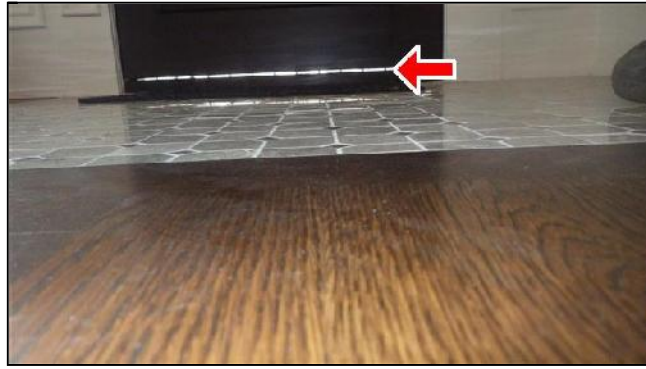
(3) The front entry door should be repaired to stop drafts and energy losses.

K. Item 4(Picture) Front Entry Door

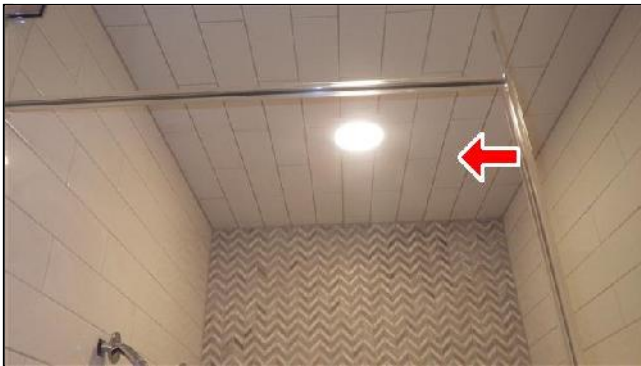
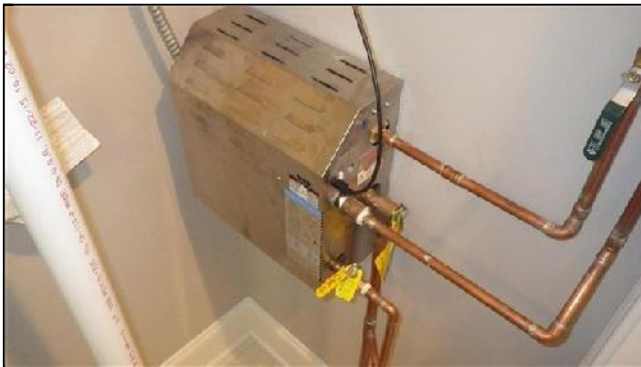
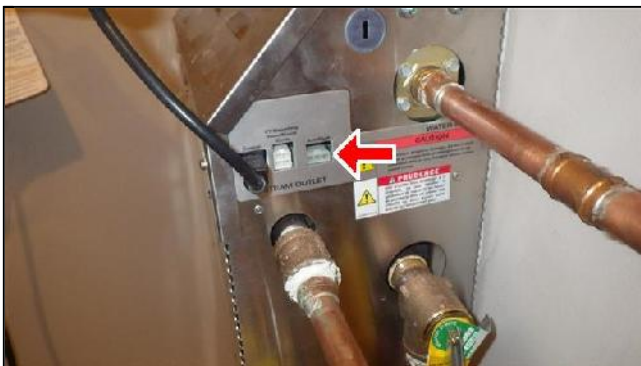
L. Item 1(Picture) Missing Slope at Ceiling

L. Item 2(Picture) Steam Generator

L. Item 3(Picture) Connection for Auto Flush Mechanism

(1) The steam shower and steam generator are lacking some desirable and/or recommended features. It is strongly recommended that an in-line chlorine filter be installed in the water supply piping leading to the

Also, the steam generator manufacturer and the Tile Contractors of North America recommend that the ceiling of the steam shower be sloped approximately three-quarter inches per foot in order to reduce the amount of condensation dripping onto the steam shower occupants. It is recommended that the master bathroom shower enclosure be further evaluated by a qualified tile setting contractor in order to determine cost and feasibility for repair of this apparent omission. The following is a quote from the manufacturer's documentation: "The ideal ceiling height is 7' to prevent uncomfortable temperature variations common in steam rooms with ceiling heights greater than 8'. As heat accumulates near the ceiling, bathers may experience uncomfortably cool temperatures near the floor. Amerec's EvenSteam™ Air Circulation Fan option available with our K200i Freedom Control system improves bather comfort in steam rooms with ceilings higher than 8'. The ceiling should be sloped a minimum of  $\frac{3}{4}$ " per foot to prevent condensation from dripping on bathers during a steam bath."

steam generator in order to reduce the amount of chlorine and chlorine byproducts that are emitted during the steam cycle.

The installation of a auto flushing mechanism (recommended by and available from the steam generator manufacturer) is also recommended in order to reduce the risk for scale and sediment build up inside the steam generator and to increase the service life of the equipment. The following is a quote from the manufacturer's documentation: "Amerec's ADK auto drain option is highly recommended to automatically drain and flush the generator after every steam bath."

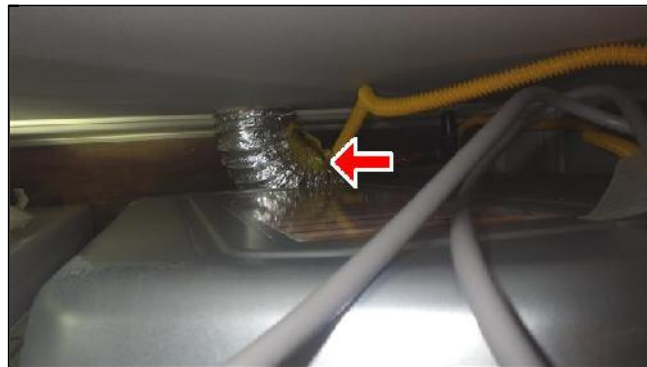
(2) The corrugated vent hose for the clothes dryer is prohibited by all appliance manufacturers due to it's poor airflow characteristics. This can result in increased drying times, reduced equipment life, and an increased risk of fire from lint build-up. The existing vent hose should be replaced with smooth wall metal vent piping.

L. Item 4(Picture) Forbidden Vent Material

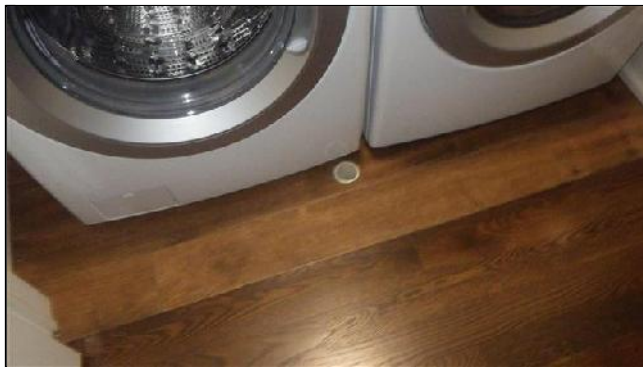
L. Item 5(Picture) Missing Drip Pan

(3) The installation of a preformed drip pan is recommended underneath the washing machine in order to reduce the risk for leaking and damage in the event of an appliance malfunction.

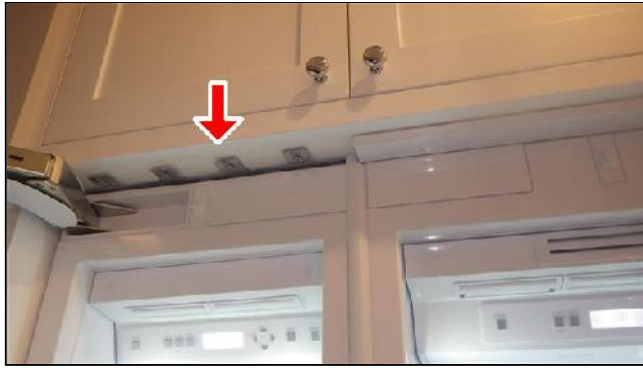
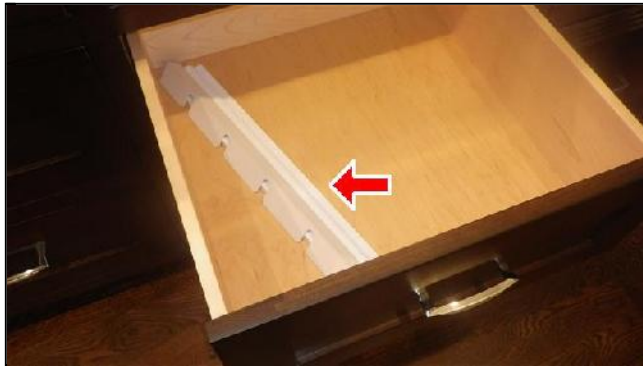
L. Item 7(Picture) Missing Refrigerator Component

L. Item 8(Picture) Detached Trim Piece

(4) The missing refrigerator components should be furnished and installed prior to closing.

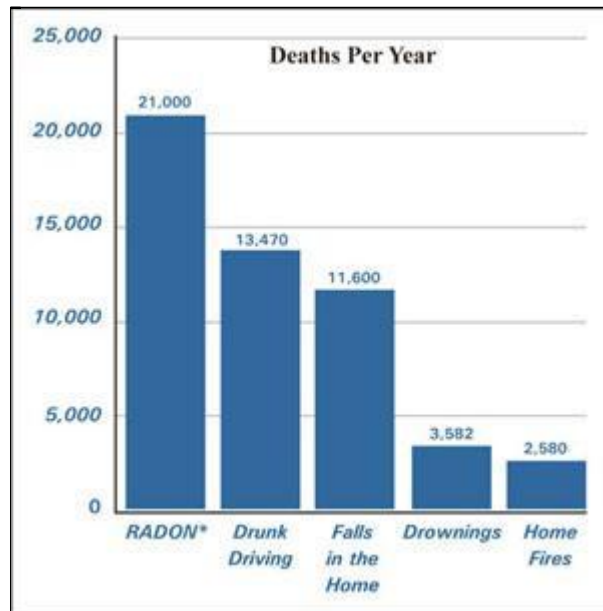
(1) New homes have been required to have Radon Resistant New Construction components installed by state law since June of 2013. No such components were noted at this newly constructed home. The buyer should get further advice regarding this failure to comply with state law from his/her attorney.

M. Item 1(Picture) Relative Health Risks

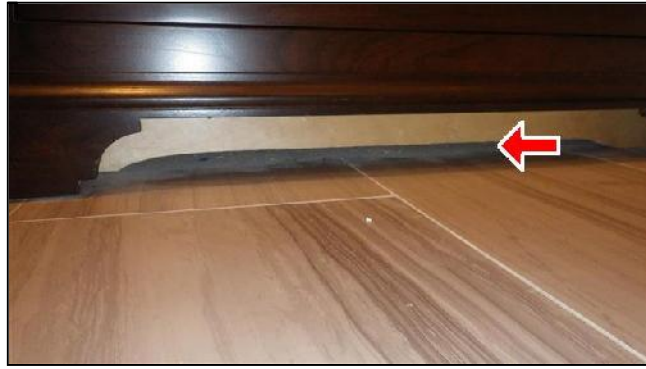
(2) Construction dirt and debris were noted in multiple areas. A thorough cleanup should be performed prior to closing.

M. Item 2(Picture) Additional Cleanup Recommended

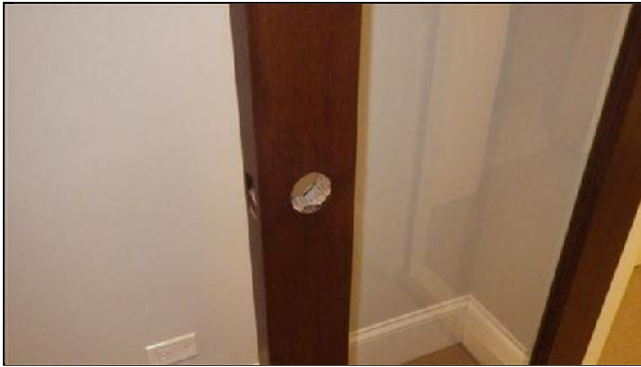
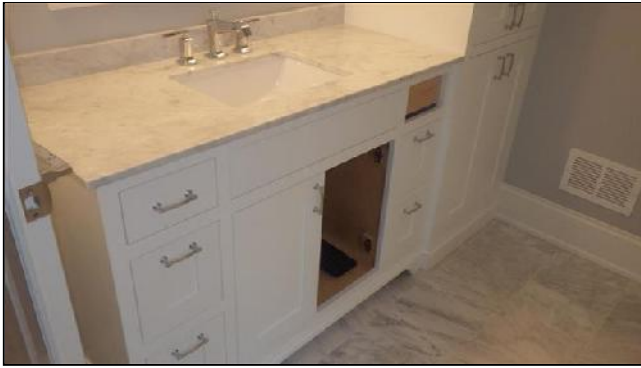
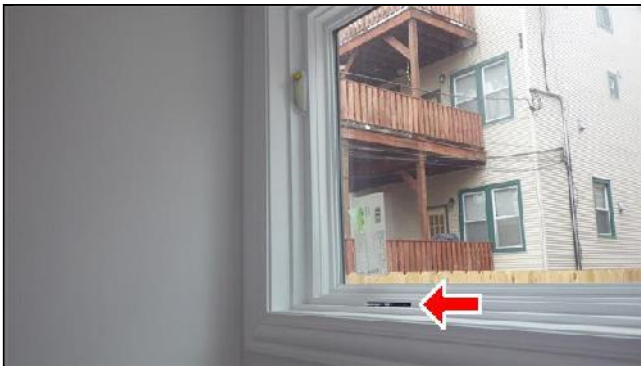
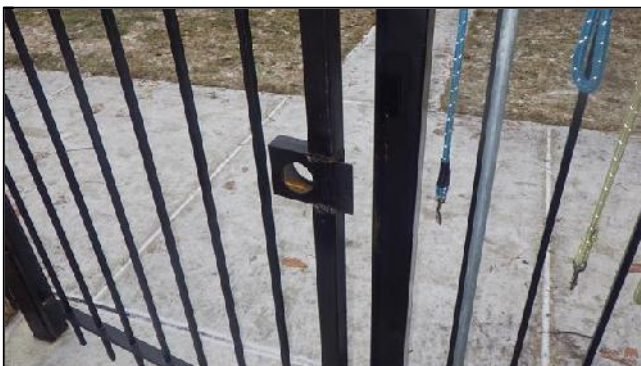
M. Item 3(Picture) Missing Hardware

M. Item 5(Picture) Incomplete Cabinetry Installation

M. Item 7(Picture) Missing Window Hardware

M. Item 8(Picture) Missing Hardware

(3) A number of incompletely installed components were noted at this new construction home. It is recommended that a final walk-through be performed prior to closing.
