Inspection Report for Property at:
Chicago, IL

Private Home Inspection for:

Date:
November 13, 2009

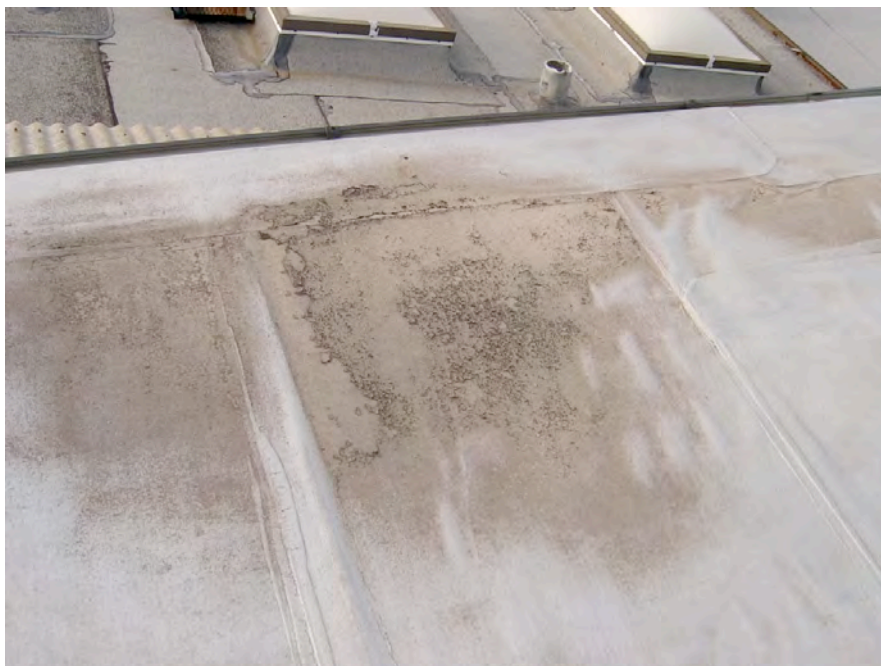
Comments: There are areas of the roof that show signs of ponding (areas that hold water) and areas that are soft to walk on. See photos. There is no rail around roof, caution should be used when working on roof.

Figure 2 evidence of ponding on roof

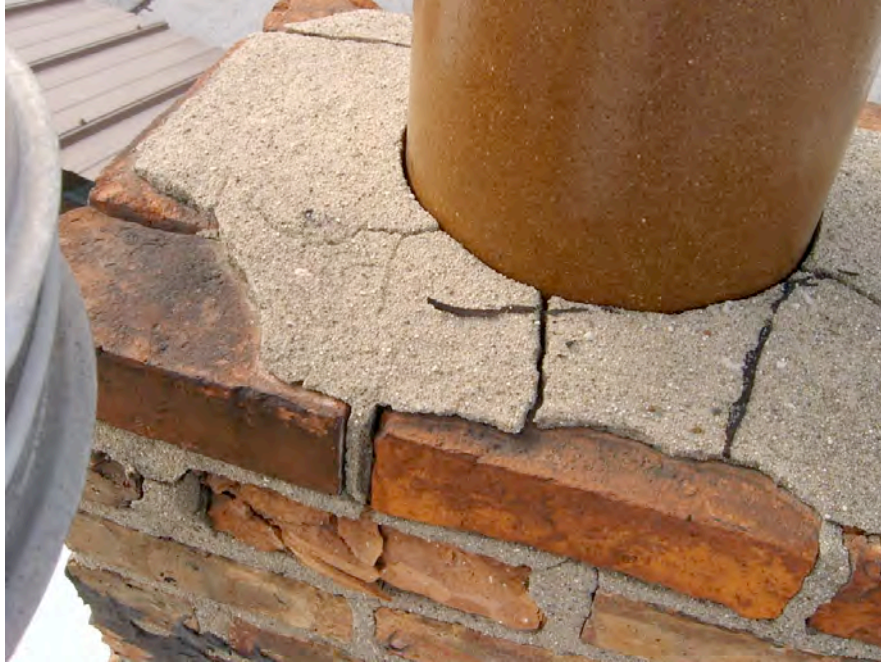
Chimney material: Metal, PVC & Masonry. Sections of the north masonry chimney have cracked bricks and deteriorating mortar. The south fireplace chimneys are not lined. Recommend this be corrected as necessary (see photos).

Figure 3 North chimney. Note deterioration of brick & cap

Keep the chimney cap well sealed to exclude moisture.

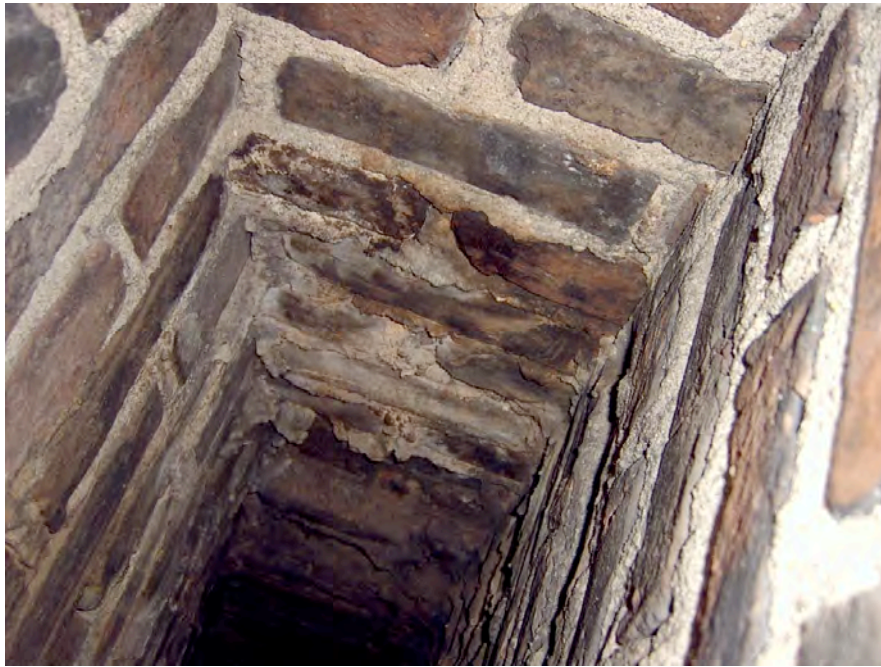
Figure 4 Unlined fireplace chimney

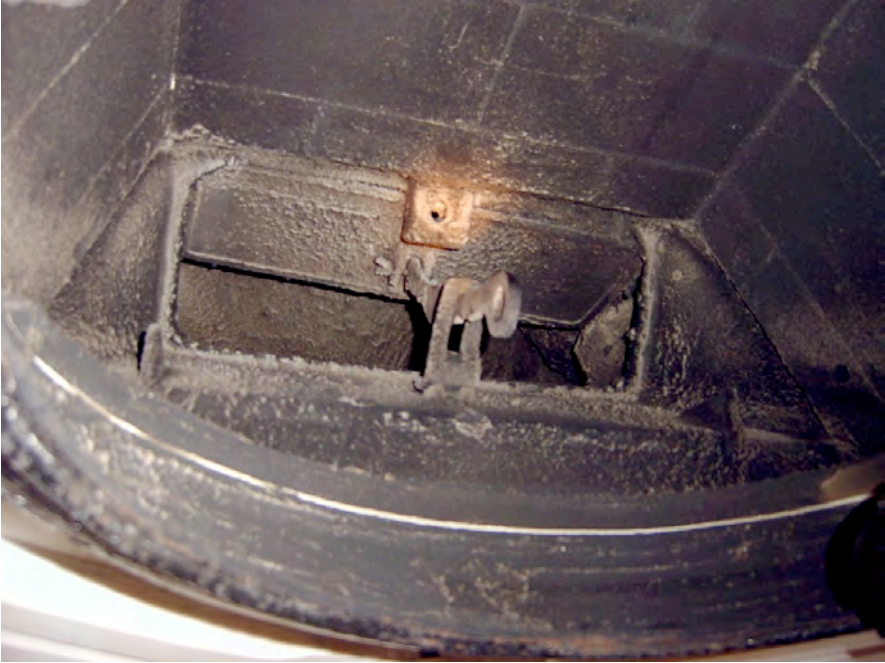
Comments: There is a build up of combustion products in the front living room fireplace chimney. Recommend this be cleaned and checked by a chimney professional for safe and proper operation. The office fireplace is equipped with a gas line to burn wood or gas. The family room fireplace is gas only.

Figure 5 Accumulation of soot and creosote in living room chimney

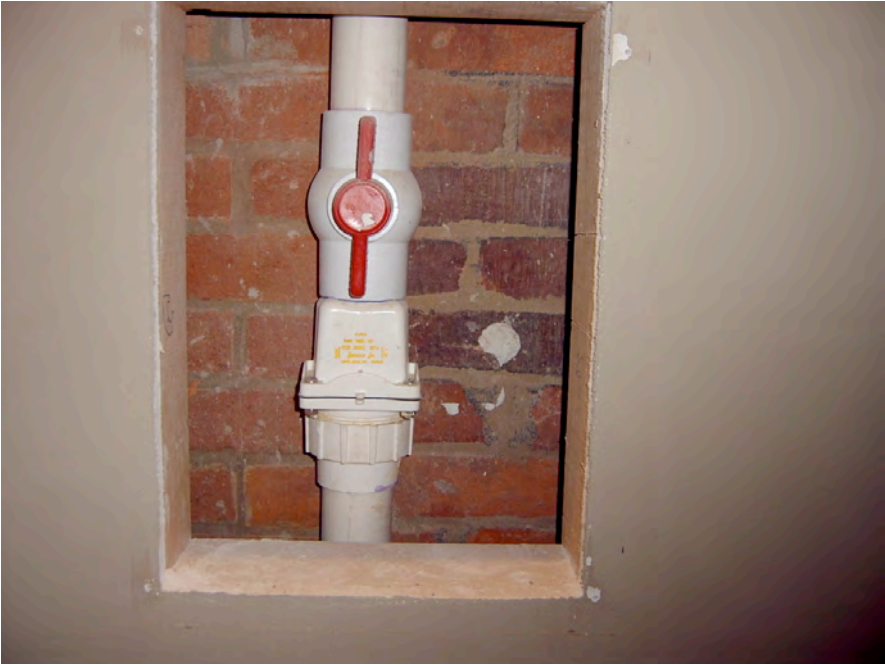
Figure 6 Shut off valves for ejector pump (behind panel in closet)

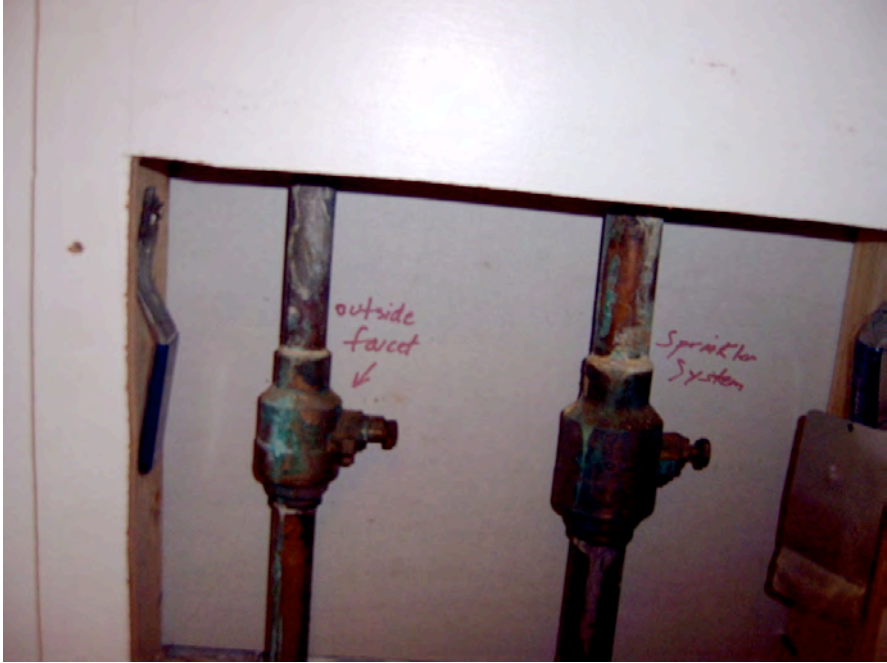
Comments: The main supply comes under ground from the city. The outside faucets did not operate at time of the inspection. Check to see if seller turned these off for winter.

Figure 7 Shut off valves for outside faucets behind cover in lower level furnace room

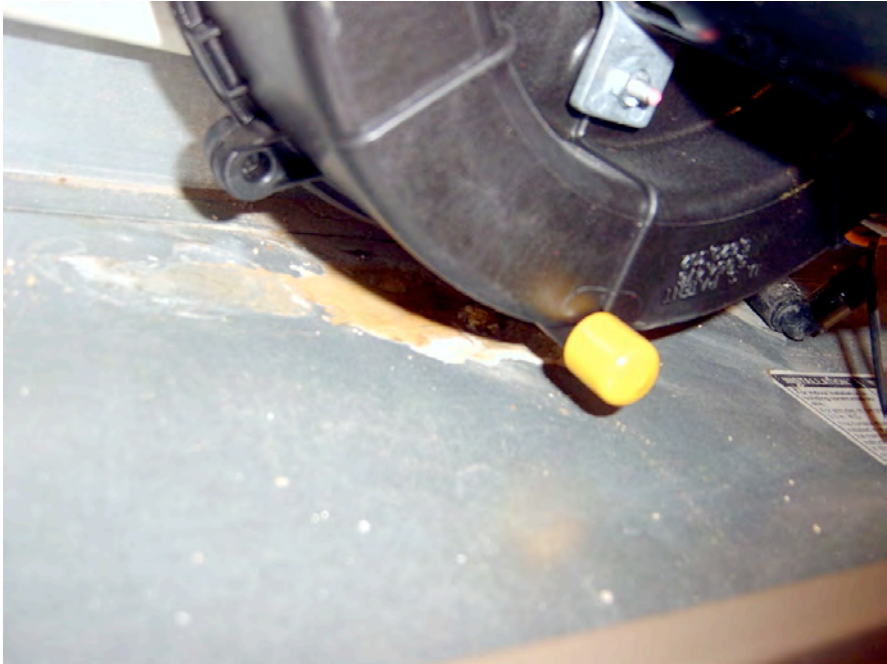
Comments: The furnaces are the higher efficiency type equipped with induced draft and electronic ignition. There is a slight condensate leak from the PVC flue pipe of lower level furnace. Recommend this be sealed or repaired as needed.

Figure 8 Condensate leakage under induced draft of lower furnace

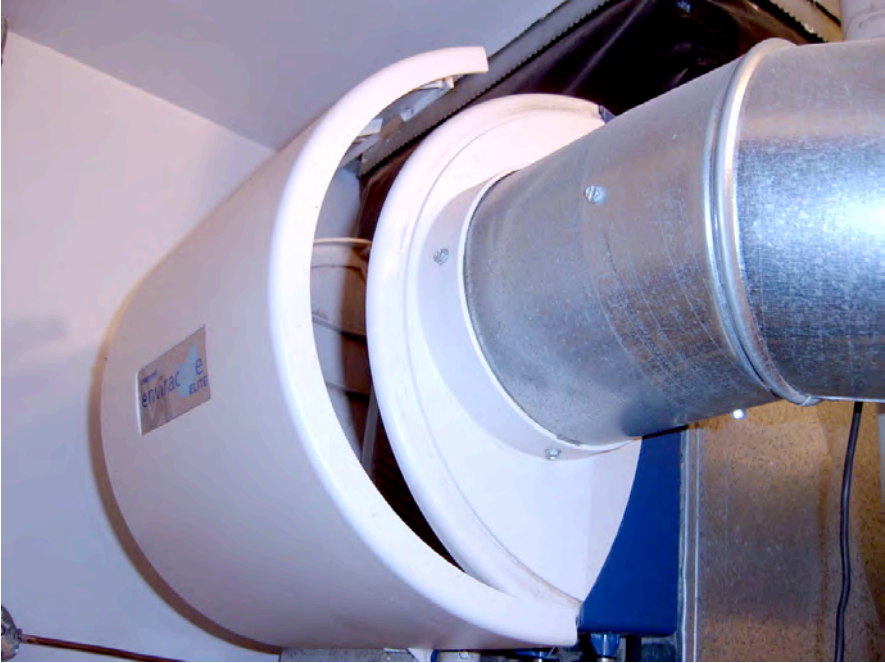
Replace humidifier evaporator pads annually. The cover for lower level humidifier is not in place properly at time of the inspection. Remember to open humidifier damper in winter. The lower level unit needs a damper.

Figure 9 Loose cover on lower humidifier

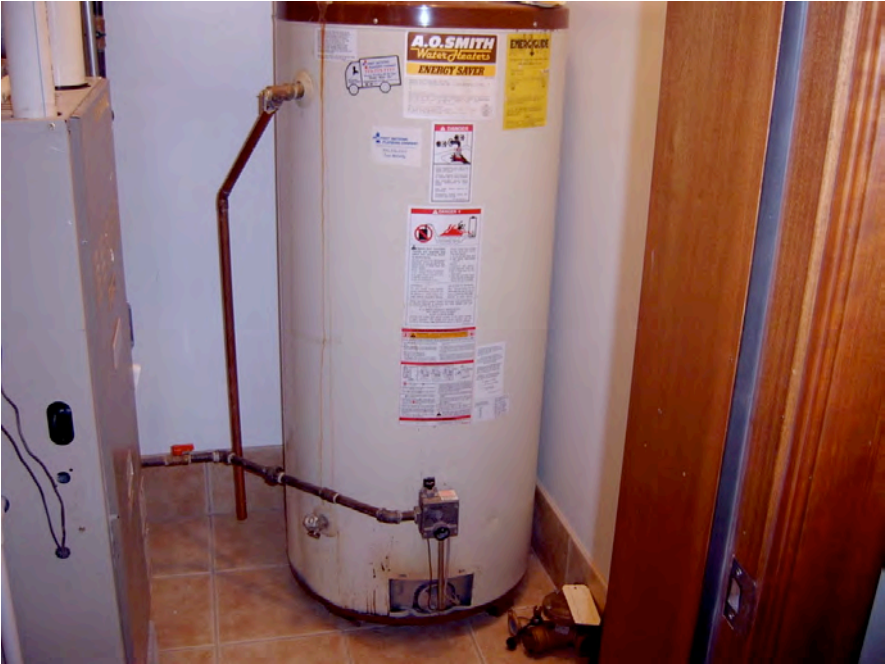
Comments: A. O. Smith®. The front burner cover is missing. There is no visible source of fresh air into the furnace area for water heater (75,000 BTU). Adequate air supply is necessary for proper operation of gas appliances. The unit is near the end of its useful life expectancy.

Figure 10 Water heater. Note missing burner cover.

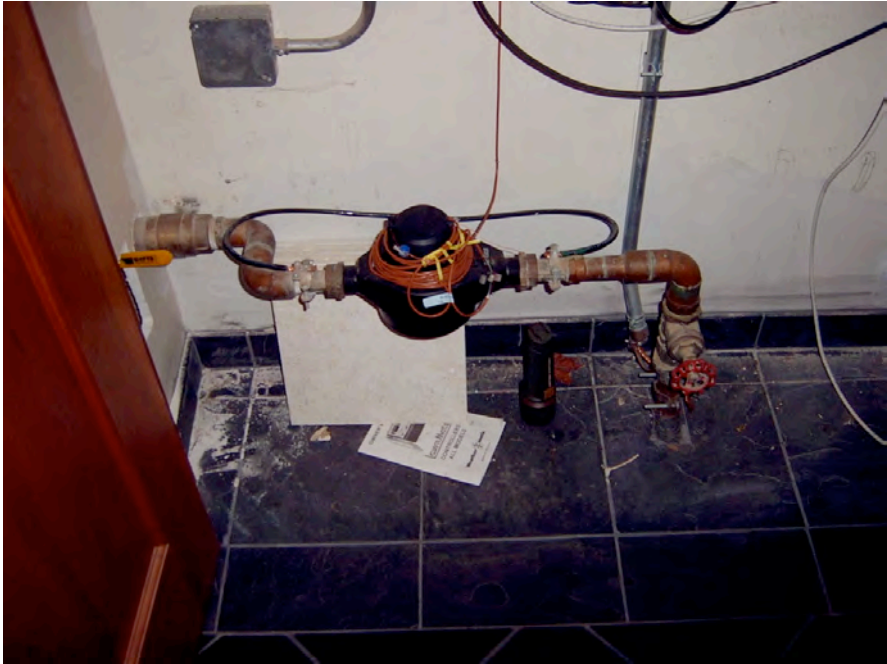
Figure 12 Main water shut off
