Inspection Report

Property Address:
1818 S Halcyon Drive
Chicago IL

Domicile Consulting

I. Domicile Consulting Report

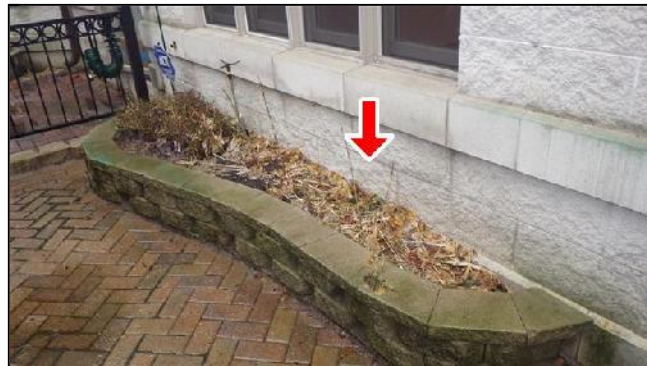
(1) The presence of soil against the lower front exterior wall presents an increased risk for moisture saturation of the masonry, moisture penetration to the interior, and moisture damage. It is recommended that the planting bed/exterior wall be provided with a moisture barrier or that it be removed altogether.

A. Item 1(Picture) Risk for Moisture Saturation and Moisture Damage

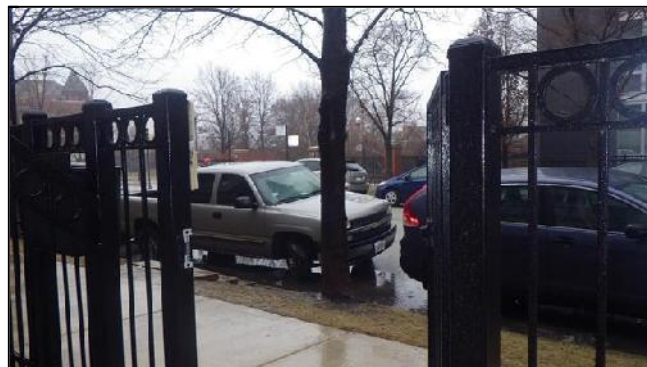
(2) The front gate requires excess effort to operate and should be repaired as needed.

A. Item 2(Picture) Front Gate

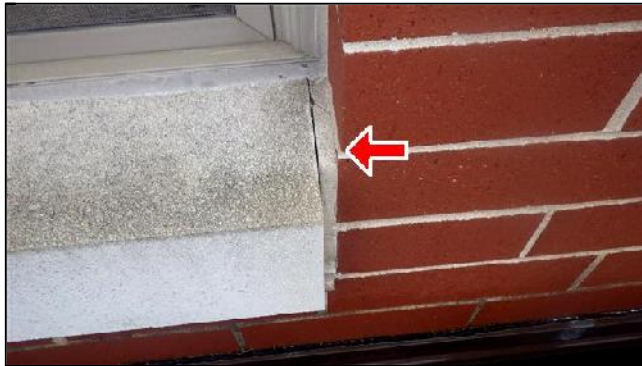
A. Item 6(Picture) Caulking Recommended

(3) The mortar joints at the corners of the stone window sills and between all limestone copings/sills should be raked out and sealed instead with a high-quality masonry caulking compound to reduce the risk of moisture saturation, moisture intrusion to the interior, and damage to the brick masonry below the sill.

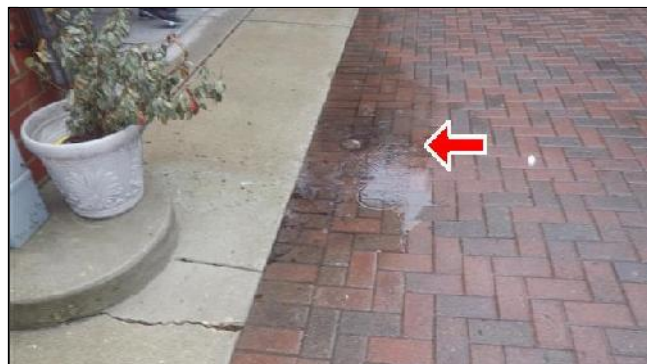
(4) The ponding at the garage apron presents a risk for icing, falls, and injuries. The townhome association should make any necessary repairs.

A. Item 7(Picture) Low Area

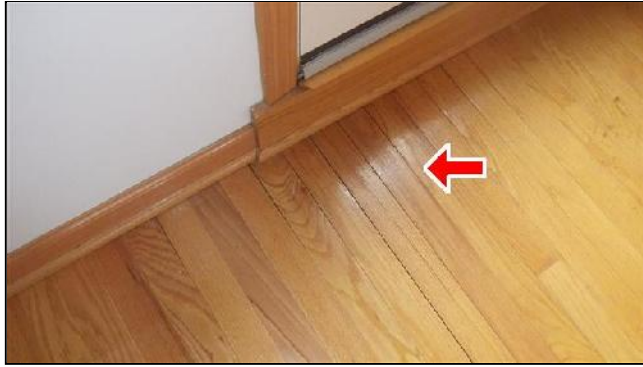
A. Item 8(Picture) Moisture Related Hardwood Flooring Damage

(5) Evidence of through-wall moisture penetration and hardwood flooring moisture damage was noted at the west balcony doorway. The door assembly as well as the adjacent masonry and flashing should be carefully evaluated and repaired as needed. The hardwood flooring damage should be addressed as part of the overall hardwood flooring repair recommended elsewhere in this report.

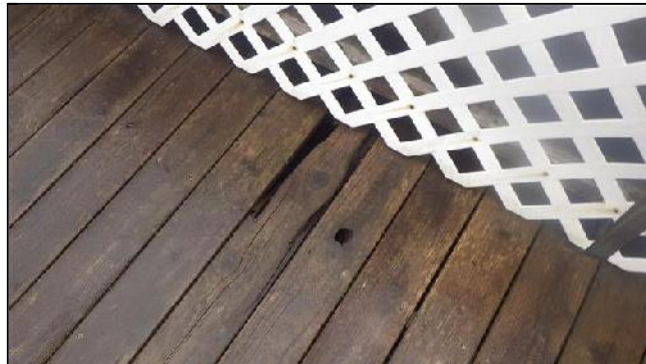
(6) The wood decking at the east penthouse balcony is badly deteriorated. It is recommended that the existing decking boards be replaced with synthetic or composite decking boards which require much less maintenance than natural wood decking. It is further recommended that, once the existing decking boards are removed, that the underlying deck framework and roof covering be evaluated and repaired or replaced as needed. It wouldn't make little sense to install a high performance decking system on top of a deteriorated framework or over a roof covering which is nearing the end of its useful life.

A. Item 10(Picture) Deteriorated Decking

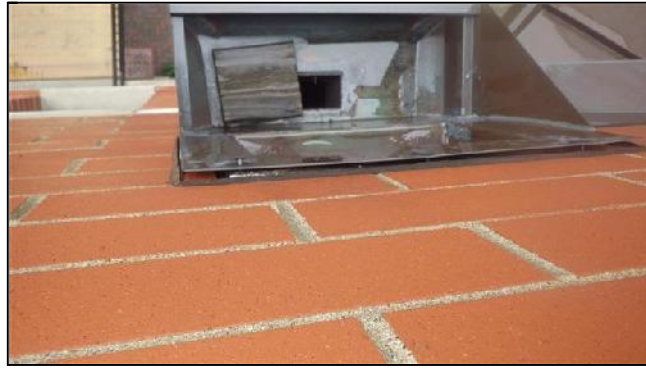
(7) The east roof scupper is partially detached and is likely allowing moisture penetration into the exterior wall cavity. A qualified sheet metal contractor should make the necessary repairs as soon as practical.

A. Item 11(Picture) East Wall Scupper

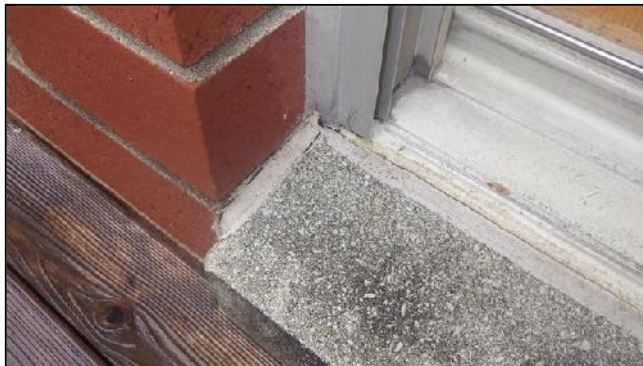
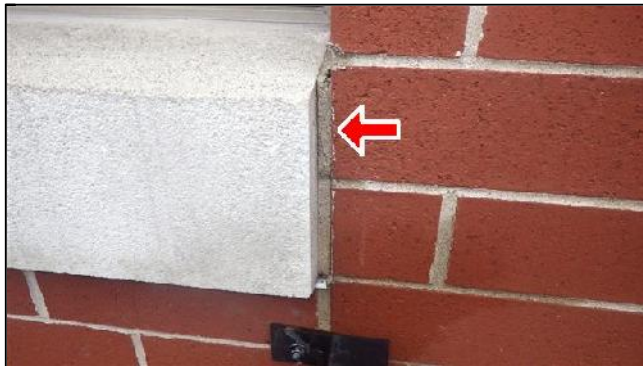
A. Item 12(Picture) Deteriorated Caulking

A. Item 13(Picture) Missing Caulking

(8) The exterior caulking is largely deteriorated and at the end of its useful life. It is recommended that all of the exterior caulking be removed and replaced by a qualified architectural sealant contractor in order to reduce the risk for moisture penetration, moisture damage, drafts, energy losses, pest entry, etc.

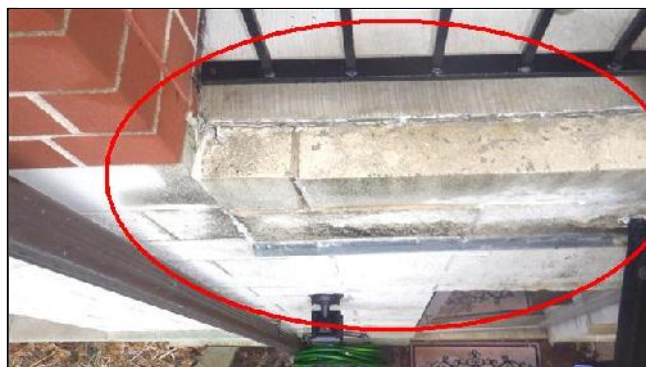
(9) Poor caulking techniques were used at the main front entry landing area in an apparent attempt to stop moisture penetration. It is recommended that the masonry/concrete joints in this area be carefully prepared and properly caulked by a qualified contractor.

A. Item 14(Picture) Apparent Attempts to Stop Moisture Penetration

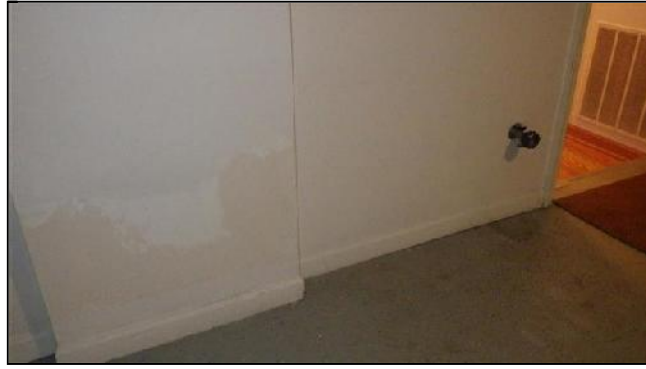
(1) It is recommended that the drywall around the hose bibb in the garage be covered with fiberglass resin panel (FRP) or equivalent protective panel to reduce the risk for moisture damage.

B. Item 1(Picture) Moisture Protection Recommended

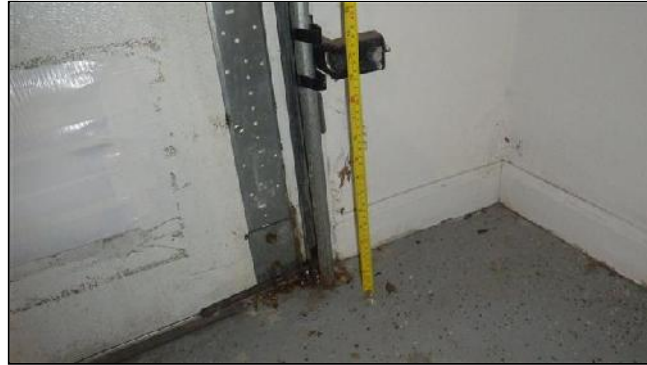
(3) The photo-electric safety sensors for the automatic overhead garage door should be placed within 4 to 6 inches of the garage slab. The existing safety sensors are higher than this standard dictates and present an undue risk for crushing and entrapment injuries. Repair by a licensed and competent garage door specialist is recommended.

B. Item 4(Picture) Unsafe Location

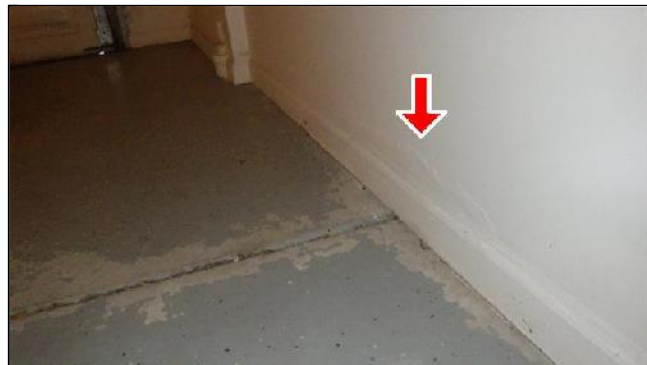
(4) It is recommended that the lower horizontal portions of the garage walls be provided with moisture/mold resistant drywall to prevent ongoing and accelerating moisture damage from slush, rising damp, etc.

B. Item 5(Picture) Moisture Damaged Wallboard

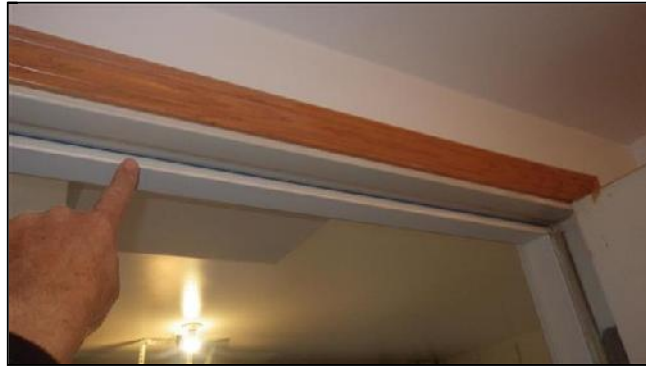
(6) The garage personnel door should be provided with a self-closing device and with properly fitting weatherstripping in order to reduce the risk for indoor air contamination with vehicle exhaust and other substances.

B. Item 7(Picture) Missing Weatherstripping at Garage Personnel Door

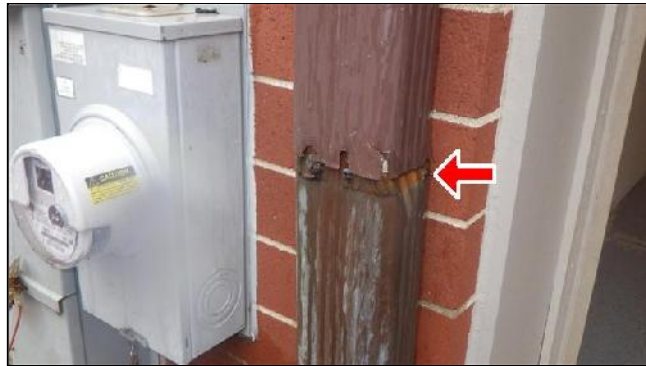
Copper and aluminum should not be joined together due to the risk for galvanic corrosion and deterioration. The corroded downspout at the rear of the home should be repaired or replaced as needed by a qualified sheet metal specialty contractor.

C. Item 1(Picture) Galvanic Corrosion

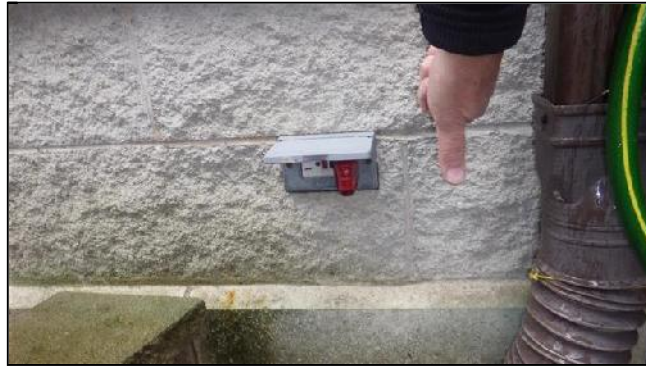
(2) The GFCI receptacle at the front exterior wall is defective, does not provide electrical power, and should be replaced.

E. Item 2(Picture) Defective Receptacle

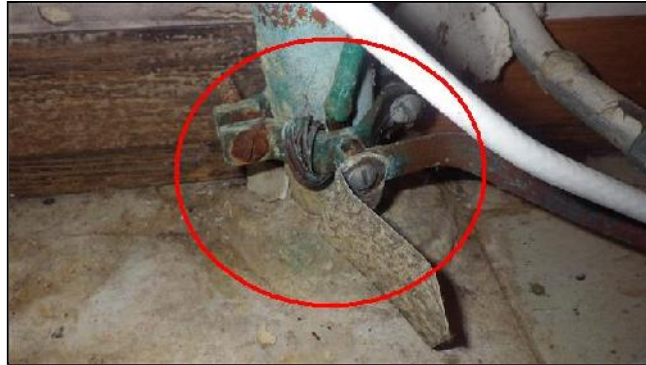
(3) The grounding electrode conductor is not properly secured to the water piping system or to their clamps. The stranded copper grounding conductor has been squeezed between the clamp and the piping. This is not allowed and is unsafe since it makes the clamp prone to loosening and can reduce the safety and effectiveness of the bonding and grounding system. The existing clamp should be replaced with ones that can properly secure the grounding electrode conductor into a screw terminals. Further evaluation and repair by a licensed and competent electrical contractor is recommended.

E. Item 3(Picture) Improper Grounding Connection

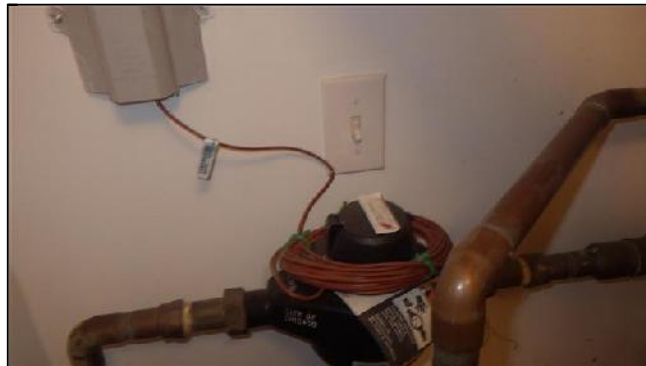
(4) A bonding jumper should be installed across the water meter by a qualified electrician in order to help insure the continuity of the bonding/grounding safety system.

E. Item 4(Picture) Missing Bonding Jumper

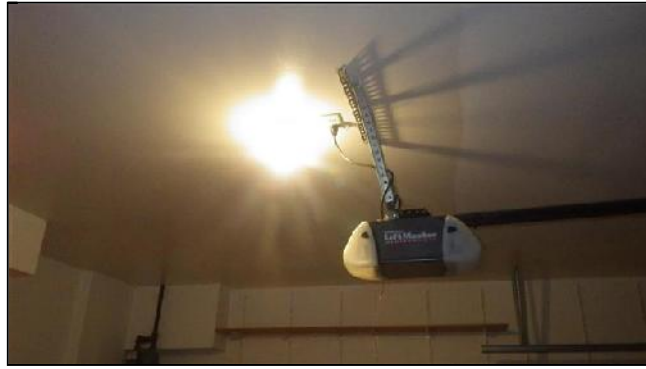
(5) It is recommended that additional interior lighting be provided in the garage for safety and convenience.

E. Item 5(Picture) Minimal Garage Interior Lighting

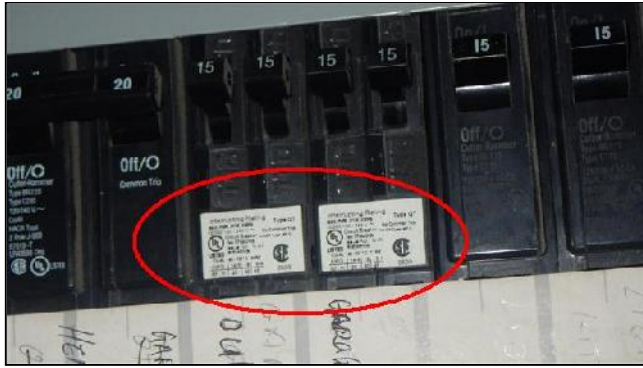
E. Item 8(Picture) "QT" Breakers Not Listed

(6) The electrical panel has been maxed out and no spare breaker spaces are available for future expansion. In addition, half-size breakers have been installed in the electrical panel in order to provide for additional electrical circuitry in the home. However, these breakers are forbidden by the local electrical code and are not listed on the electrical service panel label as approved for use. It is strongly recommended that a qualified electrical contractor further evaluate the electrical loads in the home, the adequacy of the existing distribution panel, and make all necessary repairs, replacements or alterations to ensure safe and adequate electrical power is provided.

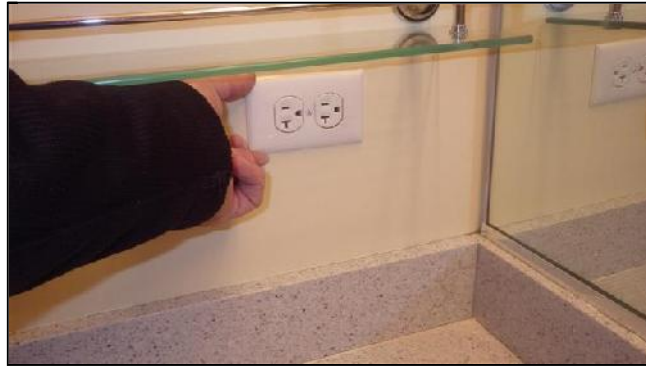
(7) Multiple loose electrical receptacles were noted in the home. Loose receptacles can result in arcing/sparking during use and an increased risk of fire in the home. All of the receptacles in the home should be evaluated and repaired as needed by a licensed electrician.

E. Item 9(Picture) Loose Receptacle

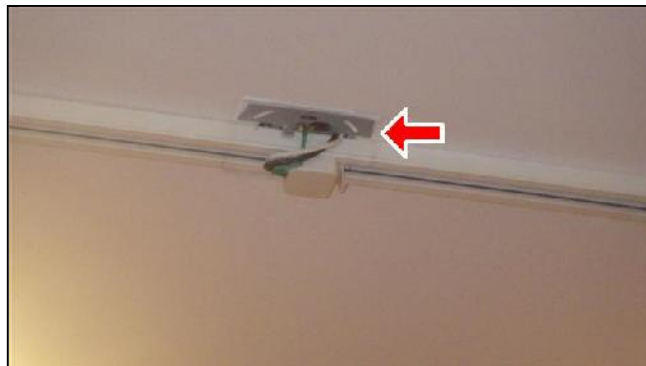
(8) The missing cover at the kitchen ceiling light fixture should be furnished and installed.

E. Item 10(Picture) Missing Cover

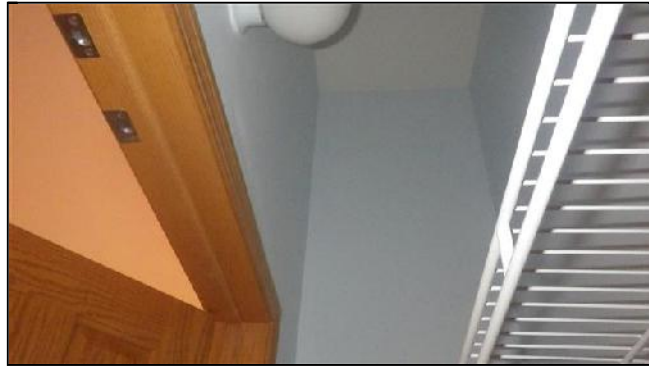
(9) Extinguished or otherwise inoperative luminaires (light bulbs) were noted during the inspection. All of the lighting in the home should be made fully operational for the final walk-through so that the proper operation of all the lighting in the home can be verified and differentiated from defective switches, fixtures, etc.

E. Item 11(Picture) Main Entry Closet Lighting

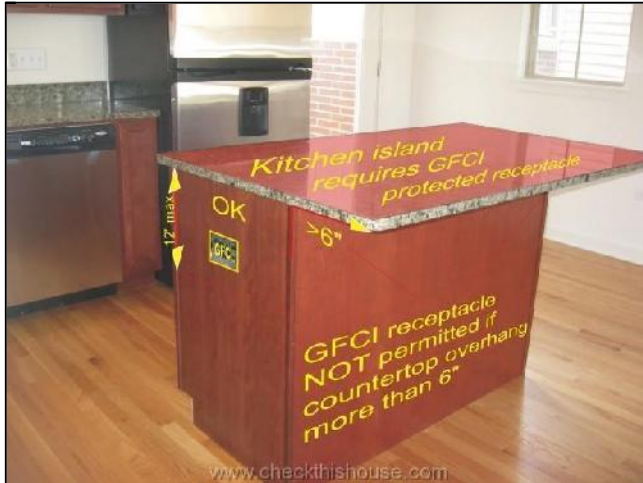
E. Item 13(Picture) Island Receptacle Standards

(10) Installation of at least one GFCI electrical receptacle is recommended on the kitchen island/peninsula in order to comply with modern safety codes and to increase the food preparation functionality of the workspace.

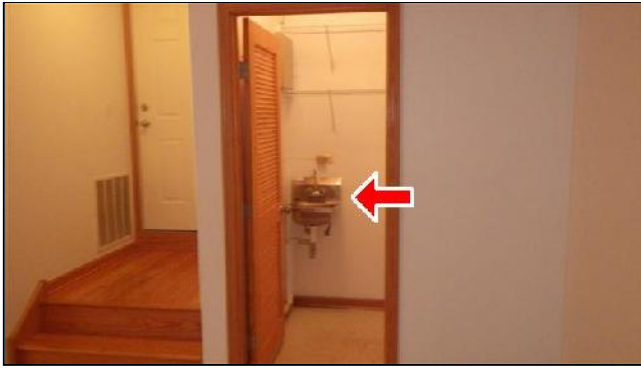
F. Item 1(Picture) Non-Conforming Installation

(1) The small utility sink in the laundry closet does not have a properly configured drain and does not conform to plumbing safety standards. A qualified plumbing contractor should evaluate the sink in consultation with the buyer to determine if repair or removal is the appropriate option.

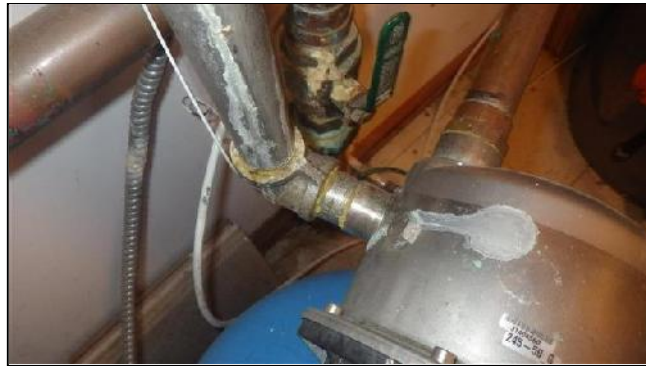
(2) A small piping leak was noted above the water pressure booster assembly. Repair by a qualified plumbing contractor is recommended.

F. Item 3(Picture) Incipient Leaking

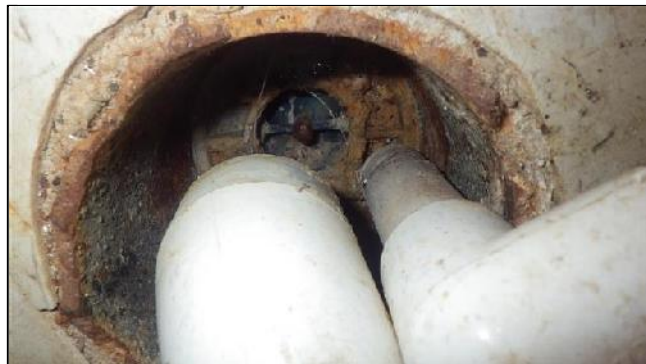
(3) It is recommended that the floor drain backup prevention device in the lower-level mechanical room be removed and either serviced or replaced to ensure its proper operation in the future.

F. Item 4(Picture) Floor Drain Backup Prevention Device

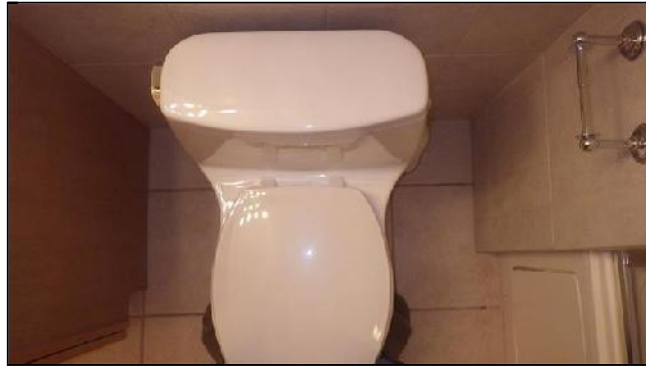
(4) None of the toilets are adequately secured to the floor. This can result in deformation of the wax ring seal, leaking, and other damage. The toilets should be evaluated by a licensed and competent plumber in order to determine if removal and reinstallation as necessary.

F. Item 5(Picture) Loose Toilet

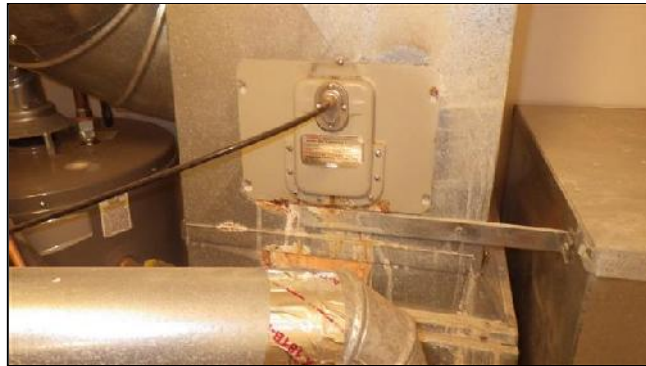
(1) The existing furnace-mounted humidifiers rely on standing water for humidification of the conditioned air. These units are difficult to clean and can allow molds, bacteria, and other biologicals to grow inside the conditioned air stream. They should be replaced with a more indoor air quality friendly unit by a licensed HVAC contractor.

G. Item 1(Picture) Furnace Mounted Humidifier

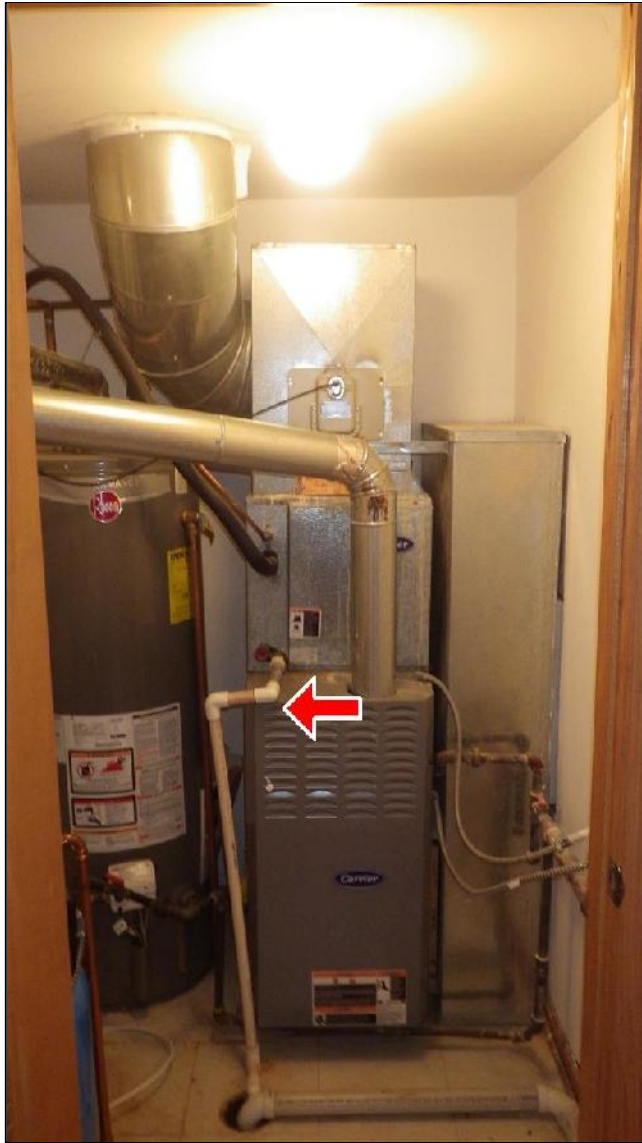
G. Item 2(Picture) Condensate Drain

(2) The installation of a air conditioning condensate trap is recommended in order to reduce the risk for energy losses and for splashing and leaking at the evaporator drain pan. Repair by a qualified HVAC contractor is recommended.

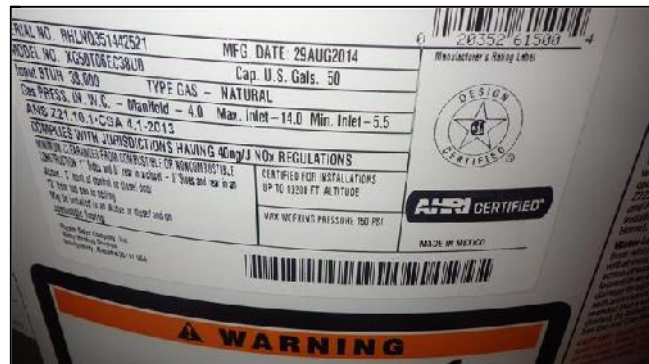
(3) The water heater is undersized for the needs of the home and cannot supply adequate hot water to fill the master bathroom bathtub. A qualified plumbing contractor should ensure that adequate hot water is available for the needs of the home.

G. Item 4(Picture) Undersized Water Heater

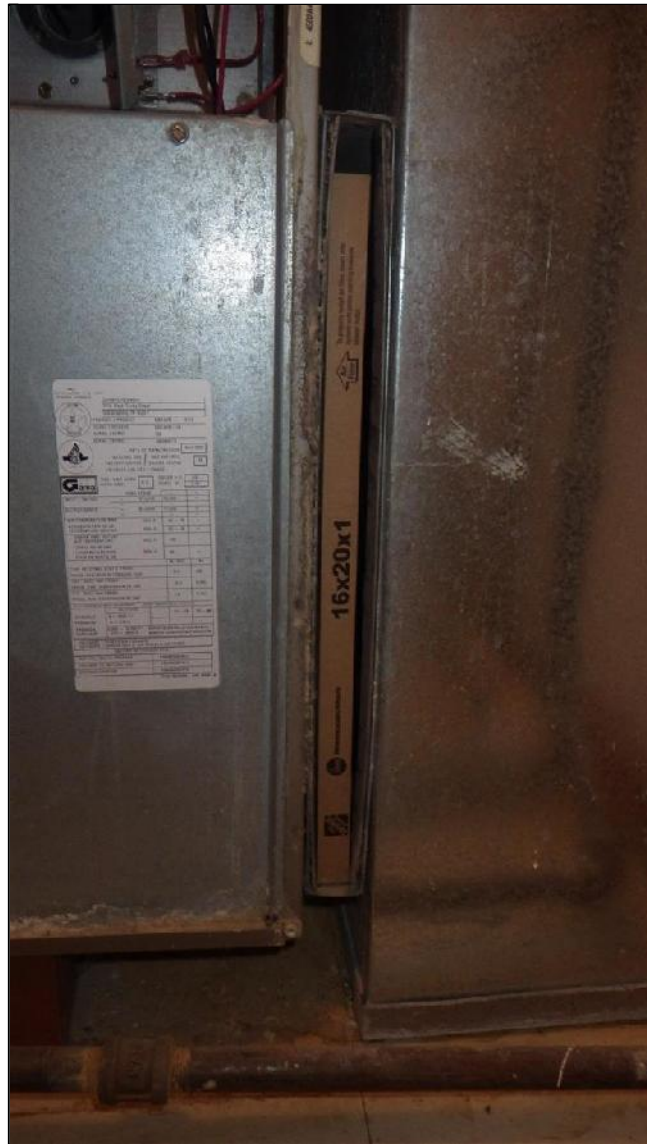
(4) The use of 1 inch pleated cartridge filters can reduce the required airflow across the heat exchanger or the evaporator coil to a point where the capacity and efficiency of the HVAC equipment is significantly compromised. Therefore, it is recommended that, especially during the heating season when airflow is even more critical, a more open weave and less restrictive air filter be used. These less restrictive filters are sometimes derisively referred to as "rock catchers" since smaller particles may not be caught by these open weave filters. The homeowner can use a light spray coating of a non-stick cooking spray on the upstream side of the air filter in order to enhance dust capture on this type of HVAC air filter.

G. Item 5(Picture) Standard 1 Inch Filter

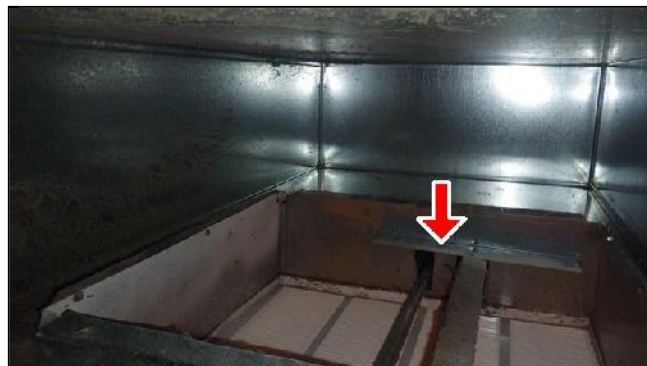
(5) The large gaps in the framework of the return air plenum present a risk for contaminated air being drawn into the HVAC duct system. The return air plenum should be sealed by a qualified contractor.

G. Item 6(Picture) Openings within the Return Air Plenum

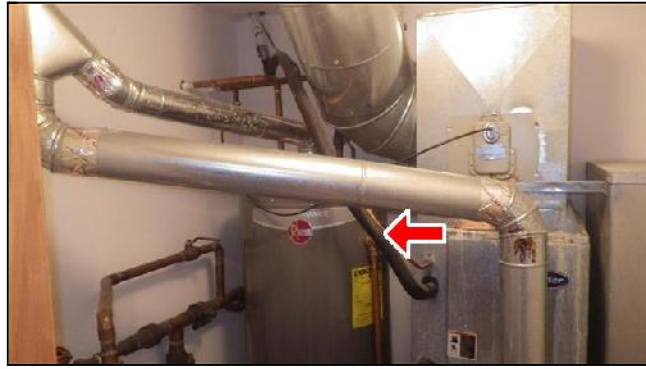
(6) Air-conditioning condensing unit for the lower level HVAC unit is located at the penthouse balcony. Typically, air-conditioning filter dryers are installed on refrigerant line sets of such length. A qualified HVAC contractor should evaluate the installation and install any components which may improve efficiency, capacity, longevity, etc. of the air-conditioning system

G. Item 7(Picture) Missing Device

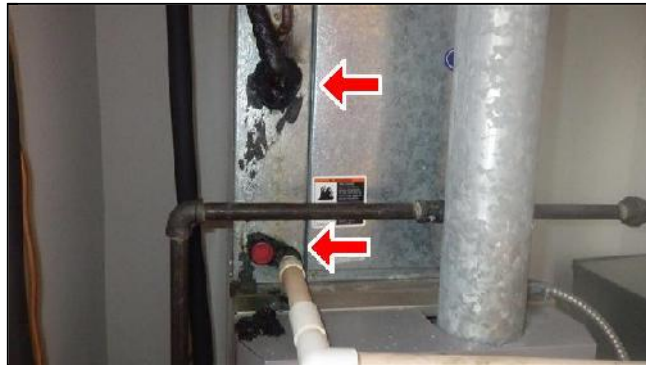
(7) Gaps were noted in the supply and return air duct work and/or in the HVAC plenums. These gaps create air leaks which can reduce the efficiency of the HVAC unit, and which can negatively impact both indoor air comfort and indoor air quality. The supply and return air ducts should be sealed using approved materials and methods; duct mastic is the preferred material for duct sealing.

G. Item 8(Picture) HVAC Air Leakage

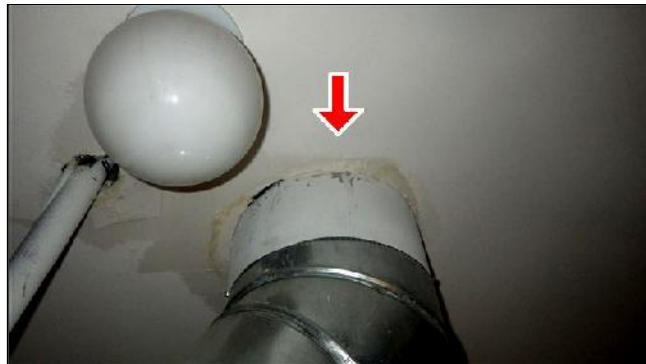
(8) The presence of moisture staining on the drywall ceiling around the top floor furnace supply duct penetration is indicative of summertime condensation on the surface of the cold metal supply ducts. This can be due to inadequately sealed HVAC ducts and/or inadequately insulated HVAC supply ducts. The inspector was unable to access the attic space above the top floor ceiling and cannot report definitively on conditions therein. It is recommended that access be provided to this area so that a thorough evaluation can be performed and recommendations for repairs or upgrades can be provided during the buyers due diligence process.

G. Item 9(Picture) Moisture Staining around Supply Ducts Penetration through Ceiling

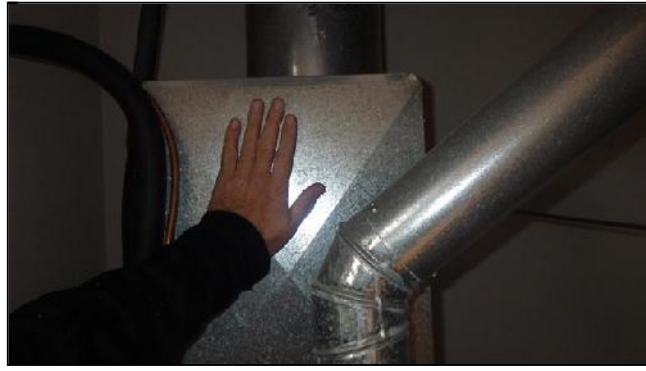
(9) The elevated supply plenum sheet metal temperature noted during the operation of the upper-level furnace may be indicative of poor duct design/installation or other HVAC duct pressure issues. Excessive heat buildup can result in short cycling of the furnace and a reduced service life. It is recommended that a qualified HVAC contractor perform duct pressure testing and any other necessary diagnostics during the buyers due diligence process.

G. Item 10(Picture) Elevated Temperature

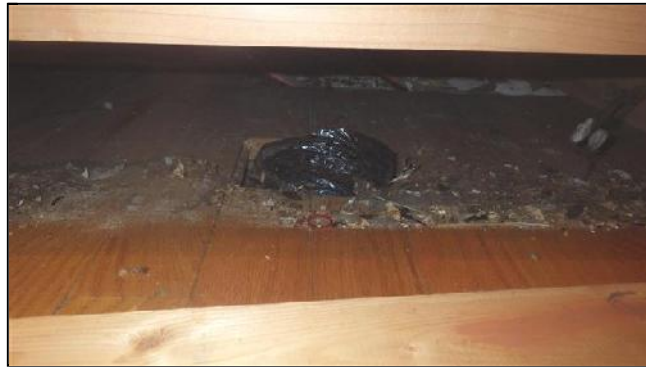
(10) It is recommended that the HVAC supply duct underneath the kitchen sink be properly configured to prevent airflow losses and to provide maximum heating and cooling in the intended area.

G. Item 11(Picture) Toe Kick Supply Duct

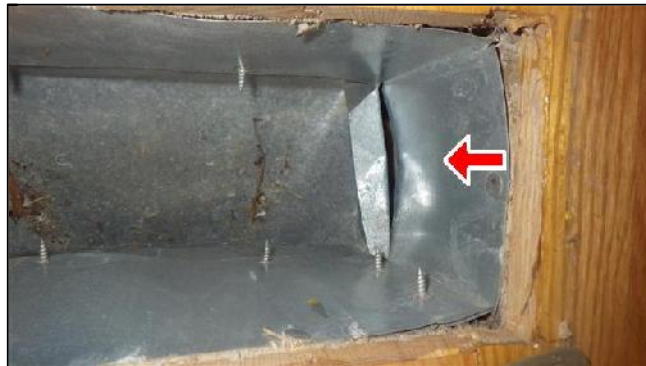
(11) The gaps at the register boots should be sealed to reduce energy losses, to promote optimal HVAC airflow, and to prevent future displacement of the inadequately secured duct boots.

G. Item 12(Picture) Duct Leakage

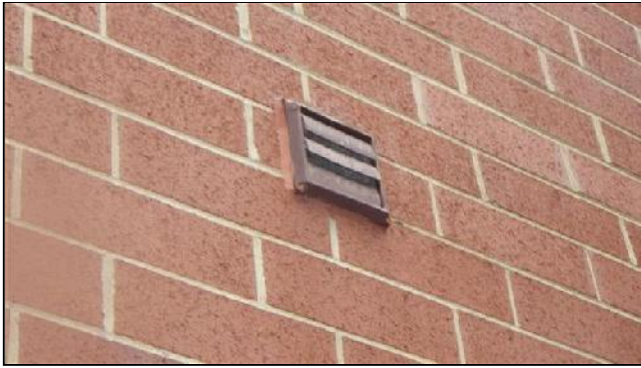
H. Item 1(Picture) Low Performance Vent Termination

The exhaust vent dampers on the exterior walls should be replaced with high-quality, gasketed, vent dampers in order to reduce drafts and energy losses.

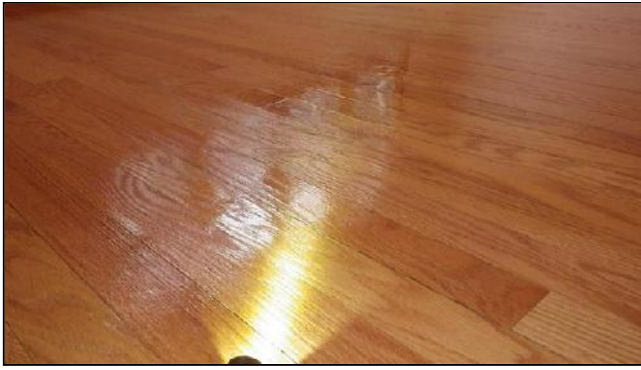
J. Item 1(Picture) Uneven Finish Application

(1) The refinishing of the hardwood flooring was not performed in a workmanlike manner. Splotchy areas, areas of inadequate floor finish, and areas of excessive floor finish accumulation will be noted. In addition, some portions of the hardwood flooring and hardwood stair treads exhibit excessive wear and were not refinished. It is recommended that a qualified hardwood flooring finishing contractor make all repairs needed to provide a uniform and properly protective finish on all hardwood flooring areas.

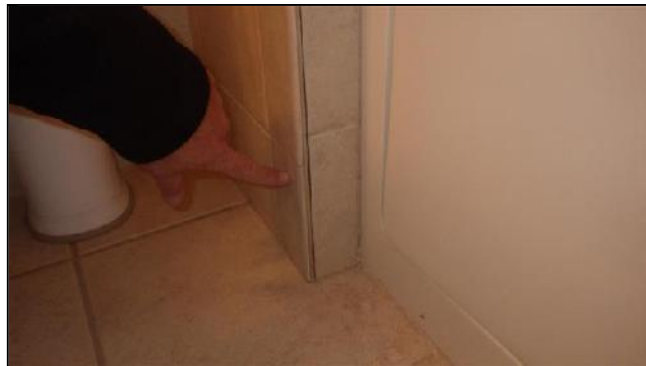
(2) The wall tile next to the master bathroom toilet should be repaired to prevent detachment, failure, etc.

J. Item 3(Picture) Loose Tile

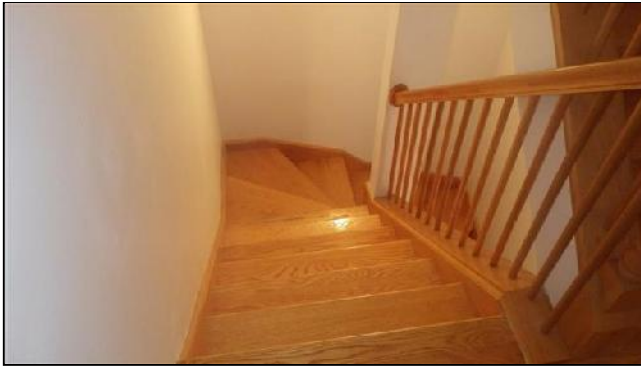
J. Item 4(Picture) Partial Handrail

(3) Winding stairs presents an increased risk for falls and injuries. Therefore, secure, continuous, and graspable handrails should be installed along the wider portion of the winding stairs in order to reduce this risk. As currently configured, occupants are encouraged to walk the narrow or more dangerous portion of the stairway and do not have access to an easily grasped railing continuous from the top landing to the bottom landings as is required. Repair by a qualified carpenter or custom stair builder is recommended in order to reduce the risk for falls and injuries.

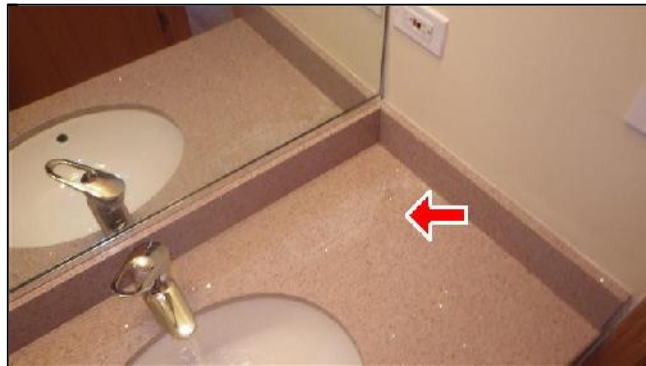
(4) The upper level guest bathroom countertop is stained and should be repaired as needed by a qualified countertop specialty contractor.

J. Item 6(Picture) Countertop Stain

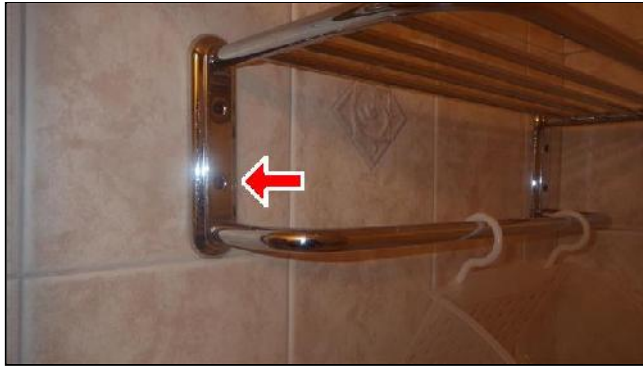
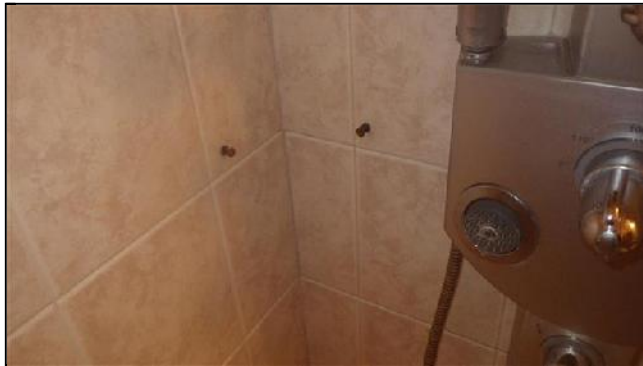
J. Item 7(Picture) Corroded Fasteners

J. Item 8(Picture) Corroded and Abandoned Fasteners

(5) The corroded fasteners in the upper-level guest bathroom should be replaced with stainless steel fasteners. The abandoned fasteners should be removed and the adjacent wall tiles repaired or replaced.

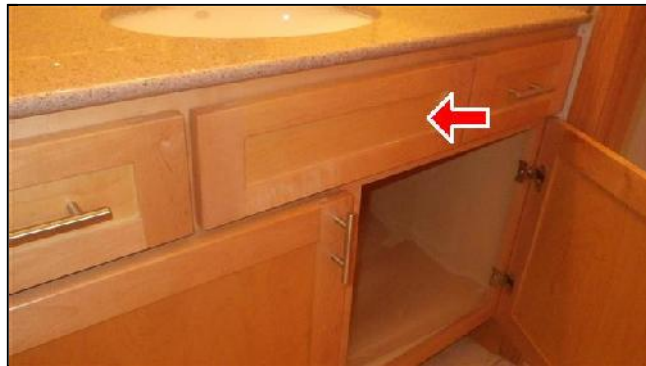
(6) The non-functioning drawer panel at the upper-level guest bathroom sink cabinet should be secured to prevent excess movement, failure, etc.

J. Item 9(Picture) Loose Panel

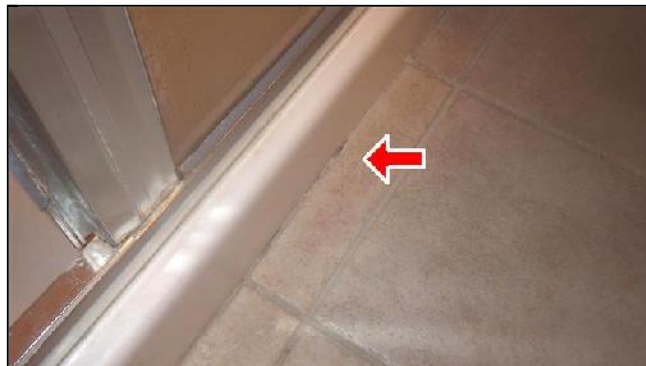
(7) Miscellaneous caulking and grouting repairs are required at the tub/shower enclosures in order to eliminate mold growth and to reduce the risk for moisture intrusion and damage.

J. Item 10(Picture) Caulking Needed

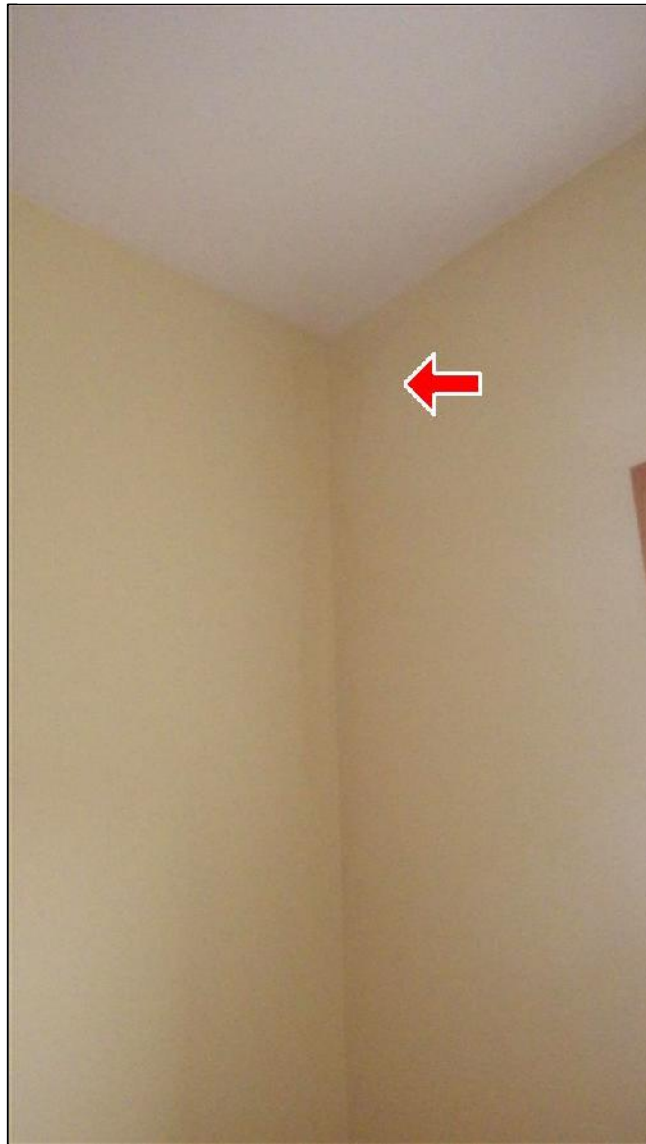
(8) FYI: The moisture staining at the upper southwest corner of the southwest guest bedroom appears to have resulted from leakage at the scupper above. This area should be monitored for signs of recurring moisture.

J. Item 11(Picture) Moisture Staining

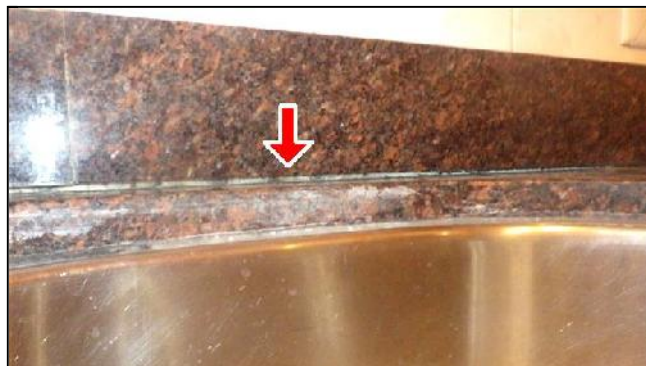
(9) The large gap between the kitchen backsplash and countertop is indicative of inadequate countertop support. The full extent of the repairs will not be known until some cabinet disassembly is performed. It is strongly recommended that a qualified contractor provide a plan and budget for repair during the buyers to diligence process.

J. Item 12(Picture) Gap Between Backsplash and Countertop

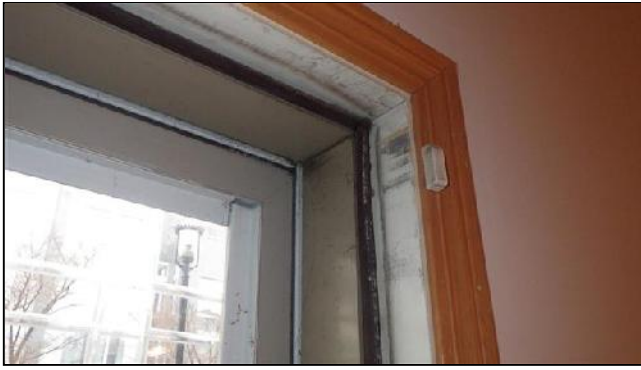
K. Item 1(Picture) Inadequate Clearance And Dust Accumulation from Continued Drafts

(1) The front entry door system is defective in multiple regards including but not necessarily limited to: defective storm door hydraulic closers; inadequate weatherstripping contact; and a poor fit between the door and doorjamb. A qualified contractor should make all necessary repairs for proper operation and draft prevention.

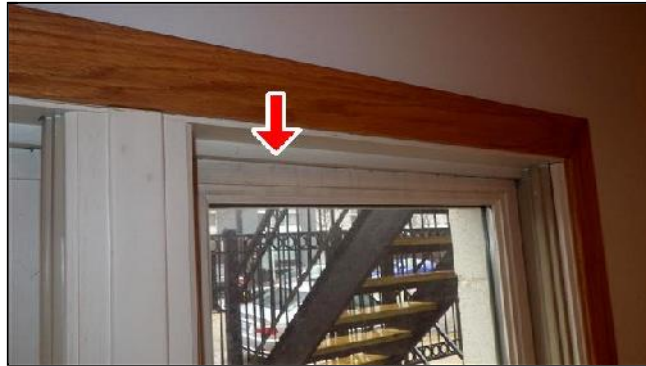
(2) The middle and right-hand windows at the lower level west wall do not fit properly along the top edge and are significantly drafty. A qualified contractor should make the repairs needed to reduce drafts and energy losses.

K. Item 3(Picture) Drafty Windows

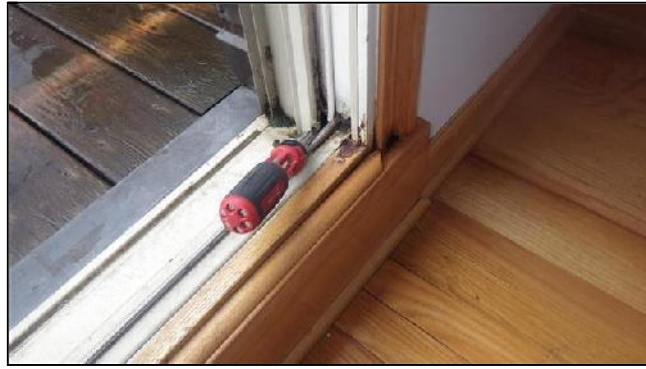
(3) Advanced rot was noted at the east balcony sliding door assembly as well as at adjacent interior surfaces. The age and condition of the sliding door assembly indicates that replacement, rather than repair, is the appropriate option. A qualified contractor should provide a plan and budget during the buyers due diligence process.

K. Item 4(Picture) Advanced Rot

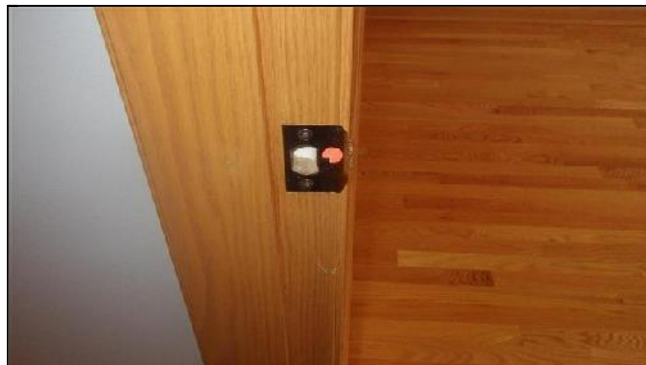
(5) The entry door to the southwest guest bedroom does not latch when placed in the closed position and should be repaired for proper operation.

K. Item 6(Picture) Failure to Latch

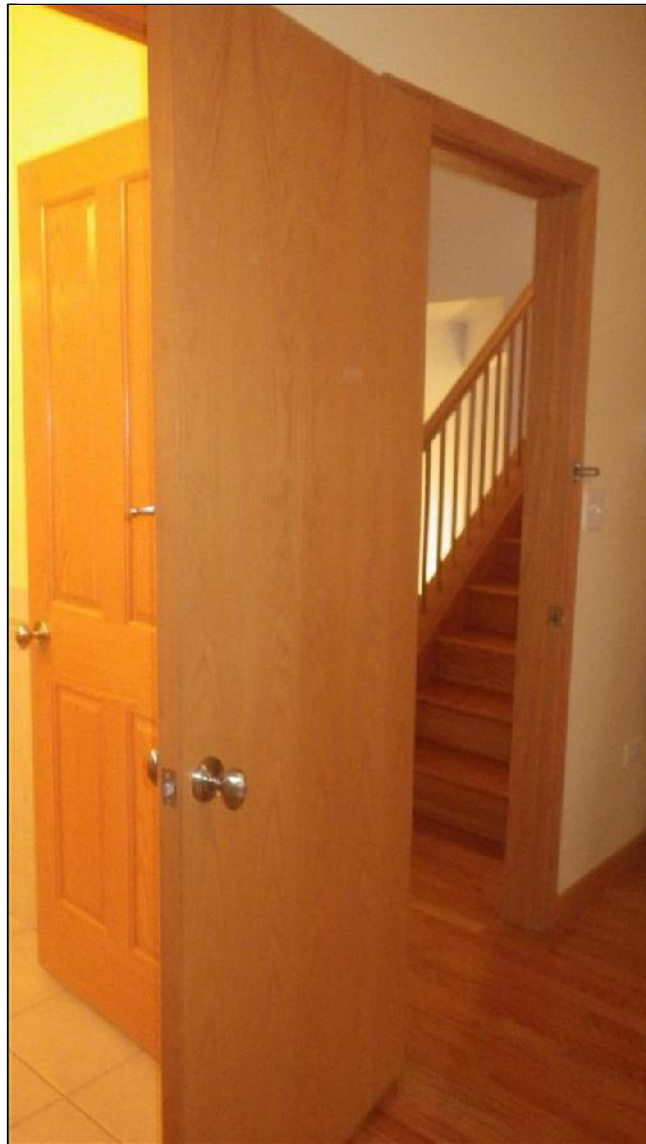
(6) The master bedroom entry door does not remain in position and opens of its own volition when left in the partially open position. A qualified contractor should repair the door so that it remains in position when partially opened.

K. Item 7(Picture) Master Bedroom Entry Door

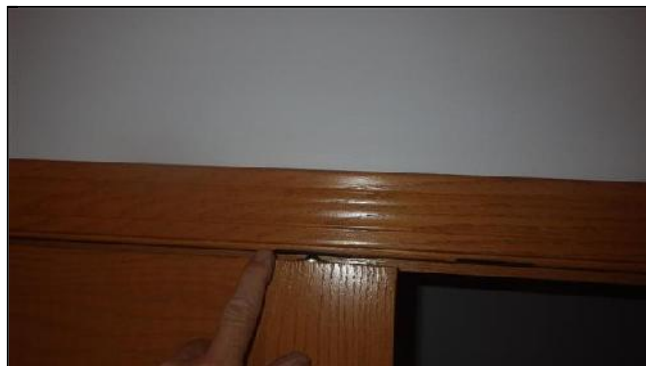
(7) The left-hand door panel at the main entry closet has a defective bullet catch. The door should be repaired so that it operates as intended.

K. Item 8(Picture) Entry Closet Door

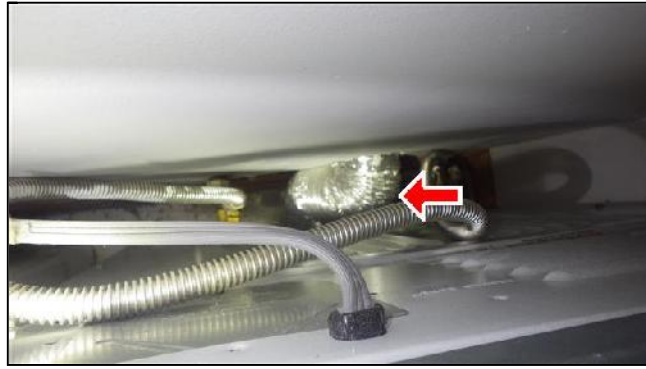
(1) The corrugated vent hose for the clothes dryer is prohibited by all appliance manufacturers due to it's poor airflow characteristics. This can result in increased drying times, reduced equipment life, and an increased risk of fire from lint build-up. The existing vent hose should be replaced with smooth wall metal vent piping.

L. Item 1(Picture) Prohibited Material

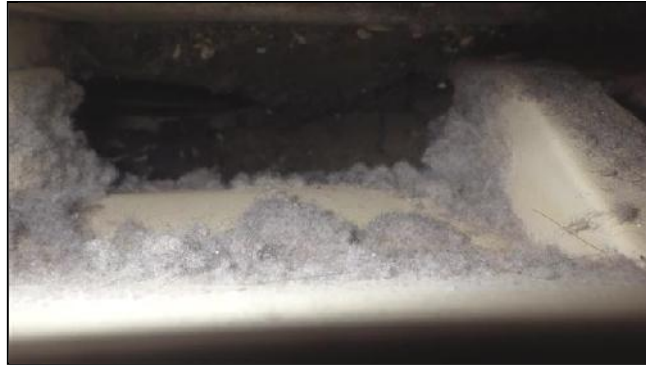
(2) Heavy lint build-up was noted inside the vent passages of the clothes dryer. Regular cleaning is recommended in order to reduce drying times, increase equipment service life, and reduce the risk of a dryer fire.

L. Item 2(Picture) Lint Buildup

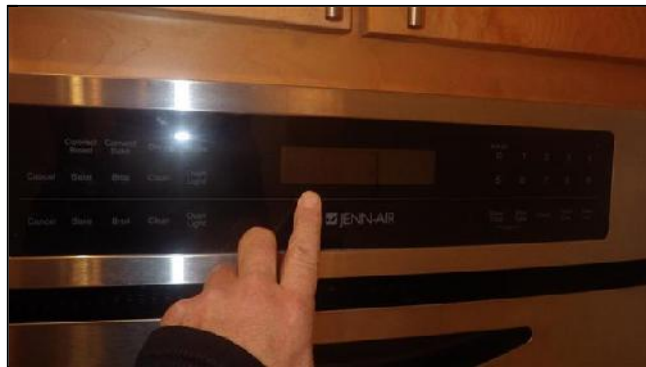
(3) The control panel for the built-in oven is defective. This condition present significant safety and convenience issues. The built-in oven should be repaired or replaced.

L. Item 3(Picture) Built-In Oven Control Panel

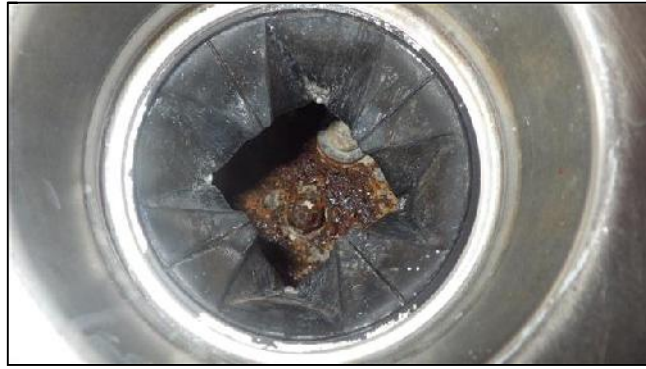
(5) The food waste disposer is aged and deteriorated. Plans should be made for its near-term replacement.

L. Item 5(Picture) Grinding Chamber

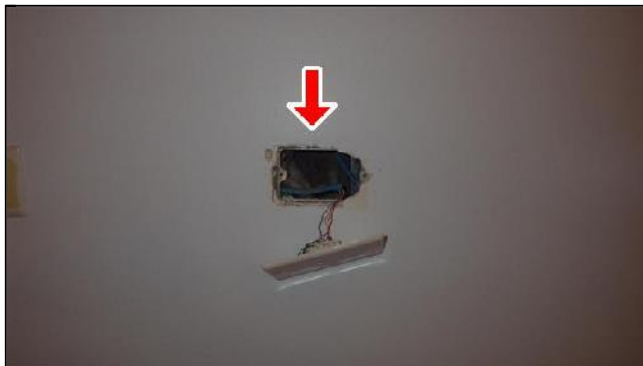
M. Item 1(Picture) Access to Wall Cavity

(1) Evidence of mold growth was noted on the interior side of the exterior sheathing gypsum wallboard. The inspector was unable to determine the full extent nor the cause of this apparent moisture related condition.

Mold growth results from moisture on organic strata and is first and foremost a moisture problem. The source of the moisture that is the proximal cause of the mold-growth should be found and eliminated before final remediation is performed. Initial remediative steps may be advisable in order to reduce the release of mold spores, fungal fragments, and mycotoxins during the moisture investigation and repair process. Small areas of mold (10 square feet or less) can be remediated by the homeowner successfully. An EPA approved mildewcide with residual mold inhibiting properties (Concrobium Brand) can be found at major home improvement stores. Relatively non-porous surfaces such as tile, laminate, concrete, etc. should be surface cleaned with this type of product and kept dry. Semi-porous surfaces such as wood framing and sheathing can also be cleaned in this manner if fungal growth hasn't degraded the material significantly. Porous surfaces such as paper-faced gypsum drywall, cellulose insulation, etc. should be removed and replaced.

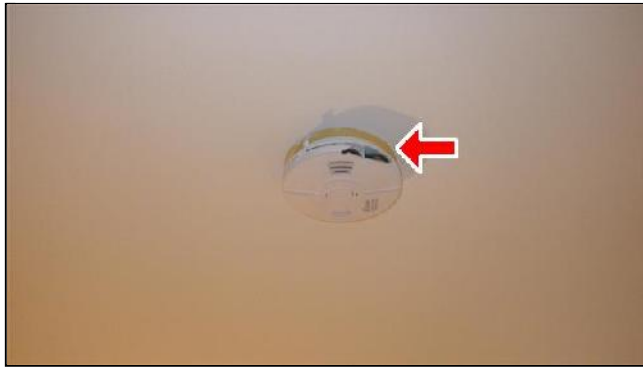
M. Item 3(Picture) Damaged Detector

(2) Smoke and carbon monoxide detectors are relatively inexpensive considering the importance of their function. It is recommended that the smoke and carbon monoxide detectors be replaced with new units upon moving into the home. Each level of living space should have both types of detectors installed. The installation of hard-wired smoke detectors in each bedroom is recommended as is the inter-connecting of all smoke and CO detectors. This is recommended so that an alarm in one area of the home would be able to alert occupants at all areas of the home.
