Inspection Report

Property Address:
1632 S Poinciana #603
Chicago IL

Domicile Consulting

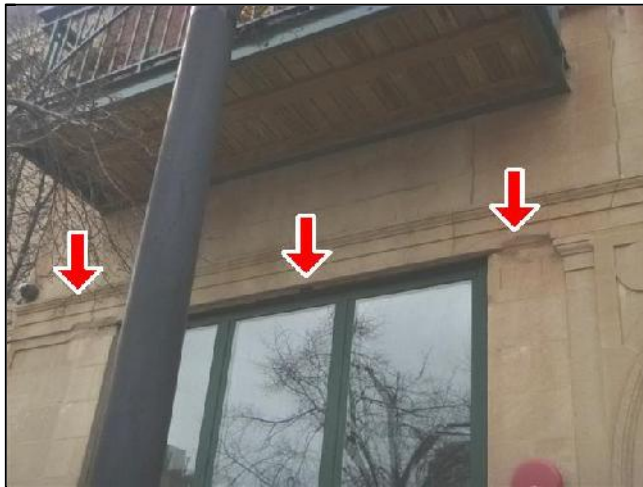
A. Item 1(Picture) Corroded Structural Steel and Resulting Masonry Damage

(1) Rusted, deteriorated, and deflected steel lintels were noted above the windows. The defective lintels have caused damage to the surrounding brick. The lintels should be evaluated by a licensed and competent masonry restoration contractor.

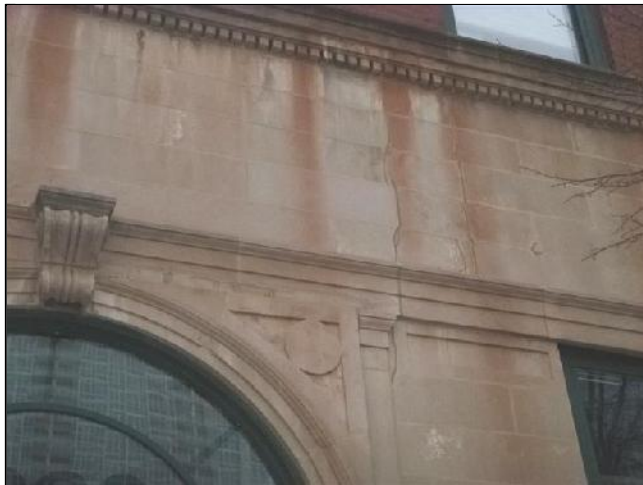
A. Item 2(Picture) Network of Patch Cracks in Exterior Stone

The exterior masonry walls are in overall good condition. Areas of deterioration and damage were noted however. The home owner's association should budget for repairs and maintenance and the exterior walls should be evaluated by a qualified masonry restoration contractor.

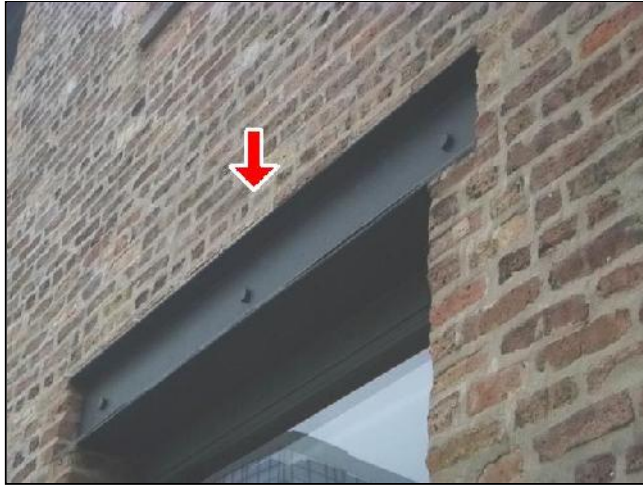
A. Item 3(Picture) No Masonry Wall Flashing Visible

(2) The masonry wall flashings are either missing or improperly installed. The flashings should be used in conjunction with stainless steel drip edge, should be 'end dammed' and should be present at the following locations: the top of the foundation wall; above the masonry pockets where the floor joists are set into the masonry wall; above and below every window, door, and all lintels/beams. Missing or improperly installed wall flashing can allow moisture to enter the home and cause rot, mold growth, and structural damage. The exterior

masonry walls of this structure should be evaluated and repaired by a licensed and competent masonry contractor.

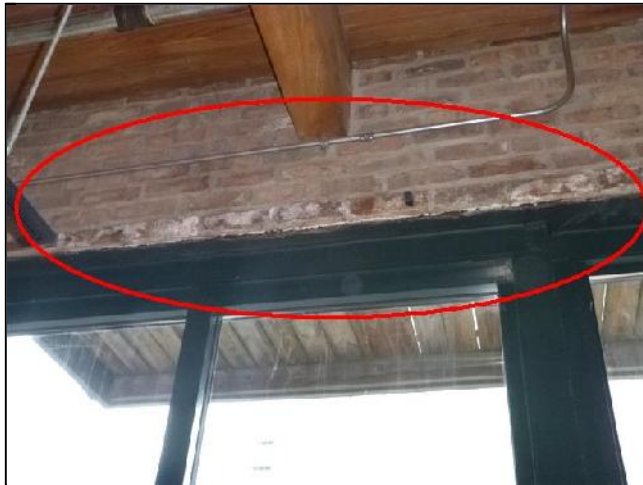
A. Item 4(Picture) Evidence of Possible Bulk Moisture Penetration Due to Missing Masonry Wall Flashing

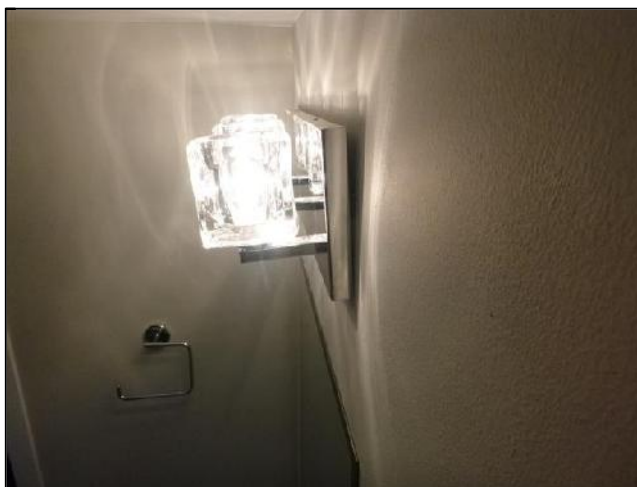
(1) The lightbar in the guest bathroom is not properly secured and is at risk for excess movement, displacement, failure, arcing/sparking, etc. It should be repaired by a qualified electrician.

E. Item 1(Picture) Loose Lightbar

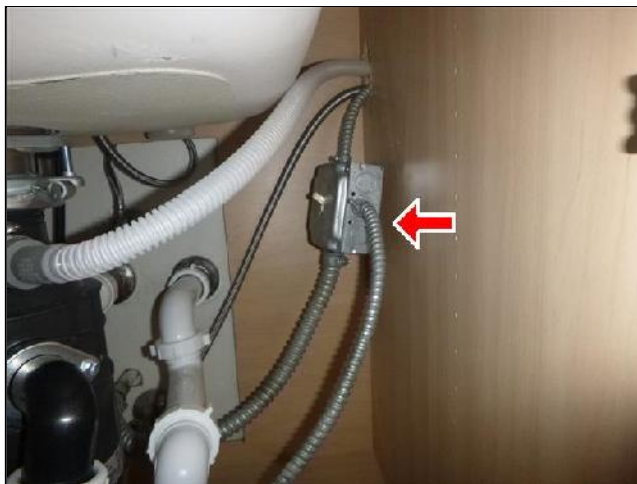
(2) The junction box and distribution wiring underneath the kitchen sink should be secured against excess movement in order to reduce the risk for shock, fire, etc.

E. Item 2(Picture) Loose Electrical Equipment

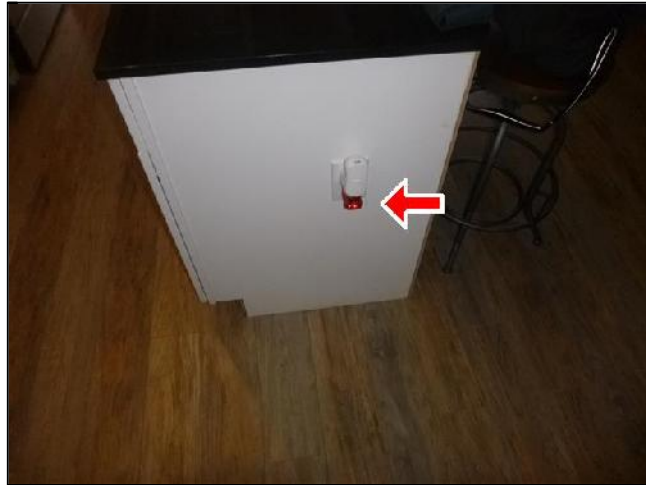
(3) The presence of an electrical receptacle with a hot/neutral reversed condition indicates that at least some of the electrical work was performed by an unqualified person. All electrical defects present significant safety concerns and therefore it is most strongly recommended that a qualified electrical contractor review the electrical distribution equipment within the condominium unit and make all necessary repairs as soon as practical.

E. Item 3(Picture) Reverse Wired Receptacle

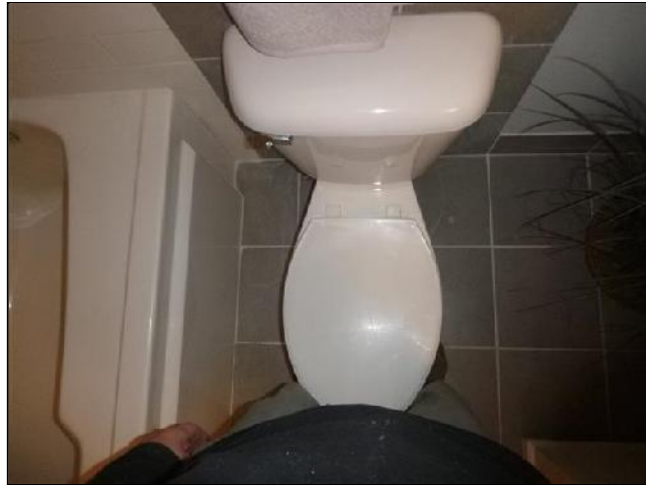
(1) The toilet in the master bathroom is not adequately secured to the floor. This can result in deformation of the wax ring seal, leaking, and other damage. The toilet should be evaluated by a licensed and competent plumber in order to determine if removal and reinstallation as necessary.

F. Item 1(Picture) Loose Toilet

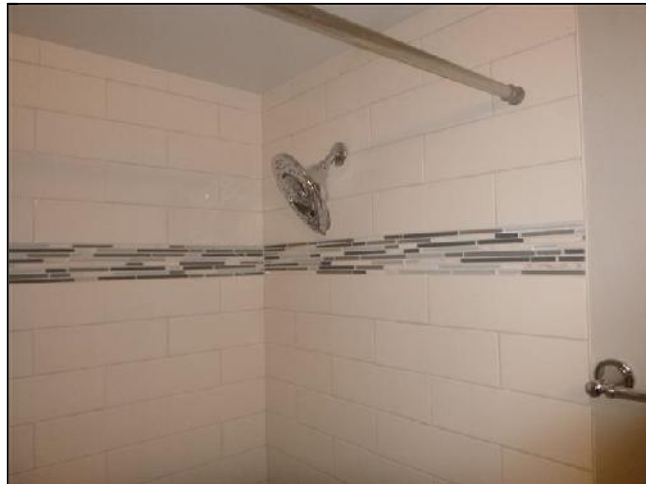
(2) The failure to properly secure the showerhead piping in the master bathroom creates an increased risk for excess movement, damage, and leaking. Repair by a qualified contractor is recommended.

F. Item 2(Picture) Loose Showerhead

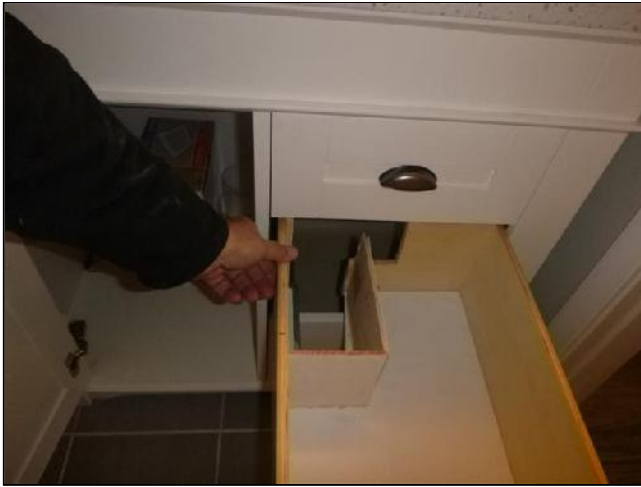
F. Item 3(Picture) Weakened Drawer

(3) A number of deficiencies were noted with regard to the master bathroom vanity and sink installation. The top drawer has been badly weakened by improper alteration and the sink drain piping is improperly configured/leaking. The overall quality of the master bathroom remodeling is poor and significant repairs are needed in order to reduce the risk for ongoing leaking, further damage, etc. A qualified remodeling contractor should provide a plan and budget for the badly needed repairs.

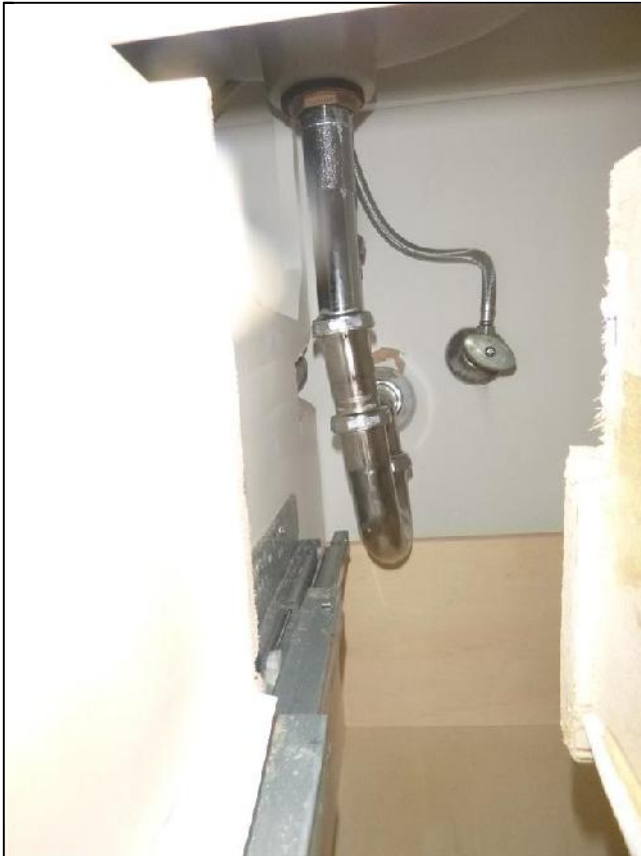
F. Item 4(Picture) Improperly Configured and Leaking Sink Drain

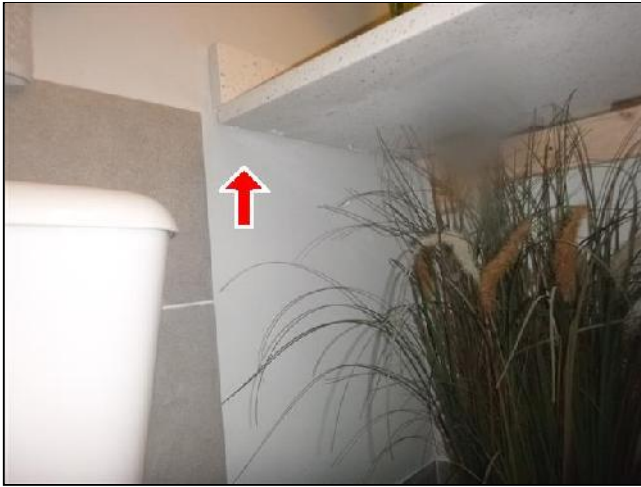
F. Item 5(Picture) Missing Countertop Support

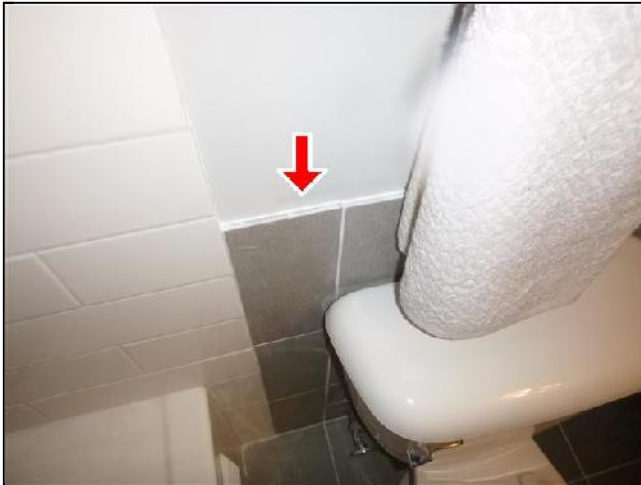
F. Item 6(Picture) Improperly Terminated Tile Edge

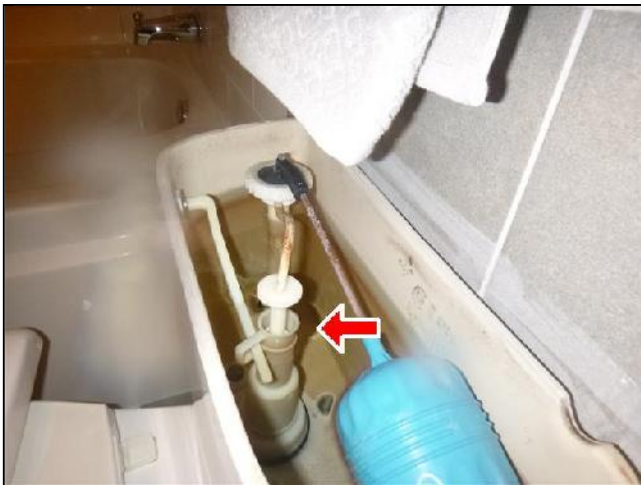
F. Item 7(Picture) Improperly Adjusted Toilet Tank Water Level

(5) The water level in the toilet tanks is too high. Water is constantly running from the toilet tanks and into the toilet bowl. The toilet fill valves should be adjusted or repaired by a qualified plumber.

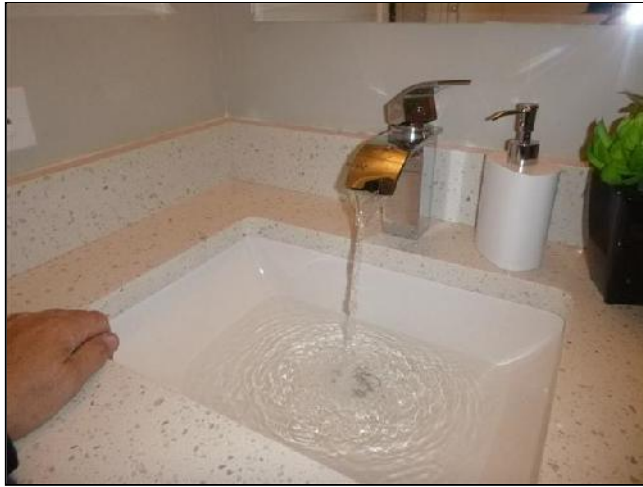
F. Item 8(Picture) Inadequate Water Flow And Loose Faucet

(4) The guest bathroom sink faucet is not properly secured to the sink-top, does not have a functioning drain stopper, and does not provide adequate water flow. It should be repaired so that it operates as intended.

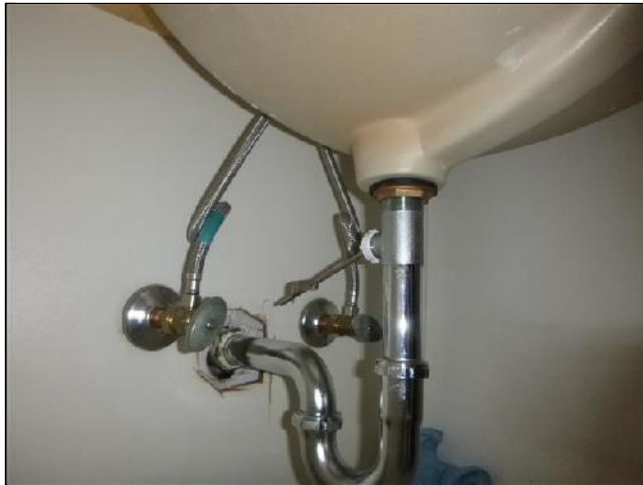
F. Item 9(Picture) Disconnected Drain Stopper

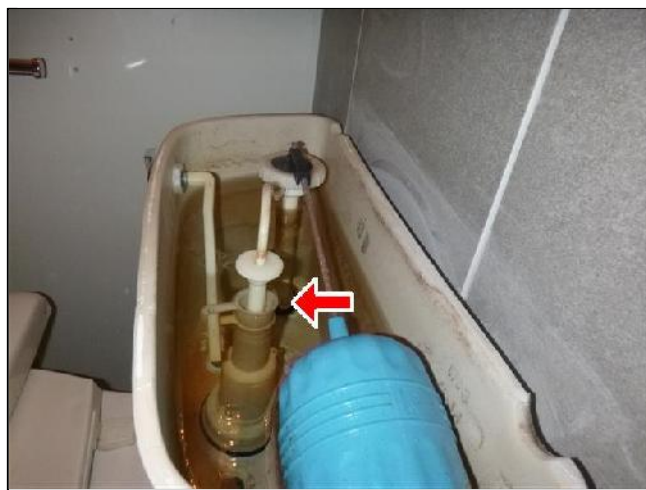
F. Item 10(Picture) Elevated Water Level

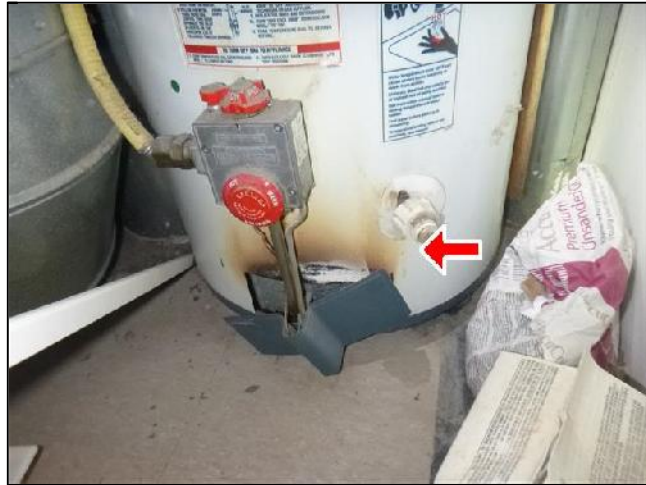
(6) The water heater is over 20 years old and show signs of unsafe venting and flame rollout. It is most strongly recommended that the water be replaced as soon as practical.

F. Item 11(Picture) Strong Evidence of Unsafe Operation

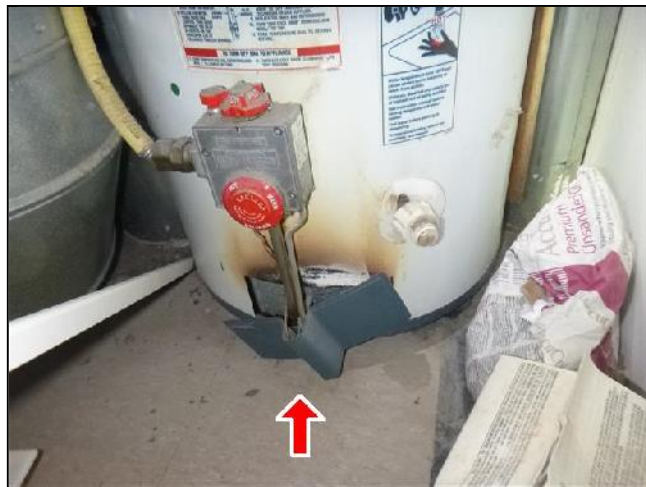
F. Item 12(Picture) Missing Drip Pan

(7) The installation of a piped drain began underneath the water heater is recommended in order to reduce the risk for potentially catastrophic damage in the event of a water heater tank failure.

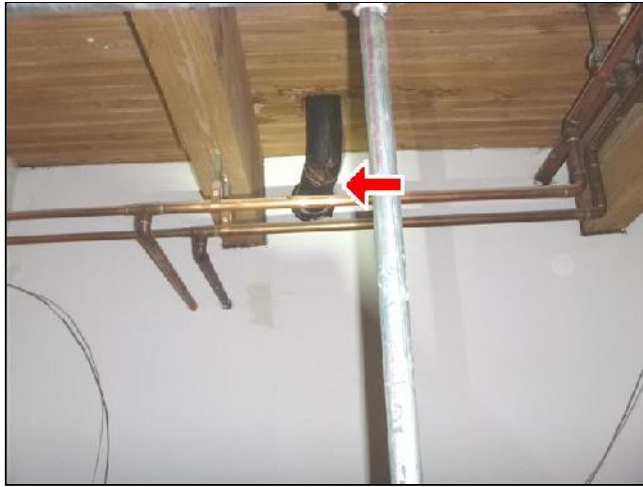
F. Item 13(Picture) Moisture Staining at Base of Cast-Iron Drain Elbow

(8) Evidence was noted of a leak condition above the guest bathroom. The cast-iron drain elbow shown in the accompanying photo may be part of the flat roof drain system. The inspector was unable to determine if an active leak condition is present. A thorough evaluation of this condition will require access to common areas and the cooperation of the HOA. It is recommended that the buyer perform further due diligence regarding this condition prior to accepting responsibility for conditions within the subject condominium unit.

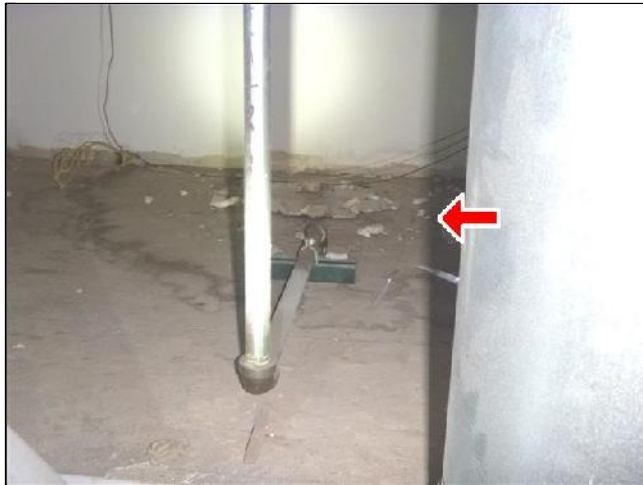
F. Item 14(Picture) Evidence of Dripping onto Area below Cast-Iron Drain Elbow

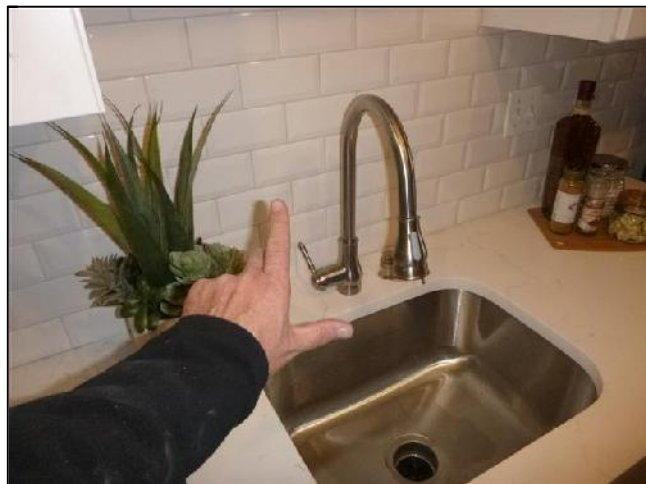
(9) The kitchen sink faucet is not properly secured to the countertop and should be repaired by a qualified plumbing contractor as soon as practical.

F. Item 15(Picture) L Stands for Loose

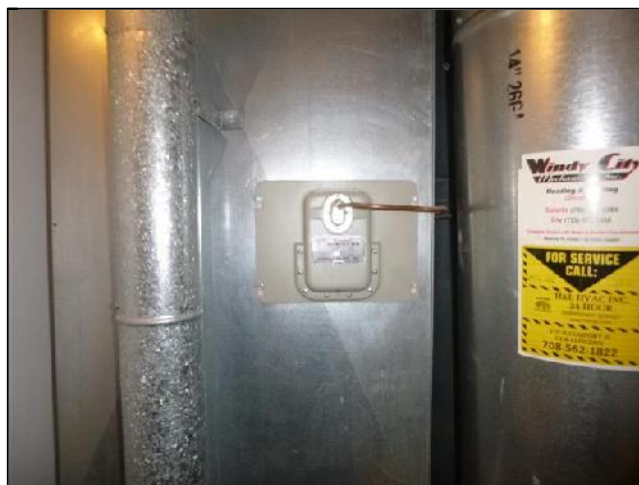
(1) The existing furnace-mounted humidifier relies on standing water for humidification of the conditioned air. This unit is difficult to clean and can allow molds, bacteria, and other biologicals to grow inside the conditioned air stream. It should be replaced with a more indoor air quality friendly unit by a licensed HVAC contractor.

G. Item 1(Picture) Problematic Humidifier

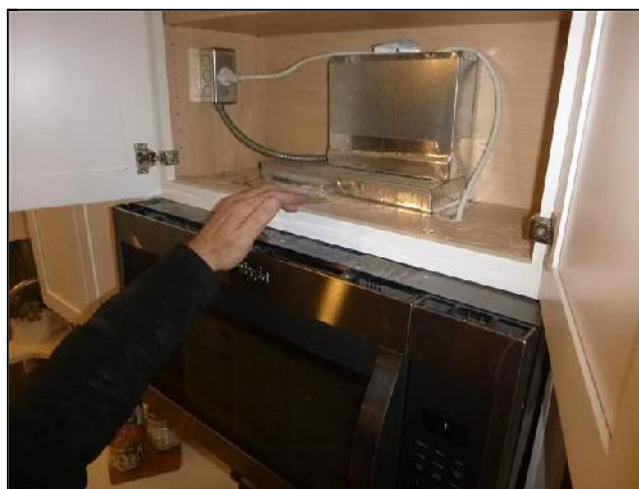
The kitchen utilizes a recirculating vent hood. Cooking in the kitchen generates a great deal of heat, steam, grease, smoke, and odors that need to be ventilated in order to maintain indoor air quality and proper housekeeping. It is the inspector's opinion that the failure to install a ventilating kitchen exhaust hood will result in reduced indoor air quality, increased energy usage, and more difficulty in keeping the home clean. A qualified contractor should determine cost and feasibility for the installation of a vented kitchen exhaust system.

H. Item 1(Picture) Recirculating Range Hood

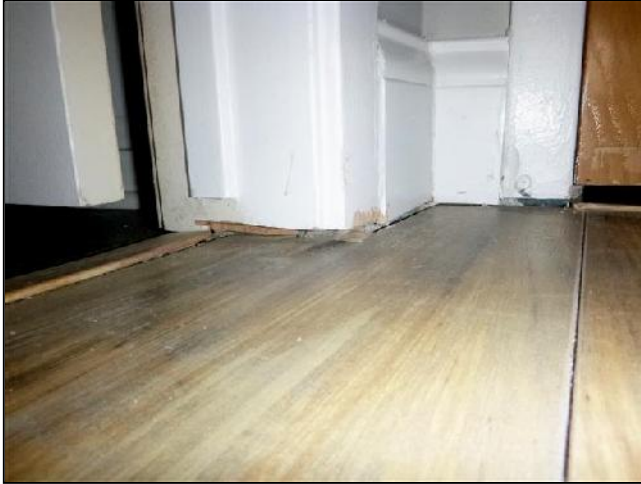
J. Item 1(Picture) Substandard Workmanship

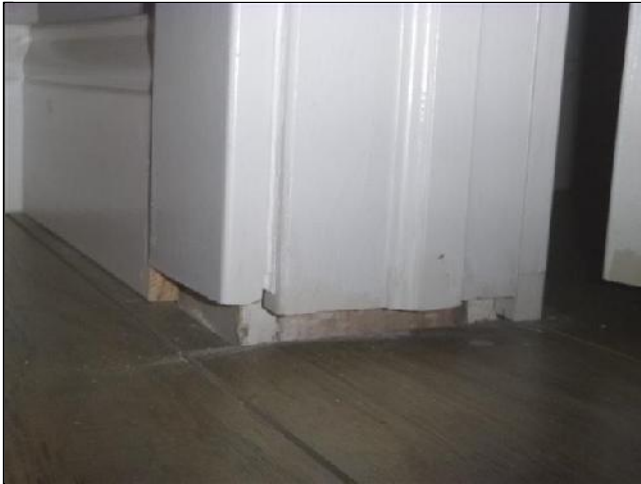
J. Item 2(Picture) Obvious Lack of Care or Concern

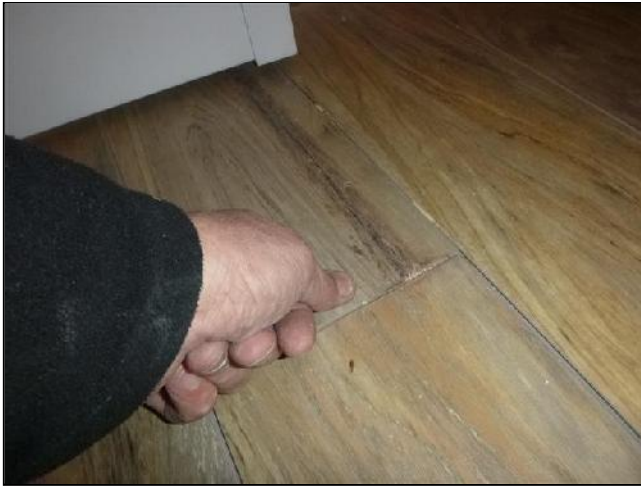
J. Item 3(Picture) Excess "Give" At Individual Pieces of MDF Flooring

(1) The recently installed MDF finish flooring is of relatively low quality and was improperly installed. Widespread installation defects were noted and significant flooring damage is already present. The extent of the installation deficiencies and existing defects indicate that replacement is the only viable option. It is most strongly recommended that a qualified flooring specialty contractor provide a plan and budget for removal of the existing MDF finish flooring and its replacement with a high-quality alternative.

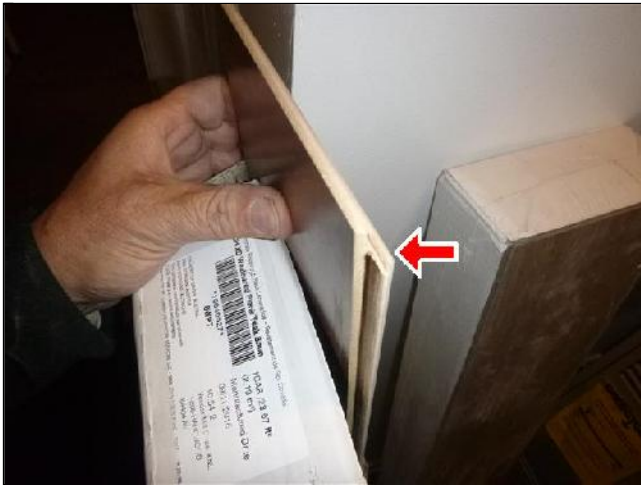
J. Item 4(Picture) Extremely Moisture Sensitive Flooring

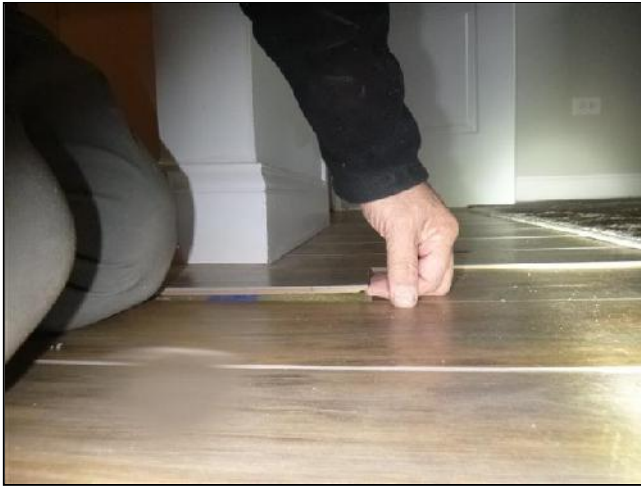
J. Item 5(Picture) Defective Tongue and Groove Installation

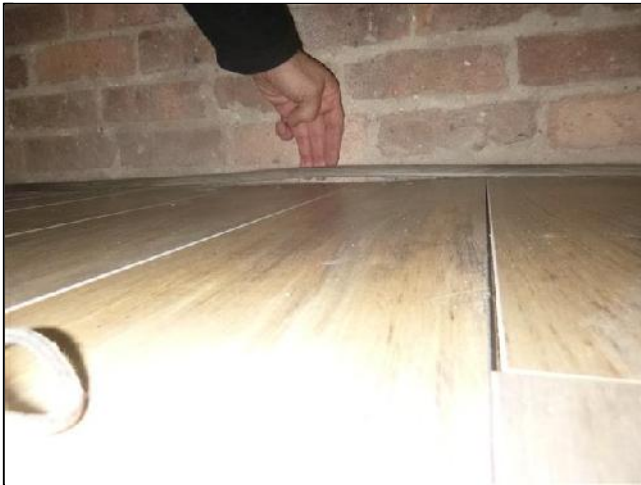
J. Item 6(Picture) Excessive Flooring Gaps and Improperly Installed Flooring Trim

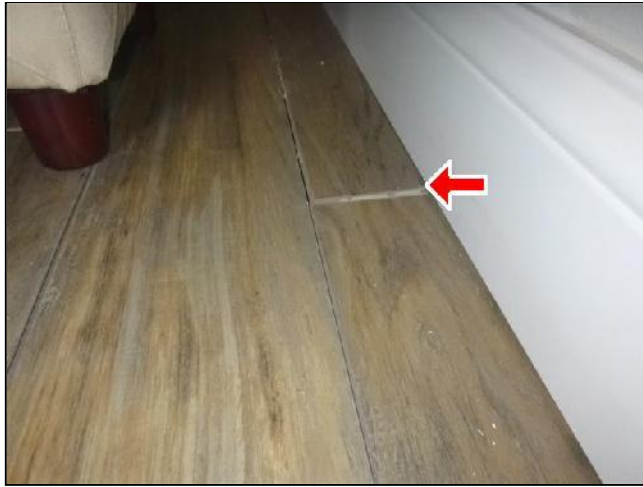
J. Item 7(Picture) Inadequately Secured Flooring

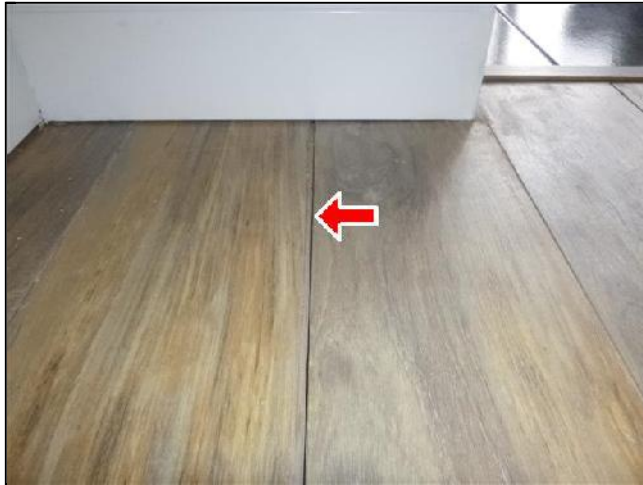
J. Item 8(Picture) Excessive Flooring Gap

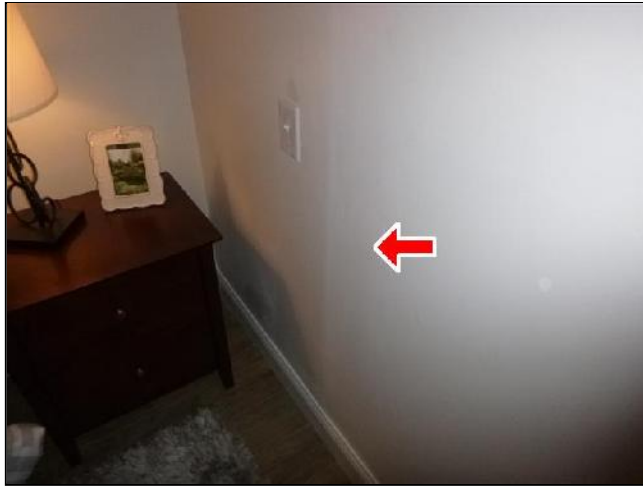
J. Item 9(Picture) Gypsum Wallboard Defects

(2) Multiple concerns were noted regarding the recently configured second bedroom within this condominium unit. The failure to provide adequate electrical receptacle spacing is indicative of work performed by unqualified and/or unlicensed individuals. The extremely sloppy gypsum wallboard finished surfaces are also indicative of substandard workmanship. It is recommended that a qualified electrical contractor install additional electrical receptacles and room lighting in order to comply with all applicable building codes. It is further recommended that a qualified drywall contractor/carpenter repair the interior finishes to comply with commonly accepted appearance standards.

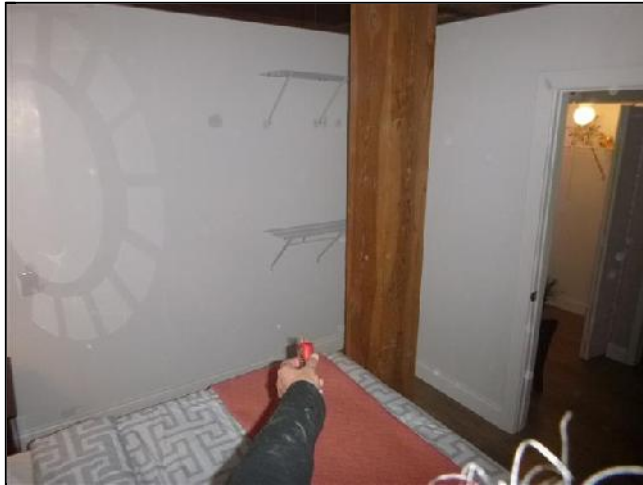
J. Item 10(Picture) Inadequate Electrical Receptacle Spacing

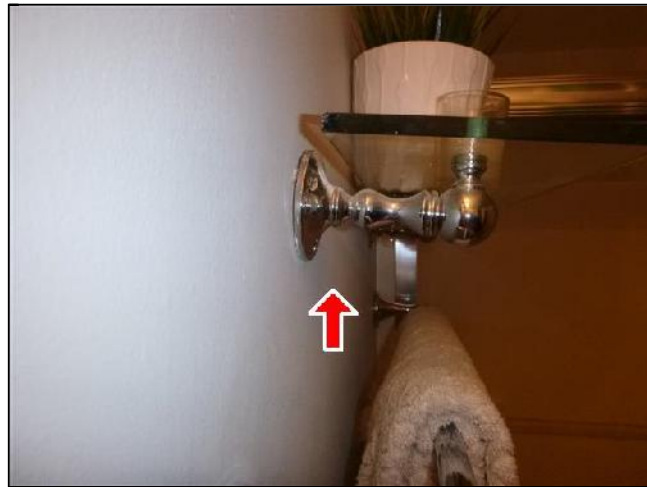
(3) The glass shelf above the guest bathroom toilet is not properly secured to the wall and is at risk for failure. It should be repaired as soon as practical.

J. Item 11(Picture) Loose Glass Shelf

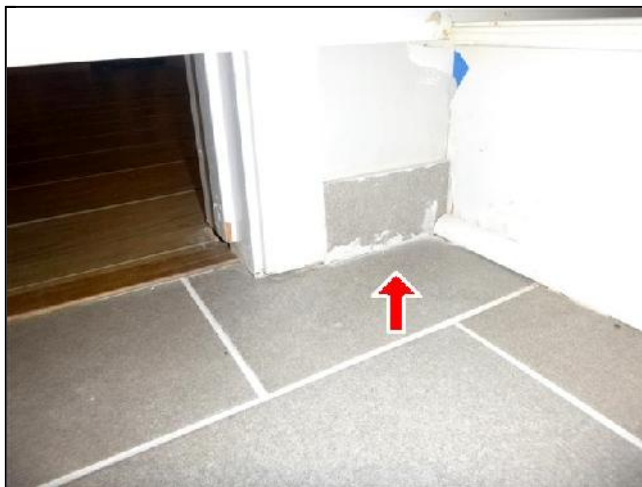
J. Item 12(Picture) Sloppy Tile Workmanship

(4) The overall quality of the ceramic tile installation is below average. A significant number of appearance defects were noted in tiled areas of the bathrooms and the kitchen.

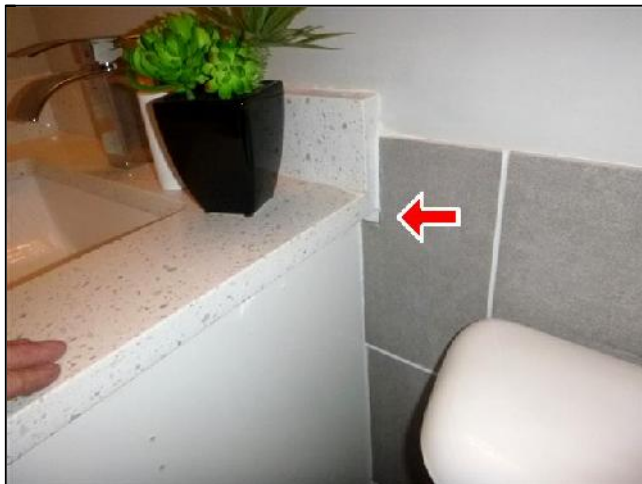
J. Item 13(Picture) Sloppy Tile Cut

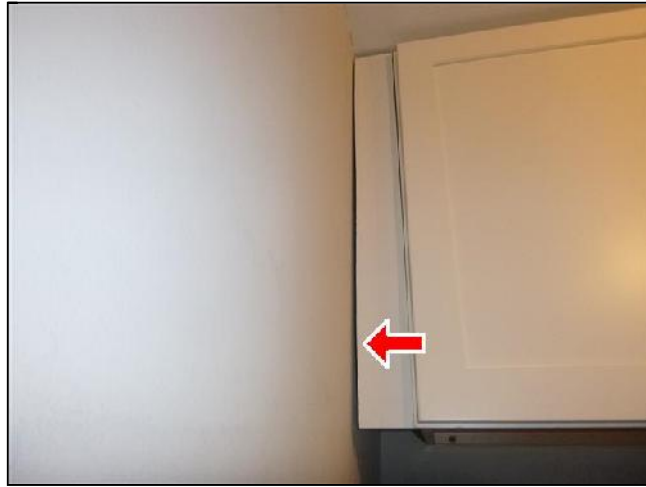
J. Item 14(Picture) Poorly Fitted Trim Piece

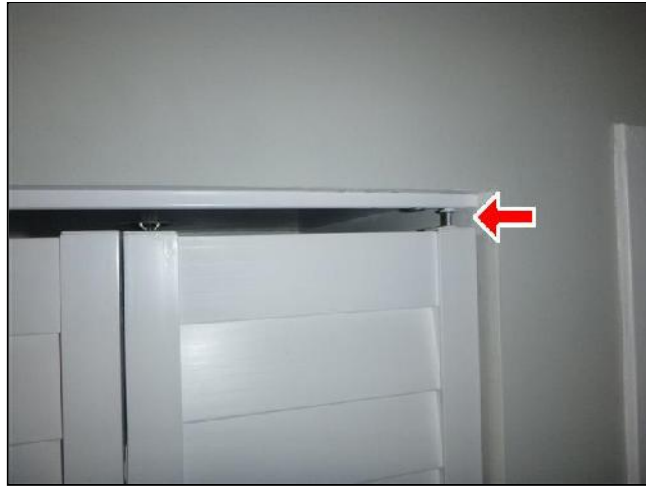
(1) All of the bi-fold closet doors should be adjusted for proper appearance and also should be adjusted to within 1/2" of the head track in order to prevent undue wear to the operating hardware.

K. Item 1(Picture) Excessive Gap

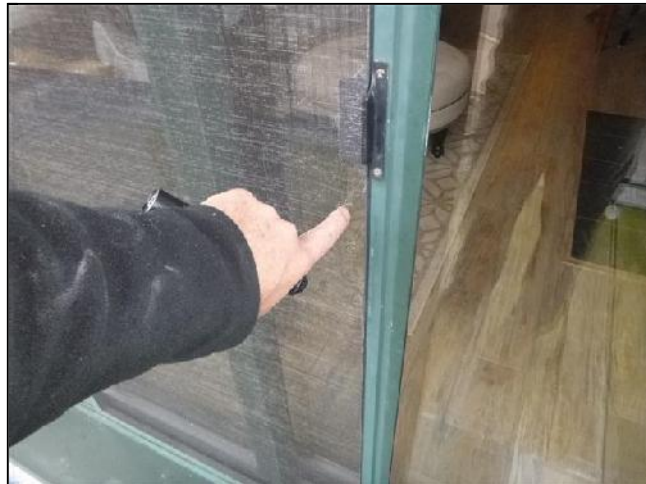
K. Item 2(Picture) Deteriorated Screening

(2) The installation of new screening material is recommended at the balcony sliding door screen.

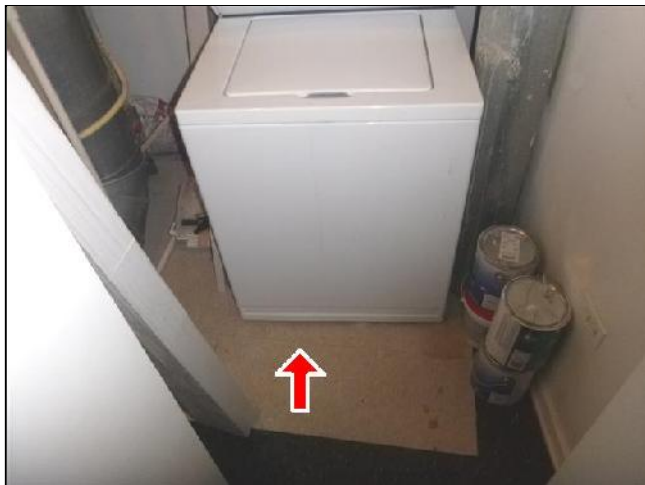
L. Item 1(Picture) Missing Drip Pan

(1) The installation of a preformed drip pan is recommended underneath the washing machine in order to reduce the risk for leaking and damage in the event of an appliance malfunction.

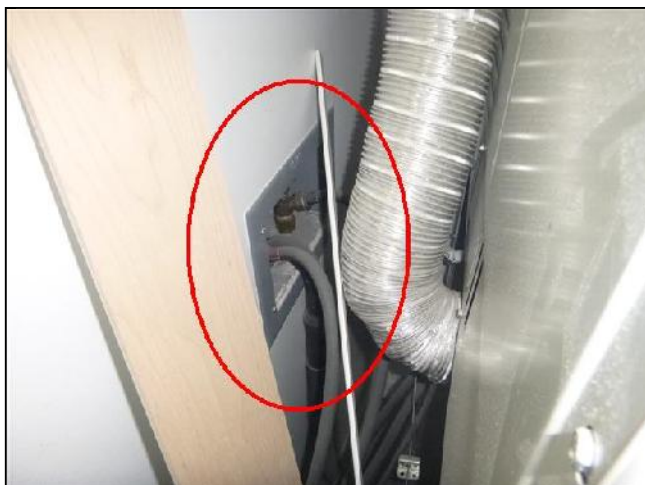
L. Item 3(Picture) Washing Machine Water Supply Hoses

(2) It is recommended that the existing rubber water supply hoses at the washing machine be replaced with braided stainless steel hoses for increased insurance against leaks and water damage. The 'Watts' corporation produces hoses with a 'Flood-Stop' feature that will further reduce the risk for the free flow of water from the laundry outlet.

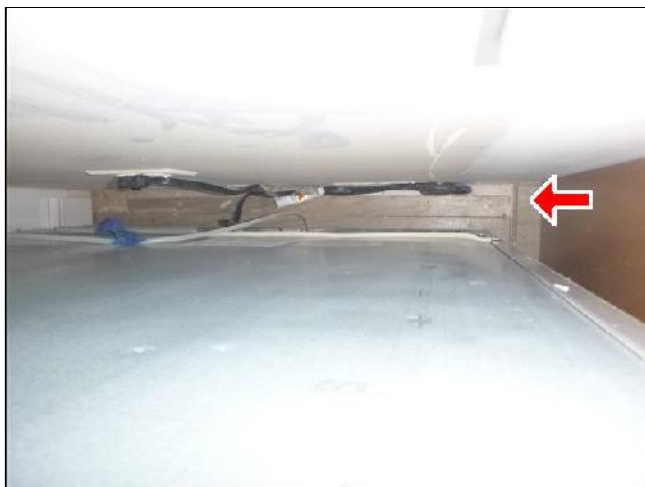
L. Item 5(Picture) No Visible Water Source for Icemaker

(3) The refrigerator icemaker was in the off position at the time of the inspection. The inspector was unable to locate any water supply components connected to the refrigerator icemaker. It is recommended that the proper operation of the refrigerator icemaker be demonstrated at the time of the final walk-through prior to closing.

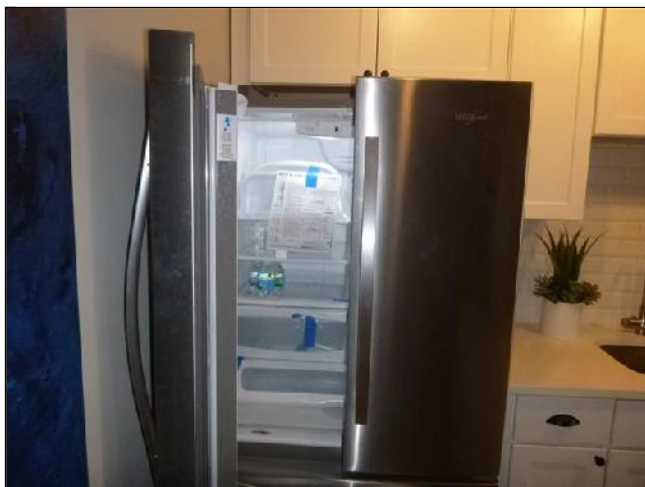
L. Item 6(Picture) Incompletely Installed Refrigerator

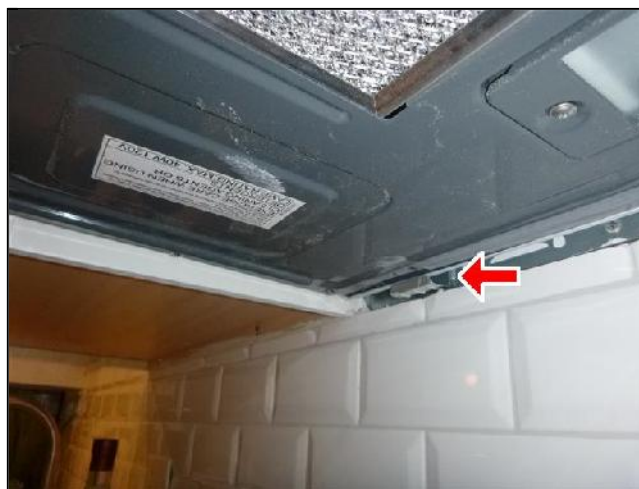
(4) The built-in microwave oven is not properly secured to the adjacent wall. The microwave oven should be removed and reinstalled by a qualified contractor so that it conforms to the manufacturer's installation requirements.

L. Item 7(Picture) Loose Microwave Oven

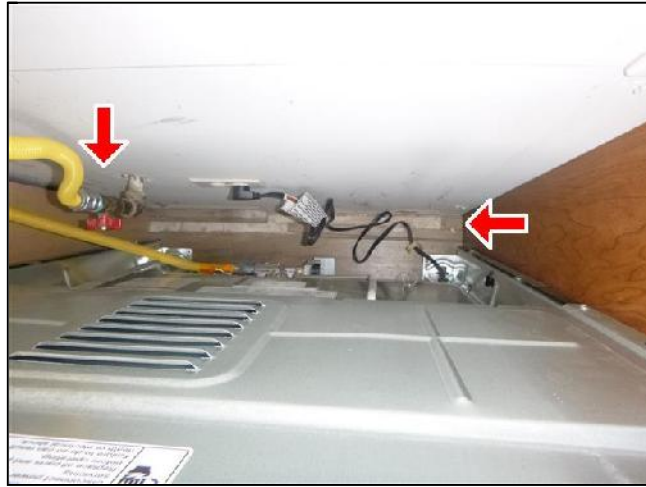
L. Item 8(Picture) Missing Safety Bracket and Gas Valve in the Off Position

(5) The kitchen range installation is incomplete. It is most strongly recommended that a qualified appliance technician install the missing safety bracket, turn on the gas supply, and certify the installation as complete and proper.

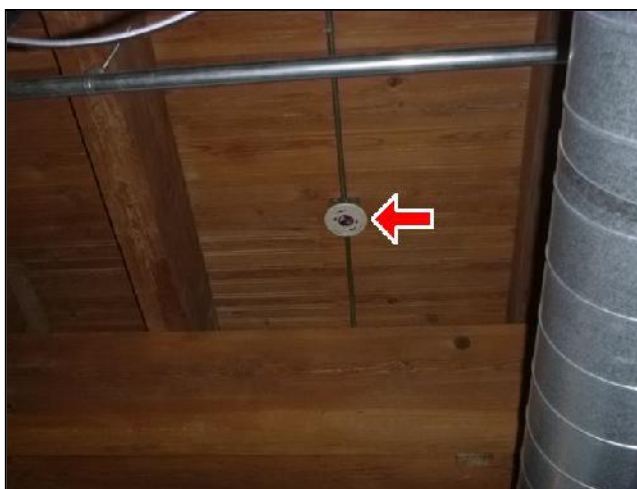
M. Item 3(Picture) Missing Detector

(3) Smoke and carbon monoxide detectors are relatively inexpensive considering the importance of their function. It is recommended that the smoke and carbon monoxide detectors be replaced with new units upon moving into the home.
