Inspection Report

Property Address:
9999 S. Garden Path
Chicago IL

Domicile Consulting

I. Domicile Consulting Report

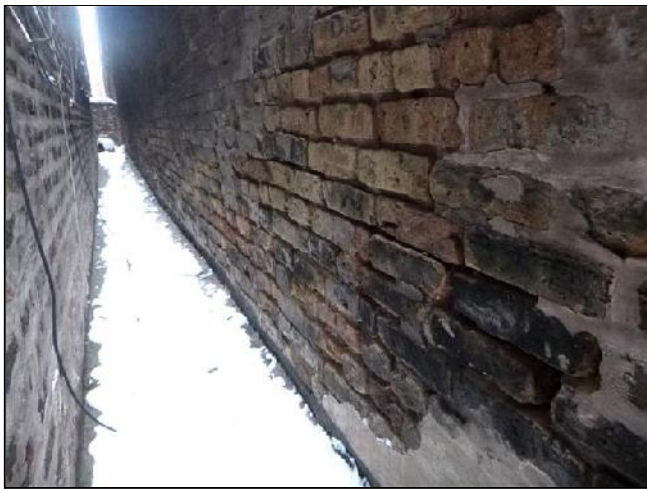
A. Item 1(Picture) exterior wall mortar erosion

(1) The exterior masonry walls are an overall good condition considering the age of the building. However, a significant area of the exterior walls are in need of repair. Some areas are in need of somewhat urgent repair while the repairs to other areas can be deferred. It is strongly recommended that a qualified masonry restoration contractor provide a plan and budget for both the immediate repairs as well as the longer-range repairs.

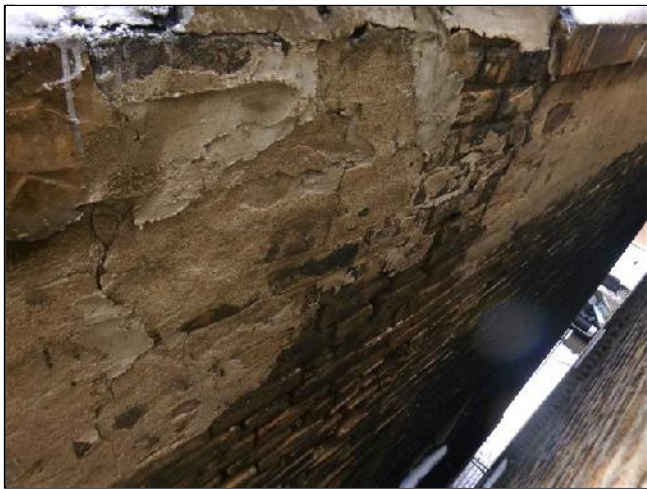
A. Item 2(Picture) deteriorated and improperly patched masonry parapet wall

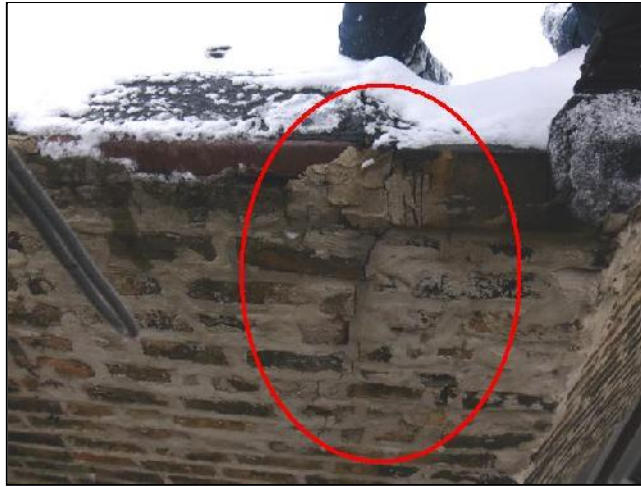
A. Item 3(Picture) masonry wall cracking and improper patching

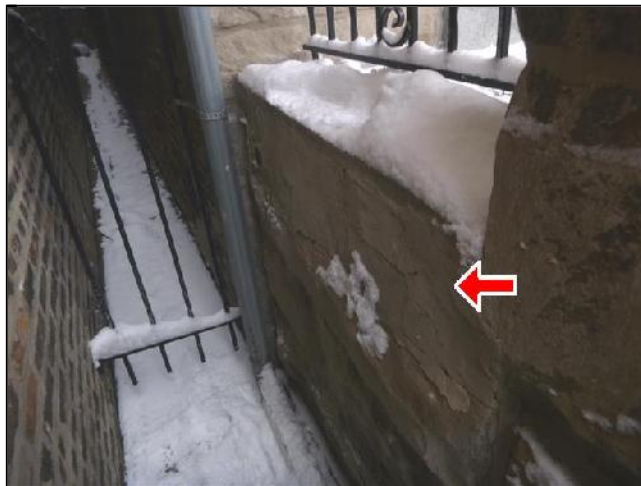
A. Item 4(Picture) failing cement parging

(2) Portions of the exterior masonry walls have been covered with a cement parging. The cement parging is splotchy and appears to have been patched a number of times. This thin cement coating which has been applied over deteriorated brick masonry will require regular upkeep and patching. The cement parging at this home is lacking several features that would be present on a high-quality cement parging job. These include a stainless steel mesh screen behind the cement parging it reduces the risk for delamination; corrosion resistant metal beading at the top and sides terminations of the cement parging; and a proper movement joint at the base of parging. The parging on the exterior masonry walls would ideally be composed of lime mortar and not Portland cement in order to allow for the best performance and optimal protection of the brick masonry walls. The application of a clear masonry sealant over the existing cement parging may extend its service life and may reduce its maintenance requirements. The homeowner should engaged the services of a qualified masonry restoration contractor with extensive experience in historic masonry repair in order to develop a plan and budget for ongoing maintenance/repair of the cement parging.

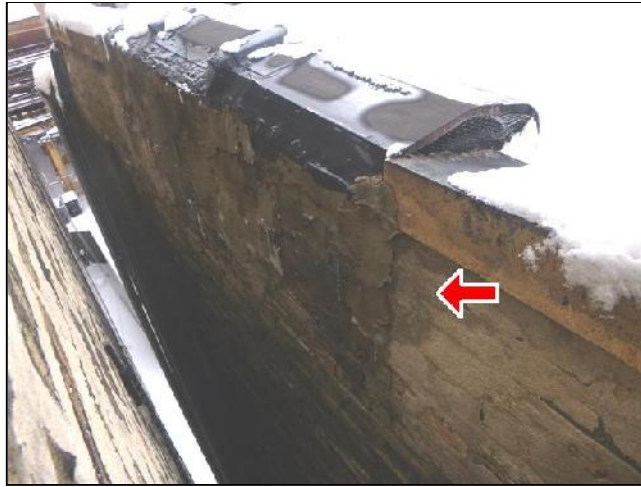
A. Item 6(Picture) failing and deteriorating parapet wall parging

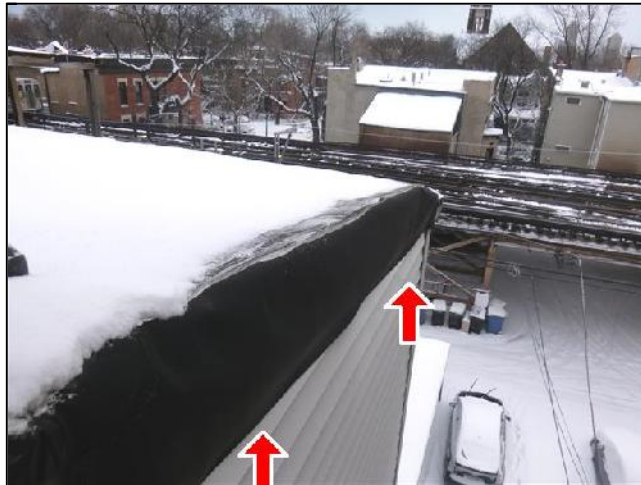
A. Item 7(Picture) enclosed rear porch rake edge

(3) Neither the roof covering nor the siding at the sides of the rear porch have been properly terminated. The failure to install edge metal flashing at these locations creates a risk for roofing damage, siding damage, leaking, etc. Repair by a qualified contractor is recommended.

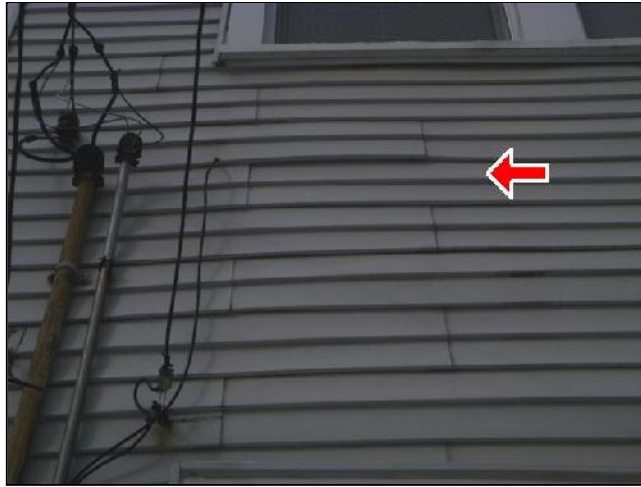
A. Item 8(Picture) buckling siding

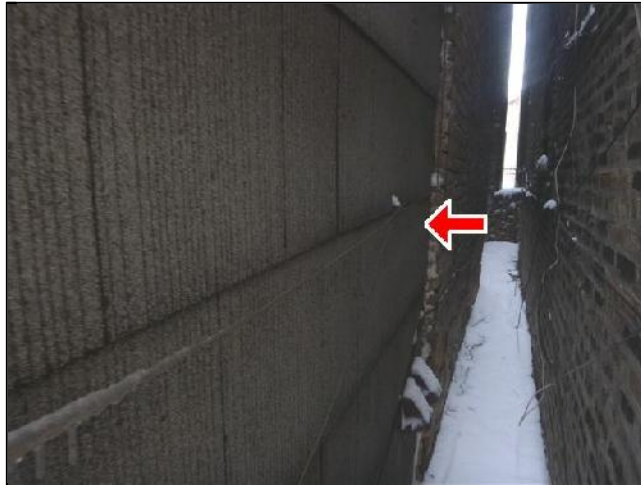
A. Item 9(Picture) aged and deteriorated siding at
North wall of enclosed rear porch

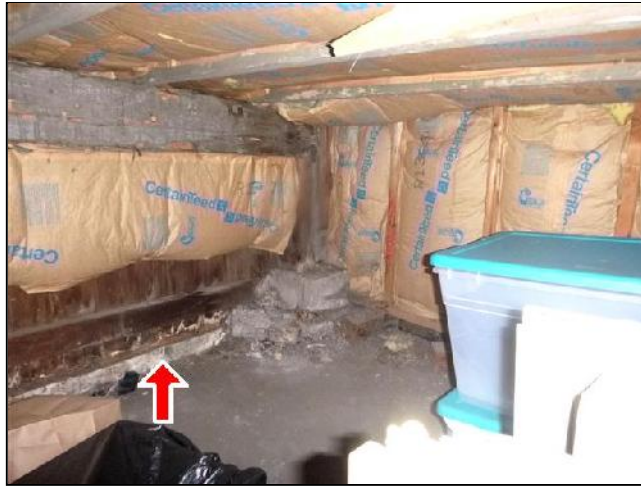
A. Item 10(Picture) moisture staining and wood rot at base of North enclosed porch exterior wall

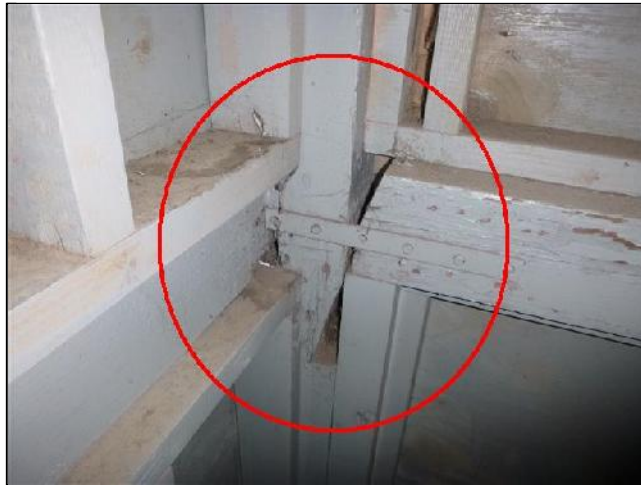
A. Item 11(Picture) suspect structural connection

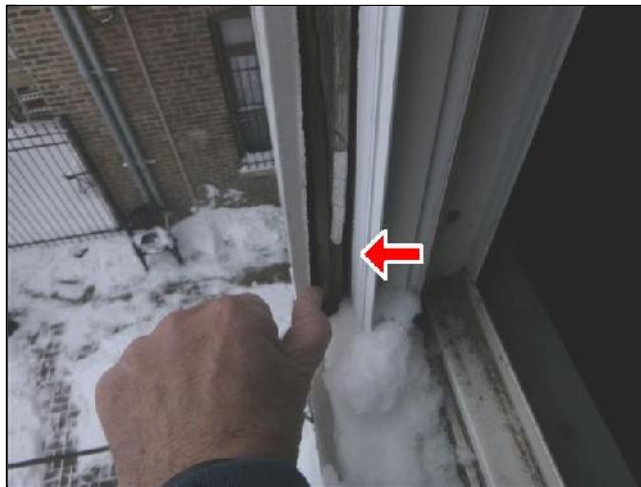
A. Item 13(Picture) ongoing moisture penetration and rot at enclosed rear porch walls

(4) Evidence of ongoing moisture penetration through the vinyl siding was noted at the enclosed rear porch. It is possible and even likely that this ongoing moisture penetration has resulted in significant damage to the siding substrate. The extent of the installation defects and ongoing deterioration indicate that removal and replacement of the siding is the appropriate option. A qualified siding specialty contractor should evaluate the vinyl siding and ancillary components on the enclosed rear porch exterior walls in order to develop a plan and budget for the needed repairs.

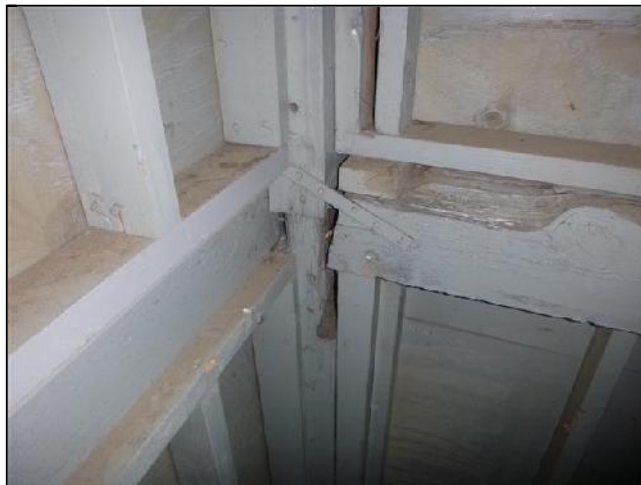
A. Item 14(Picture) suspect structural connection

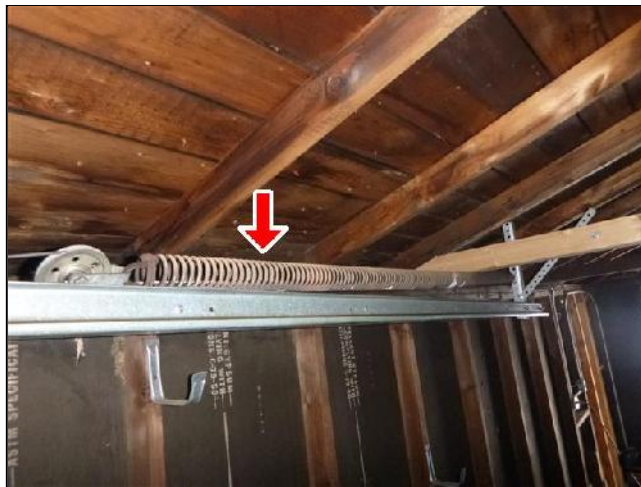
B. Item 2(Picture) Garage Door Springs

(2) Containment cable should be installed through the garage door extension springs in order to reduce the risk of injury in the event of a catastrophic spring failure.

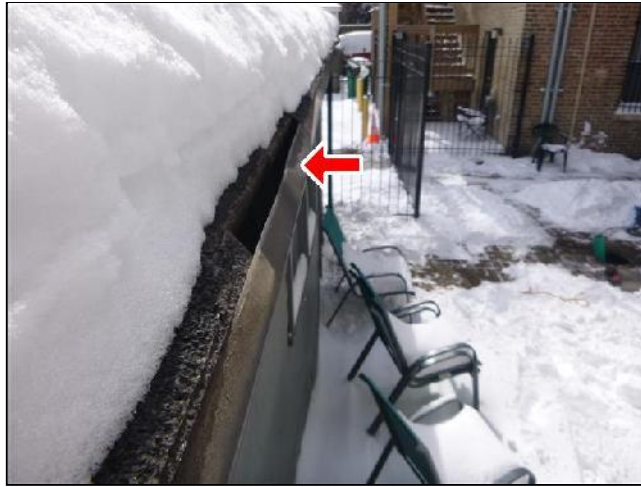
B. Item 3(Picture) Missing Drip Edge Flashing

(3) The defective aluminum fascia covering is allowing moisture penetration and damage to take place at the eaves. An overhanging drip edge flashing should be installed by a qualified contractor.

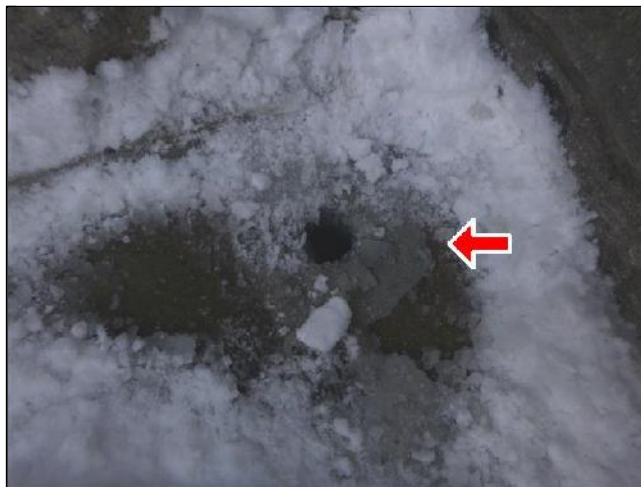
C. Item 2(Picture) Leaking Gutter/Scupper

(1) The gutter at the second floor front balcony is leaking then should be repaired by a qualified specialist in order to prevent wood rot of the front entry soffit ceiling.

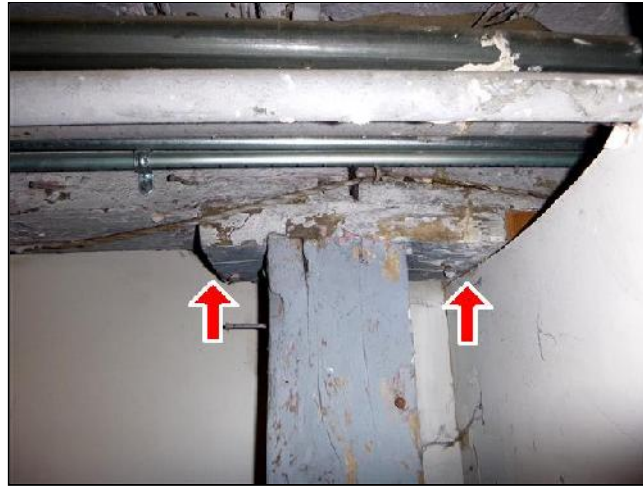
D. Item 1(Picture) wood fibers being crushed

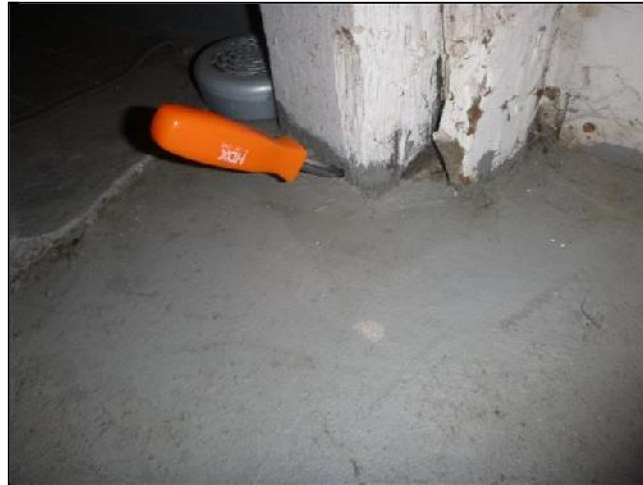
D. Item 2(Picture) deterioration at base of 6 x 6 support posts

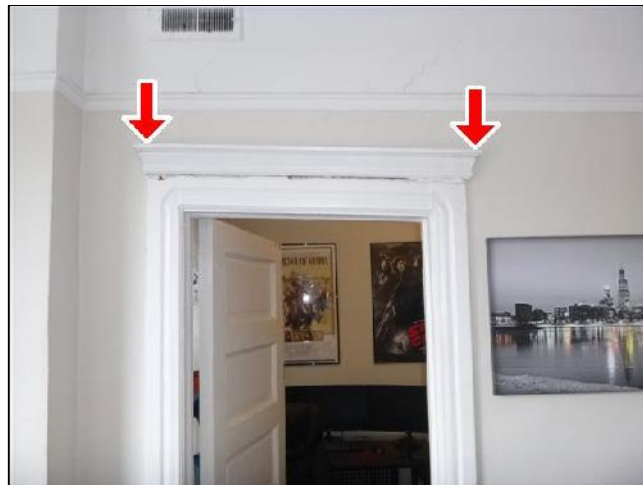
D. Item 3(Picture) Sloping Doorway

(1) Many of the interior doorways are sloping dramatically. This is indicative of unanticipated structural and framing movement in the building. Since most of the framing components are concealed within the walls and ceilings a full evaluation is not possible. However, multiple defects were noted with regard to the structural and framing components. These may include 6 x 6 main floor beams support posts which are submerged below the basement slab and therefore subjected to moisture, pests, etc., inadequate support at the lumber blocks between the top of the support posts in the underside of the main floor beam, and moisture related deterioration of floor framing. Once again, it is apparent that a full gut remodel of the property is necessary in order to bring it to its highest and best use.

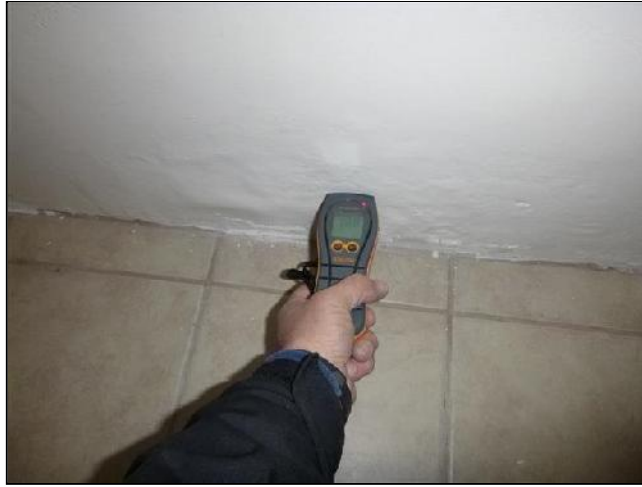
D. Item 4(Picture) wet wall

(2) Several areas of wet wall finishes and moisture damaged walls were noted in the basement. This condition is indicative of basement seepage and/or condensation within the basement wall finish cavities. It is recommended that the basement wall finishes be gutted and that a full complement of finished basement moisture management details be installed including but not necessarily limited to; foundation perimeter drainage tubing, sump pit and pump assembly, and a moisture impermeable membrane installed over the interior side of the foundation.

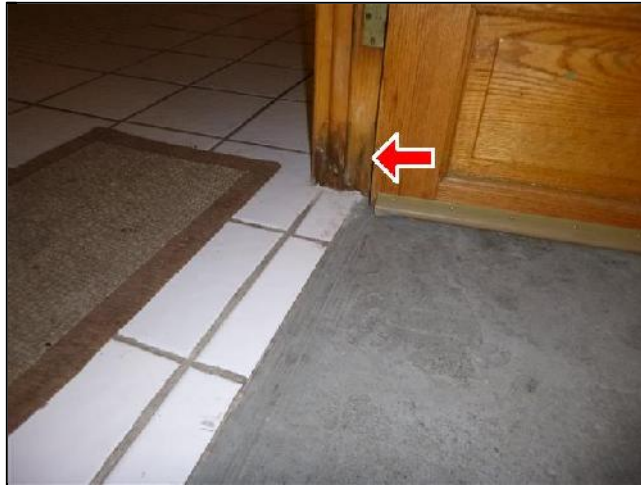
D. Item 7(Picture) evidence of previous moisture events

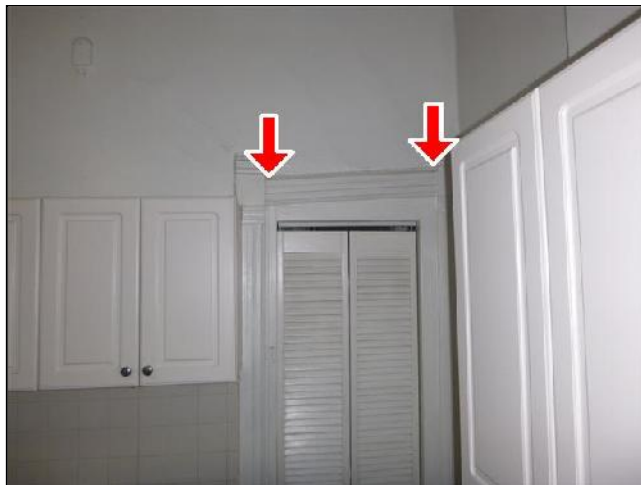
D. Item 8(Picture) Sloping Doorway

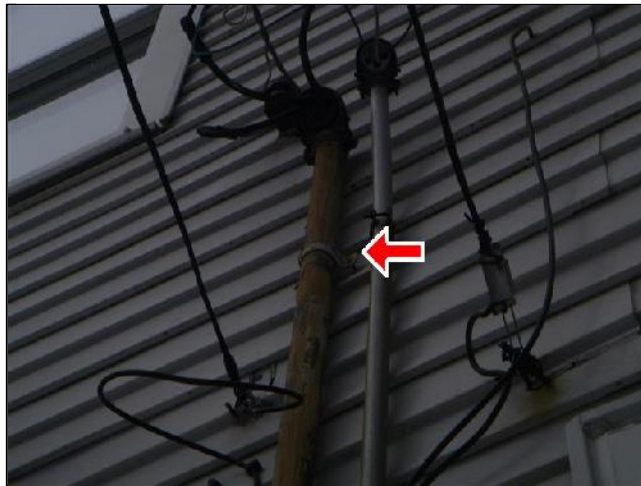
E. Item 2(Picture) dangerous electrical condition

(1) The electrical service mast at the rear wall of the building is not properly secured and is at risk for excess movement, arcing/sparking, fire, shock, and interruption of electrical service. Also, the overhead electrical service wires do not have adequate clearance from the nearest window of the enclosed rear porch. It should be repaired or replaced as soon as practical.

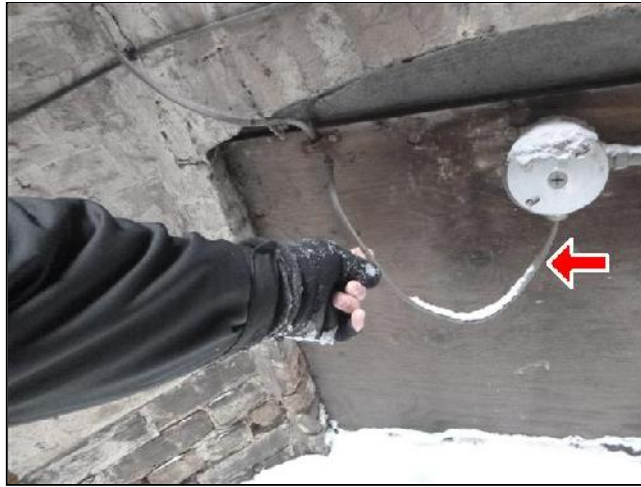
E. Item 4(Picture) dangerous wiring

(2) A section of nonmetallic sheathed cable wiring was noted at the north exterior wall. This material is not only prohibited by the local electrical code but was also not properly or safely installed. A qualified electrical contractor should make the necessary repairs.

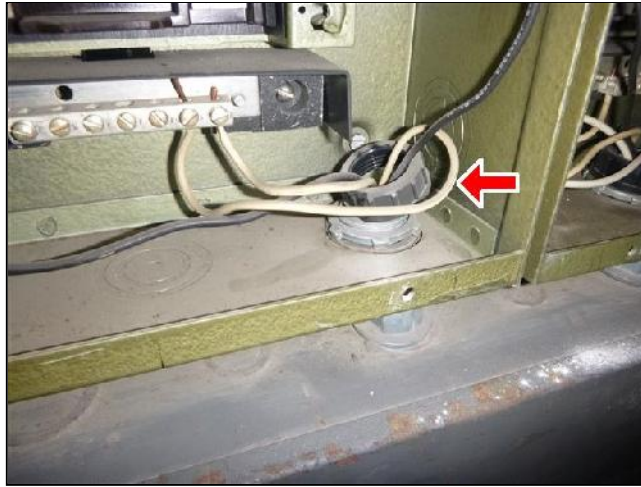
E. Item 6(Picture) defective bushing

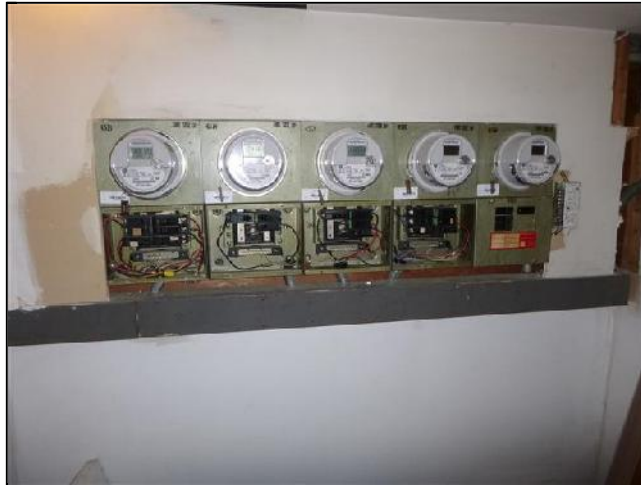
E. Item 9(Picture) undersized panels

(4) The six position electrical breaker panels for the individual apartments are seriously undersized according to today's electrical demands. Also, a significant number of individual safety defects were noted in relation to the electrical panels including but not necessary limited to; the use of prohibited half-size breakers, the presence of prohibited wire splices within the electrical panels, over fused conductors, and defective nonconductive bushings at the feeder conduit terminations inside the panels. In addition, the 200 amp electrical service coming into the building is woefully inadequate and is likely nonconforming with regard to the current electrical code. Once again, the extent of the inadequacies, defects, and deterioration regarding the electrical service/supply components indicates that a full gut remodel is warranted and appropriate.

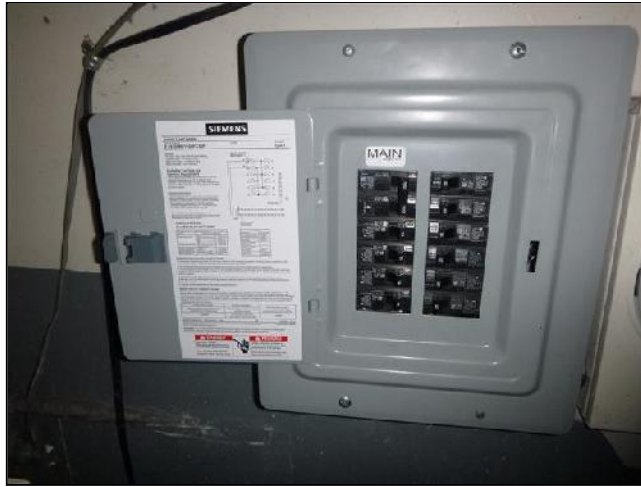
E. Item 10(Picture) missing information

(5) A complete and accurate electrical circuit directory should be provided to the buyer before closing in order to allow for safe and efficient electrical circuit interruption when required for maintenance, repairs, or in emergencies.

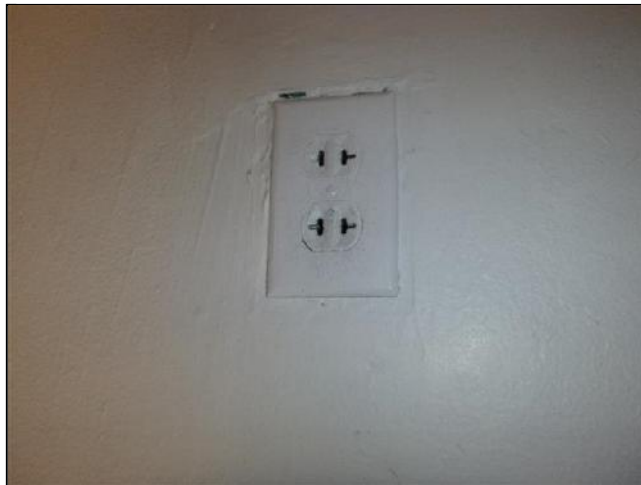
E. Item 12(Picture) obsolete two-pronged receptacle

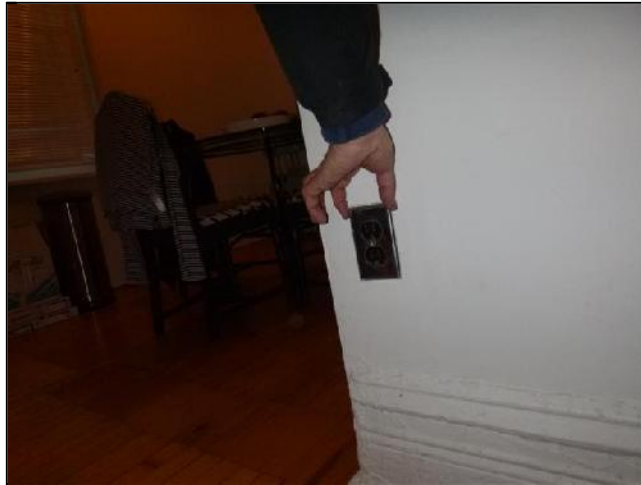
E. Item 14(Picture) Dangerously Loose Receptacle

(6) Ungrounded electrical receptacles, inoperative electrical receptacles, loose electrical receptacles, and mis-wired electrical receptacles were noted in various areas of the home. All of these conditions represent significant electrical safety defects. All the electrical receptacles in the home should be evaluated and repaired or replaced as necessary by a licensed and competent electrical contractor.

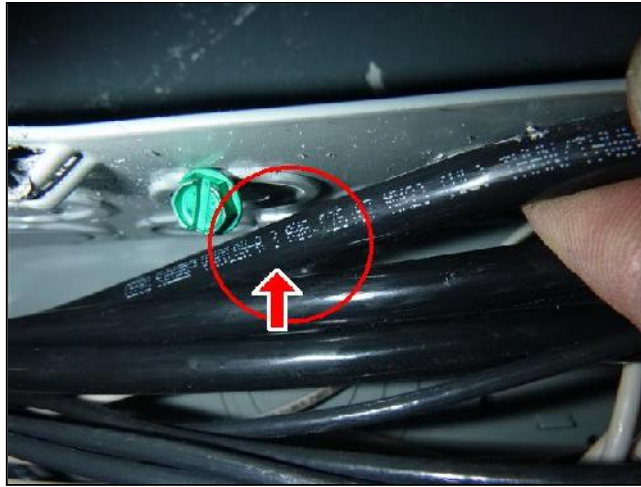
E. Item 15(Picture) protective bushing needed

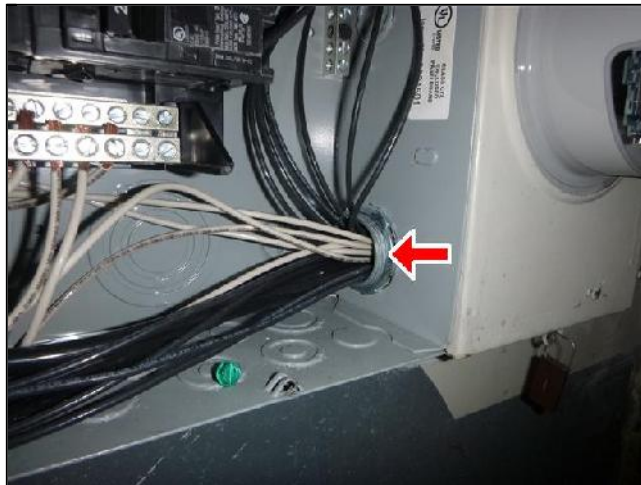
E. Item 16(Picture) missing nonconductive bushing

(7) Larger electrical conductors are required to be protected at conduit terminations with a non-conductive bushing in order to reduce the risk for arcing/sparking, shock, fire, etc. These bushings are missing in both the furnace closet subpanel as well as the main distribution panel in the master bedroom. It is strongly recommended that the electrical panels be evaluated and repaired as needed by a qualified electrician prior to closing.

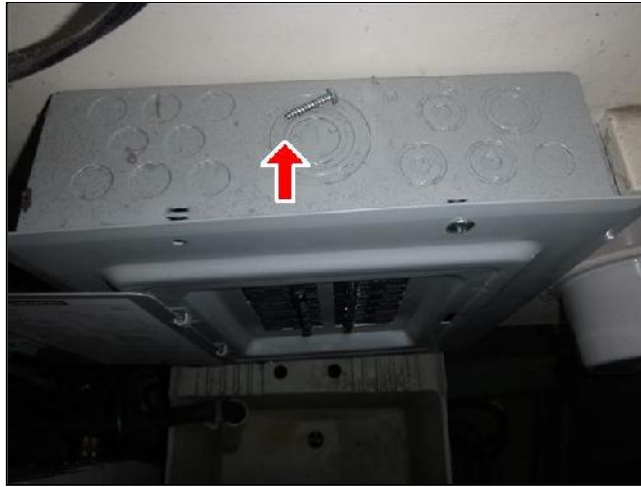
E. Item 18(Picture) improper electrical panel cover fastener

(8) The pointed tipped screws that secure the service panel cover to the enclosure presents a risk for arcing/sparking, shock, and fire. They should be replaced with blunt tipped screws by a qualified electrician.

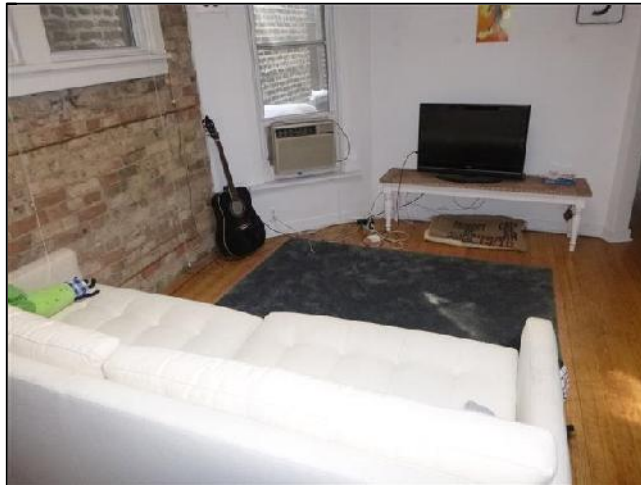
E. Item 19(Picture) inadequate receptacle spacing

(9) There is an inadequate number of electrical receptacles in the living space. Additional receptacles should be added by a qualified electrician in order to reduce the risk for over-loading of circuits, the risk associated with the excessive reliance upon extension cords, and for convenience in the use of electrical appliances.

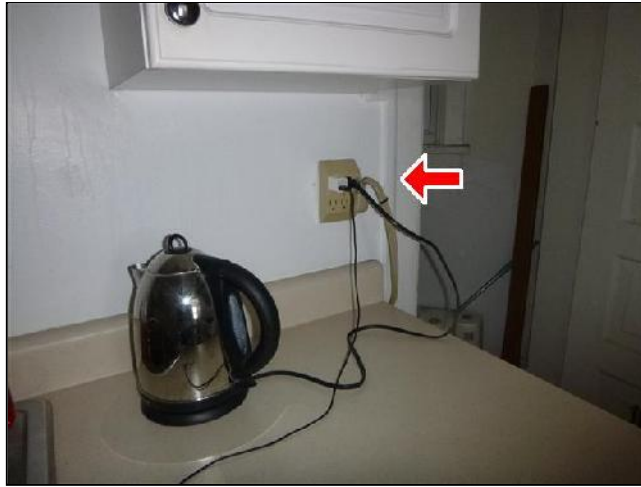
E. Item 20(Picture) missing shock protection at kitchen countertop

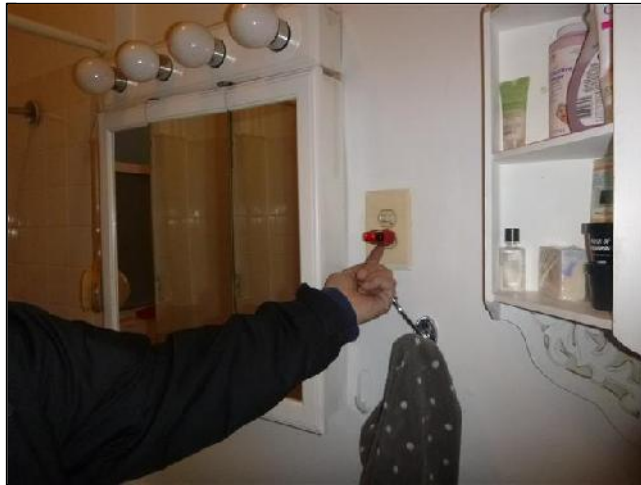
E. Item 21(Picture) Missing Shock Protection

(10) It is recommended that all electrical receptacles in the bathrooms, unfinished basement areas, kitchen counters, garage, and all exterior locations that are not already GFCI protected be upgraded to GFCI protected receptacles by a licensed and competent electrician in order to reduce the risk of electrical shock and injury.

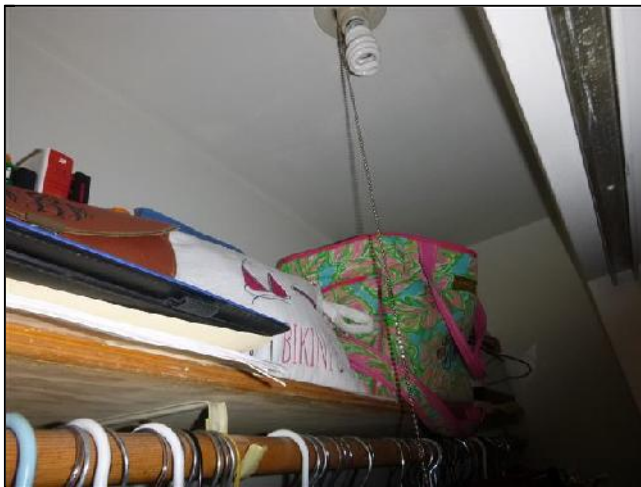
E. Item 22(Picture) Closet Light

(11) The bare bulb light fixtures in the closets should be replaced with low-profile fluorescent fixtures or their equivalent in order to reduce the fire hazard associated with their hot surfaces and also in order to reduce the risk of bulb breakage.

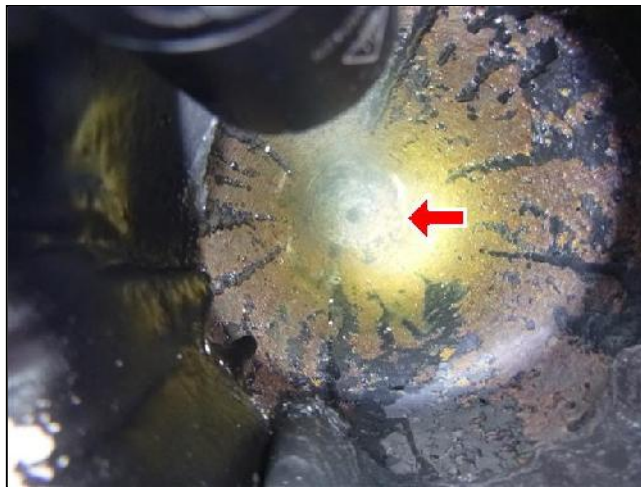
F. Item 2(Picture) blocked vent stack

(2) At least one of the plumbing vent stacks was found to be partially blocked during the roof inspection. A qualified plumbing contractor should clear or otherwise repair this defective vent stack in order to reduce the risk for sewer gas intrusion into the occupied space.

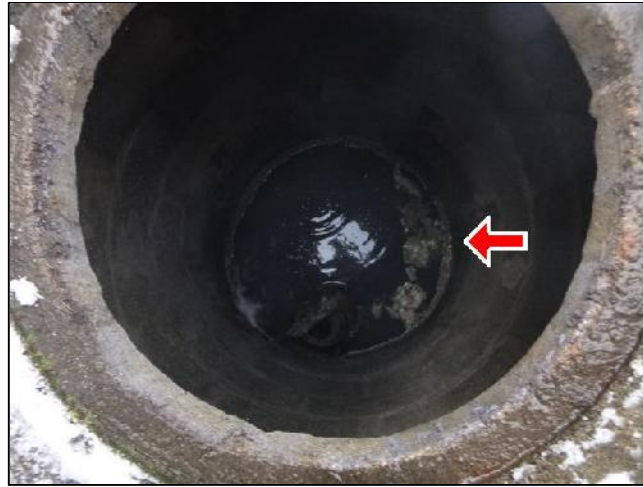
F. Item 3(Picture) catch basin

(3) An underground drain piping evaluation was being performed simultaneously with this commercial property inspection. Evaluation of the underground piping was not within the scope of work of the property inspection.

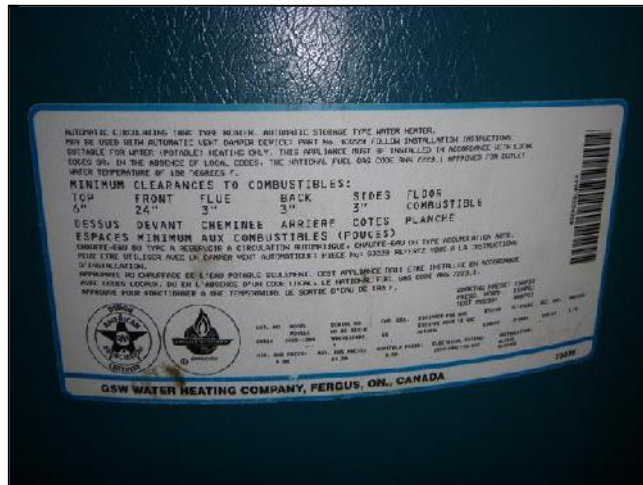
F. Item 4(Picture) older water heater

(4) The water heater is approximately 18 years old and, as such, at or near the end of its useful life. It is recommended that plans be made for its near-term replacement.

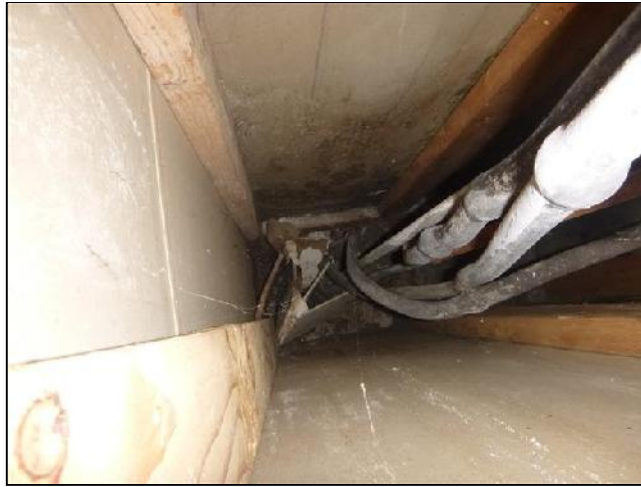
F. Item 5(Picture) lead pipe water supply piping

(5) A significant amount of lead pipe water supply piping was noted. It is strongly recommended that a qualified plumbing contractor provide a plan and budget for removal of the lead-based water supply piping in the building.

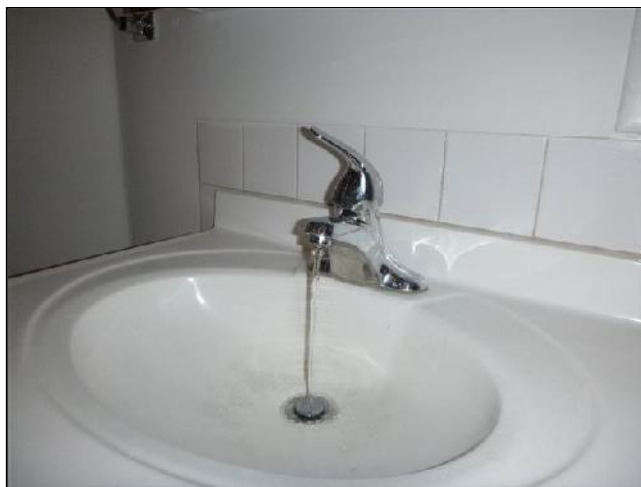
F. Item 7(Picture) inadequate water flow

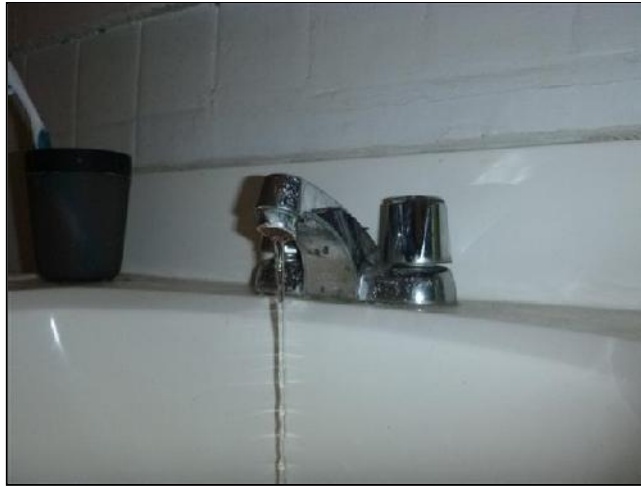
F. Item 8(Picture) Inadequate Water Volume/Pressure

(6) The water pressure and flow at the plumbing fixtures is marginal. It is recommended that the remaining galvanized water supply piping be removed and replaced with copper piping for optimal flow and pressure during the use of multiple fixtures.

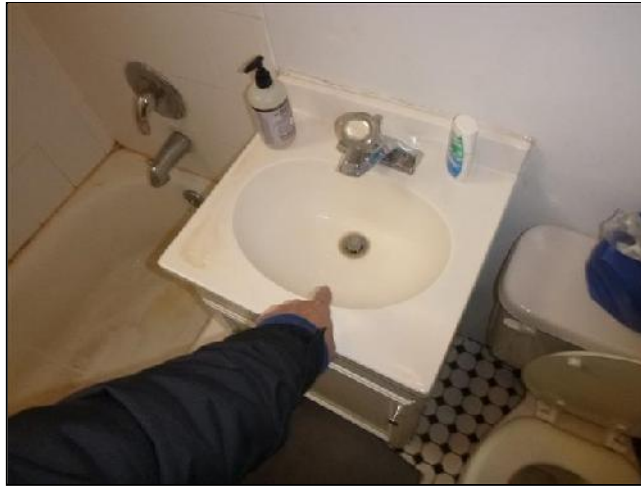
F. Item 10(Picture) evidence of inadequate plumbing venting

(8) Gurgling of the bathroom sink drains was noted in multiple locations. This phenomenon is indicative of blocked or otherwise defective plumbing venting and can result in sewer gas intrusion into the occupied space. It is most strongly recommended that a qualified plumbing contractor evaluate this condition and make recommendations for repairs. If, as suspected, many of the concealed plumbing drain/vent/waste piping is antiquated and deteriorated, then this is another indication of the need for a full gut remodel.

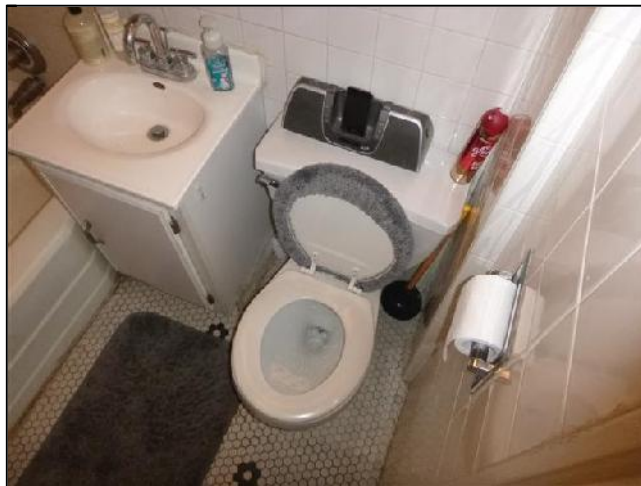
F. Item 11(Picture) Loose Toilet

(9) Two or more of the toilets were found to be inadequately secured in place. This can result in deformation of the wax ring seal, leaking, and other damage. The toilet should be evaluated by a licensed and competent plumber in order to determine if removal and reinstallation as necessary.

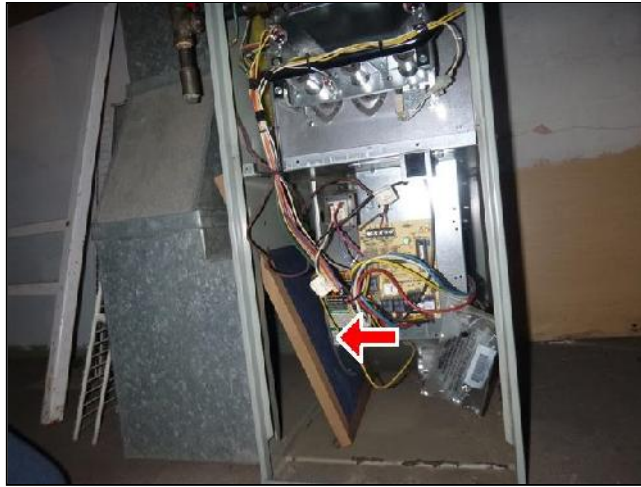
G. Item 1(Picture) defective filter slot

(1) The filter slot for the basement furnace should be repaired so that it is capable of properly securing the HVAC air filter and prevents any significant air filter bypass.

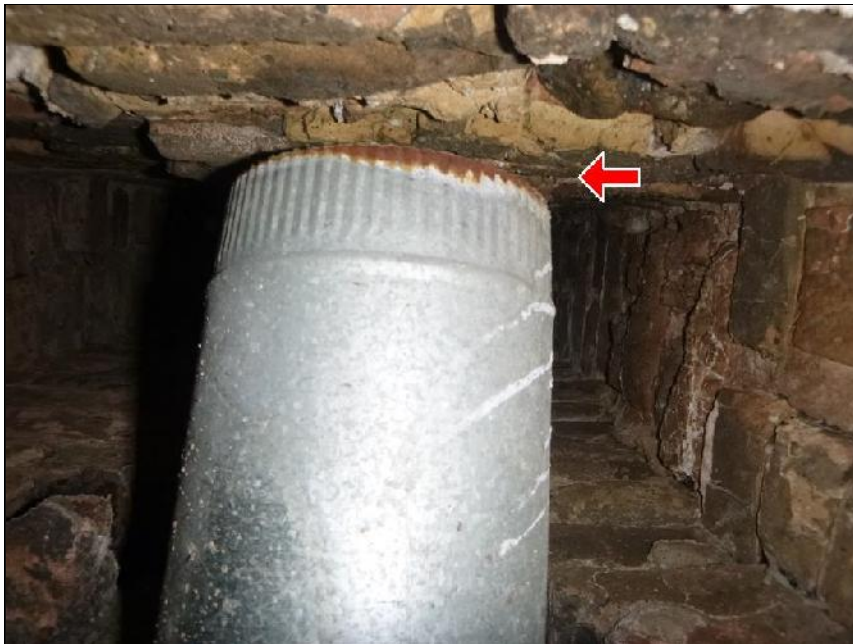
G. Item 2(Picture) dangerous gas exhaust venting

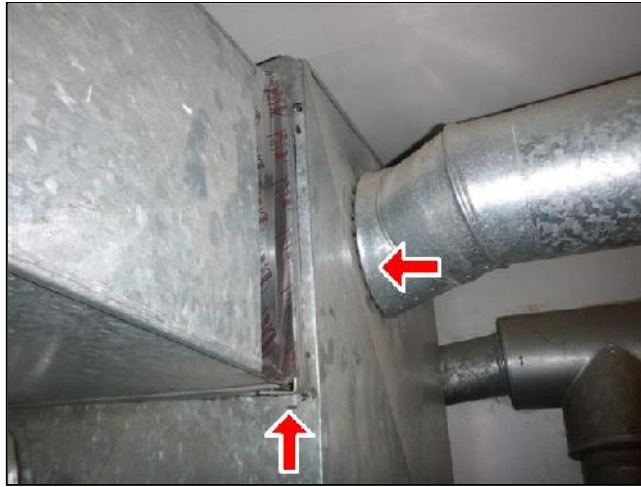
G. Item 5(Picture) HVAC duct leakage

(3) Gaps were noted in the supply and return air duct work and/or in the HVAC plenums. These gaps create air leaks which can reduce the efficiency of the HVAC unit, and which can negatively impact both indoor air comfort and indoor air quality. The supply and return air ducts should be sealed using approved materials and methods; duct mastic is the preferred material for duct sealing.

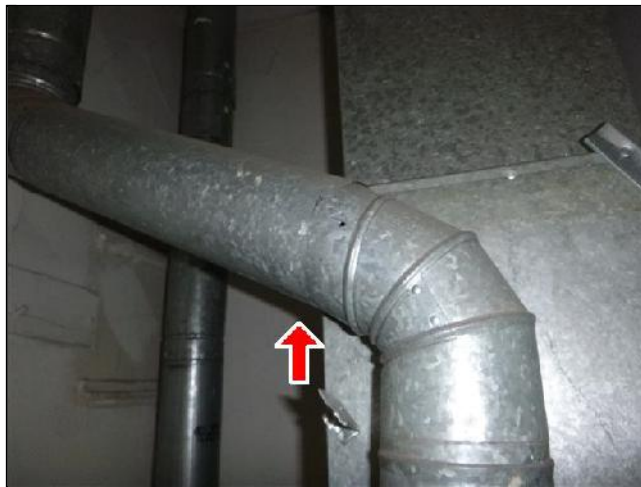
G. Item 6(Picture) unsecured piping sections

(4) The furnace exhaust piping in the top floor rear apartment is not properly secured and is at risk for displacement. This could result in carbon monoxide poisoning of the occupants. The furnace vent piping in this unit should be repaired as needed by a qualified HVAC contractor as soon as practical.

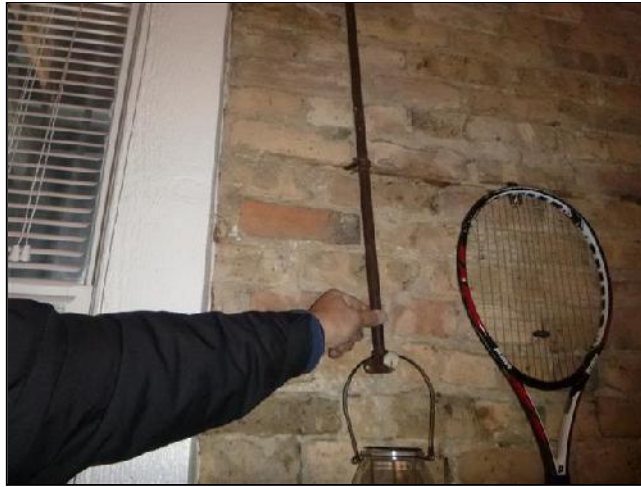
G. Item 7(Picture) antiquated gas piping

(5) It is recommended that the antiquated, abandoned, and/or obsolete gas piping in the building be removed in order to reduce the risk for leaking, fire, explosion, etc.

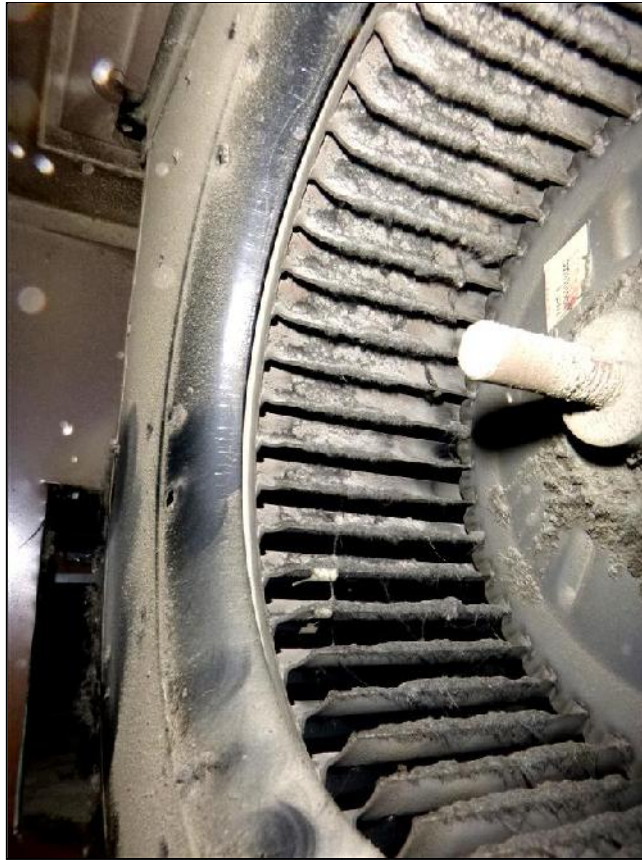
G. Item 8(Picture) Filthy Air Handler

(6) Heavy dirt build-up was noted on the interior components of the HVAC system. This can reduce the efficiency of the system and can also reduce indoor air comfort. The entire HVAC unit; including the blower assembly, heat exchanger, and evaporator coil should be professionally cleaned for optimal system performance.

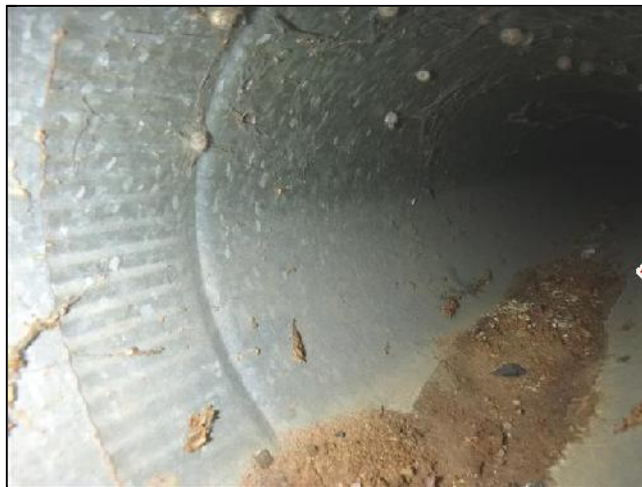
G. Item 9(Picture) Filthy Ducts

A significant build-up of dirt was noted inside the HVAC ducts. A duct cleaning performed by a member of the National Air Duct Cleaning Association (NADCA) is recommended in order to help improve indoor air quality.

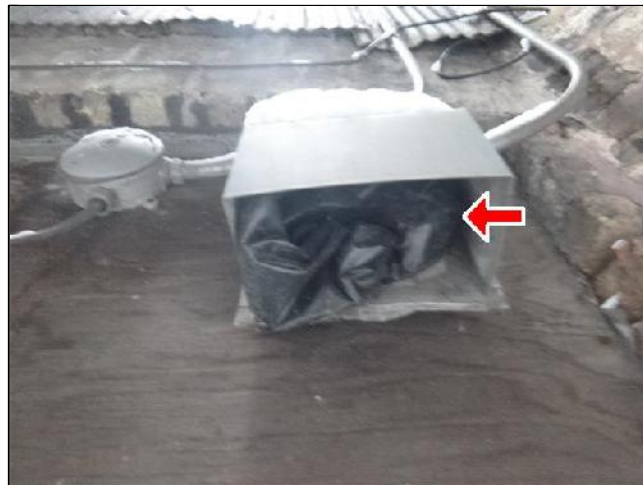
H. Item 3(Picture) blocked vent damper

(1) The exhaust vent dampers on the exterior walls should be replaced with high-quality, gasketed, vent dampers in order to reduce drafts and energy losses.

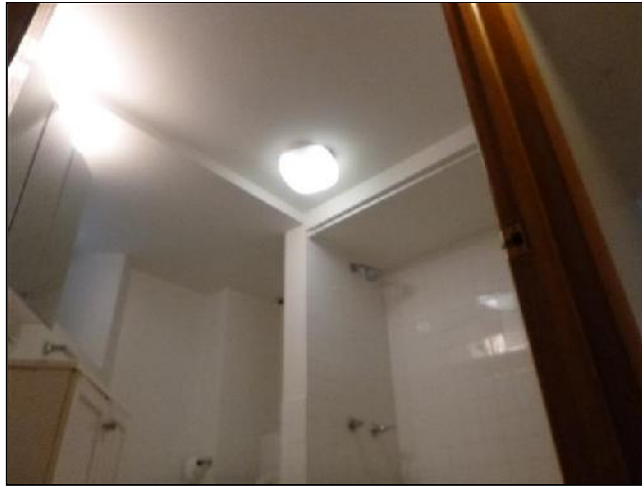
H. Item 4(Picture) bathroom ventilation fan installation recommended

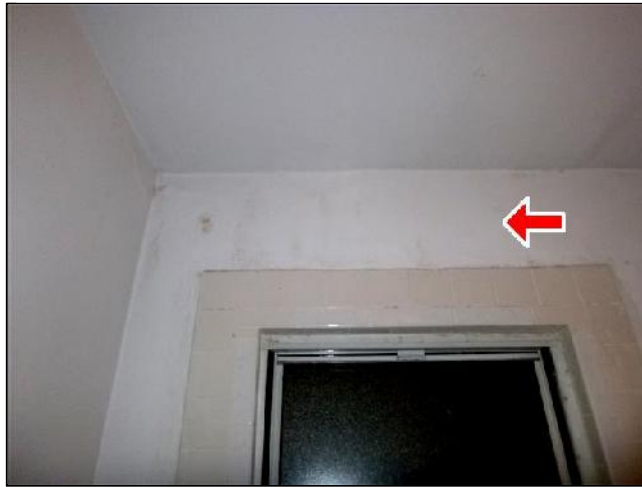
H. Item 5(Picture) Mold Growth Due to Inadequate Ventilation

(2) The installation of a ducted bathroom exhaust fan is recommended in each bathroom in order to provide for the safe and effective removal of moisture and odors. While the building code may allow the use of a bathroom window for ventilation, this practice is ineffective, uncomfortable in the winter, and wastes energy. High quality, quiet, exhaust fans (preferably controlled with a timer switch) should be installed by a qualified contractor.

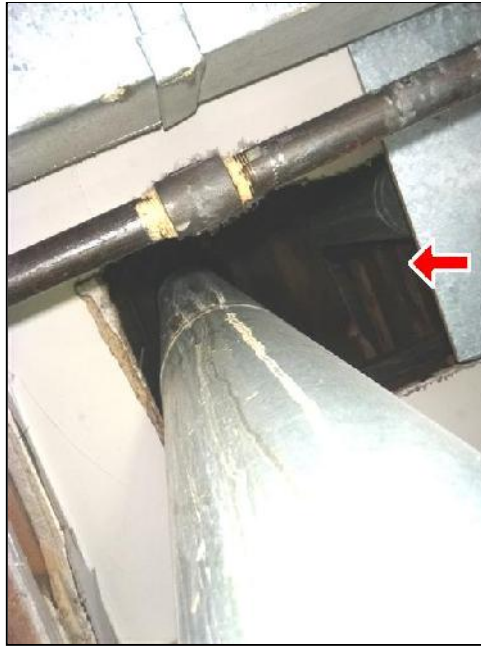
H. Item 6(Picture) missing insulation and air/fire barrier

(3) The failure to provide an intact air/fire/thermal barrier at the top floor ceiling will result in: significant energy losses; increase the risk for condensation in the roof/ceiling plenum thereby creating a risk for mold growth, wood rot, and damage to the roof covering; and in the event of a fire will allow rapid extension of fire into the roof/ceiling plenum. It is strongly recommended that a qualified weatherization contractor provide a plan and budget for insulating the space above the top floor ceiling and for providing an intact air/thermal/fire barrier at this location.

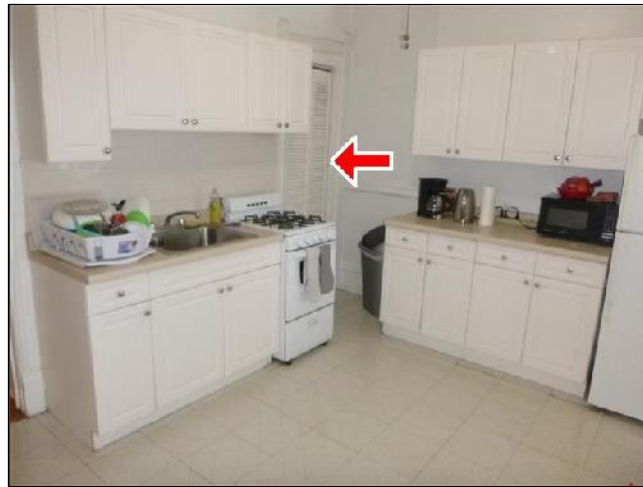
H. Item 7(Picture) No Mechanical Ventilation in Kitchen

(4) The kitchen utilizes a recirculating vent hood. Cooking in the kitchen generates a great deal of heat, steam, grease, smoke, and odors that need to be ventilated in order to maintain indoor air quality and proper housekeeping. It is the inspector's opinion that the failure to install a ventilating kitchen exhaust hood will result in reduced indoor air quality, increased energy usage, and more difficulty in keeping the home clean. A qualified contractor should determine cost and feasibility for the installation of a vented kitchen exhaust system.

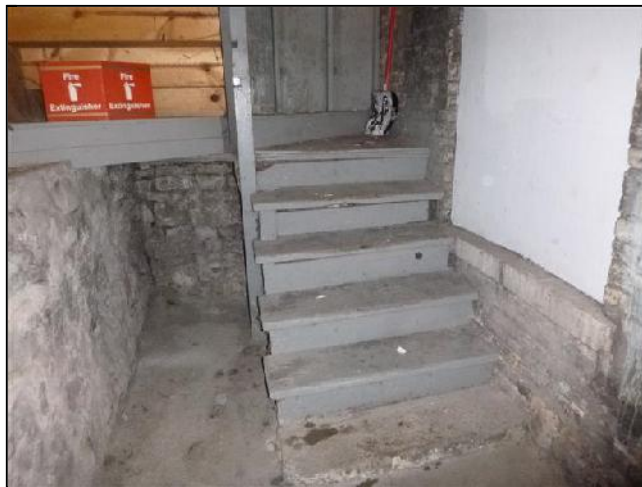
J. Item 1(Picture) missing handrail

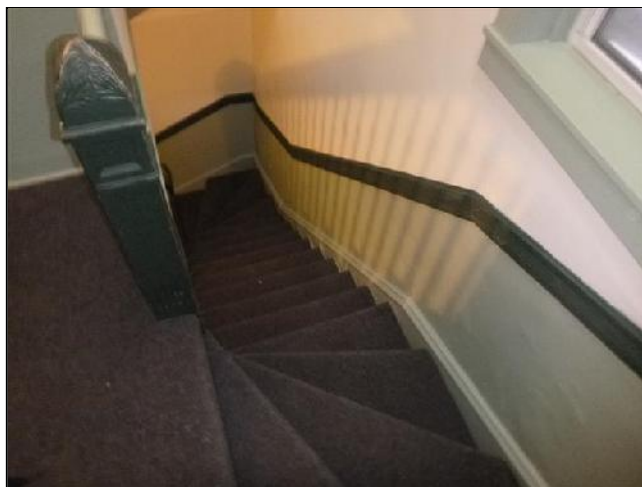
J. Item 2(Picture) missing railing
