Inspection Report

Property Address:
9999 S. Garden Path
Chicago IL

Domicile Consulting

I. Domicile Consulting Report

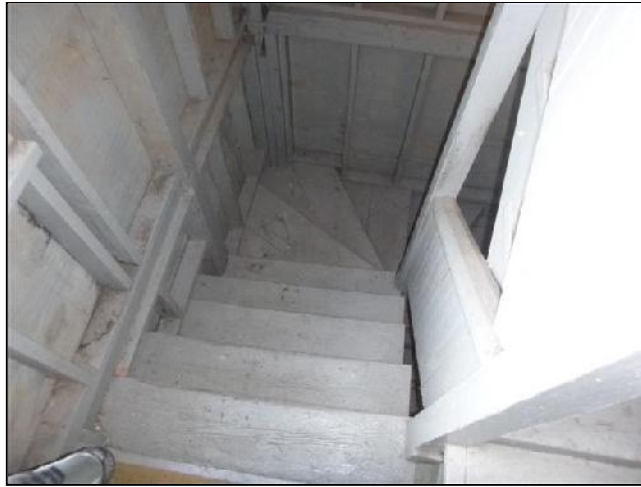
J. Item 3(Picture) Missing Handrail

(1) Secure, continuous, and graspable handrails should be installed at all of the interior stairs in order to provide for safe stair travel.

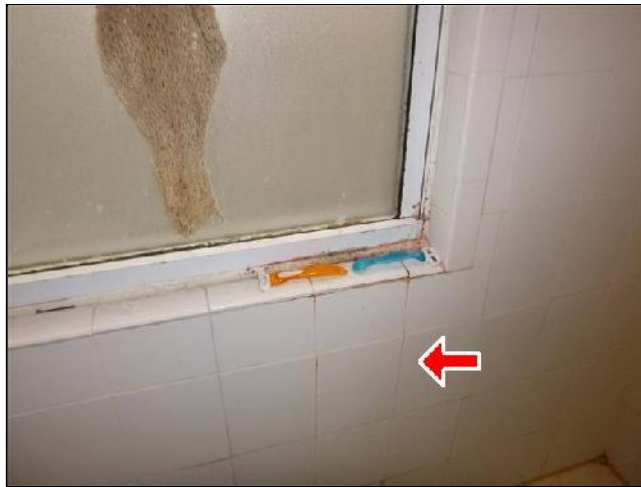
J. Item 4(Picture) moisture damaged tile and tile substrate

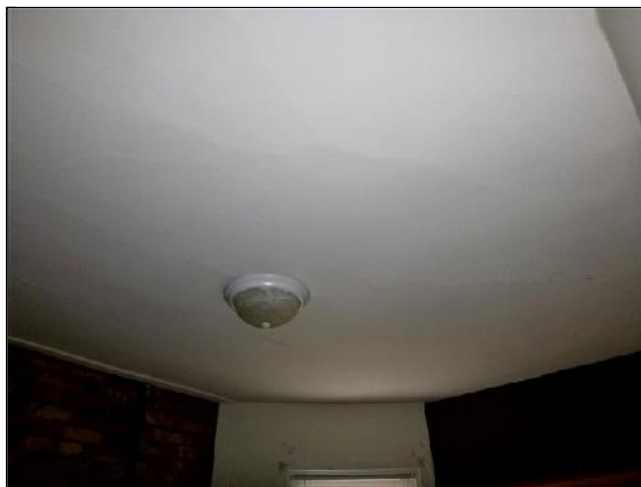
J. Item 5(Picture) badly deteriorated ceiling plaster

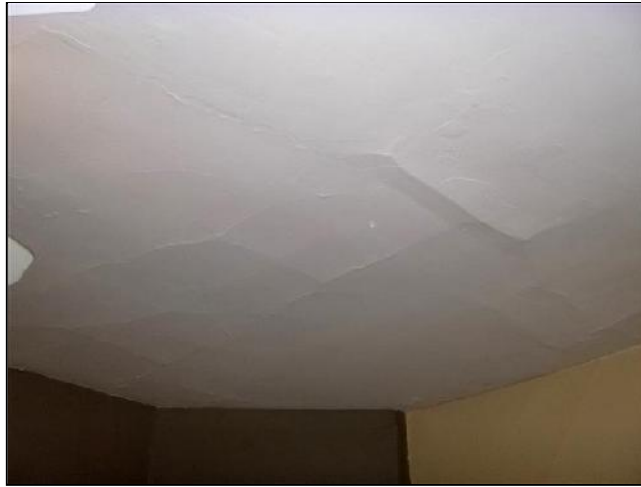
J. Item 6(Picture) Plaster is Heavy and Dangerous When Loose!

(2) The interior wall, floor, and ceiling finishes are aged and deteriorated. The interior trim and millwork is aged, defective, and damaged in multiple locations. The kitchen and bathroom cabinetry, fixtures, and appliances are also aged, deteriorated, and neglected. Extensive remodeling of the home's interior is required in order to elevate it modern standards of safety, convenience, and appearance. Further evaluation by a qualified remodeling contractor is recommended in order to assist the buyer's in developing a plan and budget for these repairs/upgrades.

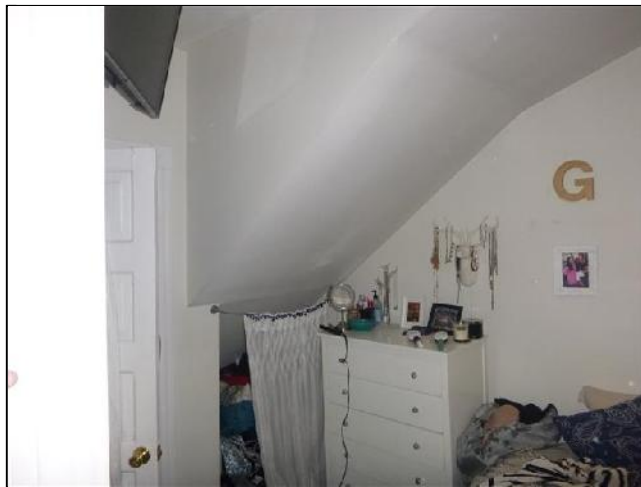
J. Item 7(Picture) Under-sized Bedroom

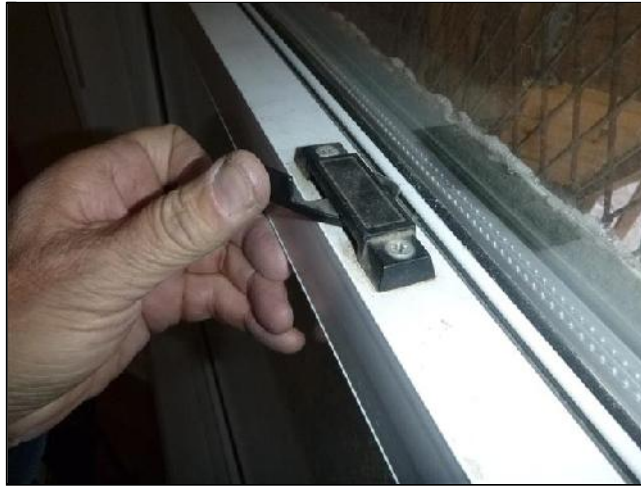
K. Item 6(Picture) Failure to Latch

(3) The double-hung, aluminum framed windows are in fair condition and are typically a durable component. A number of the windows were difficult to operate or could not be latched. It is recommended that the windows be individually evaluated and repaired as needed.

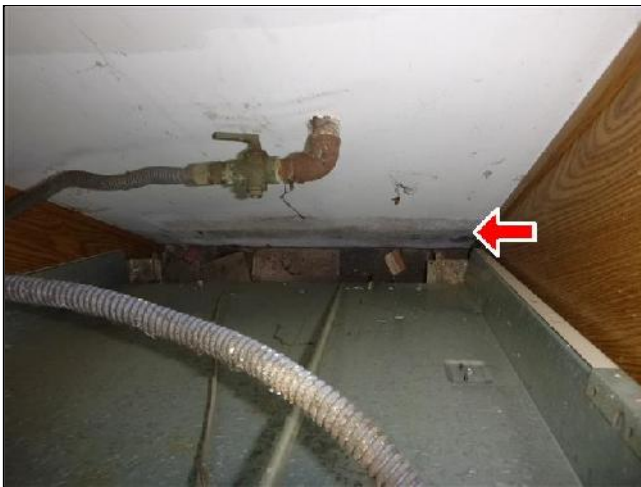
L. Item 1(Picture) missing safety bracket

An anti-tipping device (Federally mandated and shipped with all ranges) should be installed at the kitchen range for the prevention of scalds and burn injuries.

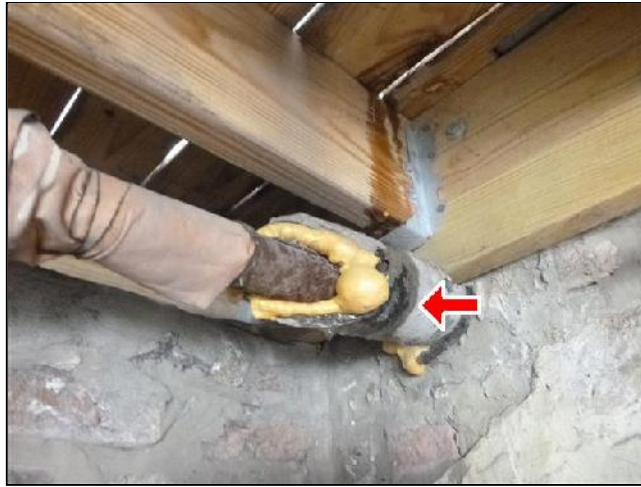
M. Item 1(Picture) possible asbestos containing building material

(1) The sleeve for the buildings natural gas supply line appears to consist of asbestos/transite piping. This material may pose little or no threat to occupant health by virtue of its exterior location however, it should be protected from damage by encapsulation in order to reduce the risk for fiber release. Also, the inspector was unable to determine whether this pipe sleeve extends to the interior of the lower-level space and that possibility should be considered during a future remodeling.

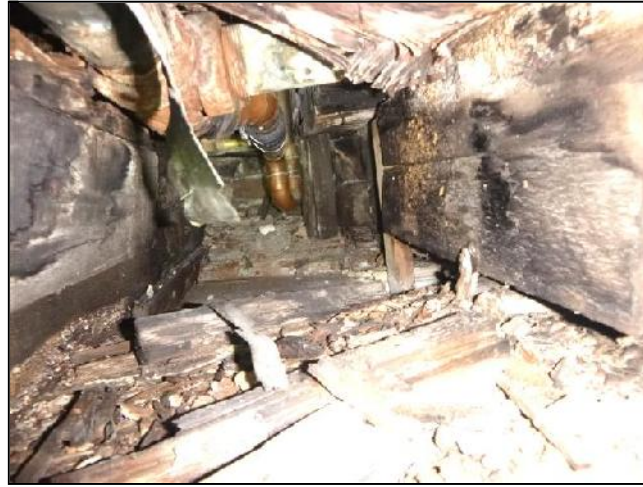
M. Item 3(Picture) deterioration within basement ceiling joist channels

(3) It is the inspector's opinion that; given the extent of the moisture damage and deterioration, aged and deteriorated plumbing/mechanical/electrical components, and badly deteriorated lath and plaster wall/ceiling finishes, that a full gut remodel of the property is indicated.

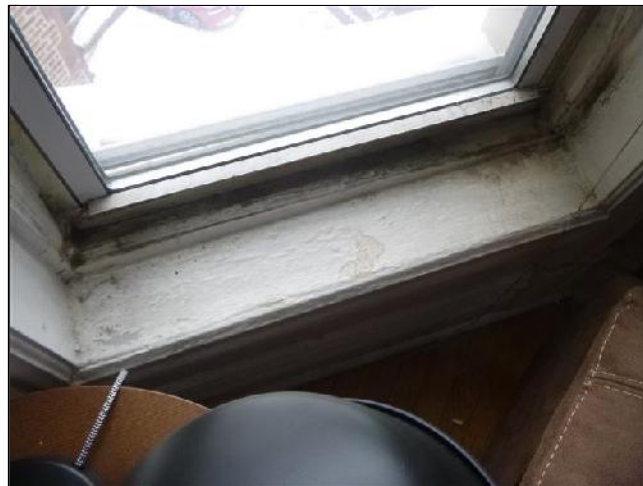
M. Item 4(Picture) Deteriorated Painted Surfaces

(4) Due to the age of the building and the existence of multiple layers of paint the possibility exists that lead based paint is present in one or more areas of the home. Further evaluation by a qualified lead paint or environmental specialist is recommended. Occupants should assume that any painted surface in an older home contains lead based paint and should be handled with all appropriate precautions. Further information is available from the US EPA or the US Department of Housing and Urban Development.

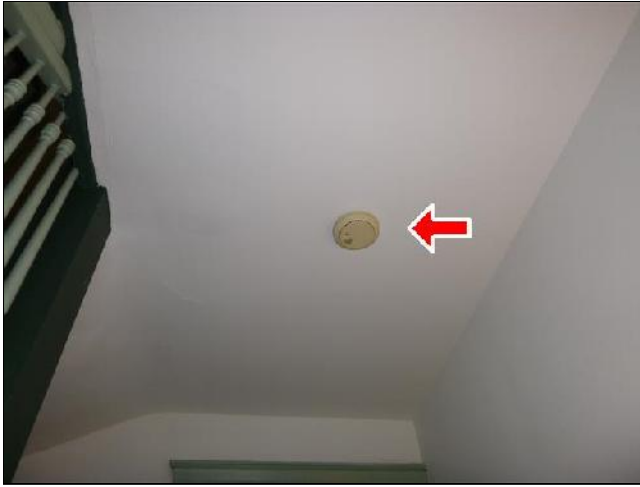
M. Item 5(Picture) Antiquated Detector

(5) Smoke and carbon monoxide detectors are relatively inexpensive considering the importance of their function. It is recommended that the smoke and carbon monoxide detectors be replaced with new units upon taking ownership. Each level of living space should have both types of detectors installed. The installation of hard-wired smoke detectors in each bedroom is recommended as is the inter-connecting of all smoke and CO detectors. New smoke detectors are available that have 10 year batteries and which combine ionization and photocell functions thereby detecting both slow smoldering fires as well as quickly developing fires.

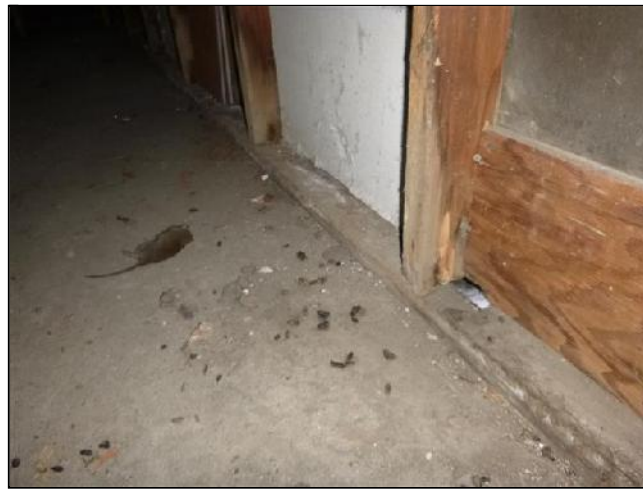
M. Item 7(Picture) Rat Hole, Rat Poop, Dead Mouse

(6) Evidence of a rodent problem was noted. Further evaluation by a qualified pest control contractor is recommended. Any openings in the exterior walls and door frames that are 1/4" or more in size could allow mice into the home. A comprehensive evaluation and sealing of the building exterior is recommended in addition to the elimination of any existing mice from inside the structure.

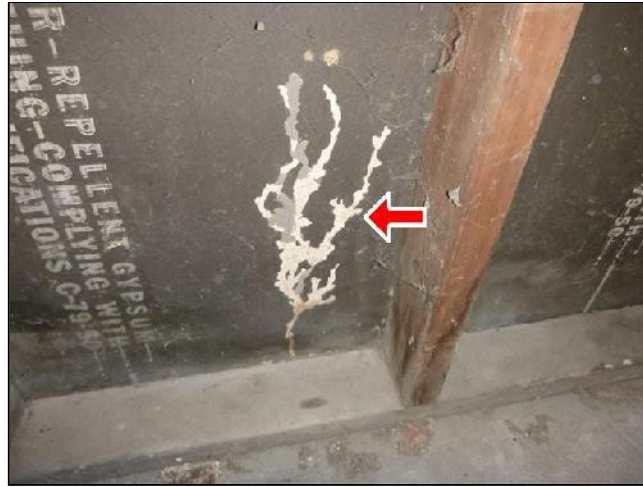
M. Item 8(Picture) Evidence of Termite Activity

(7) Evidence of wood-boring insect activity was noted in the garage. Further evaluation by a qualified pest control contactor is recommended as part of the buyer's due diligence process.
