Inspection Report

Strip Mall
Anytown IL

Domicile Consulting

I. Domicile Consulting Report

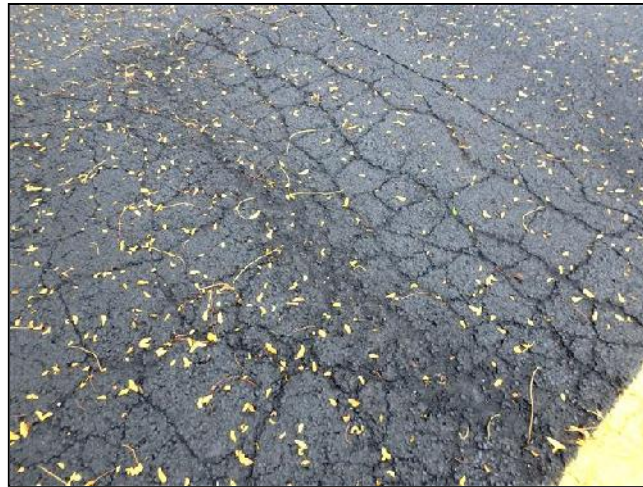
Asphalt Paving at Parking Area

(1) The parking lot and driveway areas have been recently patched and seal coated. However, the quality of the seal coating and the extent of the patching appear inadequate. Areas of seal coating were already failing from exposure to downspout roof runoff and extensive areas of cracked pavement have not been patched. As a result, increased frequency of maintenance and repairs for the asphalt paved parking/driveway areas can be expected.

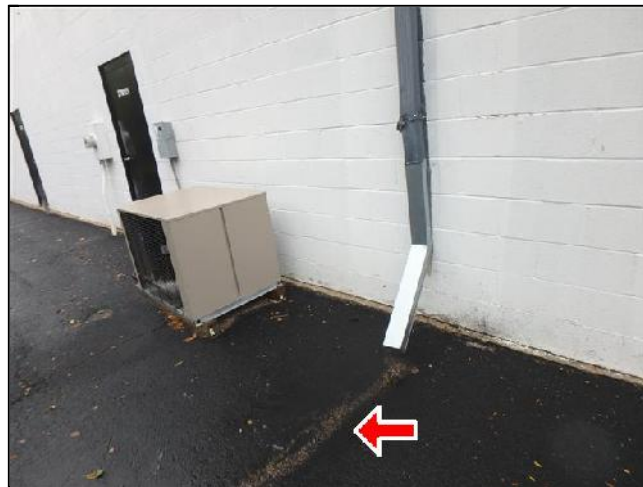
Premature Failure of Seal Coating

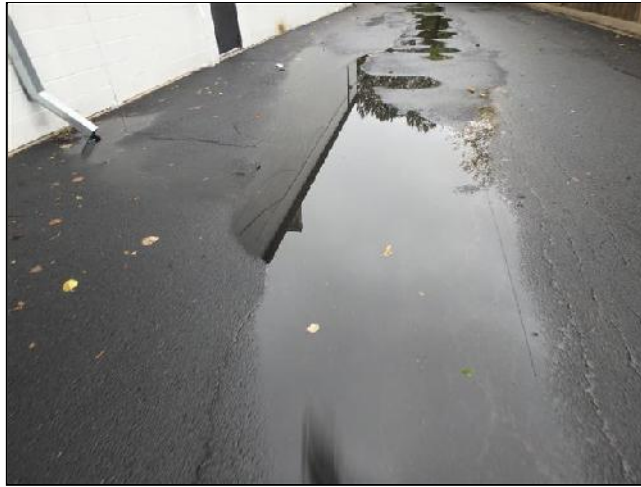
Extensive Ponding

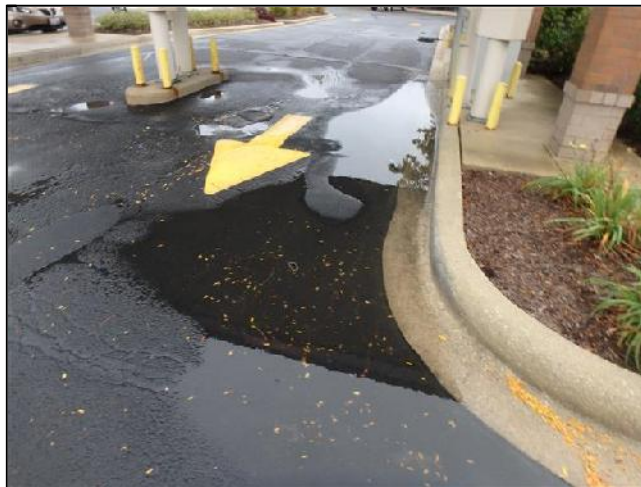
Pavement Ponding

(2) The areas of ponding at the parking/driveway areas may result in icing and an increased risk for vehicle accidents as well as slip and fall injuries. This condition should be kept in mind by the snow removal contractor until repair of the pavement drainage is performed. Maintenance personnel should give special attention to these areas during winter weather.

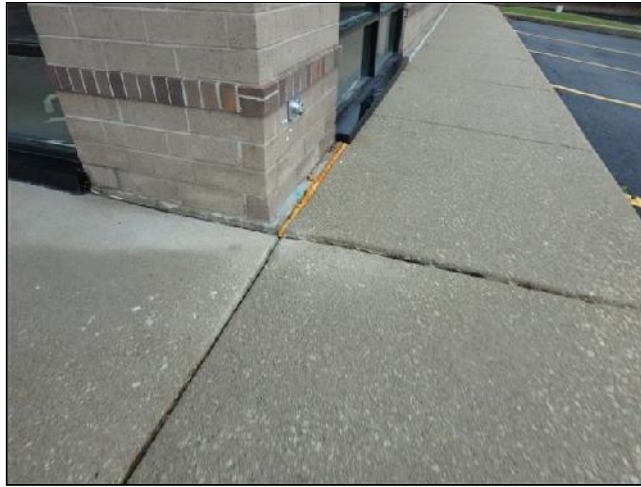
Northwest Corner of Structure

(3) Evidence of moisture penetration was noted at the northwest corner of the structure. The flat ledge at the bottom of the west facing storefront windows is, at a minimum, a significant contributing factor to this moisture penetration to the interior. The repairs that appear to have been performed are inadequate and ineffective. A qualified contractor should re-slope all exterior surfaces to provide for positive drainage and should reseal all exterior areas as needed. In addition, the moisture damaged interior components should be repaired or replaced.

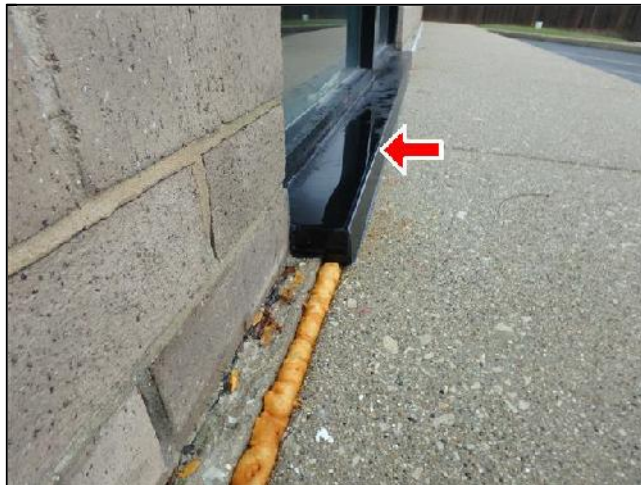
Failure to Slope

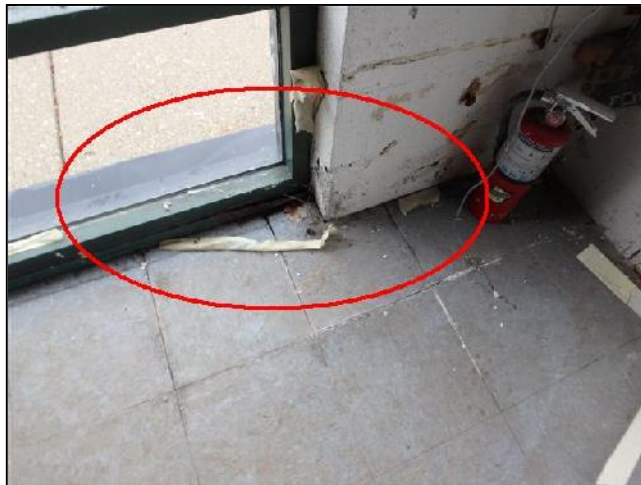
Moisture Damage

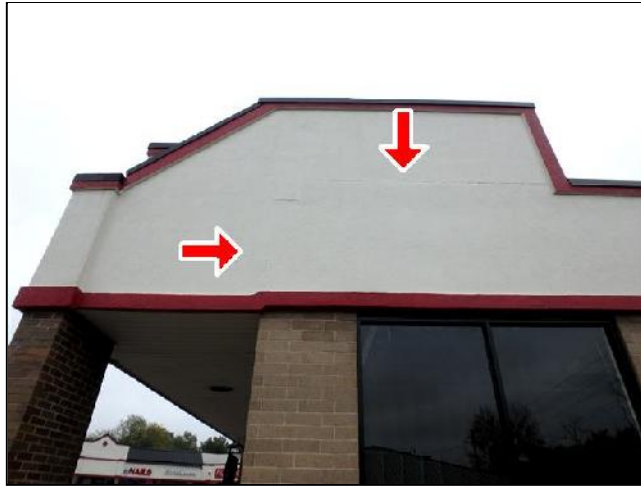
Cracking at EIFS Wall Cladding

(4) A number of significant defects were noted with regard to the EIFS wall cladding and to the gypsum wallboard substrate behind the cladding. Active leaking through multiple areas of the EIFS cladding was noted. Since the EIFS wall cladding is intimately connected to areas of the parapet sheet-metal capping and directly adjacent to areas of the roof covering it is recommended that a qualified general contractor with experience in both roofing and EIFS specialty wall cladding evaluate the leaking, damage, and general deterioration of this material in order to provide for a repair plan and budget. It is likely that repairs of the EIFS wall cladding system will need to be coordinated and integrated into repairs of the badly deteriorated roof membrane and the improperly installed sheet-metal details.

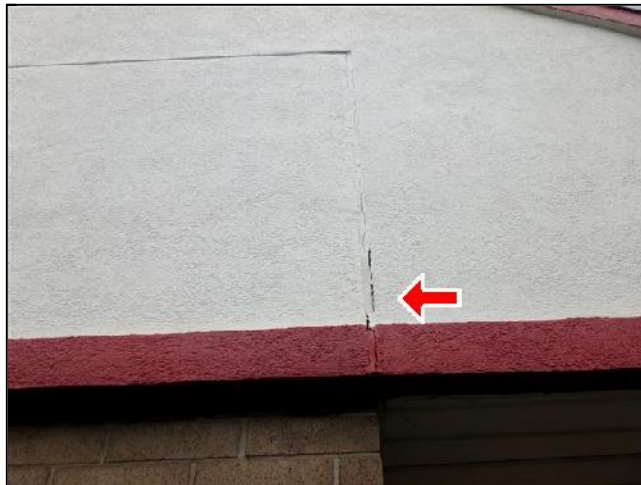
EIFS Cracking at Opposite Corner

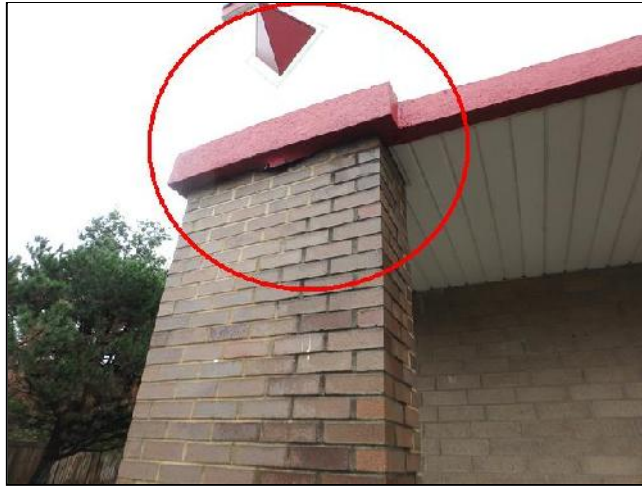
Active Leaking and Ongoing Damage

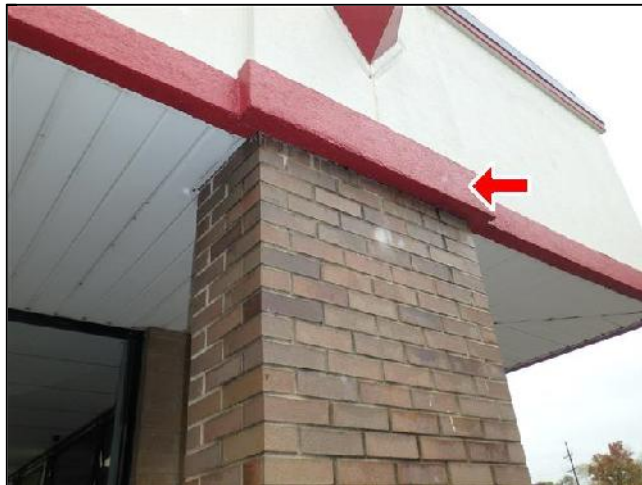
Active Leaking

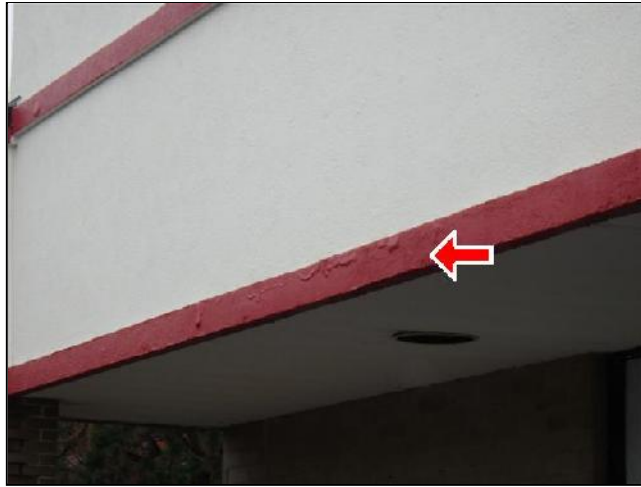
Ongoing and Significant Damage

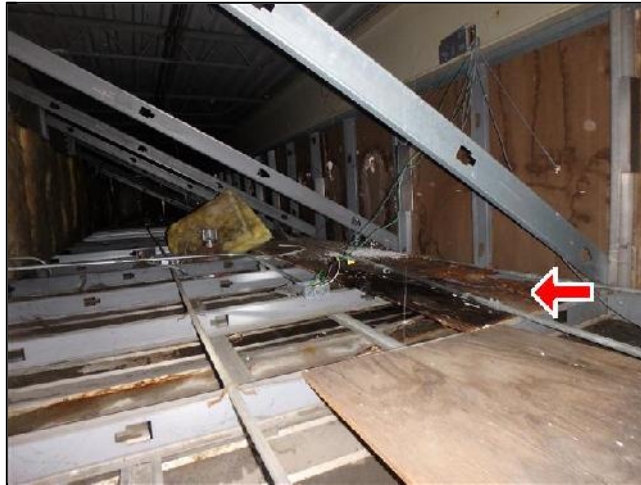
Active Moisture Penetration Inside Mansard Overhang

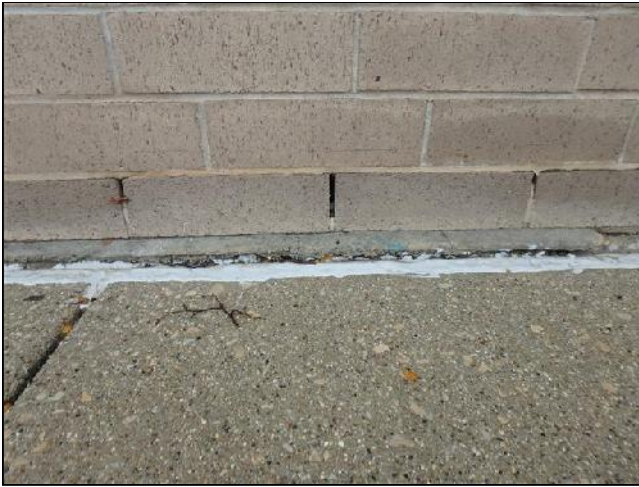
Open Masonry Wall Weep Holes

(5) It is recommended that provisions be made to prevent the entry of insects, rodents, or other pests into the home via the large masonry weep openings at the base of the exterior walls. Plastic grilles are available which are manufactured especially for this application. Repair by a qualified masonry contractor is recommended. Please visit the following website for additional information.

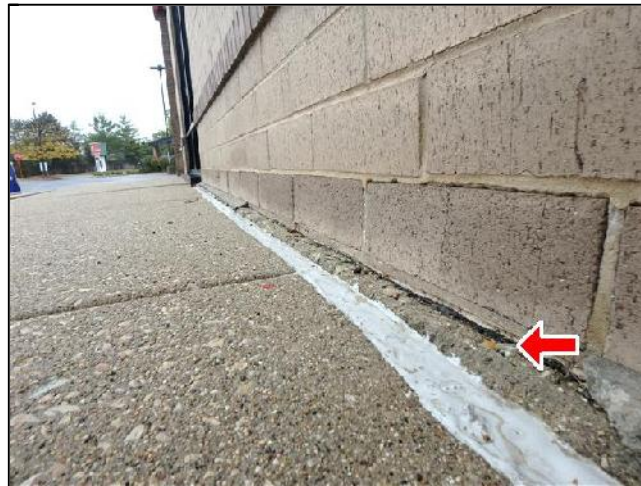
Base of Masonry Wall

(6) Some areas at the base of the exterior masonry wall are prone to allowing bulk moisture underneath the masonry wall flashing and into the finished space of the interior. The flat projecting ledge of concrete slab foundation can allow for moisture accumulation and moisture penetration underneath the flexible masonry wall flashing. This can result in damage to the interior floor and wall finishes. It is recommended that a qualified masonry restoration contractor provide for both the prevention of bulk moisture intrusion at this location as well as for the release of trapped moisture.

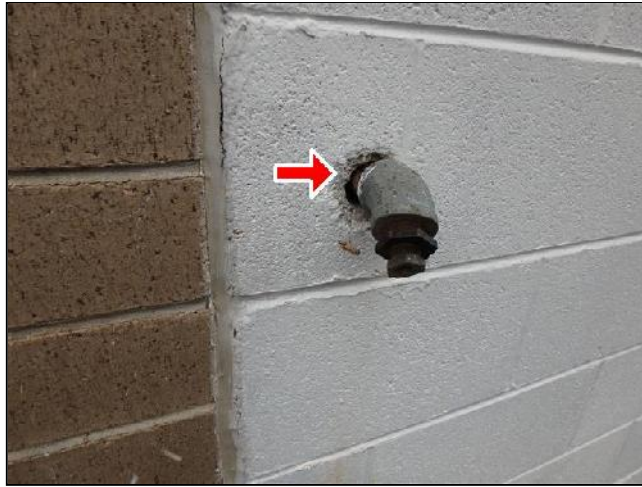
Caulking Recommended

(7) All exterior wall penetrations such as; piping, conduit, vent caps, etc. should be sealed against moisture intrusion, drafts, and energy losses through the use of the appropriate caulking methods and materials.

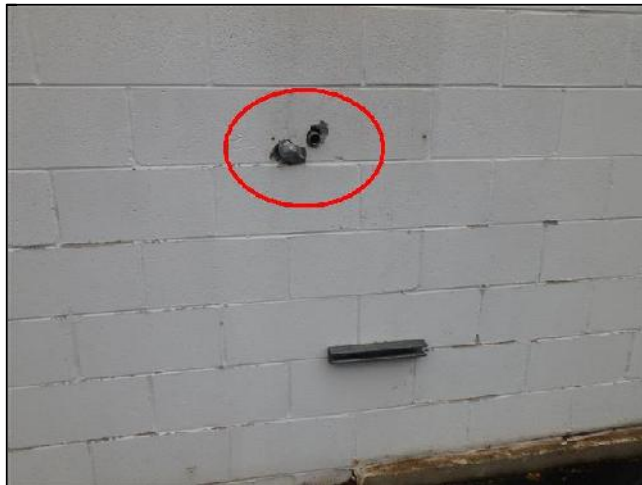
Wall Penetrations

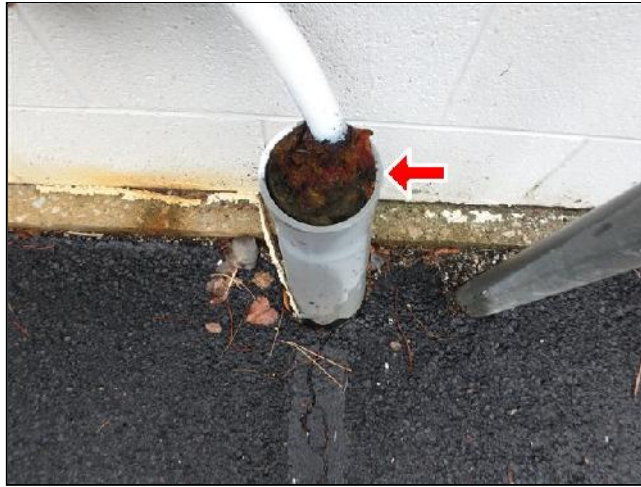
Improper and Inadequate Sealant

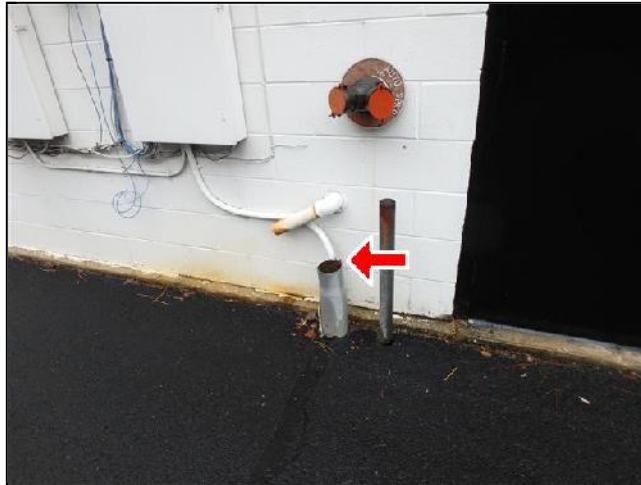
Exterior Rated Sealant Material Needed

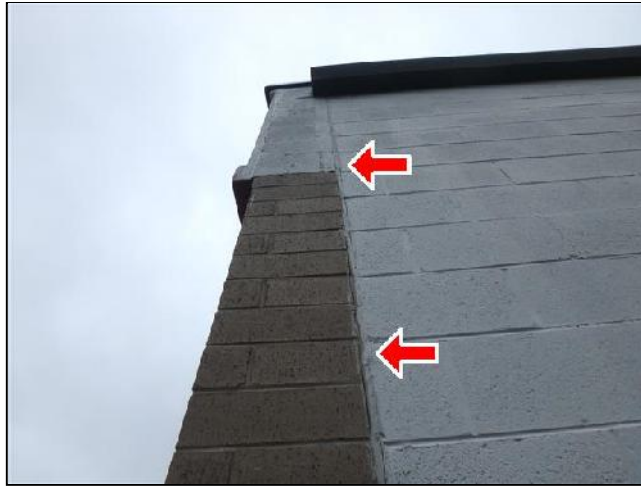
Caulking Failure

(8) The general condition of the exterior caulking is poor. It is recommended that most, if not all, of the exterior caulk joints be removed and replaced by a qualified specialty contractor in order to reduce the risk for drafts, energy losses, moisture penetration, pest entry, etc.

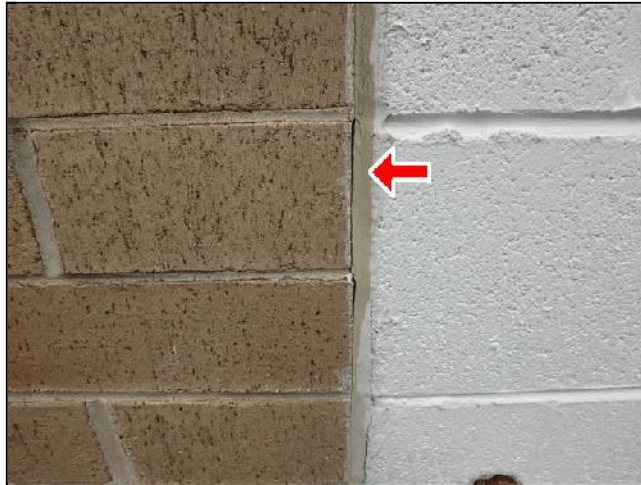
Closer Look

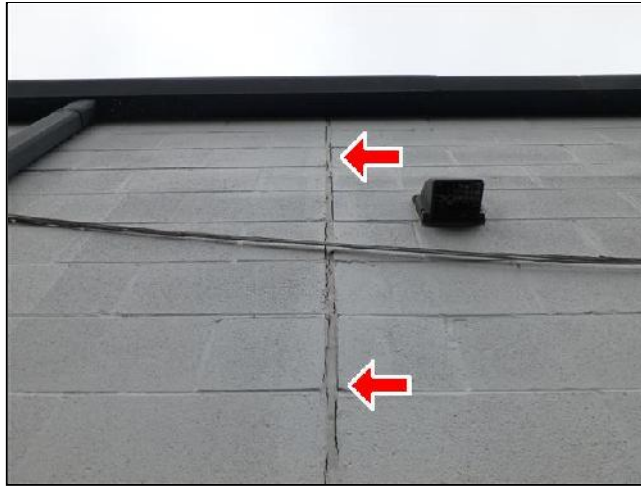
Re-caulking Recommended

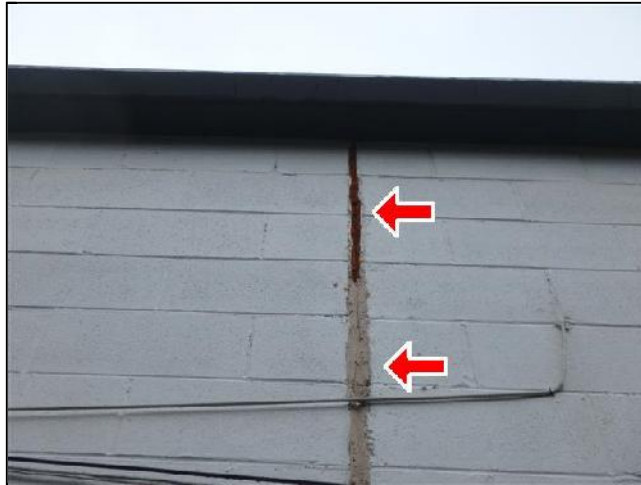
Repair Needed

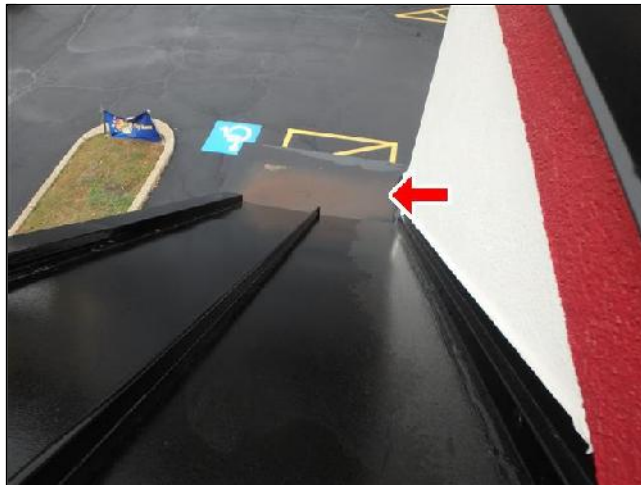
Standing Water

(9) The presence of flat horizontal projections from the exterior façade creates an increased risk for moisture accumulation, moisture saturation of the masonry, and moisture penetration through the exterior wall to the interior. The most basic concept in exterior wall moisture management is to avoid flat surfaces and to ensure

all exterior elements are properly sloped to prompt the drain moisture. Therefore, it is recommended that a qualified contractor evaluate and repair any areas on the exterior walls or roof which accumulate moisture.

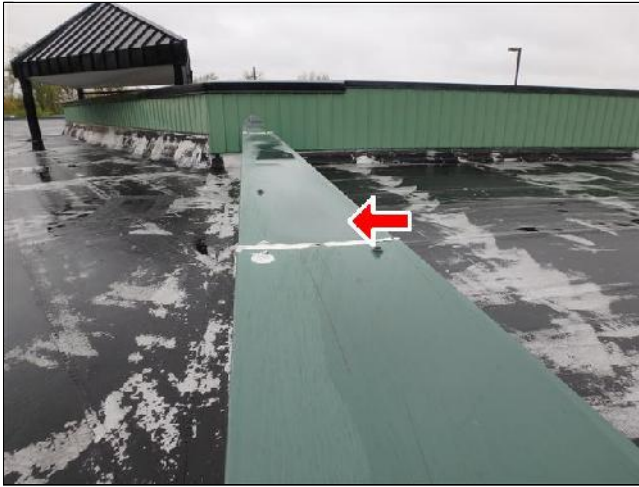
Standing Water

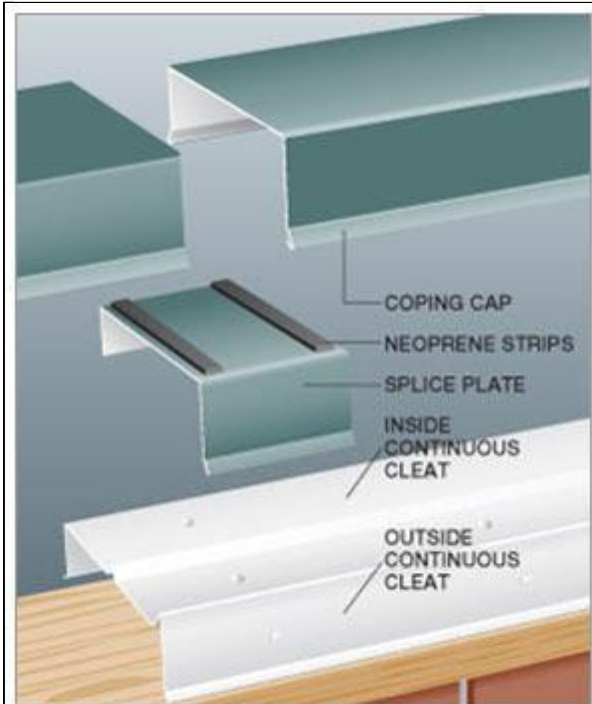
Aluminum Parapet Capping

(10) The aluminum parapet capping at the top of the masonry parapet walls does not conform to industry standards as published by the Sheet-Metal and Air Conditioning Contractors National Association (SMACNA). The aluminum wall cap does not promptly shed moisture; does not have sleeved and gasketed overlaps; and is composed of relatively thin aluminum which will expand and contract significantly from temperature changes. These defects greatly increase the risk for moisture penetration into and through the underlying masonry walls. It is recommended that plans be made for the near-term replacement of the existing parapet wall cap with one that reflects industry standards and best practices.

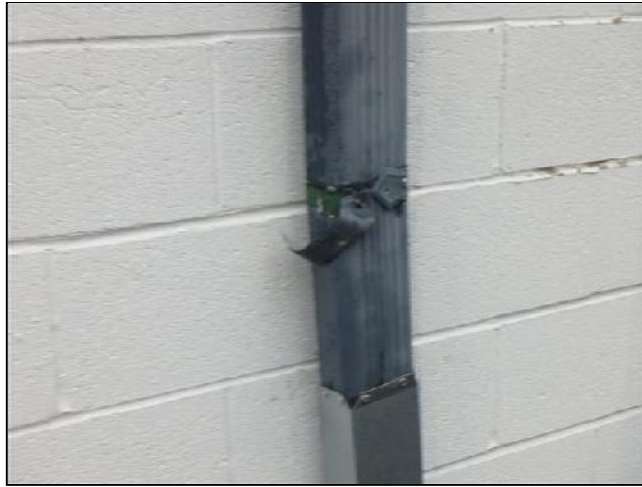
Loose and Damaged Downspout

(1) The overall condition of the gutters and downspouts is poor. The gutters are composed of relatively thin aluminum and are not properly secured to the structure. The downspouts are in varying states of disrepair, inadequately secured to the exterior wall, and improperly terminated. It is recommended that plans be made to replace the gutters and downspouts in conjunction with the recommended roof covering replacement.

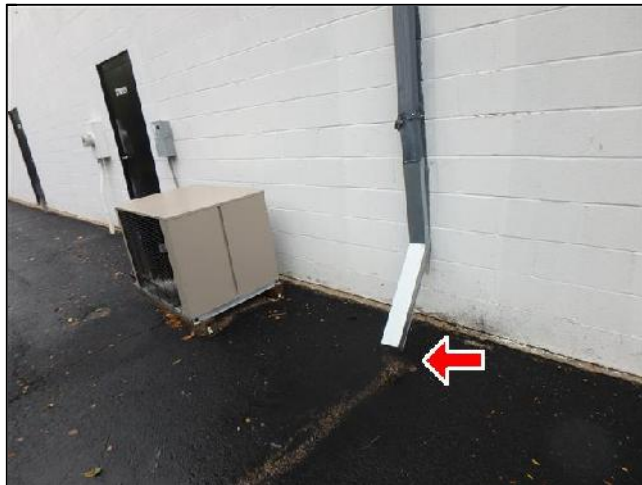
Risk for Icing and Slip/Fall Injuries

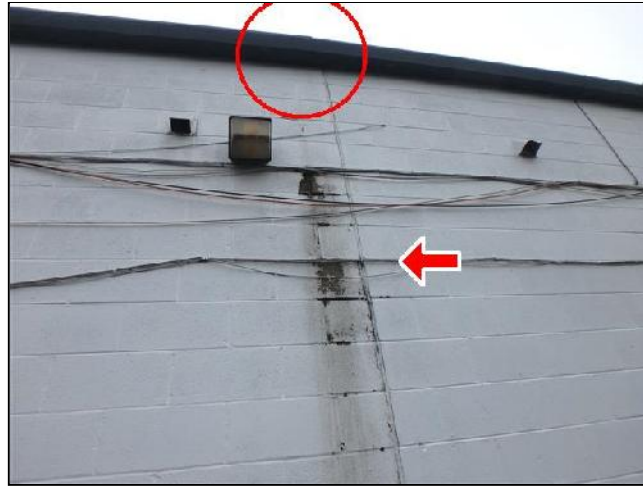
Leaking Gutter Causing Masonry Damage

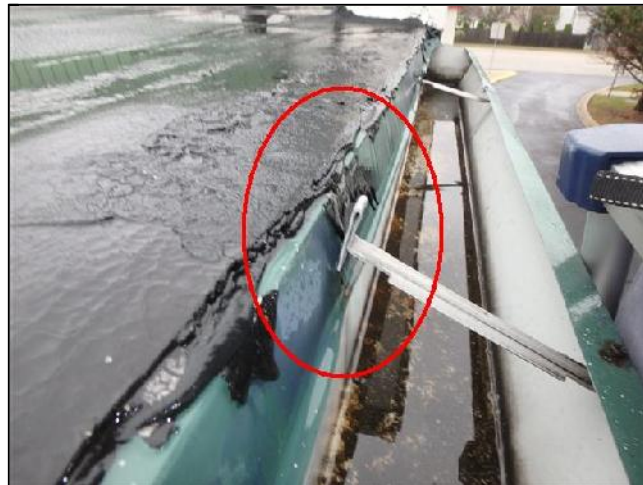
Loose Gutter Support System

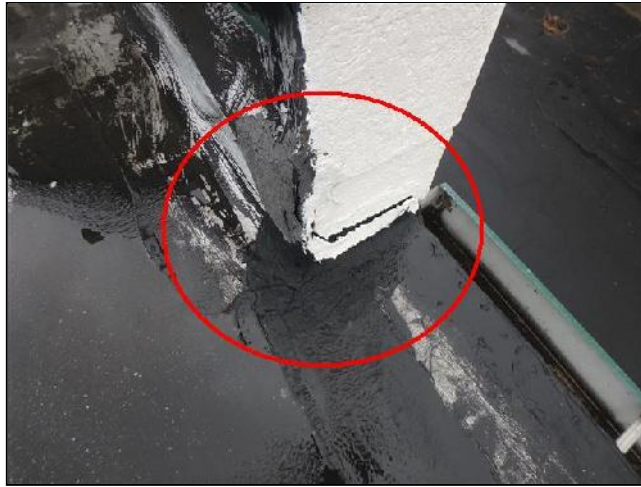
Parapet Wall Breaches

(2) The existing roof covering is suffering from advanced aging and deterioration. Extensive patching has been performed to the roof covering. It is the inspector's opinion that further patching will present a 'whack a mole' situation wherein one leak pops up as another leak is fixed. It is strongly recommended that plans be made for the near-term removal and replacement of the existing roof covering. It may be both beneficial and code required to increase the thermal insulation on top of the roof deck prior to the application of a new roof covering. Installation of a new roof covering would also entail replacement of the existing roof penetration flashings and careful integration of the new roof covering into the parapet wall covering and parapet capping.

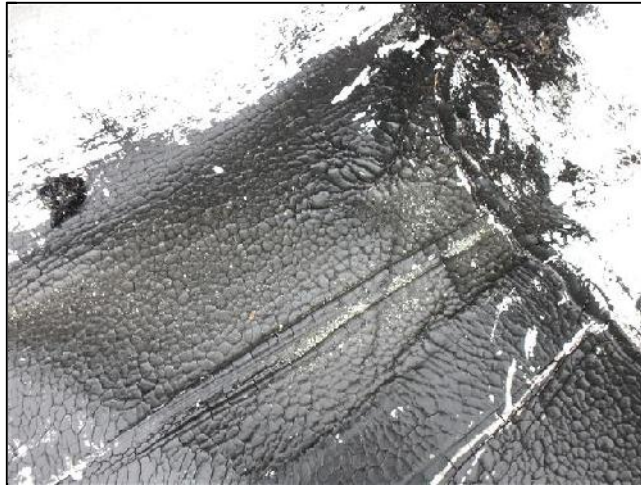
Badly Deteriorated Roof Covering

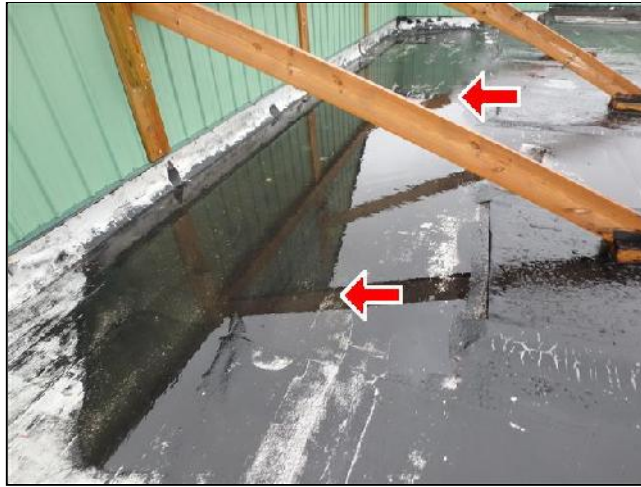
Extensive Ponding

(3) Ponded areas were noted on the low slope roof. Ponding increases the rate of roof wear/deterioration and increases the risk for leaking. Plans should be made to re-pitch the roof using tapered roof insulation and a new roof covering.

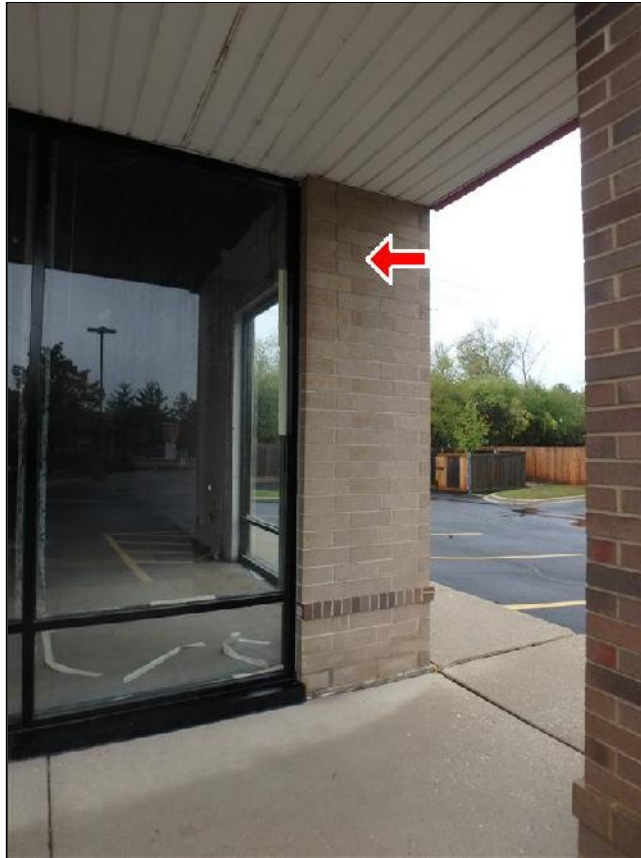
Masonry Wall Cracking

(1) Vertical cracking through multiple individual brick units was noted at the northwest exterior wall corner. This appears to be the result of unanticipated structural movement. This may indicate concealed cracking of the foundation at the base of this wall corner or excessive loading imposed from the roof above. A qualified structural engineer should determine the cause of the cracking and suggest a course of corrective action.

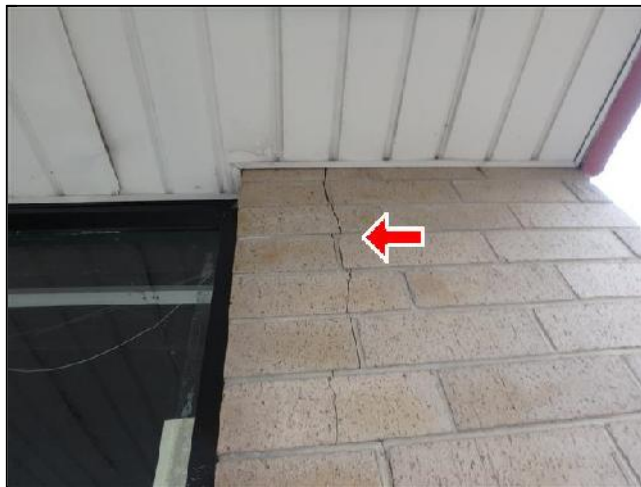
Cracking Through Multiple Brick Units

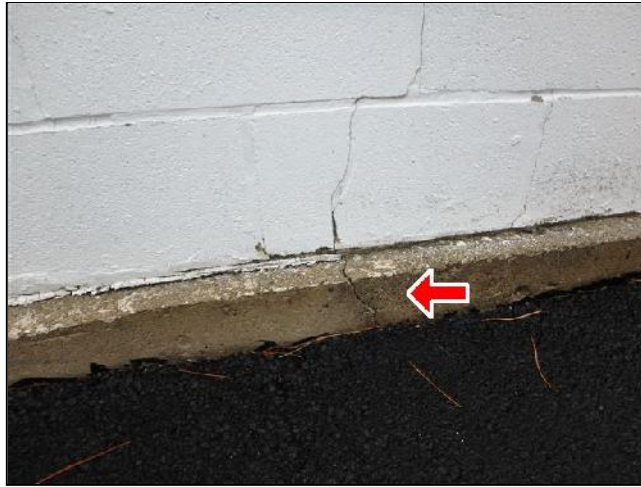
Typical Shrinkage/Settling Crack

(2) Very little of the slab on grade foundation walls were visible at the time of the inspection due to the finished lower level walls. However, multiple apparently minor cracks were noted on the exterior perimeter slab on grade edge. The should be monitored for signs of ongoing movement in which case repair by a qualified foundation repair contractor would be indicated.

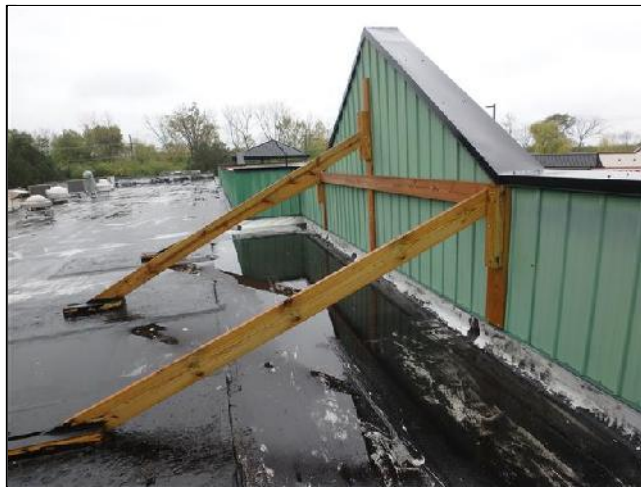
False Parapet Support System

(3) The false gable parapet wall at the Northeast corner of the structure has been recently provided with a lateral support system. It is strongly recommended that the seller provide all documentation regarding the

design and installation of this structural support system including any warranties provided by the contractor responsible for its installation. The size and type of the fasteners used are indicative of an ad hoc or makeshift configuration and proper documentation showing any plans, permits, drawings, etc. should therefore be provided to the buyer

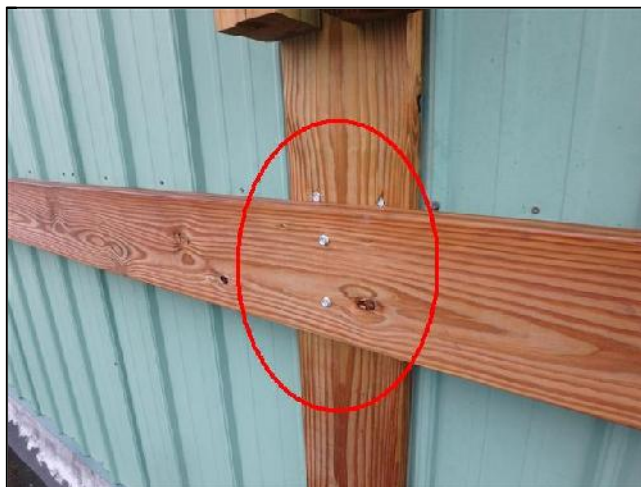
Questionable Holding Power

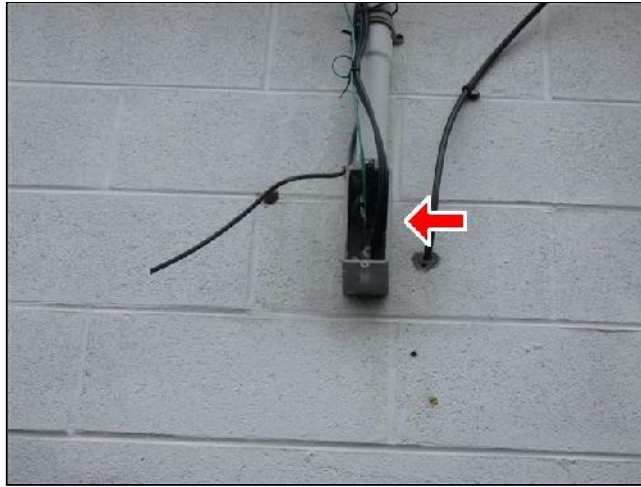
Missing Cover

(2) The missing covers at the electrical conduit fittings along the back of the exterior wall should be furnished and installed both for electrical safety and to prevent drafts/energy losses.

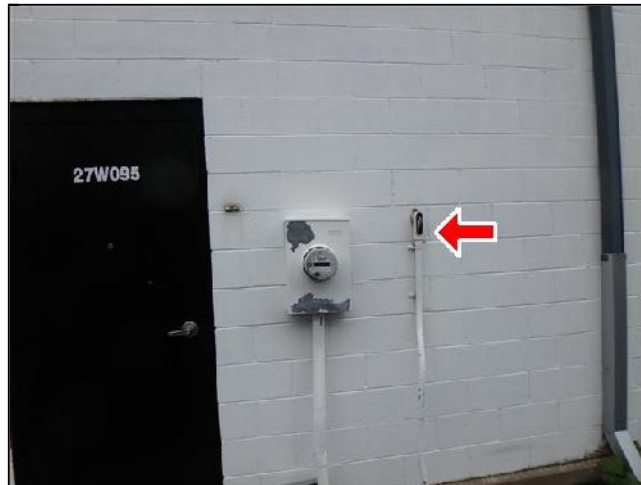
Missing Cover

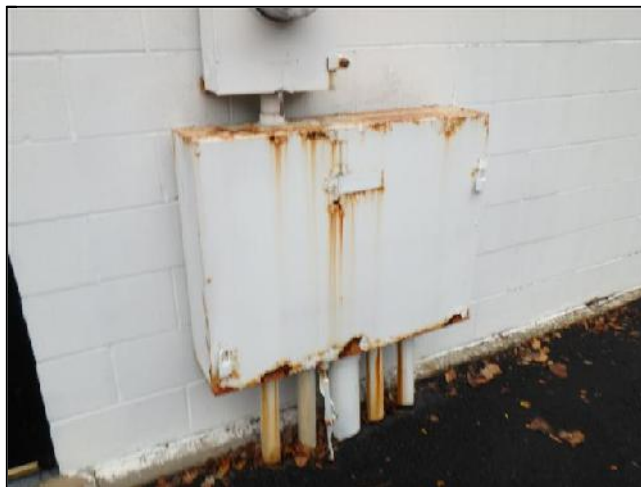
Advanced Corrosion

(3) The large electrical panel at the rear exterior wall is exhibiting evidence of advanced corrosion. It is strongly recommended that a qualified electrical contractor further evaluate this component in order to determine if repair or replacement is indicated.

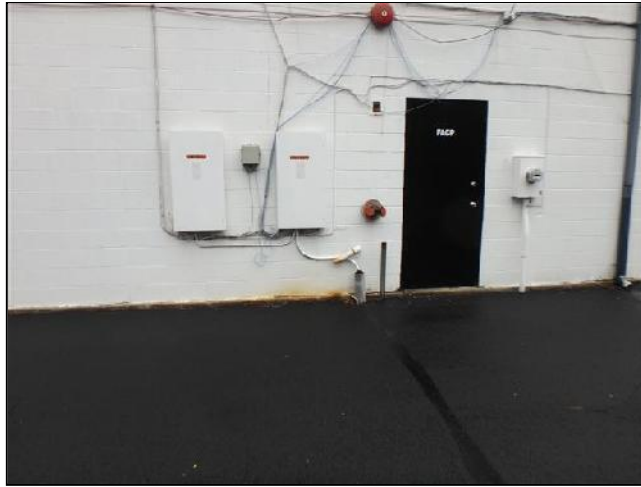
Sloppy Low Voltage Wiring

(4) The evaluation of the low-voltage equipment in the home: alarm, communication, audiovisual, etc., is beyond the scope of the home inspection and should be performed by a qualified low-voltage electrical contractor. Nevertheless, as a courtesy to the buyer, it is recommended that the low voltage wiring both inside and outside the individual business occupancies be evaluated, organized, secured, and concealed as needed.

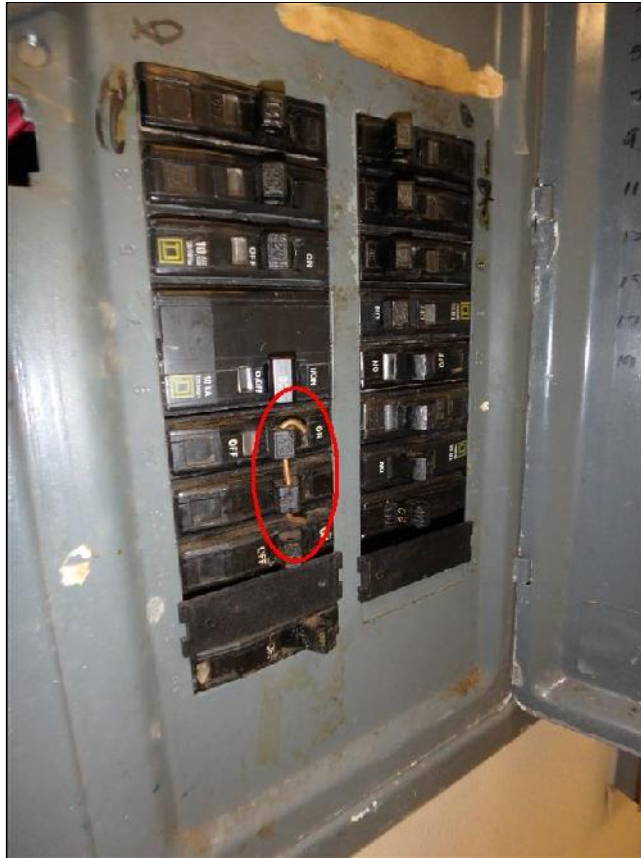
Makeshift Breaker Tie

(5) A significant number of dangerous electrical conditions were noted at the electrical panels within the former Winfield Waffle occupancy. It is strongly recommended that a qualified electrical contractor evaluate and repair the dangerous electrical conditions such as the improper double pole breaker handle tie, the double tapped and over-fused conductors inside the electrical panel, and the improperly secured grounding conductor at the neutral busbar. Also, the lighting inside this commercial occupancy is currently controlled, in large part, by the individual breakers at the electrical panel. A qualified electrician should install wall switches in order to provide for safe and convenient lighting.

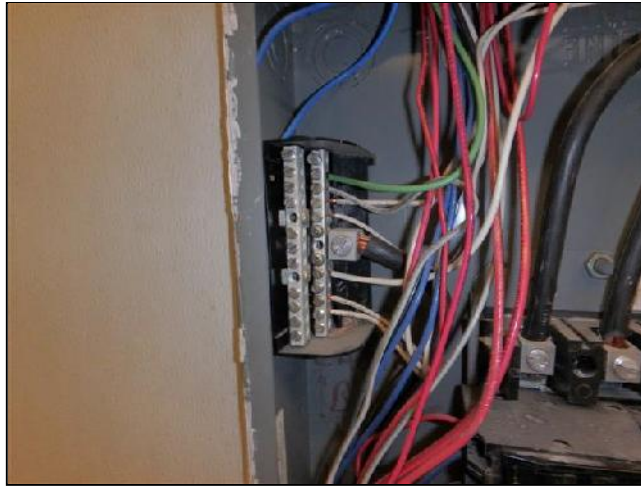
Dangerous Electrical Condition

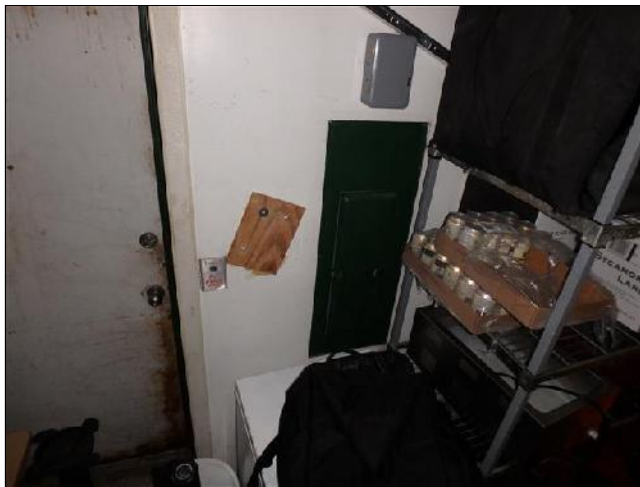
Blocked Electrical Panel

(6) The electrical service panel at the Jake's Pizza occupancy has not been provided with the required working clearances. This creates an increased risk for injury to individuals performing repairs or maintenance to the electrical panel and precluded the inspector from examining the interior components of the panel. It is strongly recommended that proper access be provided and that the electrical panel be further evaluated prior to closing.

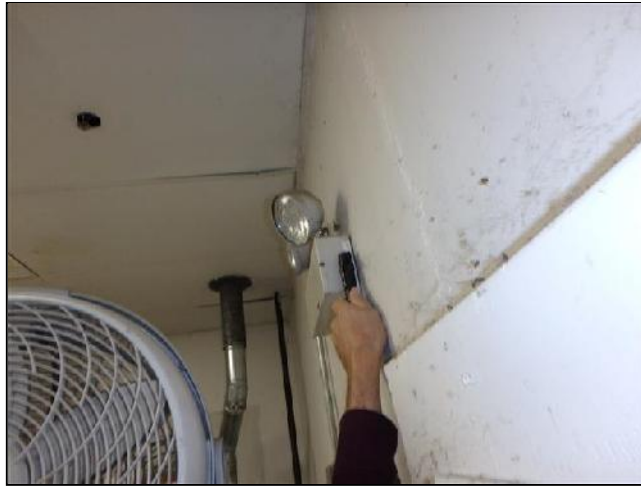
Defective Emergency Lighting

(7) A spot check of the battery operated emergency lighting system revealed one or more non-functioning units. It is strongly recommended that these critical life safety devices be regularly evaluated and repaired as needed by a qualified electrical contractor.

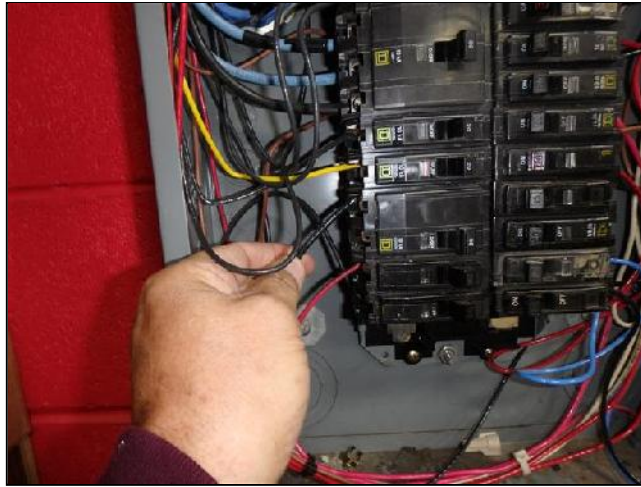
Undersized Conductors

(9) Significant electrical safety defects were also noted in the liquor store occupancy. These include but are not necessarily limited to over-fused conductors and a damaged nonconductive bushing at the large diameter feeder conduit. These defects constitute an increased risk for shock, fire, and electrical service interruption. A qualified electrical contractor should evaluate and repair the wiring as needed prior to closing.

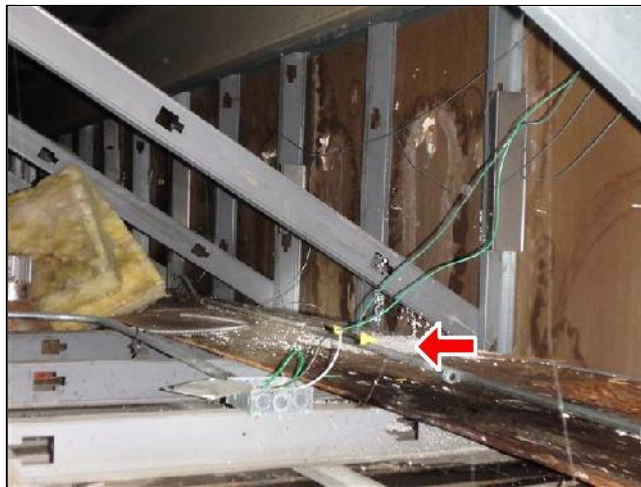
Exposed and Dangerous Wiring

(10) Areas of exposed and dangerous electrical wiring were noted inside the mansard overhang above the liquor store entryway. It is **strongly recommended** that a qualified electrical contractor evaluate and repair the wiring inside this entire area prior to closing.

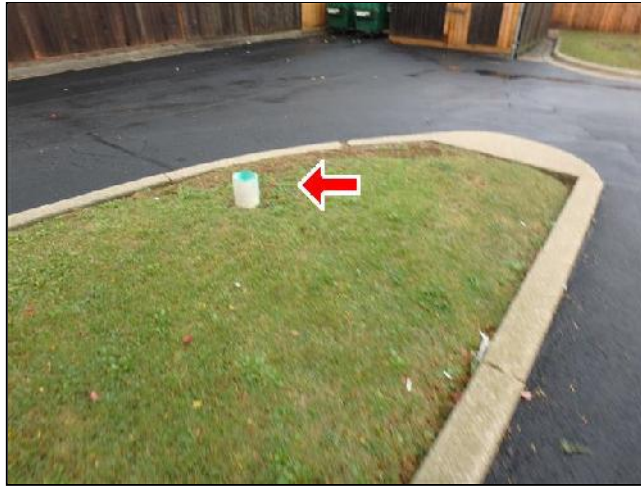
Plastic Drain Component

(1) The inspector was unable to determine the function of the projecting vertical plastic piping at the grassy island at the southwest corner of the building. The current building management personnel should describe the function of this component to the buyer.

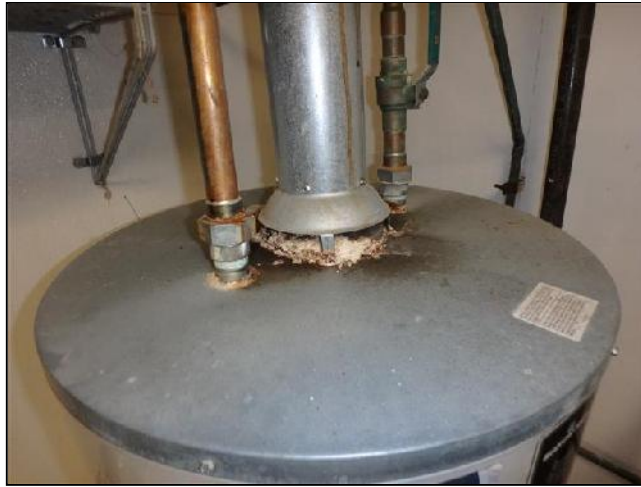
Dangerous Condition

(3) The water heater at the Jake's pizza occupancy is in an extremely dangerous condition and could expose occupants to carbon monoxide. The water heater should be repaired or replaced as soon as practical.

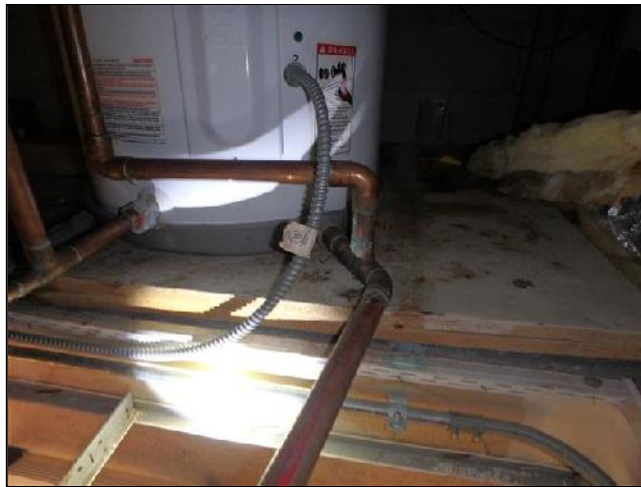
Improper Water Heater Details

(4) The small electric water heater above the ceiling of the bank occupancy has an undersized drip pan which may not function adequately in the events of a water heater leak and also has an improperly terminated TPR extension pipe which creates an increased risk for water heater failure. It is recommended that the water heater be evaluated and repaired or replaced as needed by a qualified plumbing contractor.

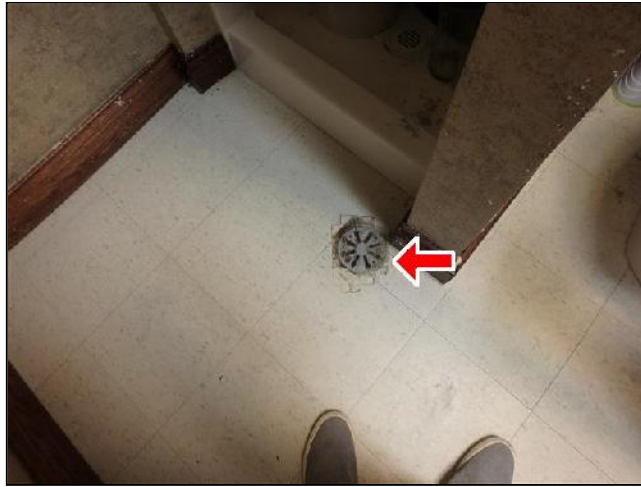
Taped Over Floor Drain

(5) **FYI:** The floor drain/s should be regularly monitored and re-filled with water as needed to prevent the migration of sewer gas into the home. The application of several drops of mineral oil can retard the evaporation of the water 'plug' in the floor drain trap.

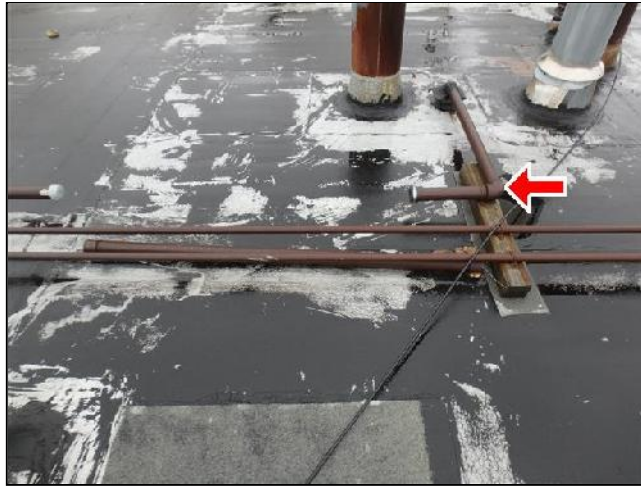
Abandoned Piping Should Be Removed

(1) Any abandoned or unnecessary mechanical components should be removed from the premises or properly terminated in order to reduce the risk for accidental energizing, leaking, or other failure.

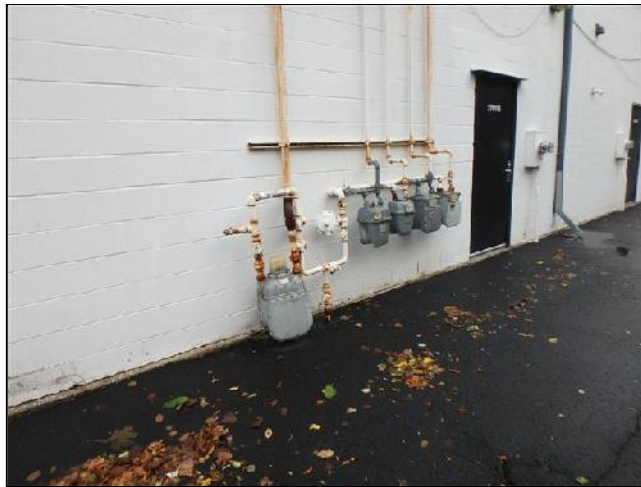
Protection Recommended

(2) The installation of protective bollards is recommended in front of the gas meter assembly in order to reduce the risk for damage, leaking, etc.

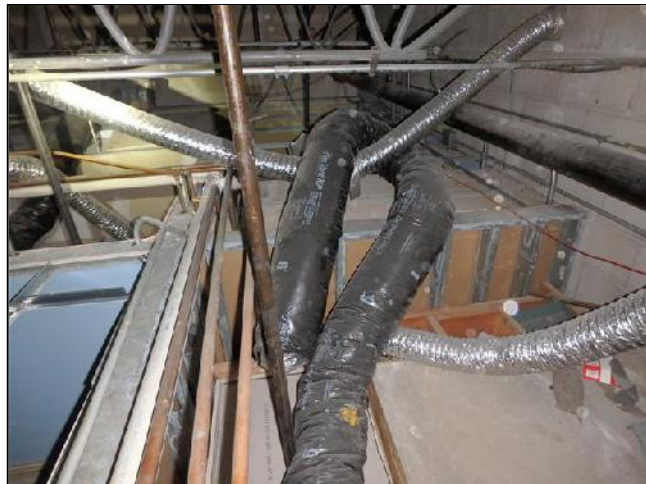
Seriously Defective Flex Duct Installation

(3) Flexible ductwork should be carefully stretched and properly configured at connections to the rigid metal duct in order to allow for proper airflow and equipment performance. It is recommended that the flexible ducts in the attic be repaired by a qualified HVAC contractor so that they conform to the applicable standards.

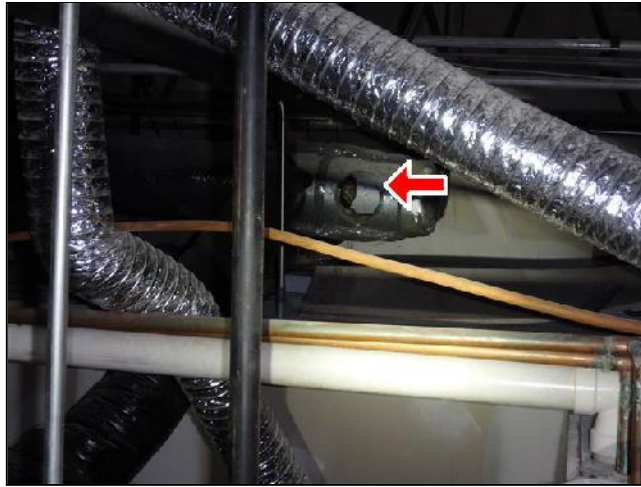
Open Duct

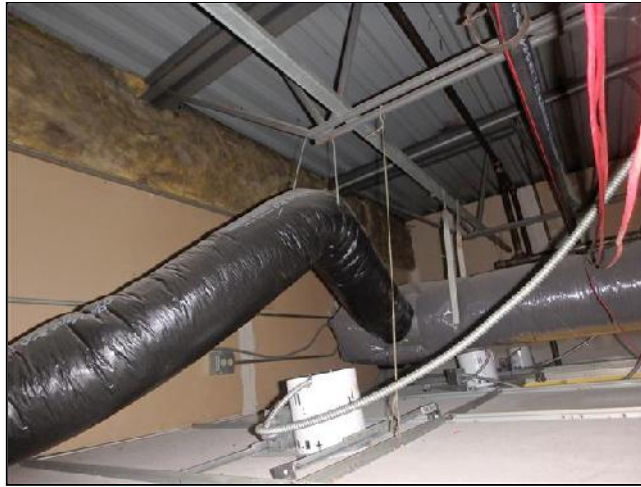
Sagging Duct

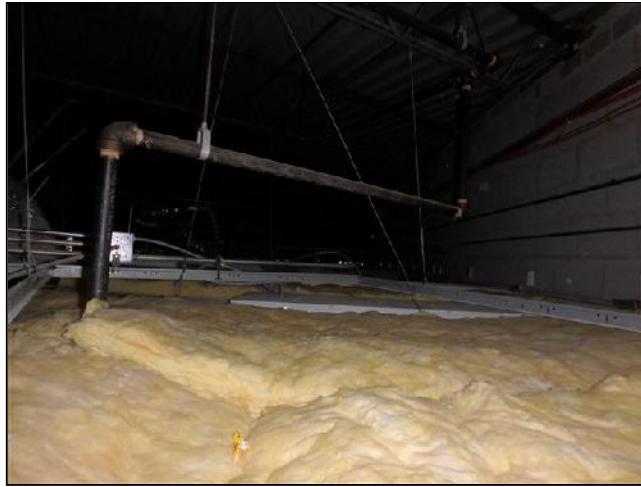
Insulation Above Suspended Ceiling

(1) FYI: The inspector was unable to verify the presence or absence of thermal insulation in the walls or ceilings with the exception of the center bank occupancy which has some fiberglass insulation placed on top of the suspended ceiling panels. It is assumed, but cannot be verified, that thermal insulation board is present on top of the metal pan roof deck.
