Inspection Report

Strip Mall
Anytown IL

Domicile Consulting

I. Domicile Consulting Report

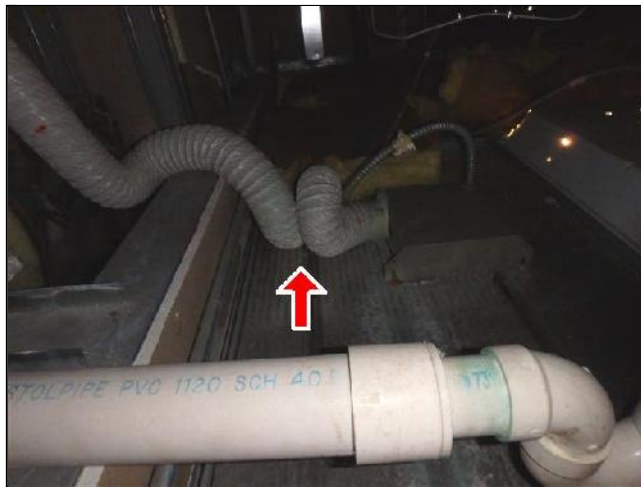
Woefully Inadequate Airflow

(2) Prohibited vent tubing material and improperly configured vent tubing were noted in multiple locations. These defects create the risk for inadequate ventilation of moisture and odors. It is strongly recommended that the bathroom exhaust piping in each of the business occupancies be evaluated and repaired or replaced as needed by a qualified mechanical contractor.

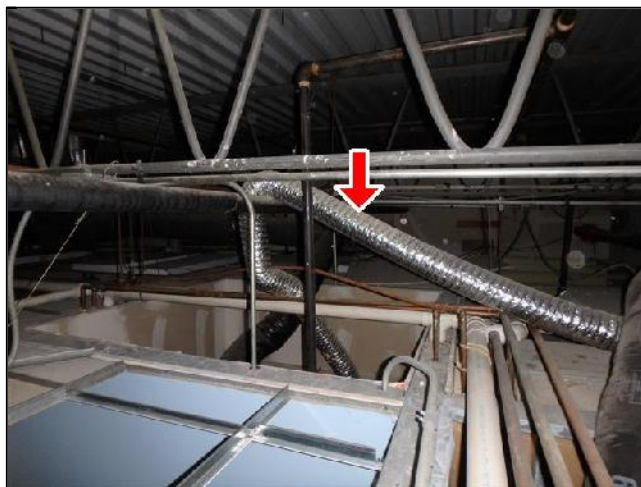
Poor Airflow Characteristics and Prohibited Material

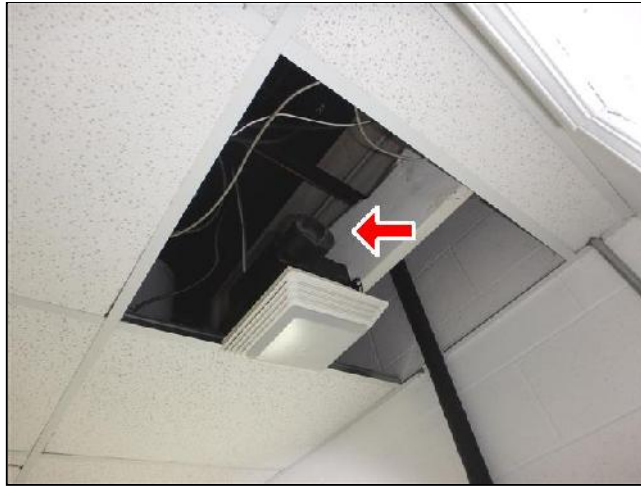
Missing Vent Tubing

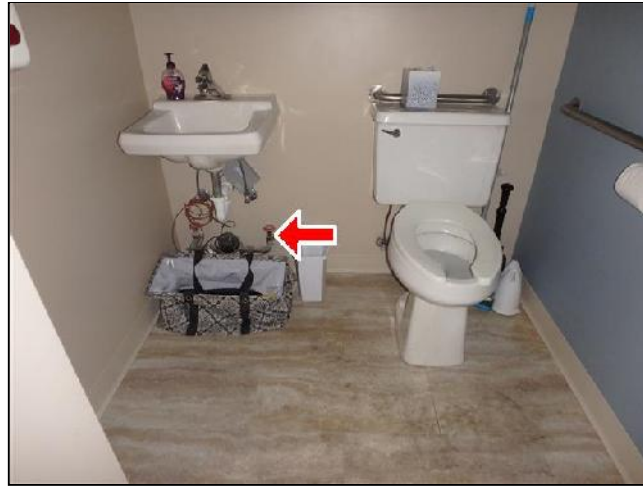
Missing Insulation and Inadequate Access

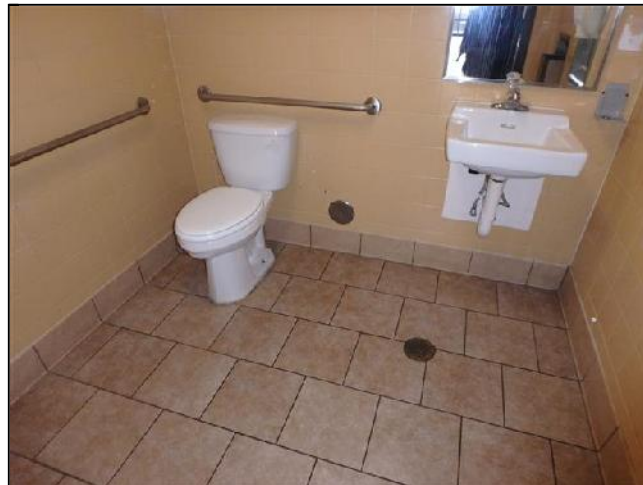
Drain Pipe Insulation and Adequate Clearances

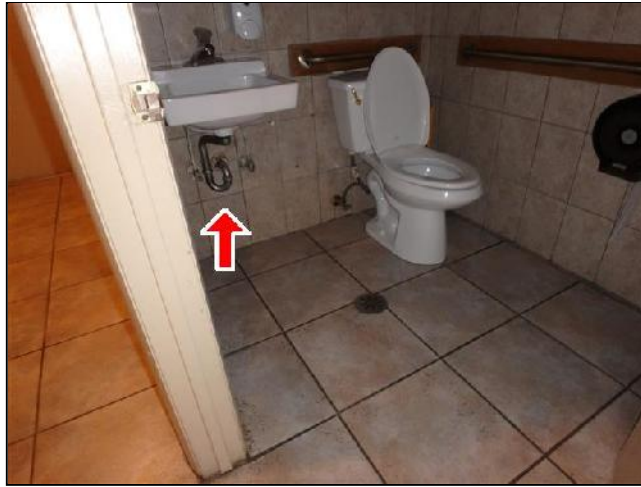
Missing Pipe Insulation

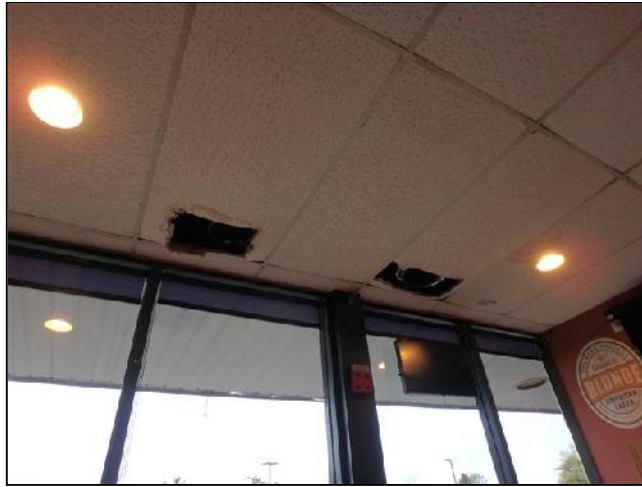
Missing Registers

(2) The interior wall, floor, and ceiling finishes are aged and deteriorated. The interior trim and millwork is aged, defective, and damaged in multiple locations. Some of the kitchen and bathroom cabinetry, fixtures, and appliances are also aged, deteriorated, and neglected. Extensive remodeling of the home's interior is required in order to elevate it modern standards of safety, convenience, and appearance. Further evaluation by a qualified remodeling contractor is recommended in order to assist the buyer's in developing a plan and budget for these repairs/upgrades.

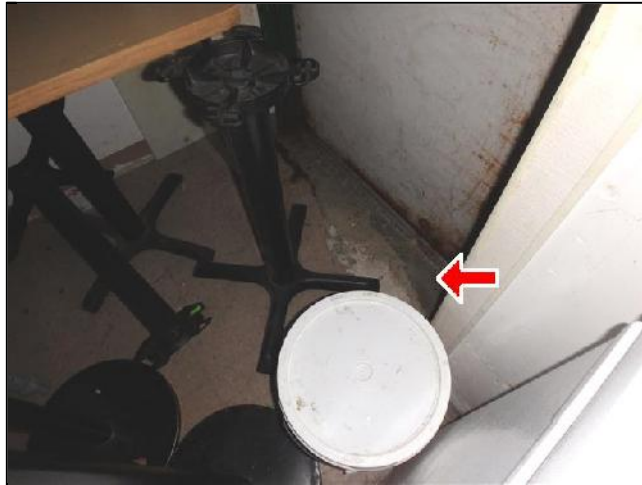
Deteriorated Flooring

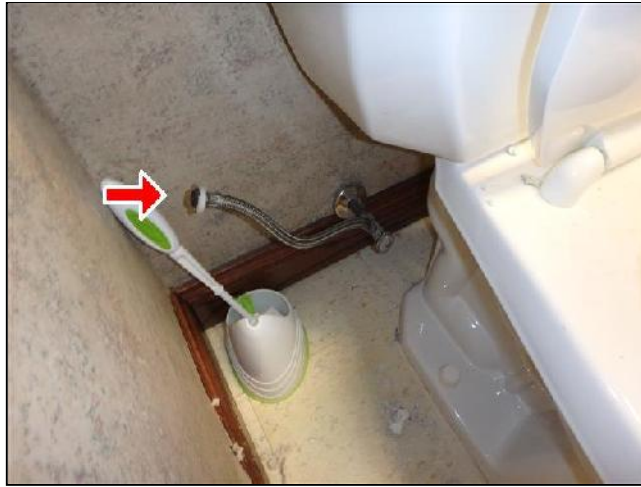
Disconnected Toilet Water Supply

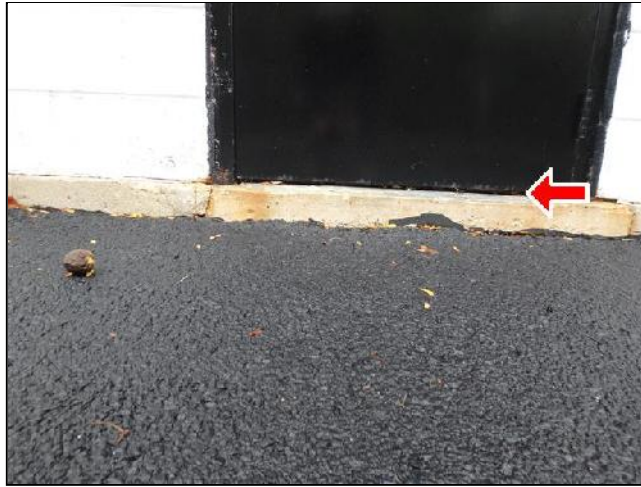
Significant Gap

(1) The installation of high quality rubber bulb weatherstripping is recommended at the top and sides of the entry door/s. The installation of a weatherstripped threshold is recommended at the bottom of the unit entry door. These modifications will conserve energy, reduce cold drafts, and reduce noise levels inside the living space.

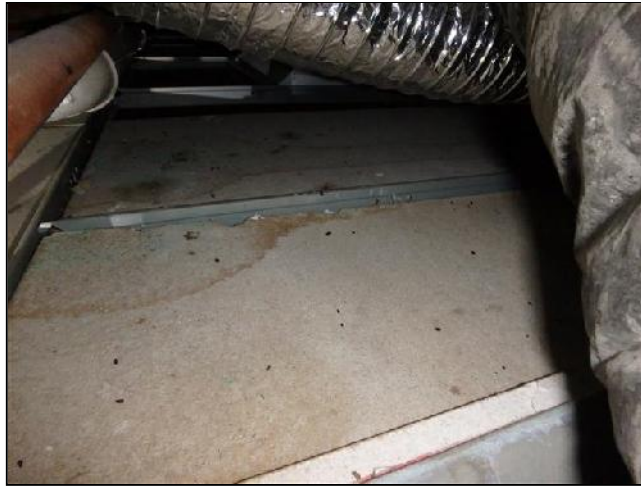
Mouse Poop

(2) Evidence of a rodent problem was noted. Further evaluation by a qualified pest control contractor is recommended. Any openings in the exterior walls and door frames that are 1/4" or more in size could allow mice into the home. A comprehensive evaluation and sealing of the building exterior is recommended in addition to the elimination of any existing mice from inside the structure.

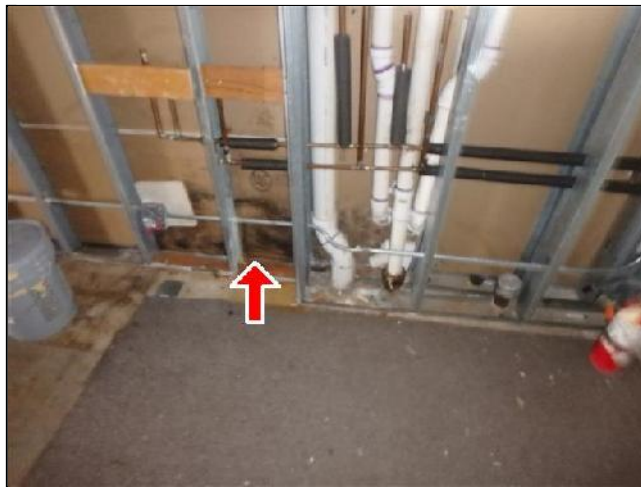
Moldy Drywall

(3) Mold-like substances were noted on interior surface/s. Mold growth results from moisture on organic strata and is first and foremost a moisture problem. The source of the moisture that is the proximal cause of the mold-growth should be found and eliminated before final remediation is performed. Initial remediative steps may be advisable in order to reduce the release of mold spores, fungal fragments, and mycotoxins during the moisture investigation and repair process. Small areas of mold (10 square feet or less) can be remediated by the homeowner successfully. An EPA approved mildewcide with residual mold inhibiting properties (Concrobium Brand) can be found at major home improvement stores. Relatively non-porous surfaces such as tile, laminate, concrete, etc. should be surface cleaned with this type of product and kept dry. Semi-porous surfaces such as wood framing and sheathing can also be cleaned in this manner if fungal growth hasn't degraded the material significantly. Porous surfaces such as paper-faced gypsum drywall, cellulose insulation, etc. should be removed and replaced.
