Inspection Report

77 E. State St.
1A
Chicago IL

Domicile Consulting

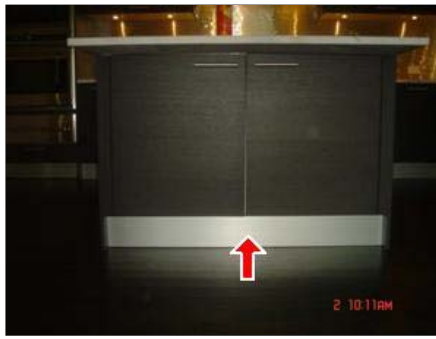
H. Picture 9

(Picture 9) The inside base cabinet trim at the Northwest corner of the kitchen has a rough and unsightly finish. It should be repaired by a qualified cabinet specialty contractor.
