Property, Energy & Moisture Intrusion Inspect

Inspection Report

Domicile Consulting

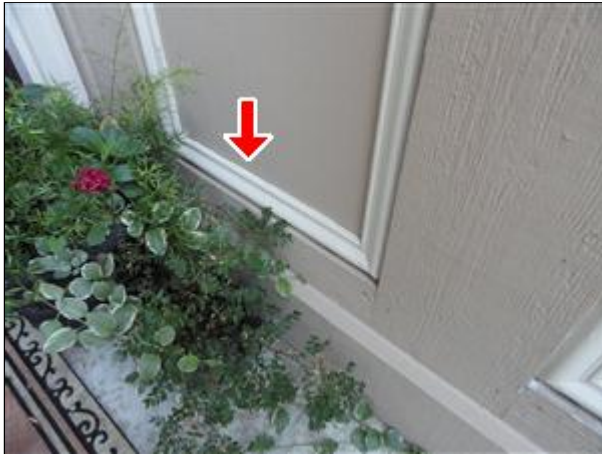
(1) Exterior sealant has an approximate lifespan of 3-7 years in our climate. The use of ASTM C 920 compliant exterior rated sealants of good quality and joint preparation is recommended for increased service life, performance, and aesthetics. Several sources regarding caulking preparation can be found online as well as the attached PDF regarding proper joint preparation and installation.

A. Picture 1 periodically inspect inset trim for water collection

All caulk joints should be inspected annually and repaired as needed.

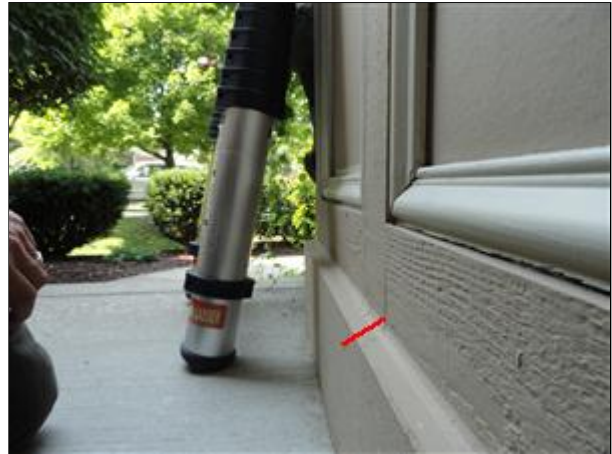
A. Picture 2 avoid flat surfaces when possible

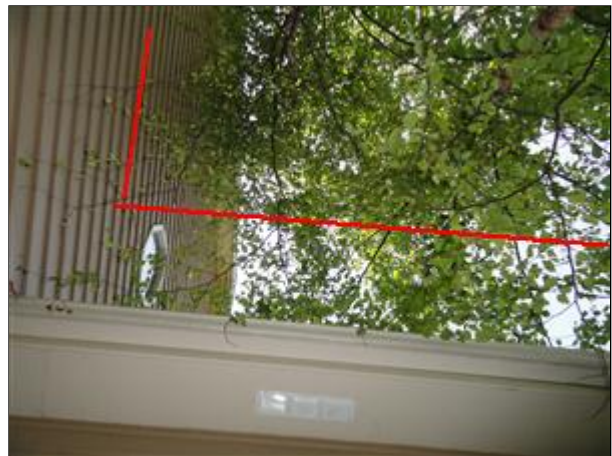
A. Picture 6 keep tree limbs 3' from home, min.

Item 1 - Picture 6 keep tree limbs 3' from home, min.

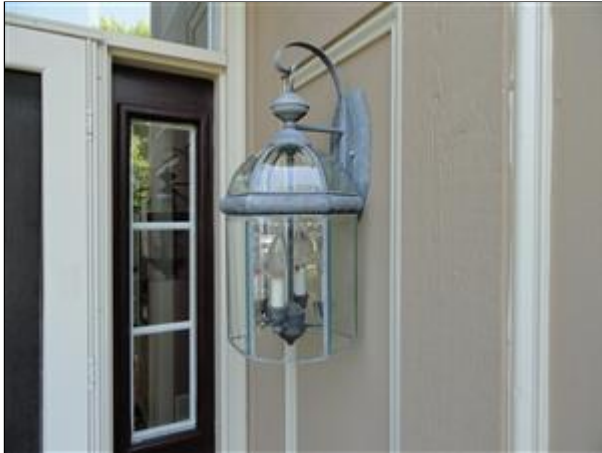
(2) Caulking is recommended at the top and sides of the exterior electrical lighting fixtures, equipment and outlets in order to prevent moisture penetration into the home and/or moisture contact with energized electrical equipment.

A. Picture 8 seal exterior electrical fixtures

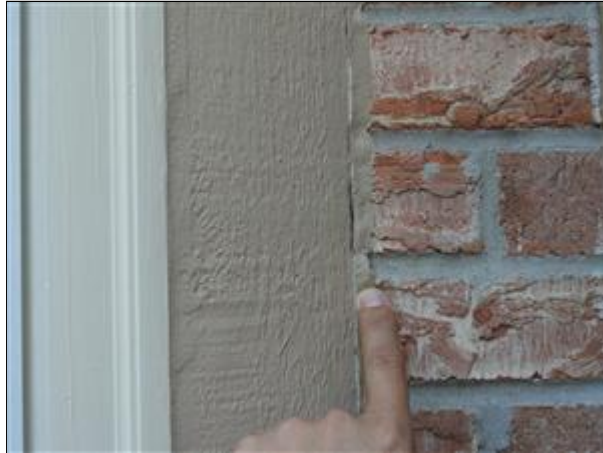
(3) All dissimilar elements at the exterior walls of the home such as: brick-to-stone; brick-to-concrete block; concrete block-to-glass block, etc. should be joined one to the other and sealed against moisture through the use of backer rod and urethane caulk or its equivalent. These dissimilar elements have differing coefficients of expansion and contraction in relation to temperature and moisture. This can lead to cracking of the cladding material and/or of the mortar joints. The existing cement mortar joints should be ground out and replaced with the appropriate backer rod and ASTM approved caulking. This procedure is in keeping with the standards set forth by the Brick Industry Association. Further information is available at www.bia.org

A. Picture 10 repair sealant joints as needed

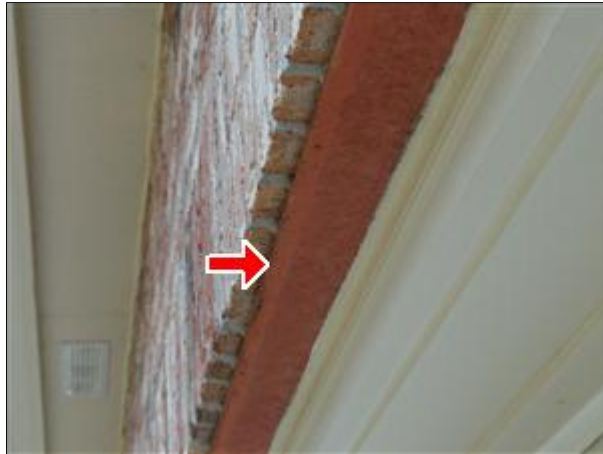
(4) All of the steel window and door lintels should be finish painted in order to provide protection against corrosion and also for proper appearance.

A. Picture 11 prep and finish paint lintels

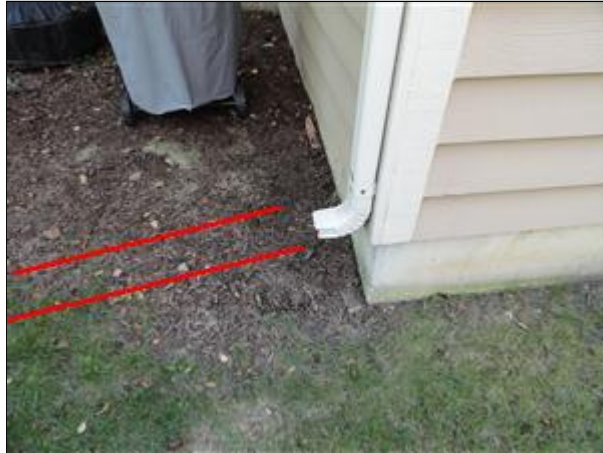
A. Picture 12

(5) The downspouts around the home should extend approximately 6 feet away from the basement foundation walls to well-drained areas in order to reduce the risk of soil saturation and basement seepage.

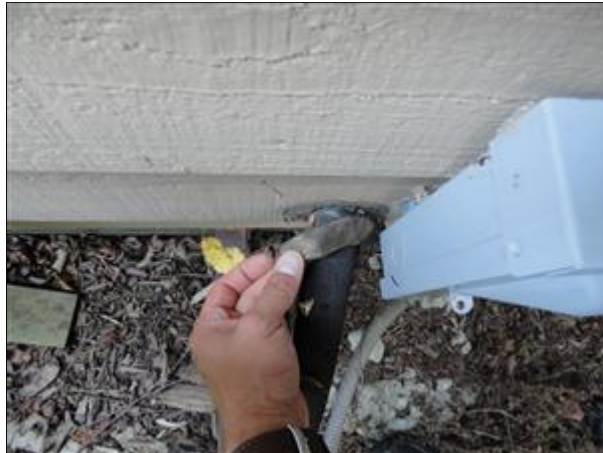
(6) **ALL** exterior wall penetrations such as: piping, conduit, vent caps, etc. should be sealed against moisture intrusion through the use of the appropriate caulking methods and materials.

A. Picture 13 loose putty at a/c lineset

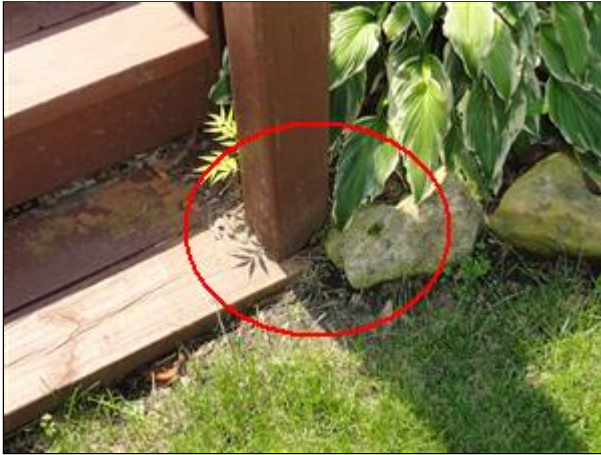
(7) Several areas of the decking require repairs or adjustments for continued service and safety. No access was available beneath the deck to view the ledger connection to the home (please see following comment regarding flashing, Sect D.). A qualified carpentry contractor is recommended for these repairs.

A. Picture 14 stringer/post/tread soil contact

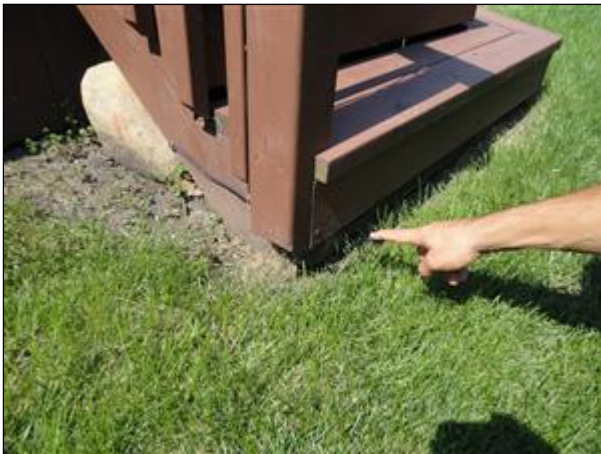
A. Picture 16 stringer termination not on concrete or stable surface

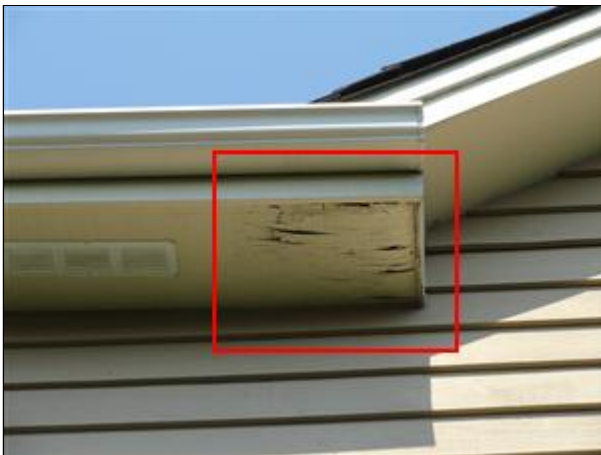
A. Picture 18

(8) Rotted trim was noted at the SW corner soffit and mid West above gutter line and will require replacement.

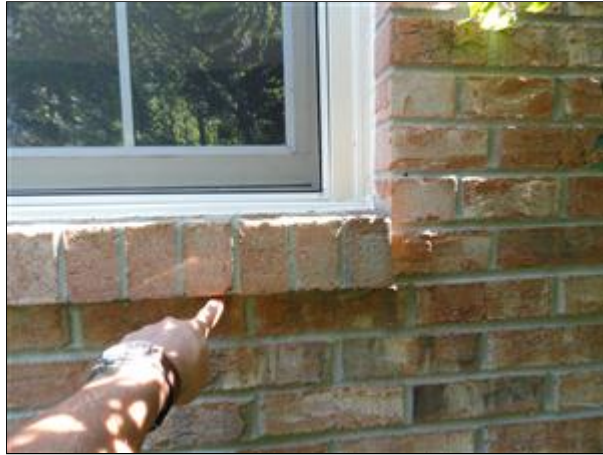
(9) Modern masonry standards call for minimum 15 deg pitch on masonry sills for increased drainage and to prevent saturation or adjacent masonry and building components, as well as attendant flashing details with end dams. The sills should be reviewed and repaired as necessary by a qualified masonry contractor.

A. Picture 20 minimal pitch sills

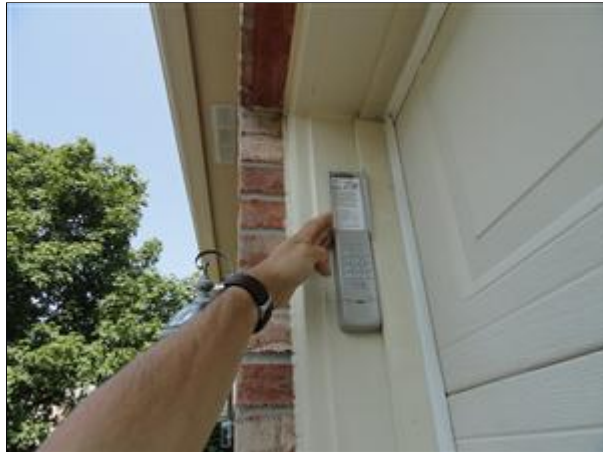
(1) The garage keypad code should be given to the Client prior to closing and then CHANGED post closing for security purposes.

B. Picture 1 change code post closing

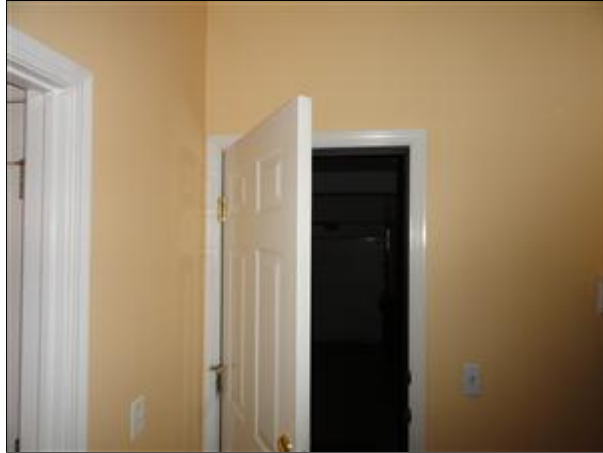
(2) Attached garages are high hazard locations and often have gasoline, solvents, and other hazardous chemicals stored inside. Vehicle exhaust is particularly dirty and heavy with carbon monoxide during cold starts in the garage. Therefore it is recommended that the personnel entry door to the garage be a self-closing door with tight weatherstripping at all 3 sides and at the bottom. A solid core door or insulated steel door is recommended at a minimum. Local codes may require a door with a specific fire rating.

B. Picture 2 adjust already present spring loaded hinges

Modern building science is also advocating installing high efficiency, low cfm bath fans exhausted to the outside in garages to keep them at negative pressure with respect to the home. The fan is to be operated 24/7/365. This will reduce the likelihood of solvents and irritants from entering the home when the garage service door is opened by keeping the garage at negative pressure to the home. Making sure that the garage overhead door is weather stripped and tightly fitting is recommended as well. A qualified HVAC or specialty contractor is recommended for evaluation.

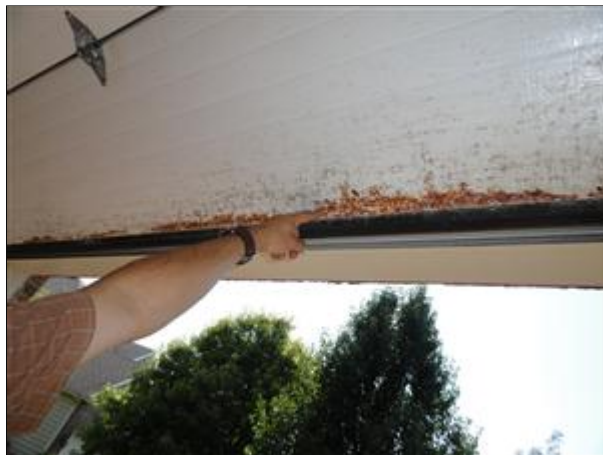
(3) The overhead door base panels should be prepped, primed and repainted to extend service life. Panel replacement may be necessary in near future.

B. Picture 3 door rust at bottom panel

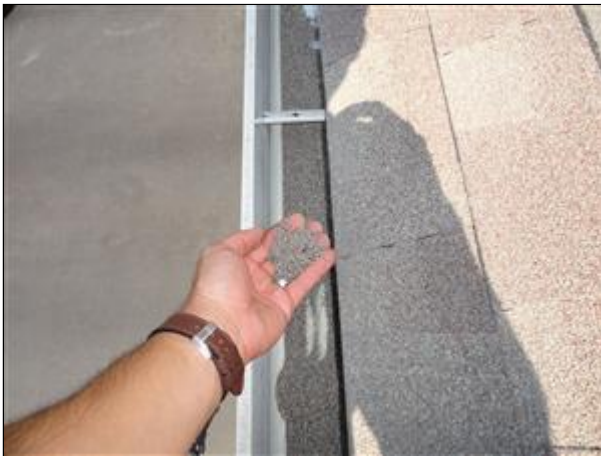
(1) Heavy granular erosion/loss and fiberglass composition exposure of the composition shingles indicates they are at their useful service life's end and will require very near future replacement. The Client should budget for approximately \$10-12k for a tear off and re-roof, preferably with the lightest color acceptable for extended service and solar load reduction.

C. Picture 1 loss of protective granules, exposed fiberglass

It is poor practice to splash downspouts on granular covered roofs such as this. The downspout should connect to the lower gutter system with a color matched downspout to avoid granular erosion and prolong the life of the roofing components. A qualified contractor should repair.

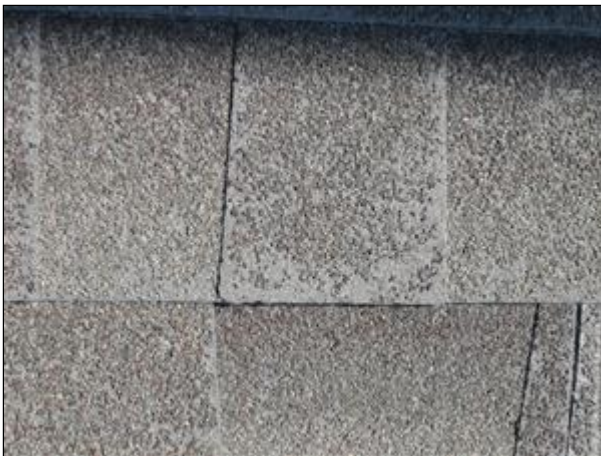
C. Picture 3 note shingle wear

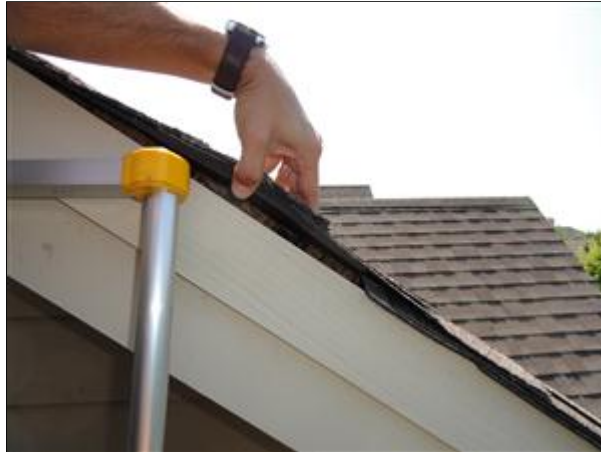
C. Picture 5

(2) It is recommended that a rake edge flashing be installed to minimize moisture intrusion in wind driven rains and reduce the potential for mold, rot and structural damage to roof sheathing, framing and adjacent components. A qualified roofing contractor should install as needed.

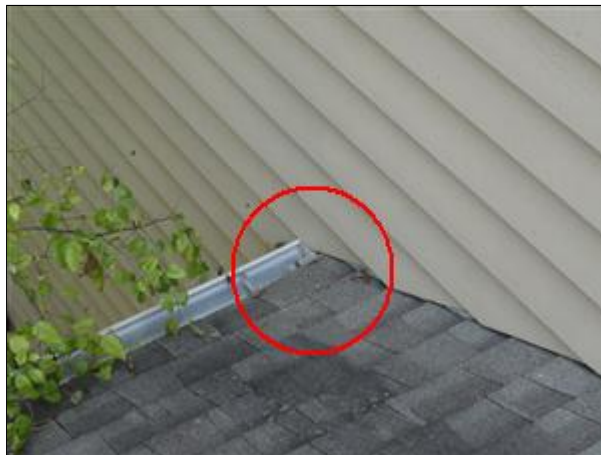
C. Picture 6

(3) A kick out flashing should be installed at roof to sidewall terminations to help prevent liquid water from saturating the sidewall junction and increasing the risk of damage to siding or adjacent components. A standard photo and details can be seen here: [Kick Out Flashing](#)

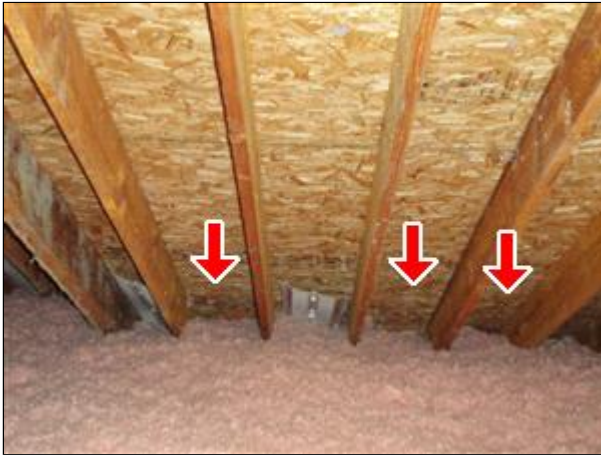
(4) The attic spaces are not properly insulated or ventilated. Therefore the following recommendations are made: The eave ends of **all** the rafters channels should have insulation baffles installed in them in order to promote low-to-high attic ventilation and to reduce the tendency for ice damming and condensation to occur at this location. All ceiling penetrations through the attic floor should be sealed to maintain a pressure boundary. Attic insulation installed against sidewalls, kneewalls or skylight shafts should have an air barrier (housewrap, drywall, rigid foam board w/flame suppression, etc.) to reduce 'washing' of fibrous insulation which does not resist airflow. The attic insulation should be increased to a minimum of R-49 and the attic scuttle(s) should be weather stripped and insulated (typically 3 layers of rigid foam board glued to hatch). **Also, additional low ventilation points should be added preferably at the soffit.** Evaluation and repair by a licensed and competent specialty contractor is recommended in order to promote effective attic ventilation and reduce energy losses. Balanced airflow between high and low positions in the roof is paramount for proper performance.

C. Picture 7 increase ventilation

The use of a radiant barrier at the roof underside may be implemented for reduced solar gains and cooling efforts. If a healthy topcoating of cellulose insulation is installed, the radiant barrier may still be installed (low cost, material is 14c a sq/ft); however, cellulose in itself is an effective radiant barrier at sufficient depths. [Radiant Barrier Info](#)

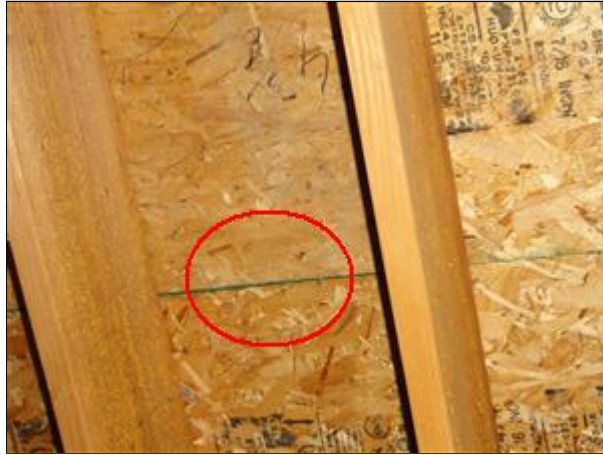
D. Picture 2

(2) The roof plywood sheathing was installed without the use of H clips which increase resistance to uplift and detachment (may have been code requirement at time of construction). Retrofitting may be costly.

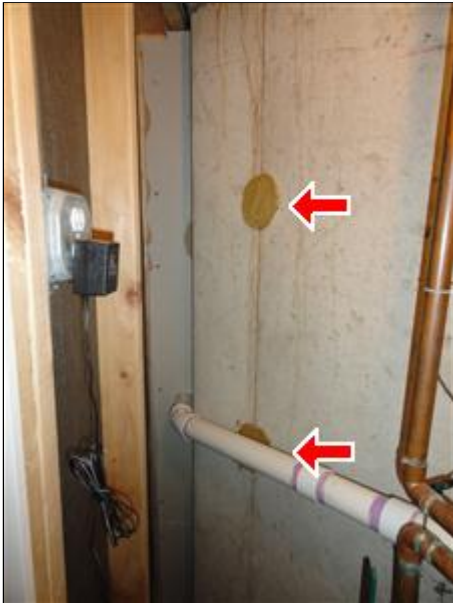
(3) Any information or warranty status of the foundation epoxy repairs is recommended to be presented to the Buyers for evaluation. The repairs and foundation at this area appear to be stable and functioning properly.

D. Picture 3 West basement

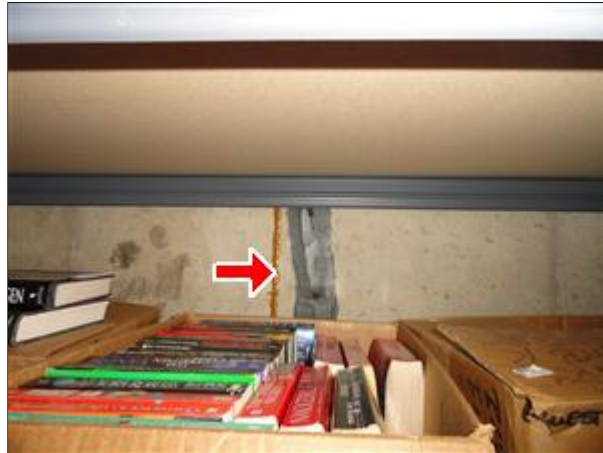
D. Picture 4 East basement foundation repairs

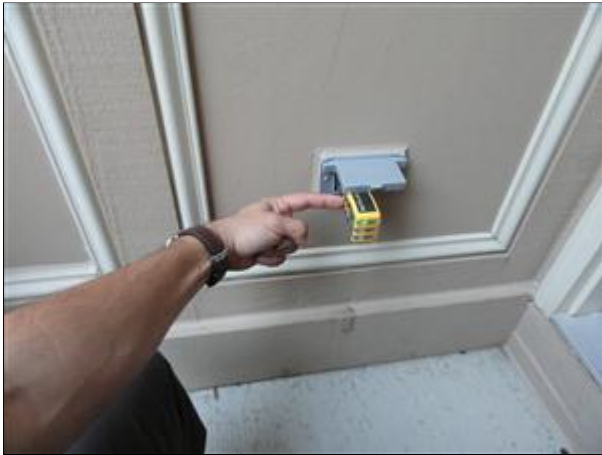
The exterior GFCI receptacles are aged and did not respond to instrument or manual trip functions. They should be replaced for safe and proper function.

E. Picture 1 replace aged receptacles

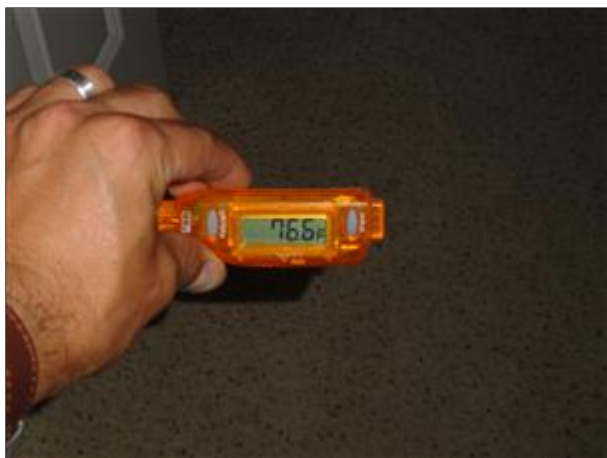
(1) The condensing unit is 13 years old and nearing its useful service life's end. Budgeting for its near future replacement is recommended and may require slightly reduced sizing if energy improvements are implemented. A cooling load calculation is recommended prior to this replacement.

Moderate cooling temperatures were recorded at the time of inspection; recommend a servicing of unit.

F. Picture 2 elevated 2nd fl temp (insulation/ ventilation also a role)

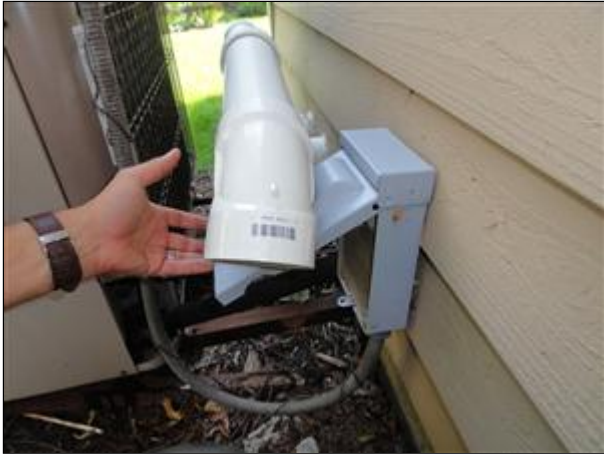
(2) The intake and exhaust routing of the high efficiency furnace illustrates a lack of forethought regarding a/c unit maintenance and access of the a/c disconnect. They should be rerouted for convenience purposes.

F. Picture 3 poor installation

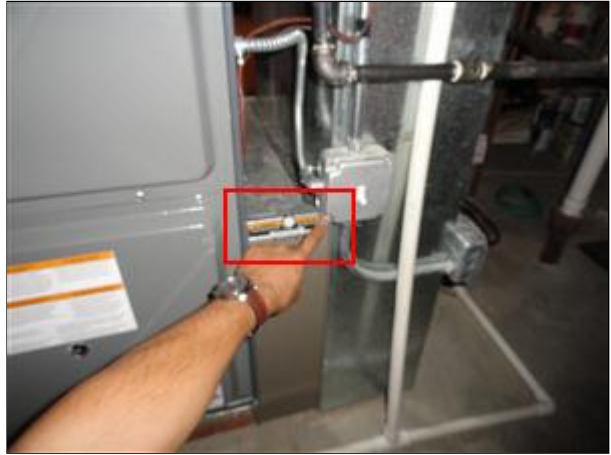
F. Picture 4 difficult to remove filter access panel

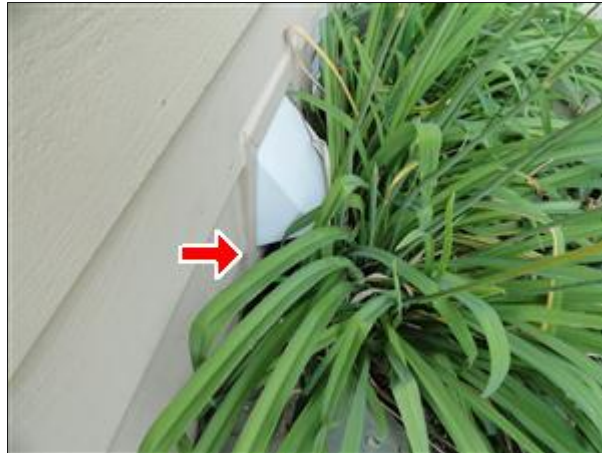
(3) The vegetation in front of the fresh air exchange unit intake and exhaust should be trimmed or removed to provide adequate ventilation and performance.

F. Picture 5 risk of choking off pathways

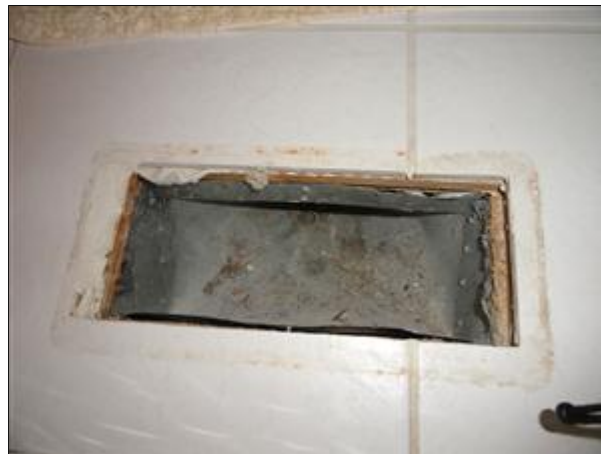
(5) All of the HVAC ducts should be cleaned professionally to avoid the circulation of unwanted odors, debris and pollutants throughout the conditioned airstream and living quarters. It is also good practice to seal the register "boots" to their openings using foil tape, spray foam or caulk. The use of a National Air Duct Cleaning Association (NADCA) member is recommended.

F. Picture 8 clean ductwork

If any construction/remodeling is to occur, we recommend delaying cleaning until the completion of such work.

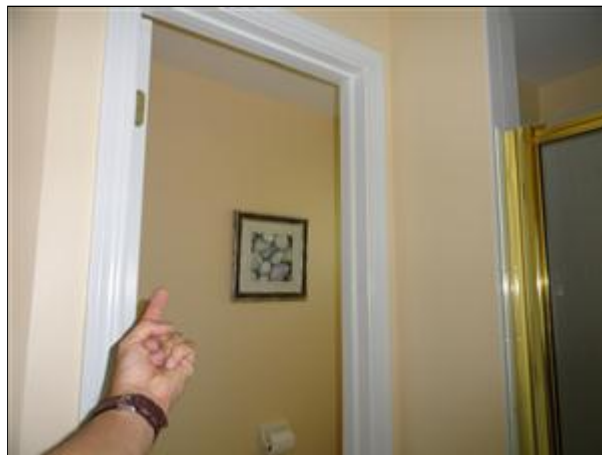
(7) The bath fan located in the water closet of the master may not be sufficient to remove latent air post bathing. The Clients should consider an additional fan in the main bathing area, ideally equipped with a bath fan timer switch for extended run cycles.

F. Picture 9 sole fan in water closet

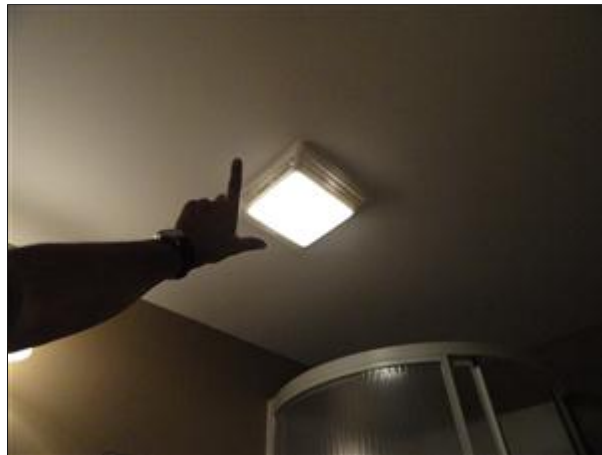
(10) The basement bathroom exhaust fan did not operate properly at the time of inspection and may require repair or replacement (frozen motor sound)

F. Picture 12 repair/replace bath fan

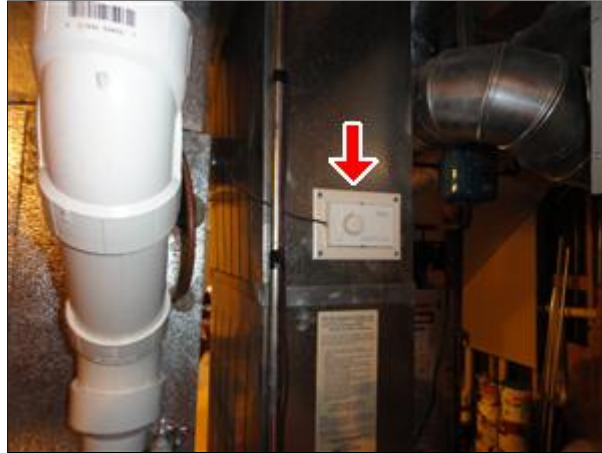
(11) The humidistat control would ideally be placed next to the thermostat control. It's placement in the furnace closet presents an 'out of sight, out of mind' situation for the homeowner. The humidistat requires frequent adjustment during the heating season. Therefore, it is recommended that the humidistat be relocated next to the thermostat.

F. Picture 13 recommend relocation

The humidifier pads should be replaced twice during the heating season to avoid mineral and biological growth build up and improved performance and indoor air quality of the humidifier. An indoor hygrometer of decent quality is recommended to effectively evaluate indoor humidity levels in order to adjust the moisture levels on the humidistat and keep within comfort range during winter, typically between 35-45% relative humidity. Summer humidity levels should not exceed 50% if possible. Note, during periods of very cold weather, the humidity scale on the humidistat may provide too much moisture as the furnace will be cycling much more frequently, thus adding more moisture to the air. Care should be taken to "throttle" back moisture levels during these times.

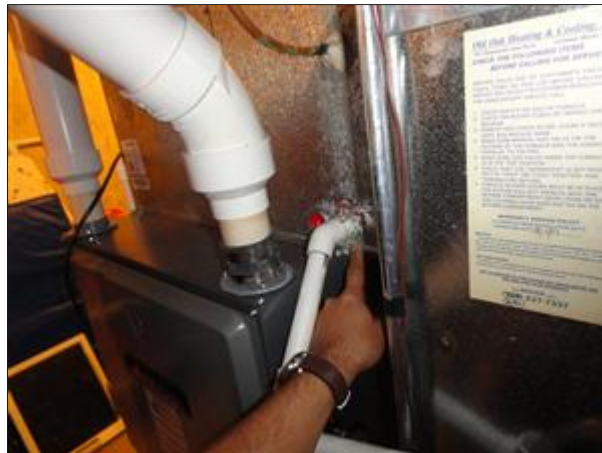
(12) Condensation staining and air gaps were noted at the air conditioning lineset entry points into the HVAC unit. These entry points should be sealed a licensed and competent HVAC contractor in order to prevent further condensation and possible damage to the HVAC equipment.

F. Picture 14 seal entry points

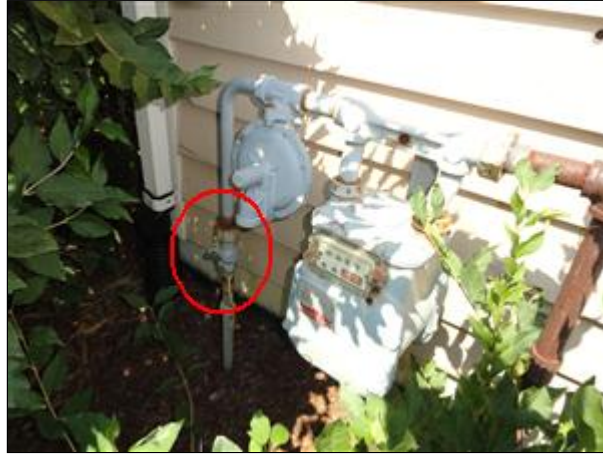
(1) Location of the main gas shut-off to the home is at the SW exterior. The use of a large pipe wrench, Channel-Locks, or crescent wrench is required to align the valve so that both holes "meet up" in the event of an emergency.

G. Picture 1 main gas shut-off

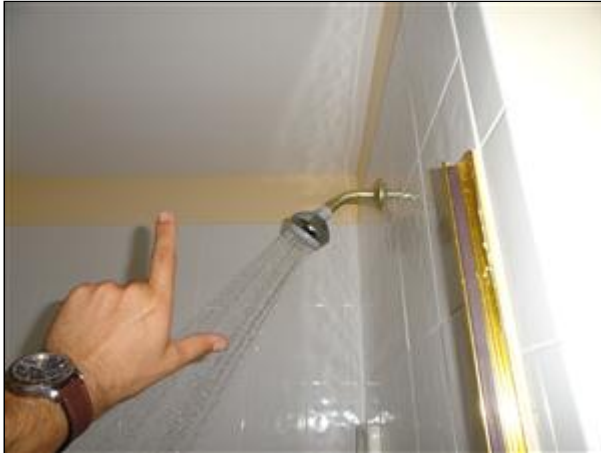
G. Picture 2 low master water volume, shower

(2) Several plumbing deficiencies or repairs are required in the home. The following were noted and should be addressed by a qualified plumbing contractor or handyman should the repair be basic.

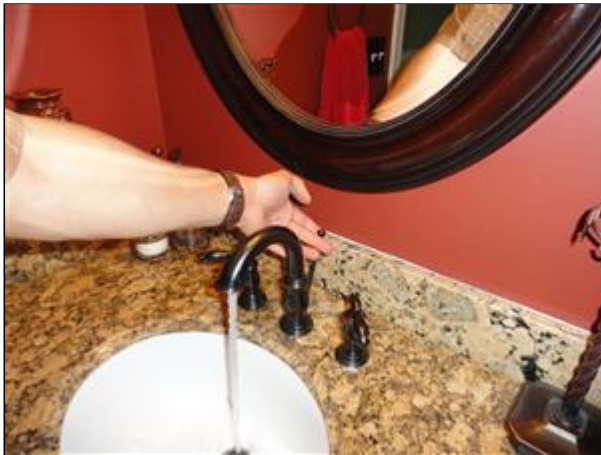
G. Picture 4 powder room pop up

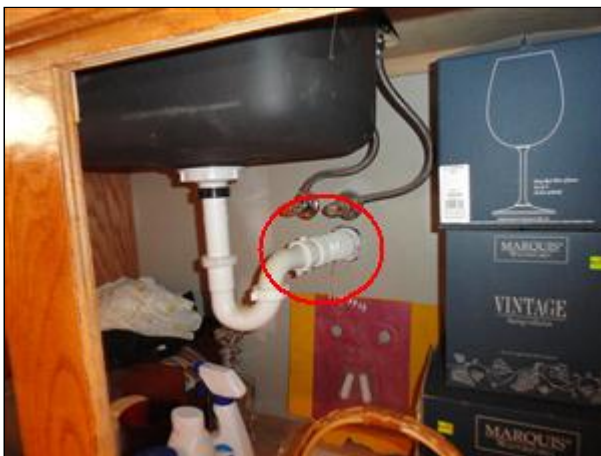
G. Picture 6 recommend replacing corrugated drain pipe with smooth wall metal, wet bar

Item 36 - Picture 5 recommend replacing corrugated drain pipe with smooth wall metal, wet bar

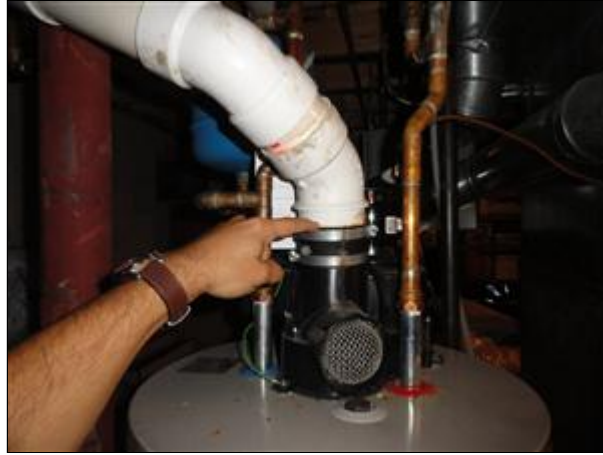
G. Picture 8 condensate 'roll back' after exhaust operation, not threatening

Item 36 - Picture 7 condensate 'roll back' after exhaust operation, not threatening

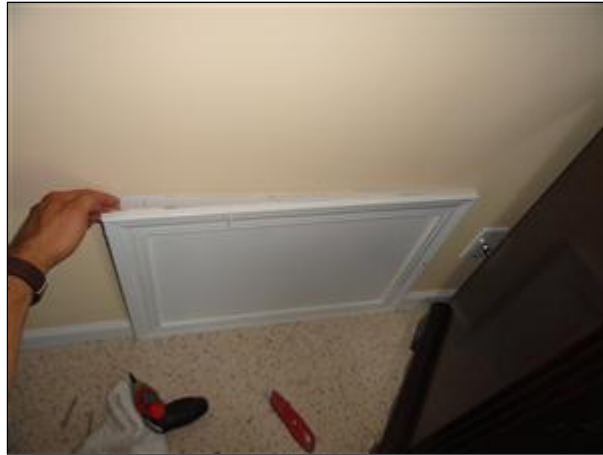
G. Picture 9 unable to access without damage to area

(3) The access panel to the hydromassage bathtub motor should be made readily accessible so that the components inside may be easily serviced, maintained, or accessed in the event of an emergency.

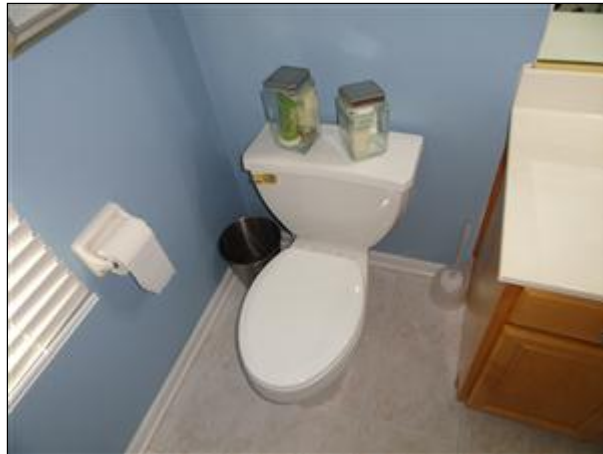
G. Picture 10 guest bath, 2nd fl

(4) The toilet is not adequately secured to the floor. This can result in deformation of the wax ring seal, leaking, and other damage. The toilet should be evaluated by a licensed plumber in order to determine if removal and reinstallation as necessary.

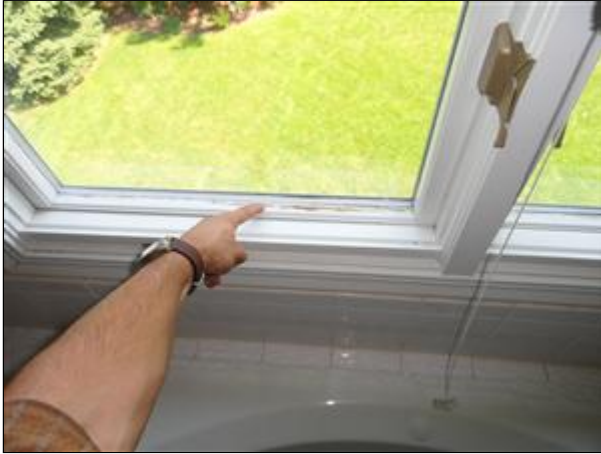
H. Picture 1 wood deterioration, master bath

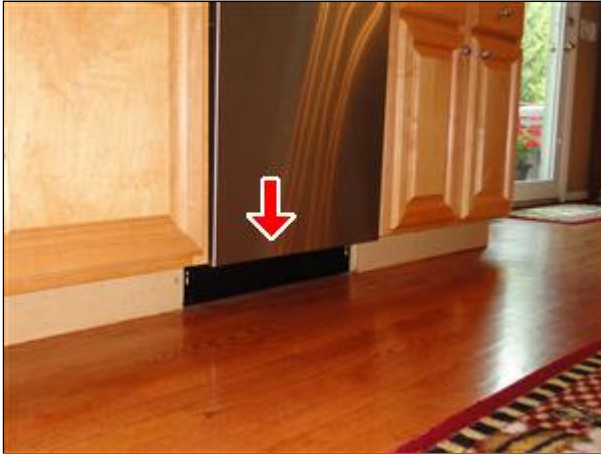
H. Picture 3 color matched toe kick for appearance recommended

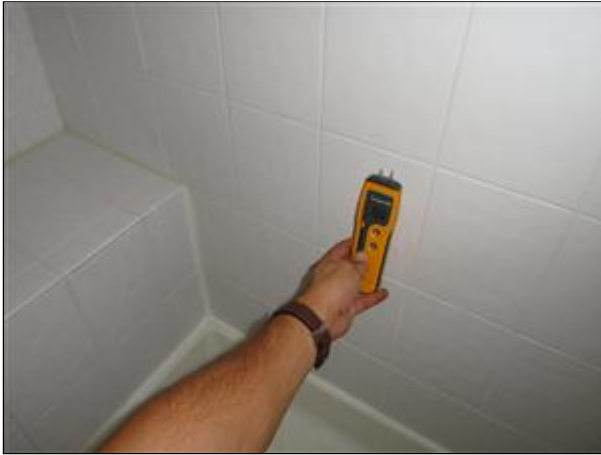
(2) Poor tiling details and open grout joints at the master shower have allowed moisture penetration for unknown length of time. The tiling will, and should, be removed to assess substrate condition and reinstalled by a competent and qualified tile setting contractor.

H. Picture 6 baseline moisture reading

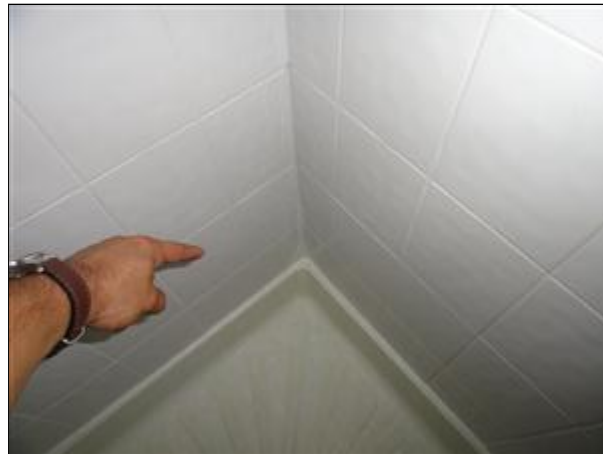
H. Picture 8 reseal shower junctions

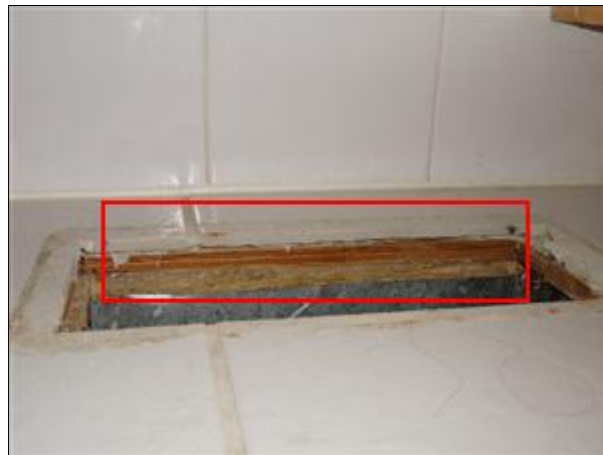
H. Picture 9

(3) The master bath floor tile has been installed over plywood which is not an accepted best building practice. The tile should be removed and reinstalled over a proper substrate by a competent tile setting contractor.

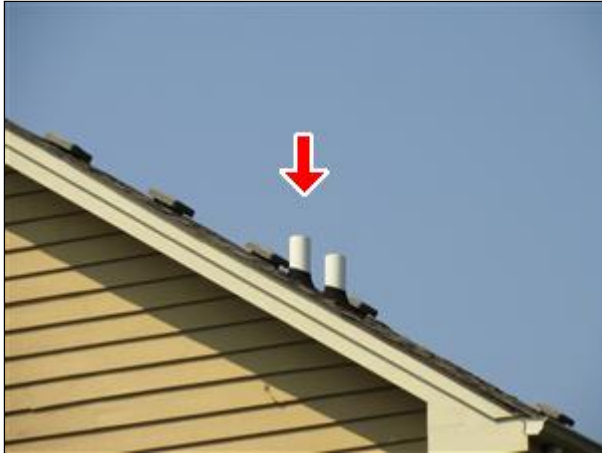
(4) A past stain was noted at the SE living room ceiling and may be attributed to the (inaccessible) vent flashings at this location. Further review by a qualified roofing contractor may be desired or required.

H. Picture 10 flashings may have degraded

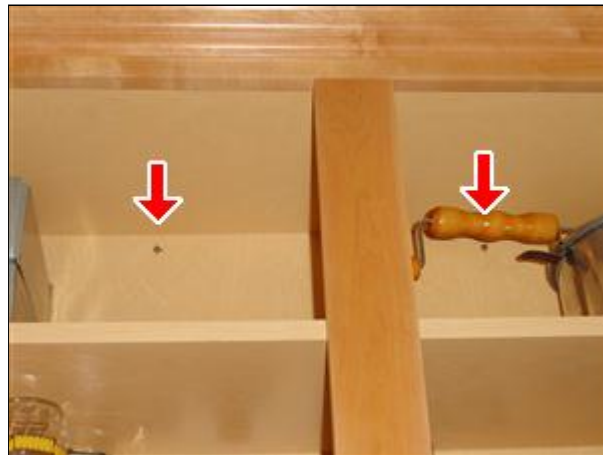
H. Picture 12

(5) Some of the screws used to fasten the cabinets to the wall framing are not the recommended washer head screws. ALL non cabinet rated screws should be removed and replaced at ALL UPPER cabinets in order to reduce the risk of the cabinets pulling through the existing fasteners and loosening or becoming detached.

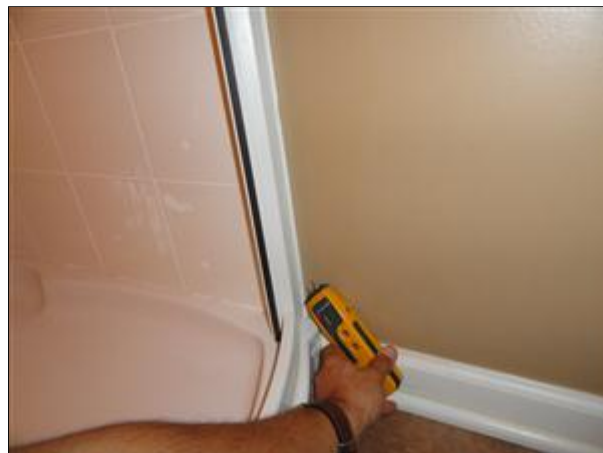
(6) The basement bathroom shower stall is not properly sealed and has allowed moisture to escape at the corners as evidenced by appearance and moisture meter readings. The stall should be sealed at all junctions and the drywall repaired appropriately.

H. Picture 13 elevated moisture at both corners

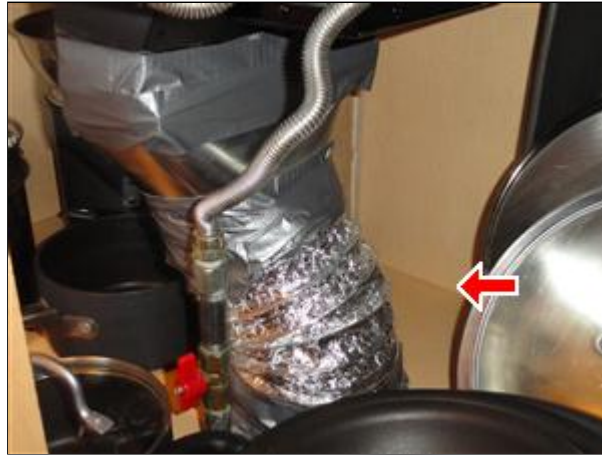
(1) The use of smooth wall metal venting is recommended for the kitchen exhaust to avoid grease collection within the corrugations of the existing vent which may cause odor or health issues over time as well as reduce performance.

I. Picture 1 upgrade venting

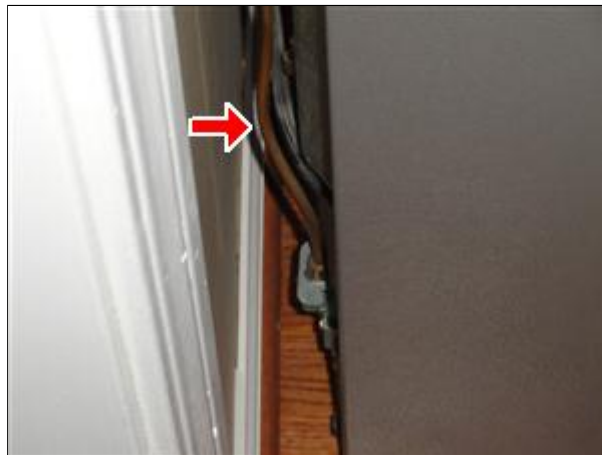
(2) It is recommended that the flexible copper supply piping be replaced with braided stainless steel tubing for the optimal resistance against leakage and damage to the surrounding finishes.

I. Picture 2 upgrade fridge supply

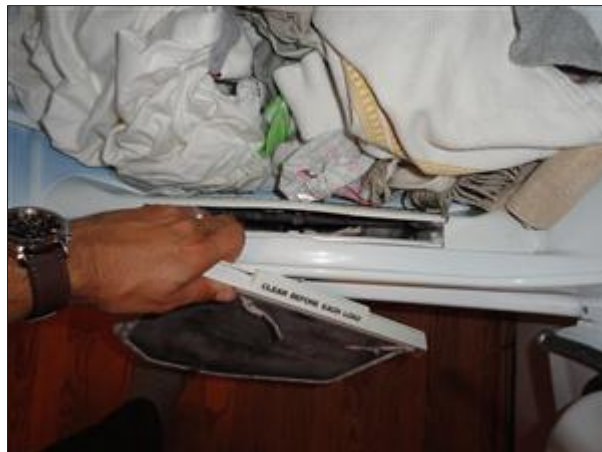
(3) Lint build-up was noted inside the vent passages of the clothes dryer. These passages and any vent piping should be cleaned in order to reduce the risk of dryer fire, reduce drying times, and to maximize the service life of the clothes dryer.

I. Picture 3 clean lint passages

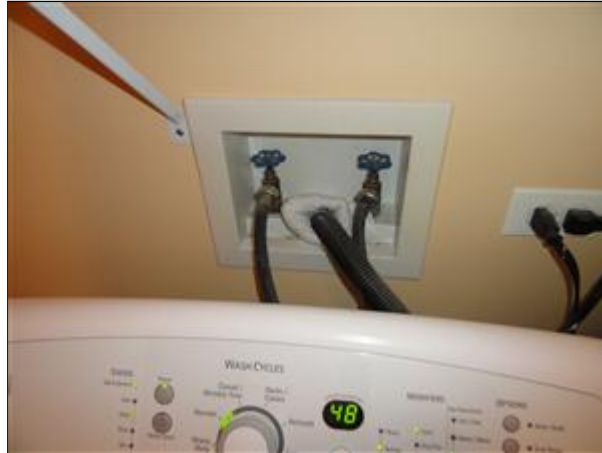
(4) It is recommended that the existing rubber water supply hoses at the clothes washer be replaced with braided stainless steel hoses for increased insurance against leaks and water damage.

I. Picture 4 upgrade washer hoses

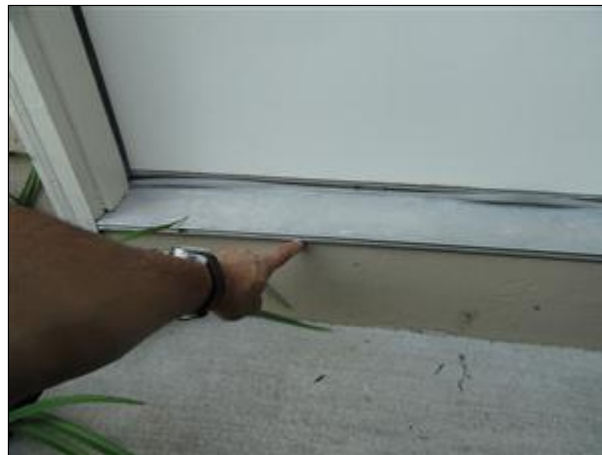
J. Picture 1 laundry door

(1) A drip edge flashing is recommended (preferably end dammed) at the rear laundry door to reduce the risk of moisture entry beneath the door sill and apron.

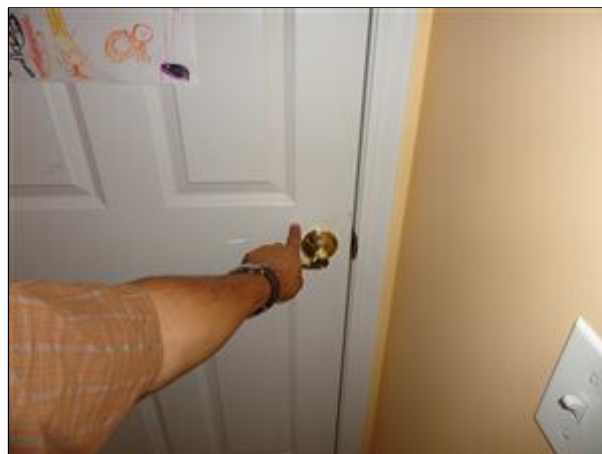
J. Picture 2 SW bedroom

(2) All doors should be adjusted so that they fit snugly in the strikeplates and don't rattle or have excess movement when shut.

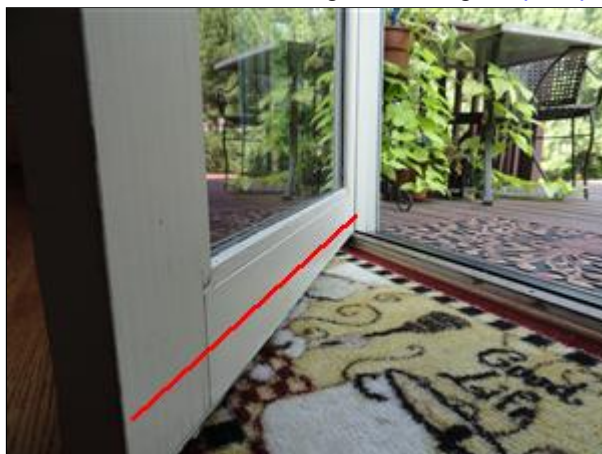
(3) The addition of a rain or drip cap is recommended for the kitchen 'exterior' door to reduce moisture loads and convey to the exterior. Similar items such as this are found at better building material stores or online. This is generally recommended for any exterior door without a storm door or large overhang. [Drip Cap](#)

J. Picture 3 recommend drip cap

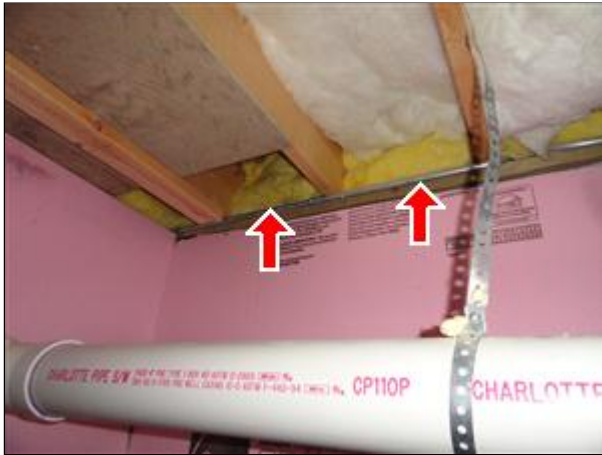
K. Picture 1

The box sills (area where joists rest on the foundation sill plate and abut the outer rim joist) are insulated with poorly installed fiberglass insulation. Modern building science has proven this area as a high leakage point in blower door testing as well as standard building pressure differences. It is recommended that the fiberglass be removed and either expanding spray foam or neatly cut rigid foam insulation 'boxes' installed and sealed into place for greater performance.

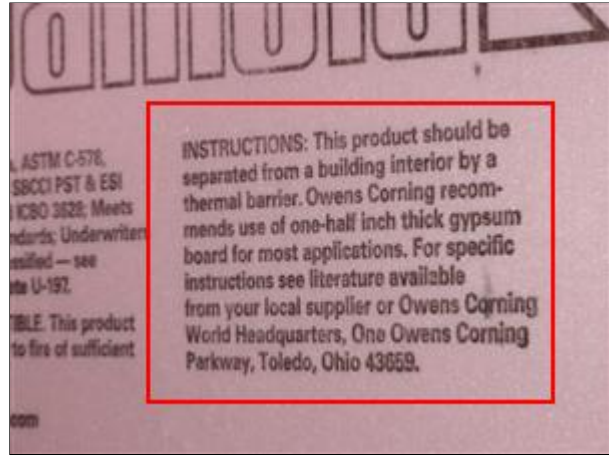
The exposed extruded polystyrene (XPS) foam board insulation in the basement should be properly covered with an approved fire retardant covering to reduce the risk of flame spread or ignition.

K. Picture 2 required fire suppression (typ. 5/8' drywall)

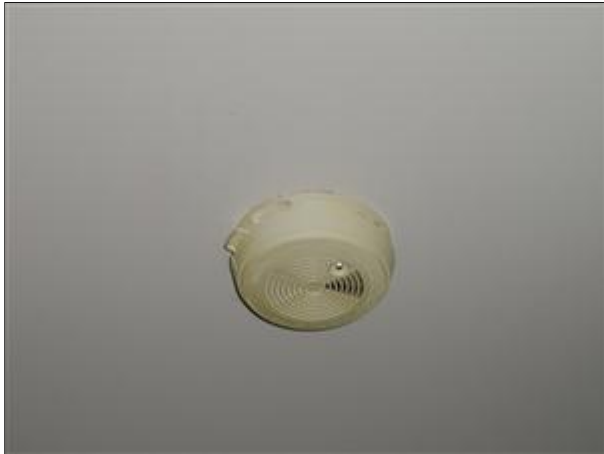
The smoke detectors noted in the home appeared to be at or beyond the end of their service lives, typically taken to be 10 years. It is recommended that the smoke detector and carbon monoxide detector systems be upgraded to reflect current life safety codes which include; smoke detectors on each level of living space and in each sleeping room, hard-wired 120 V smoke detectors that are interconnected in order to alarm simultaneously when any individual smoke detector responds, and low level carbon monoxide detectors on every level of living space and within 15 feet of a sleeping room. The installation of these critical life safety devices by a licensed and competent electrician is recommended.

L. Picture 1 aged detectors, replace due to low cost vs critical function

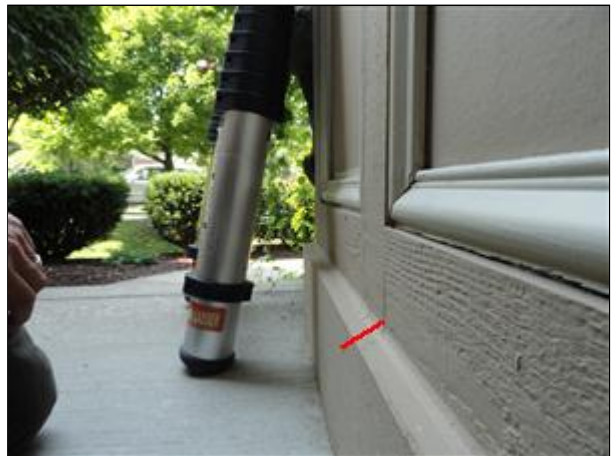
Item 1 - Picture 2 avoid flat surfaces when possible

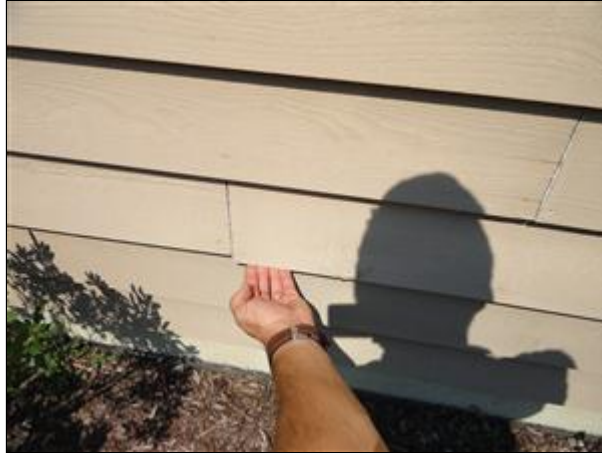
A. Picture 7 South siding near gas meter,

Item 1 - Picture 7 South siding near gas meter,

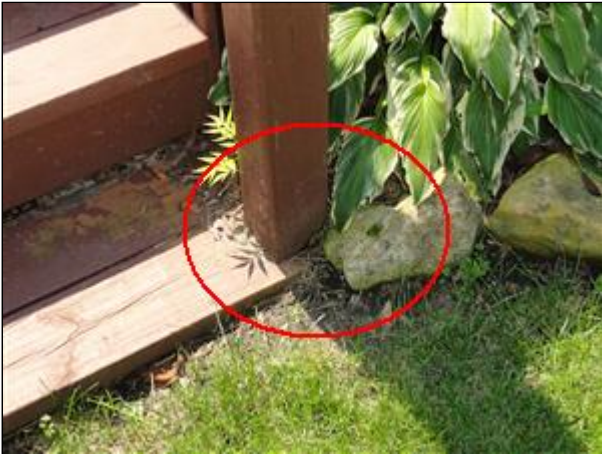
7. (7) Several areas of the decking require repairs or adjustments for continued service and safety. No access was available beneath the deck to view the ledger connection to the home (please see following comment regarding flashing, Sect D.). A qualified carpentry contractor is recommended for these repairs.

Item 7 - Picture 1 stringer/post/tread soil contact

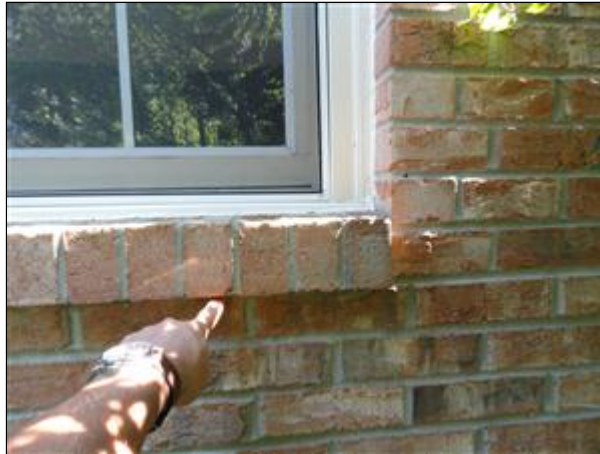
9. (9) Modern masonry standards call for minimum 15 deg pitch on masonry sills for increased drainage and to prevent saturation or adjacent masonry and building components, as well as attendant flashing details with end dams. The sills should be reviewed and repaired as necessary by a qualified masonry contractor.

Item 9 - Picture 1 minimal pitch sills

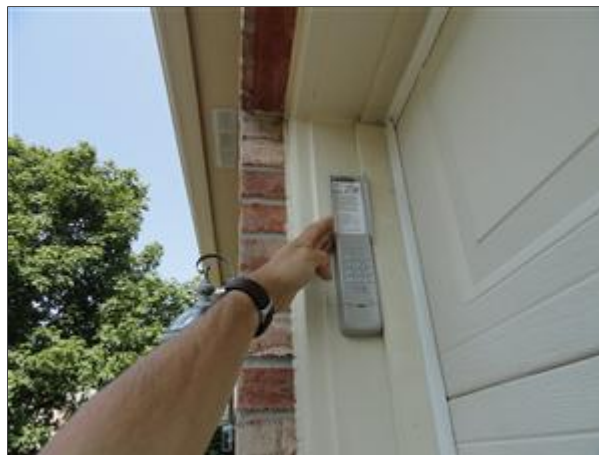
10. (1) The garage keypad code should be given to the Client prior to closing and then CHANGED post closing for security purposes.

Item 10 - Picture 1 change code post closing
