Property, Energy & Moisture Intrusion Inspect

Inspection Report

Domicile Consulting

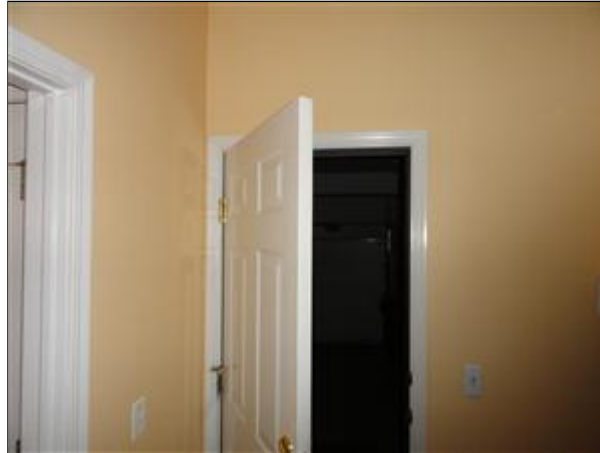
11. (2) Attached garages are high hazard locations and often have gasoline, solvents, and other hazardous chemicals stored inside. Vehicle exhaust is particularly dirty and heavy with carbon monoxide during cold starts in the garage. Therefore it is recommended that the personnel entry door to the garage be a self-closing door with tight

Item 11 - Picture 1 adjust already present spring loaded hinges

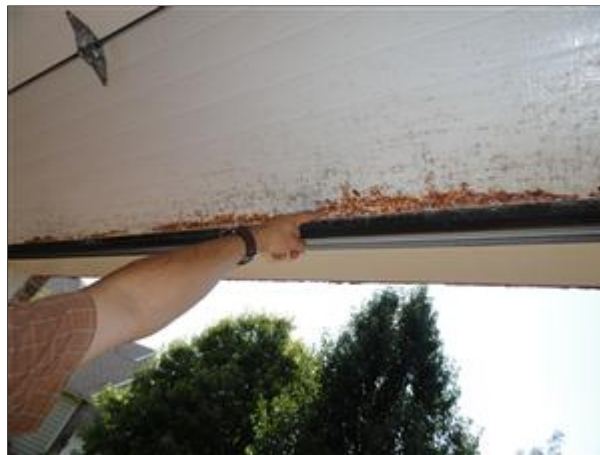
12. (3) The overhead door base panels should be prepped, primed and repainted to extend service life. Panel replacement may be necessary in near future.

Item 12 - Picture 1 door rust at bottom panel

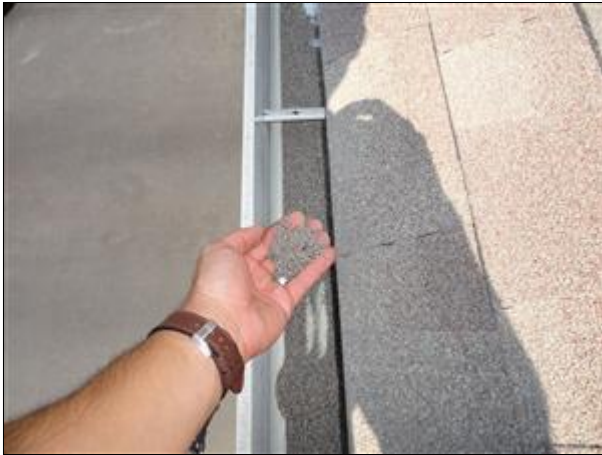
13. (1) Heavy granular erosion/loss and fiberglass composition exposure of the composition shingles indicates they are at their useful service life's end and will require very near future replacement. The Client should budget for approximately \$10-12k for a tear off and re-roof, preferably with the lightest color acceptable for extended service and solar load reduction.

Item 13 - Picture 1 loss of protective granules, exposed fiberglass

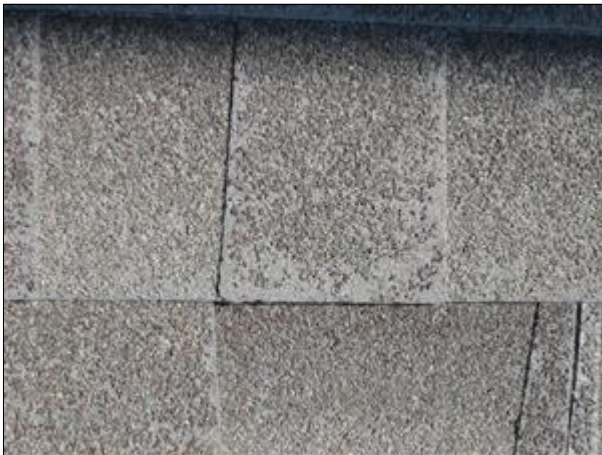
Item 13 - Picture 3 note shingle wear

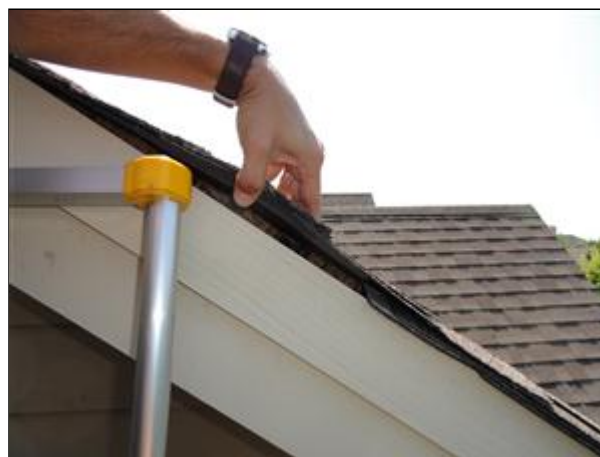
Item 14 - Picture 1

14. (2) It is recommended that a rake edge flashing be installed to minimize moisture intrusion in wind driven rains and reduce the potential for mold, rot and structural damage to roof sheathing, framing and adjacent components. A qualified roofing contractor should install as needed.

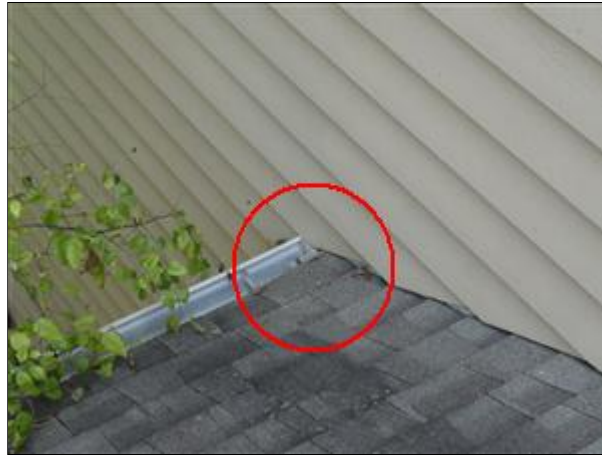
Item 15 - Picture 1

15. (3) A kick out flashing should be installed at roof to sidewall terminations to help prevent liquid water from saturating the sidewall junction and increasing the risk of damage to siding or adjacent components. A standard photo and details can be seen here: [Kick Out Flashing](#)

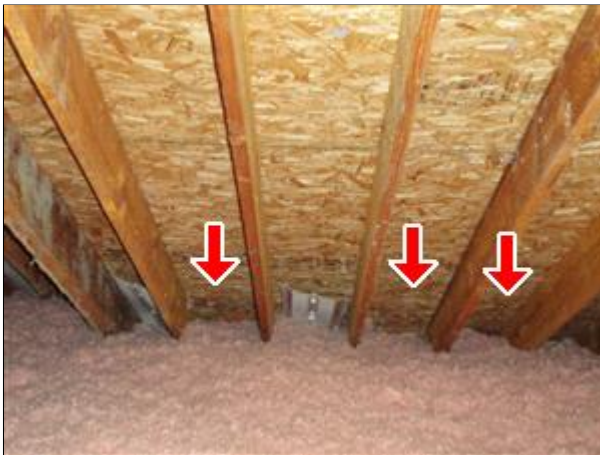
C. Picture 7 increase ventilation

16. (4) The attic spaces are not properly insulated or ventilated. Therefore the following recommendations are made: The eave ends of **all** the rafters channels should have insulation baffles installed in them in order to promote low-to-high attic ventilation and to reduce the tendency for ice damming and condensation to occur at this location. All ceiling penetrations through the attic floor should be sealed to maintain a pressure boundary. Attic insulation installed against sidewalls, kneewalls or skylight shafts should have an air barrier (housewrap, drywall, rigid foam board w/flame suppression, etc.) to reduce 'washing' of fibrous insulation which does not resist airflow. The attic insulation should be increased to a minimum of R-49 and the attic scuttle(s) should be weather stripped and insulated (typically 3 layers of rigid foam board glued to hatch). **Also, additional low ventilation points should be added preferably at the soffit.** Evaluation and repair by a licensed and competent specialty contractor is recommended in order to promote effective attic ventilation and reduce energy losses. Balanced airflow between high and low positions in the roof is paramount for proper performance.

Item 16 - Picture 1 increase ventilation

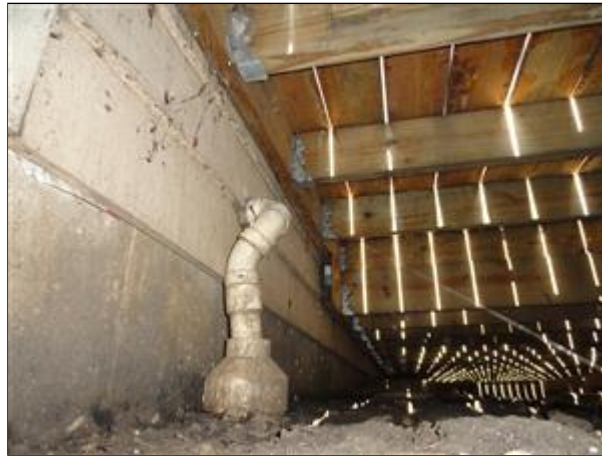
17. (1) INFORMATIONAL (no access beneath deck): The deck ledger is not properly flashed and should be repaired. This critical flashing should be installed in order to prevent moisture from entering the wall cavity and loosening or weakening the structural connection between the ledger board and wall framing--essentially the most important connection in the deck structure for safety as the vast majority of deck failures occur at this location according to several construction and safety organizations. [North American Deck and Railing Association](#)

Item 17 - Picture 1 inconclusive view from gap at South

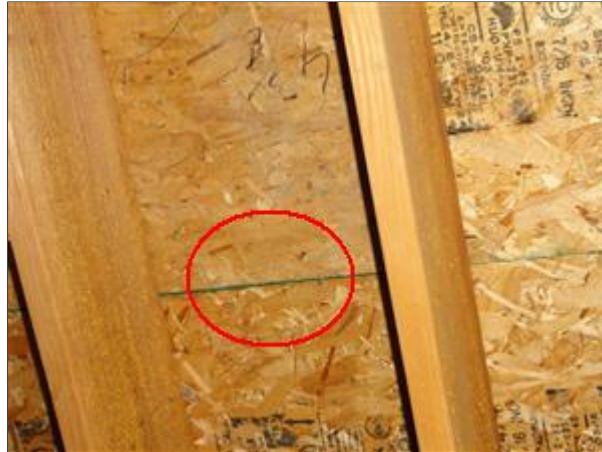
Item 18 - Picture 1

18. (2) The roof plywood sheathing was installed without the use of H clips which increase resistance to uplift and detachment (may have been code requirement at time of construction). Retrofitting may be costly.

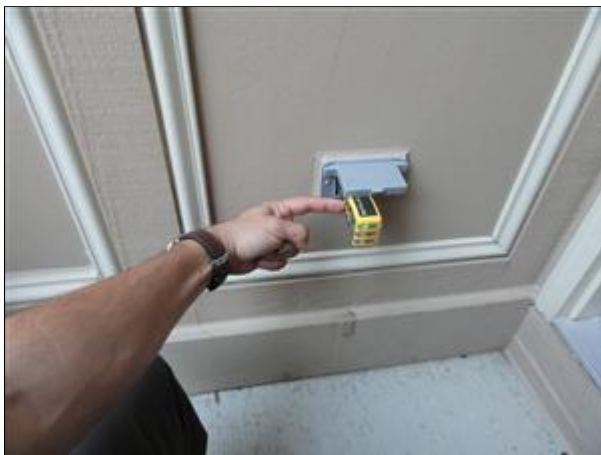
The exterior GFCI receptacles are aged and did not respond to instrument or manual trip functions. They should be replaced for safe and proper function.

Item 20 - Picture 1 replace aged receptacles

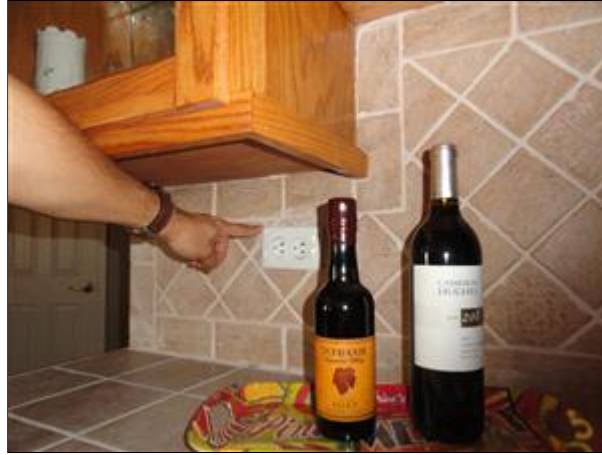
Item 20 - Picture 3 secure loose receptacle, wet bar

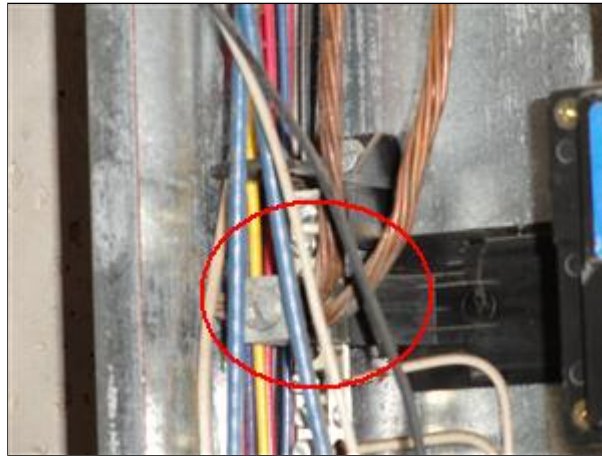
21. (2) The main grounding and bonding electrodes must terminate on individual lugs for proper performance in the event that if one should become loose, so would the other. A qualified electrician should repair as soon as possible.

Item 21 - Picture 1 install second lug

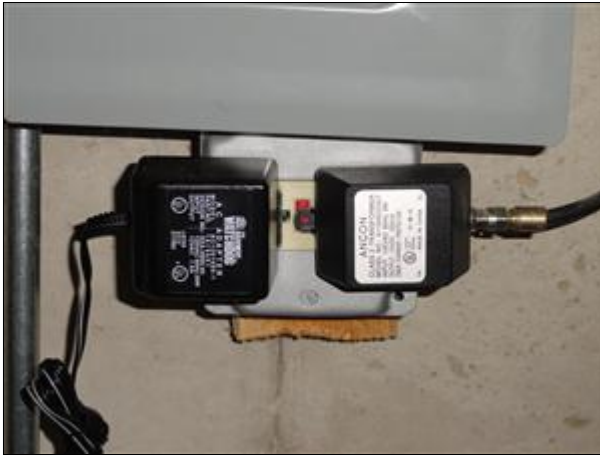
22. (3) It is continually debated by electricians, inspectors and code officials as to whether a sump pump should be installed on a GFCI protected receptacle. Local codes may necessitate the installation of a GFCI receptacle at the sump pump location; this is to prevent electrocution or shock injuries in the event of an electrical fault or appliance malfunction. Others prefer to have a dedicated, non-GFCI receptacle to prevent the potential for nuisance tripping and increased risk of basement seepage (greater risk of shock to anyone touching malfunctioning sump pump).

Item 22 - Picture 1 sump pump GFCI

Further discussion with a qualified electrician may be desired by the client.

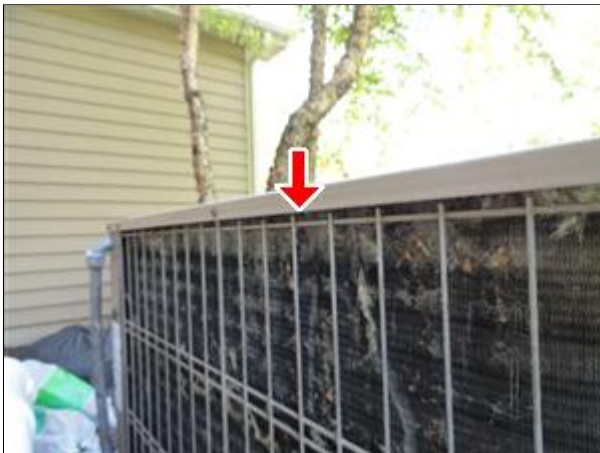
- 23. (1) The condensing unit is 13 years old and nearing its useful service life's end. Budgeting for its near future replacement is recommended and may require slightly reduced sizing if energy improvements are implemented. A cooling load calculation is recommended prior to this replacement.

Moderate cooling temperatures were recorded at the time of inspection; recommend a servicing of unit.

Item 23 - Picture 1 clean exterior of unit

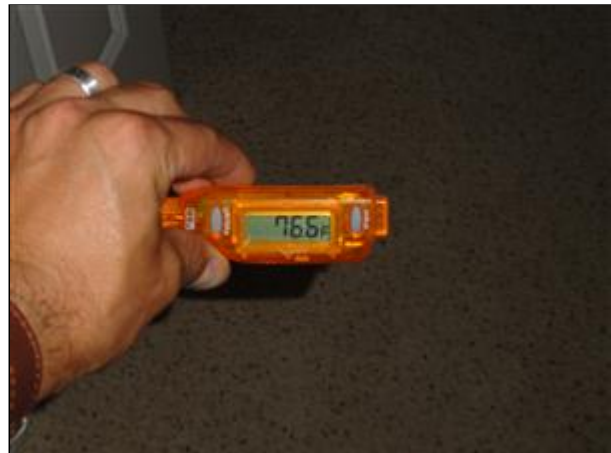
Item 23 - Picture 2 elevated 2nd fl temp (insulation/ventilation also a role)

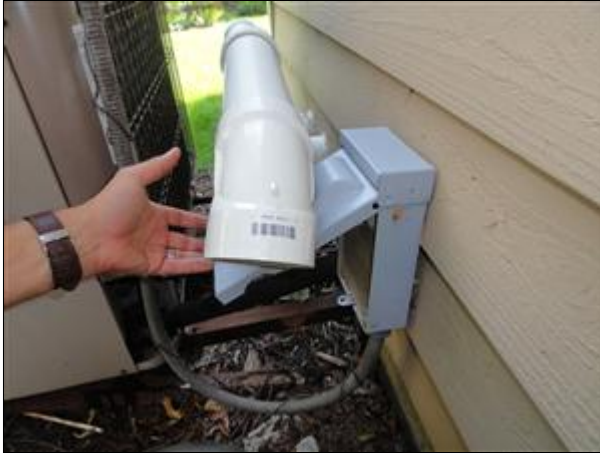
- 24. (2) The intake and exhaust routing of the high efficiency furnace illustrates a lack of forethought regarding a/c unit maintenance and access of the a/c disconnect. They should be rerouted for convenience purposes.

Item 24 - Picture 1 poor installation

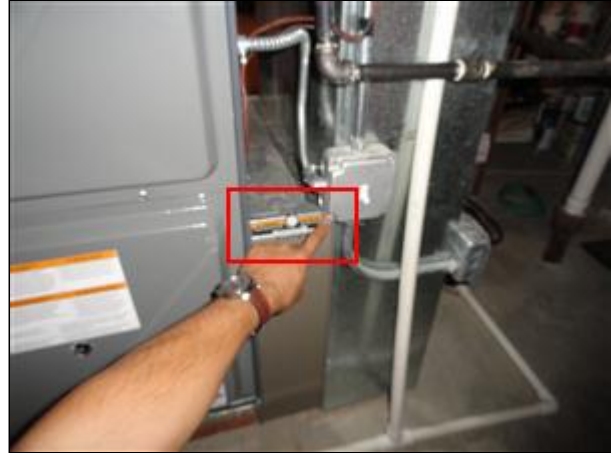
Item 24 - Picture 2 difficult to remove filter access panel

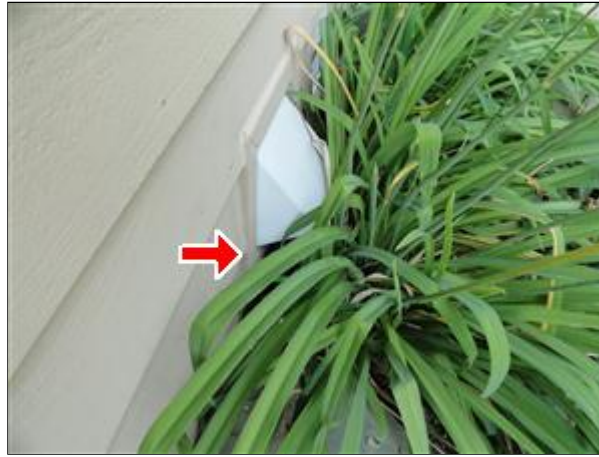
25. (3) The vegetation in front of the fresh air exchange unit intake and exhaust should be trimmed or removed to provide adequate ventilation and performance.

Item 25 - Picture 1 risk of choking off pathways

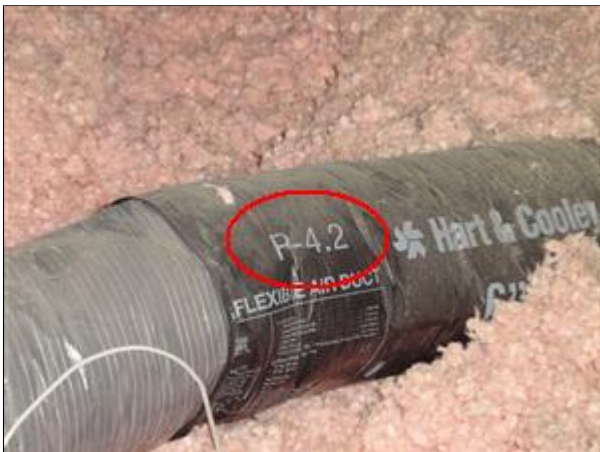
26. (4) The Department of Energy recommends insulating ductwork in unconditioned spaces to a level of at least R-8 for maximum delivered comfort and efficiency.

Item 26 - Picture 1 increased insulation and LESS flex duct use is recommended

The cloth tape duct sealing should be removed and replaced with proper UL approved foil tape or duct mastic for extended service life and performance. Cloth duct tape fails 100% of the time in laboratory tests.

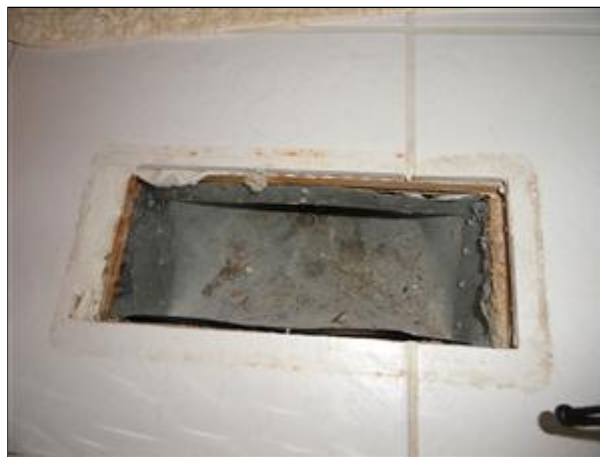
27. (5) All of the HVAC ducts should be cleaned professionally to avoid the circulation of unwanted odors, debris and pollutants throughout the conditioned airstream and living quarters. It is also good practice to seal the register "boots" to their openings using foil tape, spray foam or caulk. The use of a National Air Duct Cleaning Association (NADCA) member is recommended.

Item 27 - Picture 1 clean ductwork

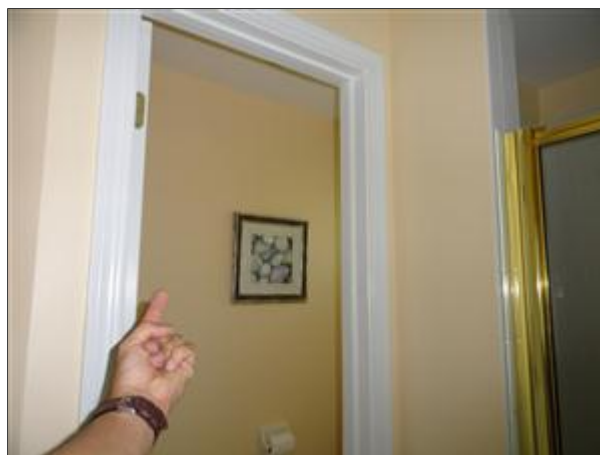
29. (7) The bath fan located in the water closet of the master may not be sufficient to remove latent air post bathing. The Clients should consider an additional fan in the main bathing area, ideally equipped with a bath fan timer switch for extended run cycles.

Item 29 - Picture 1 sole fan in water closet

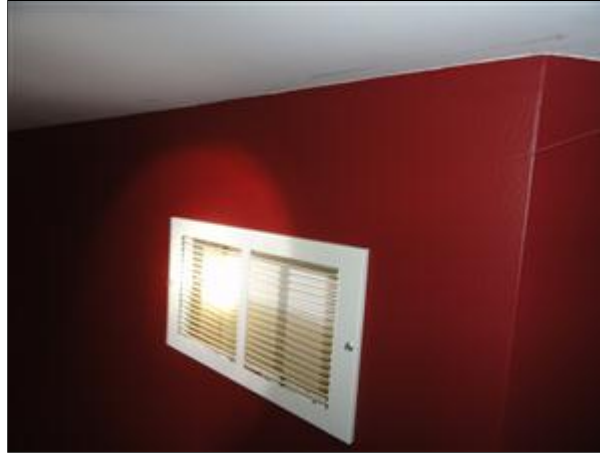
30. (8) Some of the return ductwork in the home is "panned". While allowable by some codes, panned ductwork is not ideal as it uses the framing cavities instead of dedicated ductwork for its return or supply path. This can introduce allergens and particulates as well as unconditioned air from adjoining interstitial spaces into the conditioned airstream and

increase energy costs. The use of dedicated ductwork is recommended and should be evaluated by a qualified HVAC contractor.

Item 30 - Picture 1 panned ductwork

NOTE for those return ducts at 2nd floor that ARE NOT routed through attic-- a simple, but not perfect, repair is to remove the existing grille and install a piece of rigid foam cut neatly to size and wedged/sealed in the wall cavity ABOVE the return as the routing of these returns are below the grille back to the furnace.

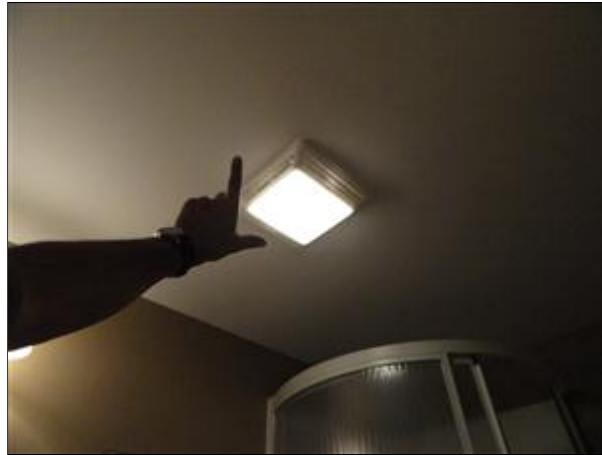
32. (10) The basement bathroom exhaust fan did not operate properly at the time of inspection and may require repair or replacement (frozen motor sound)

Item 32 - Picture 1 repair/replace bath fan

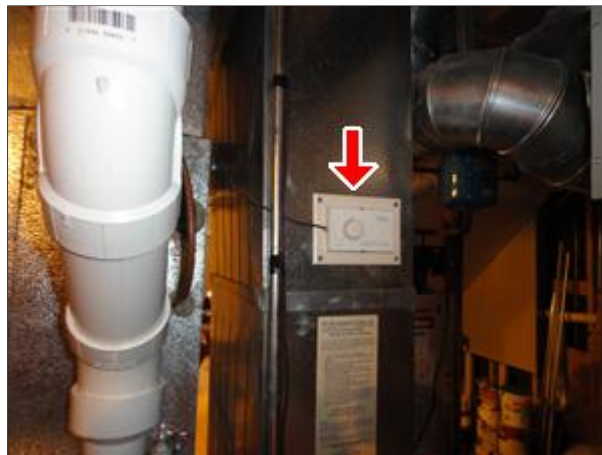
33. (11) The humidistat control would ideally be placed next to the thermostat control. It's placement in the furnace closet presents an 'out of sight, out of mind' situation for the homeowner. The humidistat requires frequent adjustment during the heating season. Therefore, it is recommended that the humidistat be relocated next to the thermostat.

Item 33 - Picture 1 recommend relocation

The humidifier pads should be replaced twice during the heating season to avoid mineral and biological growth build up and improved performance and indoor air quality of the humidifier. An indoor hygrometer of decent quality is recommended to effectively evaluate indoor humidity levels in order to adjust the moisture levels on the humidistat and keep within comfort range during winter, typically between 35-45% relative humidity. Summer humidity levels should not exceed 50% if possible. Note, during periods of very cold weather, the humidity scale on the humidistat may provide too much moisture as the furnace will be cycling much more frequently, thus adding more moisture to the air. Care should be taken to "throttle" back moisture levels during these times.

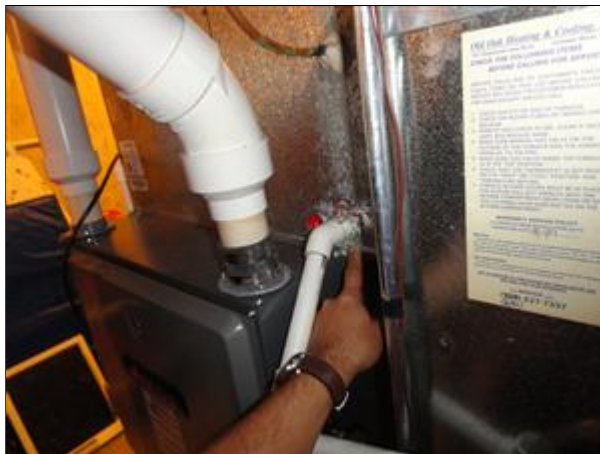
34. (12) Condensation staining and air gaps were noted at the air conditioning lineset entry points into the HVAC unit. These entry points should be sealed a licensed and competent HVAC contractor in order to prevent further condensation and possible damage to the HVAC equipment.

Item 34 - Picture 1 seal entry points

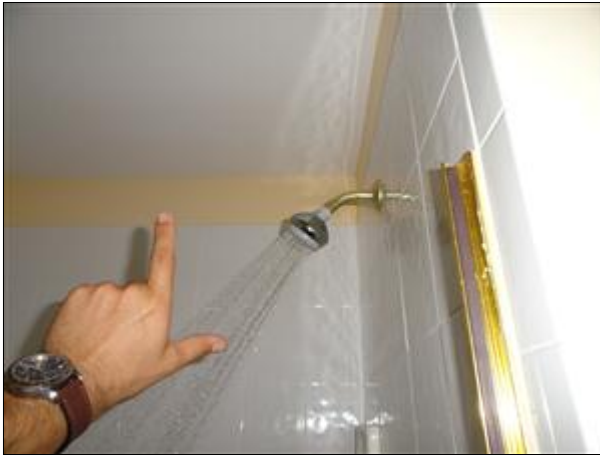
36. (2) Several plumbing deficiencies or repairs are required in the home. The following were noted and should be addressed by a qualified plumbing contractor or handyman should the repair be basic.

Item 36 - Picture 1 low master water volume, shower

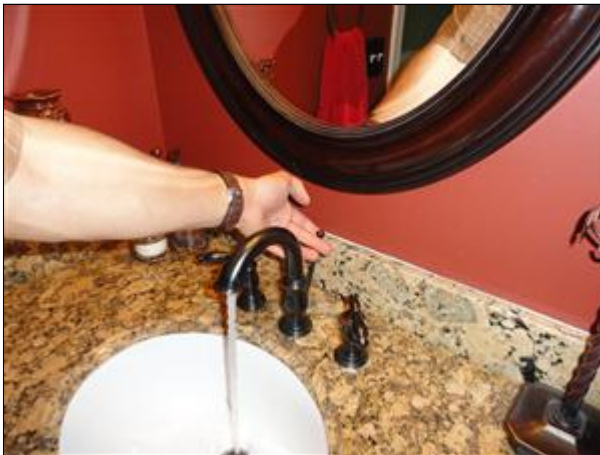
Item 36 - Picture 3 powder room pop up

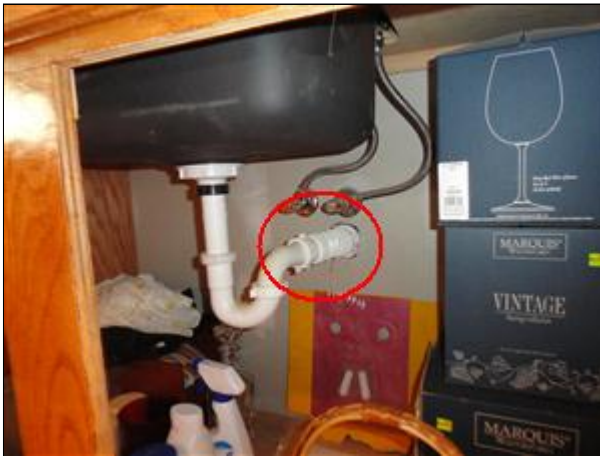
Item 36 - Picture 5 recommend replacing corrugated drain pipe with smooth wall metal, wet bar

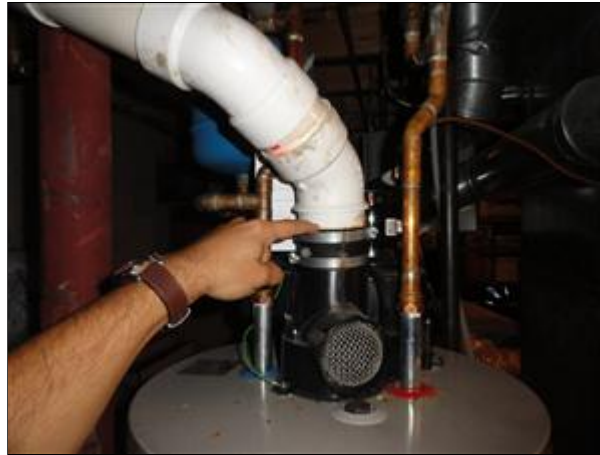
Item 36 - Picture 7 condensate 'roll back' after exhaust operation, not threatening

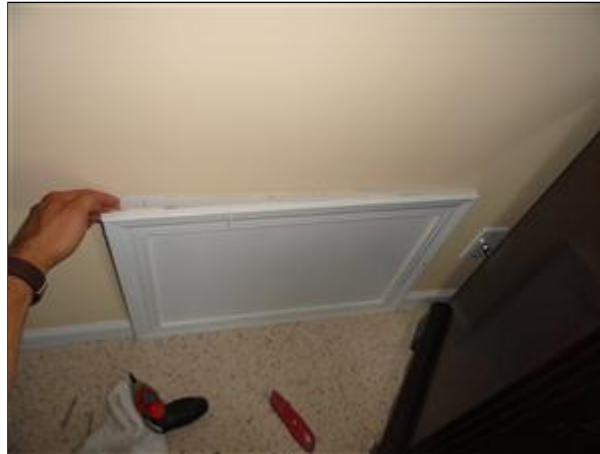
37. (3) The access panel to the hydromassage bathtub motor should be made readily accessible so that the components inside may be easily serviced, maintained, or accessed in the event of an emergency.

Item 37 - Picture 1 unable to access without damage to area

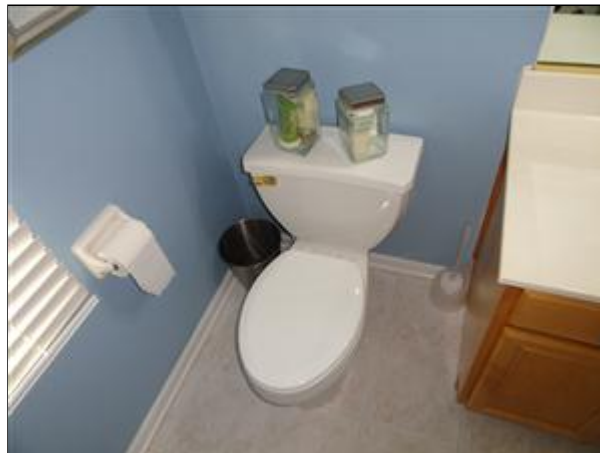
38. (4) The toilet is not adequately secured to the floor. This can result in deformation of the wax ring seal, leaking, and other damage. The toilet should be evaluated by a licensed plumber in order to determine if removal and reinstallation as necessary.

Item 38 - Picture 1 guest bath, 2nd fl

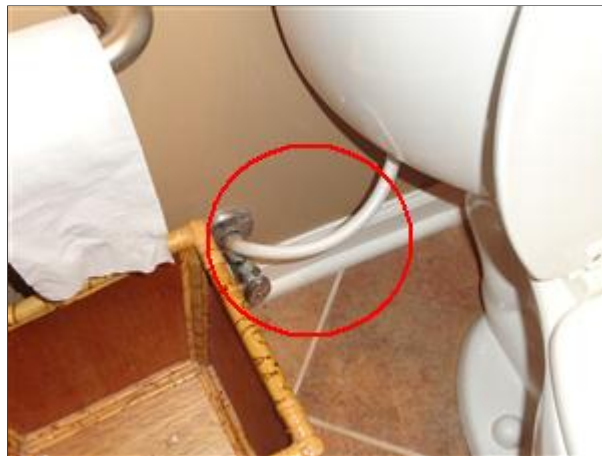
40. (6) The installation of stainless braided supply lines is recommended for each fixture to increase abrasion, puncture and bursting resistance levels.

Item 40 - Picture 1 basement toilet line

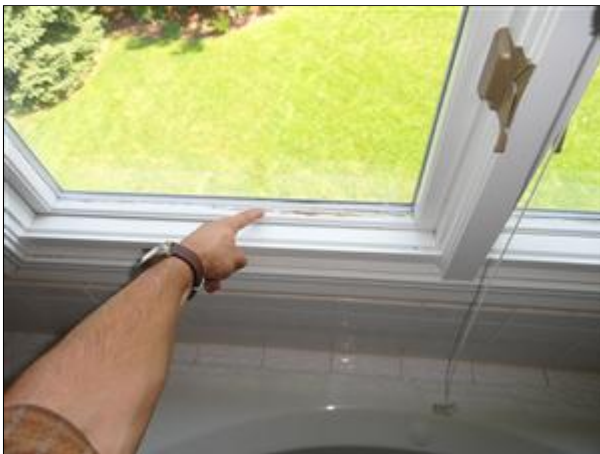
- 42. (1) Multiple interior blemishes or required repairs exist, some of which are omitted from this report and considered maintenance. A qualified drywall, plaster or painting contractor, or handyman is recommended to repair these areas as needed for proper appearance. Finish painting may be required which may 'flash' over the existing finish.

Item 42 - Picture 1 wood deterioration, master bath

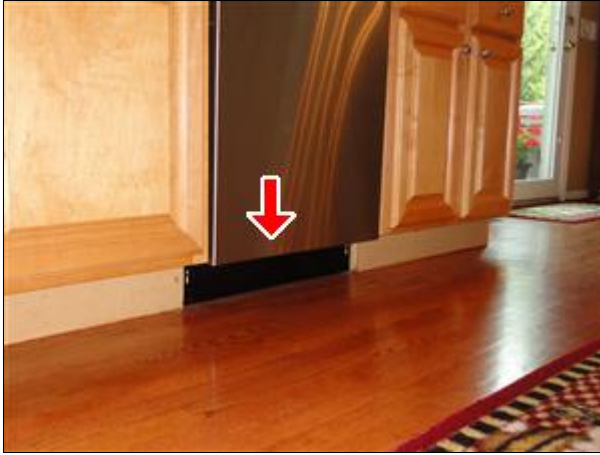
Item 42 - Picture 3 color matched toe kick for appearance recommended

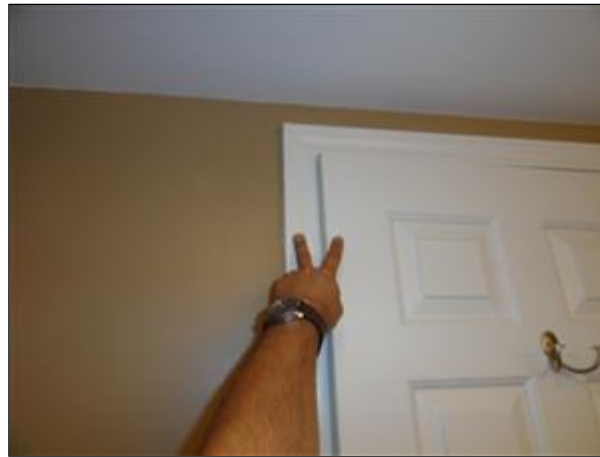
Item 42 - Picture 5 basement bathroom door fitment

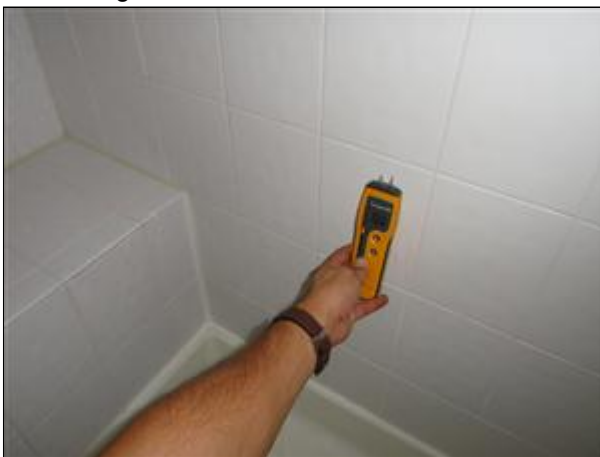
43. (2) Poor tiling details and open grout joints at the master shower have allowed moisture penetration for unknown length of time. The tiling will, and should, be removed to assess substrate condition and reinstalled by a competent and qualified tile setting contractor.

Item 43 - Picture 1 baseline moisture reading

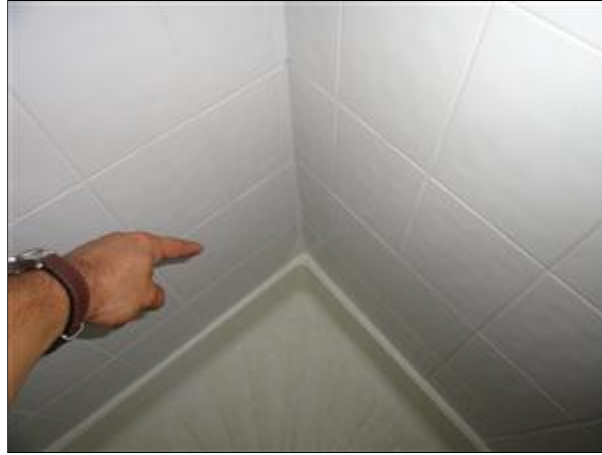
Item 43 - Picture 3 reseal shower junctions

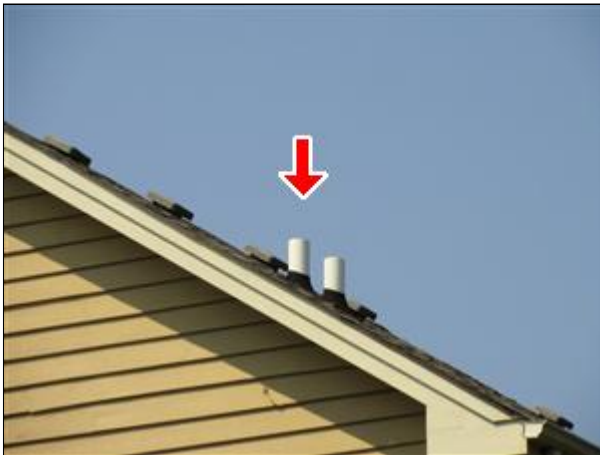
45. (4) A past stain was noted at the SE living room ceiling and may be attributed to the (inaccessible) vent flashings at this location. Further review by a a qualified roofing contractor may be desired or required.

Item 45 - Picture 1 flashings may have degraded

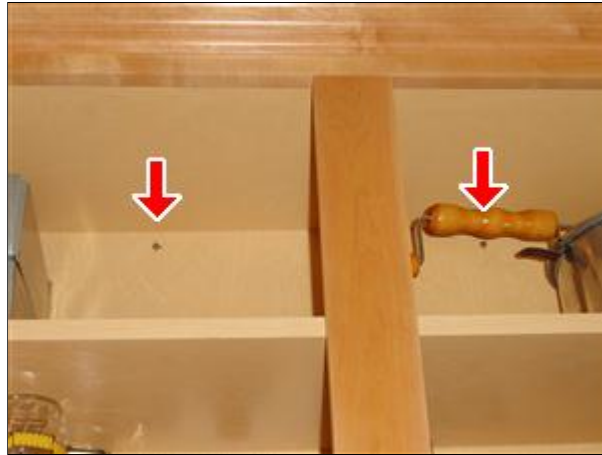
Item 46 - Picture 1

46. (5) Some of the screws used to fasten the cabinets to the wall framing are not the recommended washer head screws. ALL non cabinet rated screws should be removed and replaced at ALL UPPER cabinets in order to reduce the risk of the cabinets pulling through the existing fasteners and loosening or becoming detached.

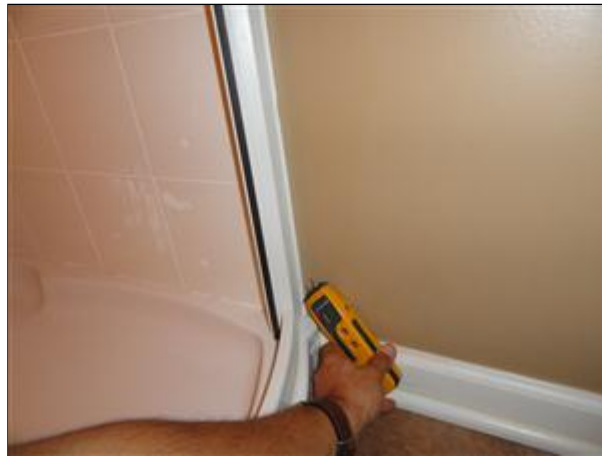
47. (6) The basement bathroom shower stall is not properly sealed and has allowed moisture to escape at the corners as evidenced by appearance and moisture meter readings. The stall should be sealed at all junctions and the drywall repaired appropriately.

Item 47 - Picture 1 elevated moisture at both corners

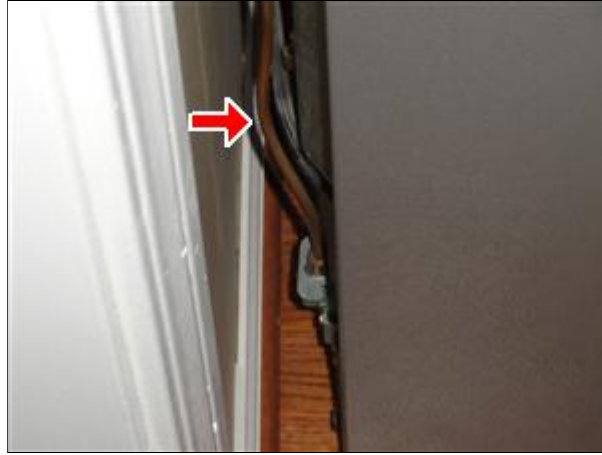
49. (2) It is recommended that the flexible copper supply piping be replaced with braided stainless steel tubing for the optimal resistance against leakage and damage to the surrounding finishes.

Item 49 - Picture 1 upgrade fridge supply

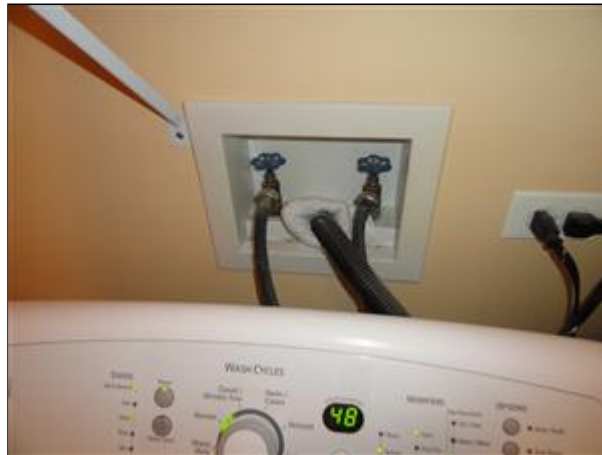
51. (4) It is recommended that the existing rubber water supply hoses at the clothes washer be replaced with braided stainless steel hoses for increased insurance against leaks and water damage.

Item 51 - Picture 1 upgrade washer hoses

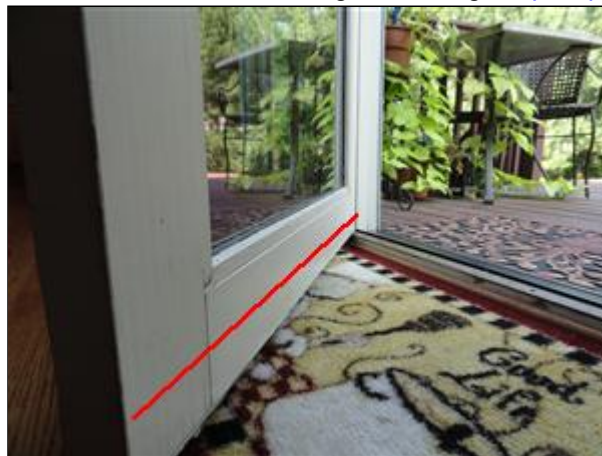
54. (3) The addition of a rain or drip cap is recommended for the kitchen 'exterior' door to reduce moisture loads and convey to the exterior. Similar items such as this are found at better building material stores or online. This is generally recommended for any exterior door without a storm door or large overhang. [Drip Cap](#)

Item 54 - Picture 1 recommend drip cap

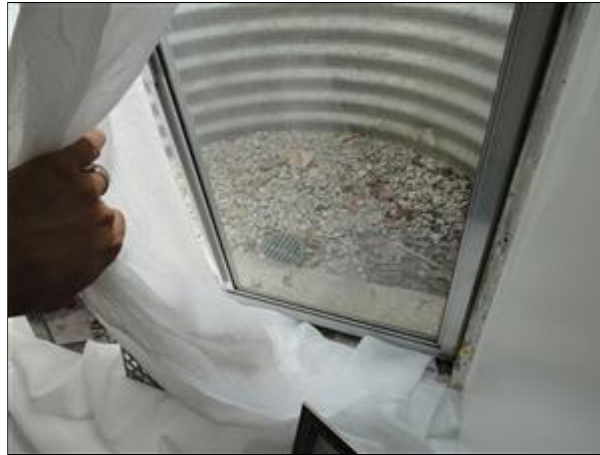
55. (4) The single pane, metal frame basement windows are poor performers in terms of energy savings. The Client is recommended to upgrade to at least a double pane, thermally glazed window. Care should be taken to follow all local fire and egress codes in terms of sizing and window construction.

Item 55 - Picture 1 inefficient windows

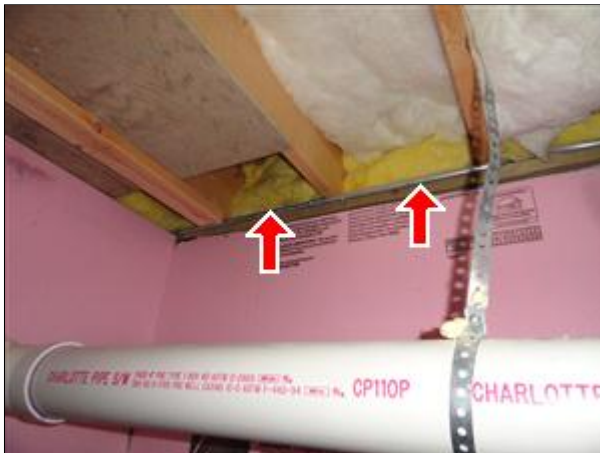
Item 56 - Picture 1

56. The box sills (area where joists rest on the foundation sill plate and abut the outer rim joist) are insulated with poorly installed fiberglass insulation. Modern building science has proven this area as a high leakage point in blower door testing as well as standard building pressure differences. It is recommended that the fiberglass be removed and either expanding spray foam or neatly cut rigid foam insulation 'boxes' installed and sealed into place for greater performance.

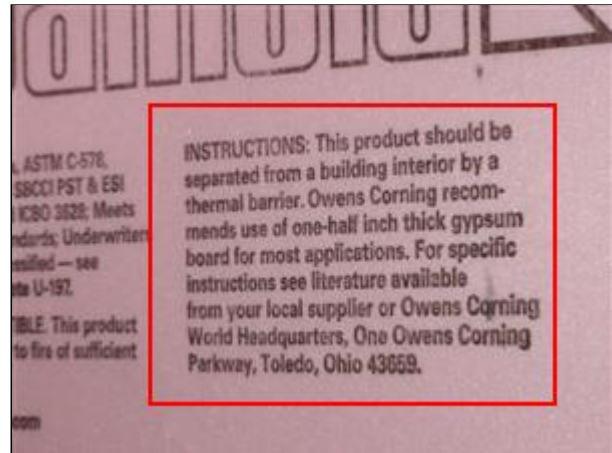
The exposed extruded polystyrene (XPS) foam board insulation in the basement should be properly covered with an approved fire retardant covering to reduce the risk of flame spread or ignition.

Item 56 - Picture 2 required fire suppression (typ. 5/8' drywall)

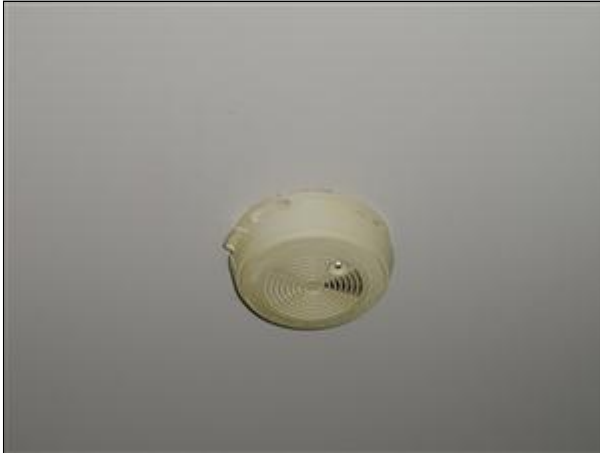
57. The smoke detectors noted in the home appeared to be at or beyond the end of their service lives, typically taken to be 10 years. It is recommended that the smoke detector and carbon monoxide detector systems be upgraded to reflect current life safety codes which include; smoke detectors on each level of living space and in each sleeping room, hard-wired 120 V smoke detectors that are interconnected in order to alarm simultaneously when any individual smoke detector responds, and low level carbon monoxide detectors on every level of living space and within 15 feet of a sleeping room. The installation of these critical life safety devices by a licensed and competent electrician is recommended.

Item 57 - Picture 1 aged detectors, replace due to low cost vs critical function
