Property, Energy & Moisture Intrusion Inspections

Inspection Report

Property Address:
4455 West Waverly Place
Anytown IL 60000

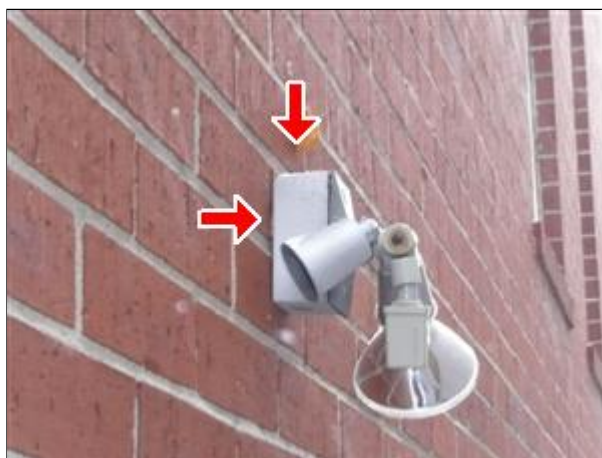
(9) Caulking is recommended at the top and sides of the exterior electrical lighting fixtures, equipment and outlets in order to prevent moisture penetration into the home and/or moisture contact with energized electrical equipment.

A. Picture 16 seal tops and sides of fixtures and outlets

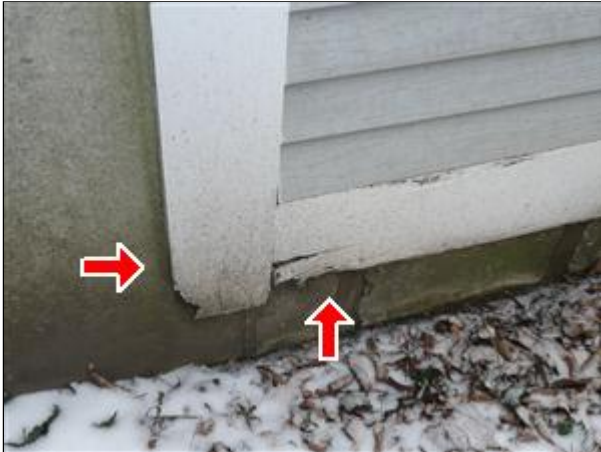
(1) The base garage trim is missing a z-type flashing between it and the aluminum siding above for proper moisture management and should be repaired by a qualified contractor. The base trim should be replaced at that time, preferably with composite material for longer service life and rot resistance.

B. Picture 1 aged trim, west garage

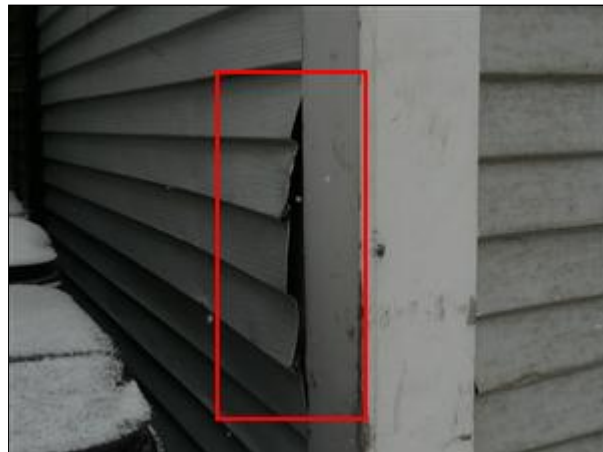
B. Picture 5 repair south siding

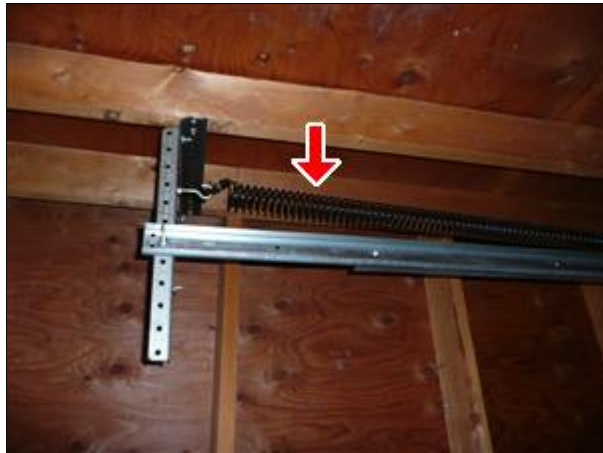
(4) Containment cables should be installed through the garage door extension springs in order to reduce the risk of injury in the event of a catastrophic spring failure.

B. Picture 9 missing containment cables

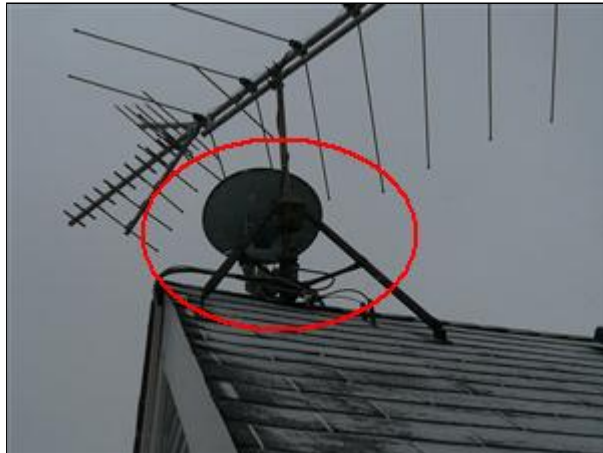
(3) It is poor practice to mount satellite dishes to roof surfaces. These penetrations can introduce leaks or damage to roof sheathing, especially in high winds. The dish should be relocated to a structural portion of the building other than the roof.

C. Picture 3 recommend relocation

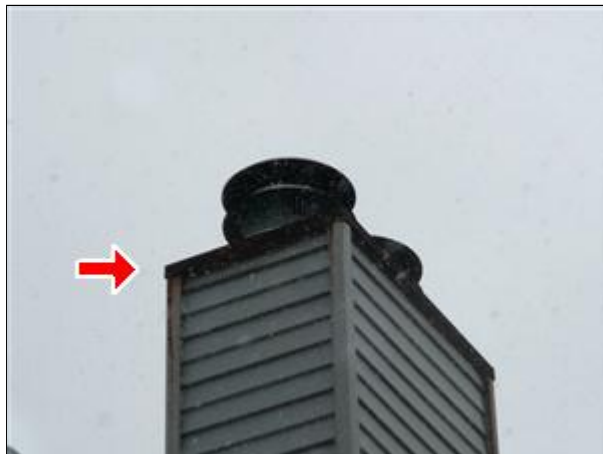
(4) The west metal chimney crown is rusted and was unable to be inspected. Its replacement appears likely and should be budgeted for by the Client.

C. Picture 4 heavy rust of west metal crown

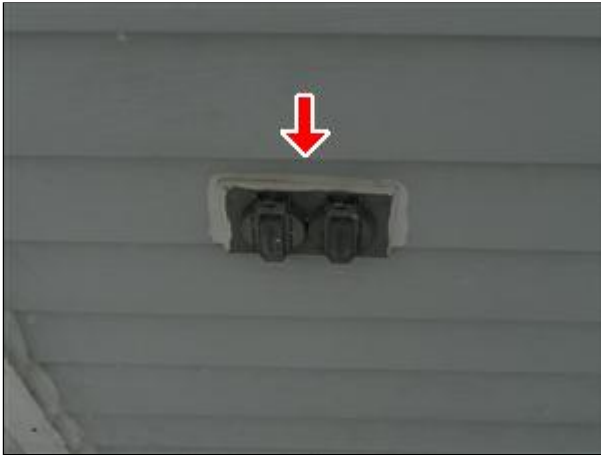
It is recommended that **ALL** electrical receptacles in the bathrooms, wet bars, kitchen and food service counters, garage, and all exterior locations be upgraded to GFCI protected receptacles by a licensed and electrician in order to reduce the risk of electrical shock and injury.

D. Picture 1 upgrade aged exterior outlets

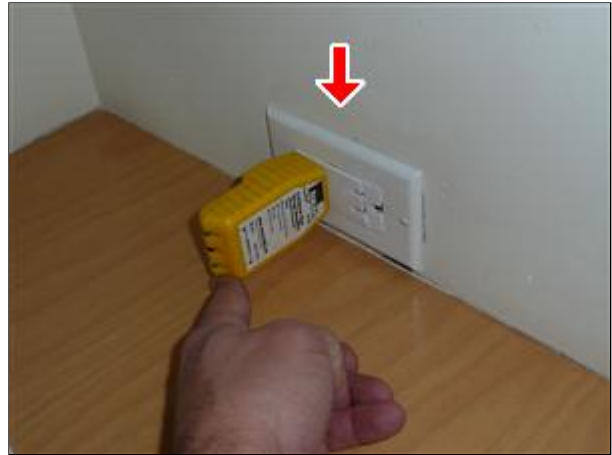
D. Picture 2 upgrade kitchen 'nook' outlets

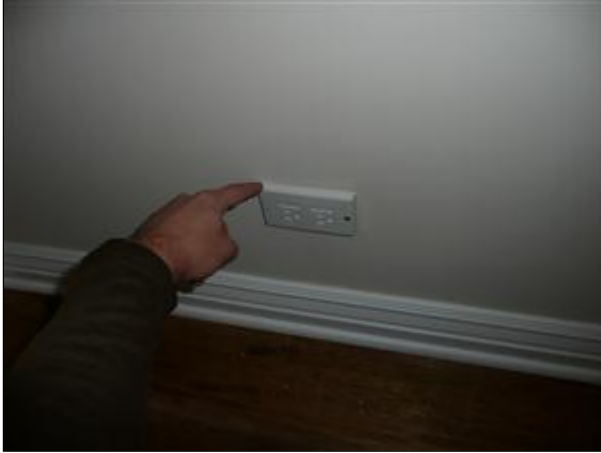
(4) Several of the child proof outlet protectors are loose and should be secured to provide proper plug alignment and insertion efforts.

D. Picture 6 align and secure child safety covers

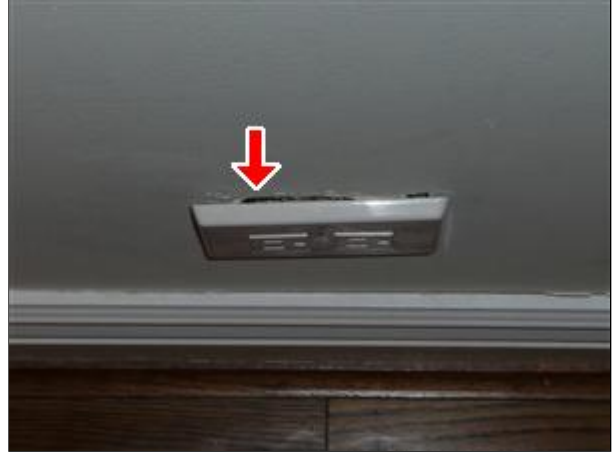
D. Picture 7 hallway outlet outside childrens' bath

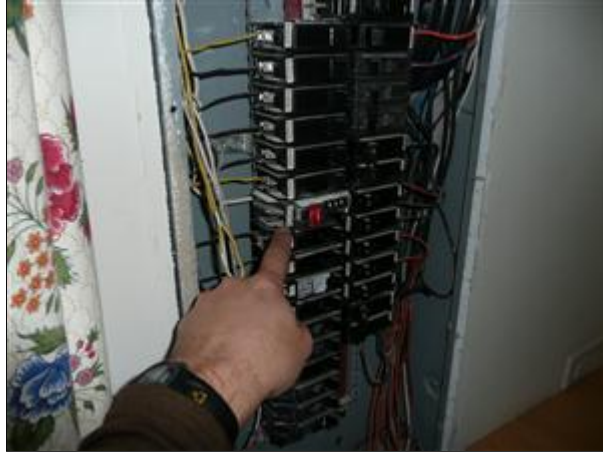
(7) The GFCI protected breaker, presumably for the master hydromassage tub as labeled, is not energized. The Client may wish to have the circuit energized versus a local GFCI outlet at the tub for safety purposes.

D. Picture 11 breaker in OFF position

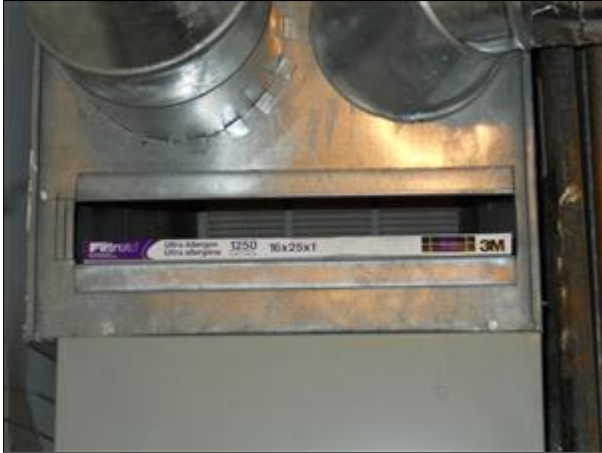
(1) The first floor furnace filter rack is poorly fitted and allows the bypass of filtered air into the conditioned air stream. The filter rack should be retrofit for substantially tight fitment included with a filter cover.

E. Picture 1 poor rack fitment

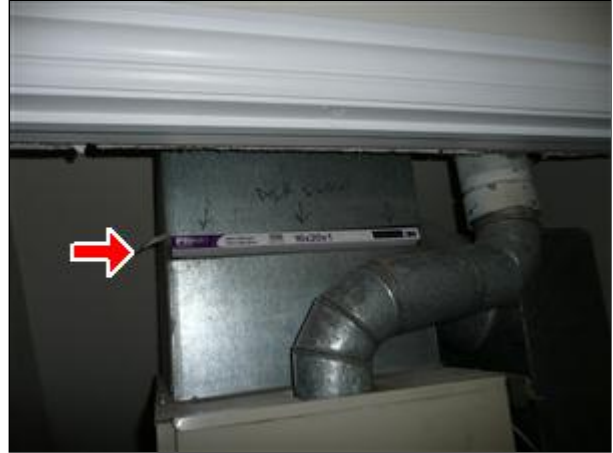
E. Picture 2 install filter cover for 2nd fl furnace

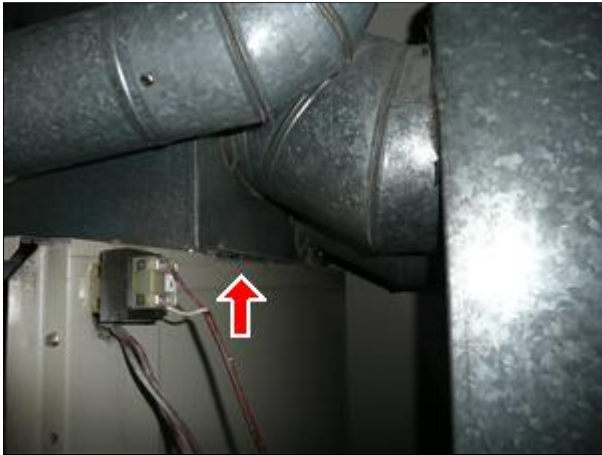
Gaps were noted in the supply and return air duct work and/or in the HVAC plenums. These gaps create air leaks which can reduce the efficiency of the HVAC unit, and which can negatively impact both indoor air comfort and indoor air quality. The supply and return air ducts should be sealed using approved materials and industry-standard methods-- typically UL approved foil tape or duct mastic. The use of cloth duct tape is NOT recommended due to its 100% failure rate.

E. Picture 3 large plenum gap @ 2nd fl furnace

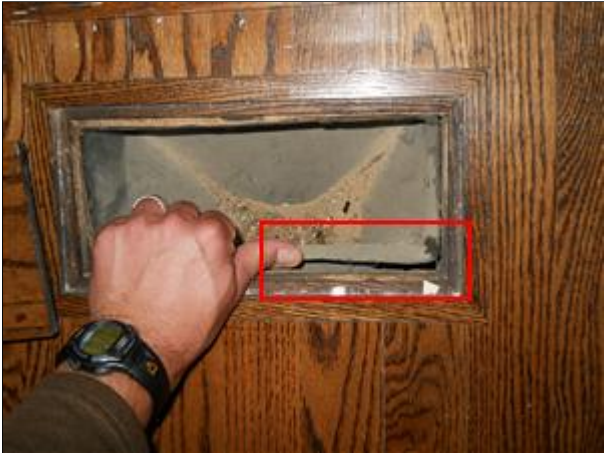
(3) The HVAC register boots/grilles are poorly fitted to their rough openings. This increases the likelihood of energy losses and diminished temperature delivery of conditioned air. The boots should be sealed to their openings with proper methods and materials for maximum energy savings and occupant comfort. A qualified contractor should repair as needed.

E. Picture 6 note boot gap

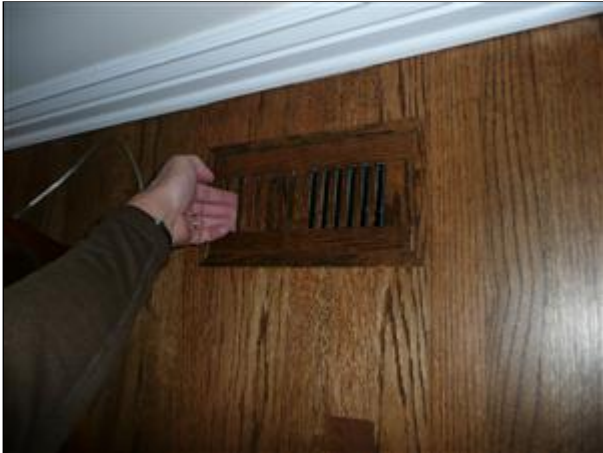
E. Picture 7 registers should be readily removable

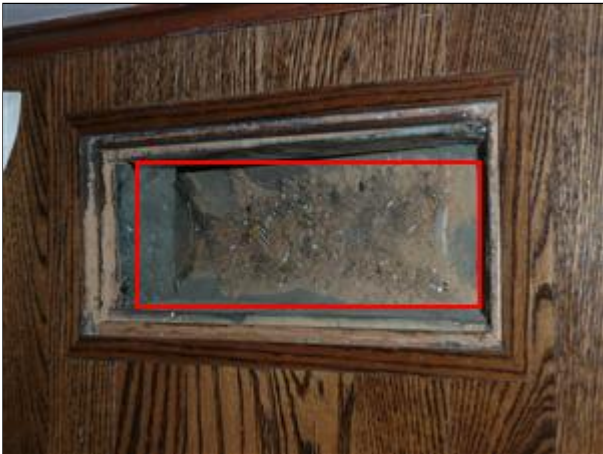
E. Picture 8 master BR vent, east

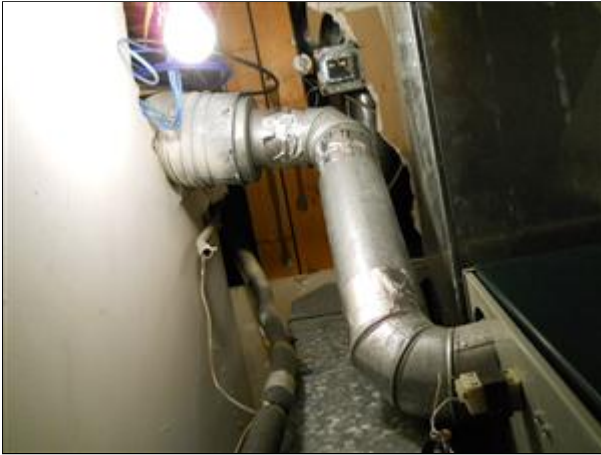
(4) The furnace closet is not adequately protected from fire spread. The combustion closet and penetrations should have 5/8" fire rated drywall or equivalent, taped at all edges, installed and/or intumescent foam or caulking to prevent flame spread to the framing members which abut attic framing members. A qualified contractor should repair.

E. Picture 9 seal 2nd fl furnace closet

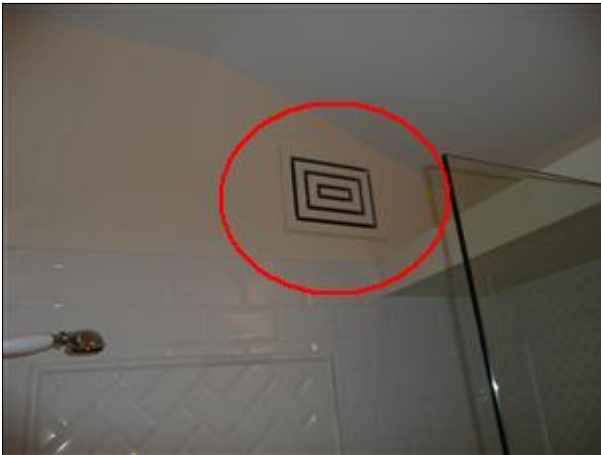
(5) The bath fan(s) within the shower enclosure may not be rated for wet location operation and increase the risk of shock injuries due to moisture and vapor presence and travel. The fan(s) should be repaired or replaced with properly rated units by a qualified electrician for safe operation and shock avoidance.

E. Picture 11 2nd fl bath fan

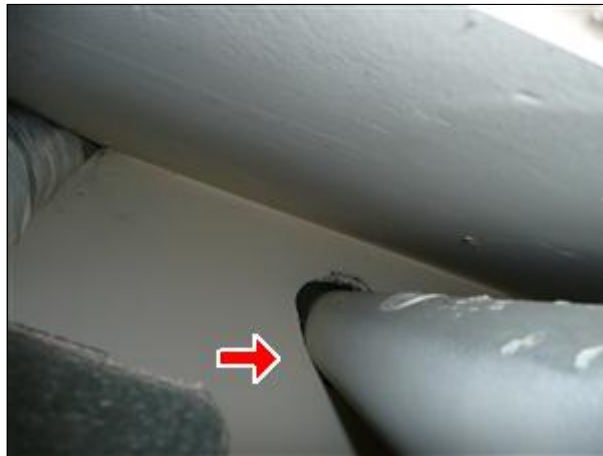
E. Picture 14 B vent clearance needs 1" airspace from combustibles

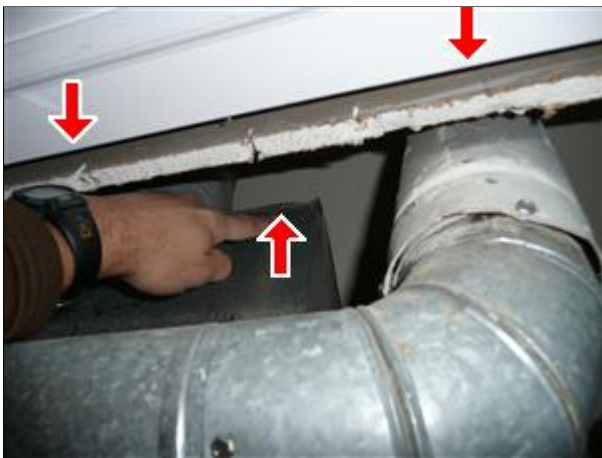
E. Picture 15 seal gaps at drywall penetrations

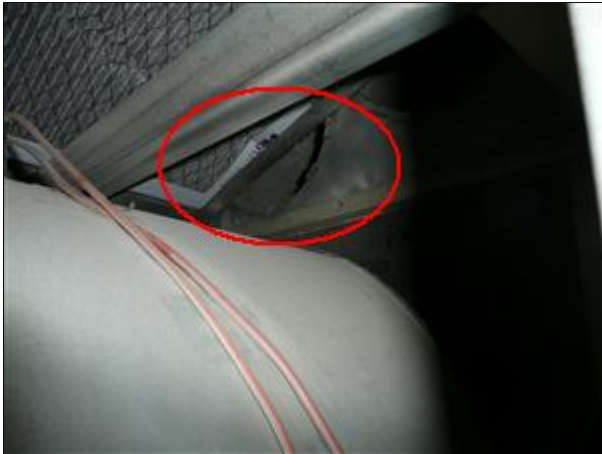
(7) The 2nd floor furnace is approximately 27 years old and beyond its statistical life. Very high supply temperatures in excess of 150F were noted at several supply registers indicating unbalanced distribution and improper performance. The furnace should be replaced with a properly sized unit of the highest efficiency affordable (preferably sealed combustion, 90% AFUE or greater) and the airflow balanced by a qualified HVAC contractor certified or educated in air balancing.

E. Picture 17 large return bypass of filter, 2nd fl furnace

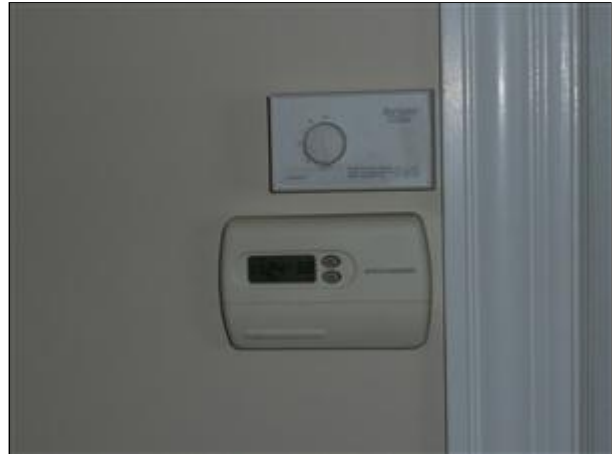
E. Picture 18 relocate t-stat of 2nd fl

The thermostat should be relocated to a more centralized location for more accurate temperature sensing.

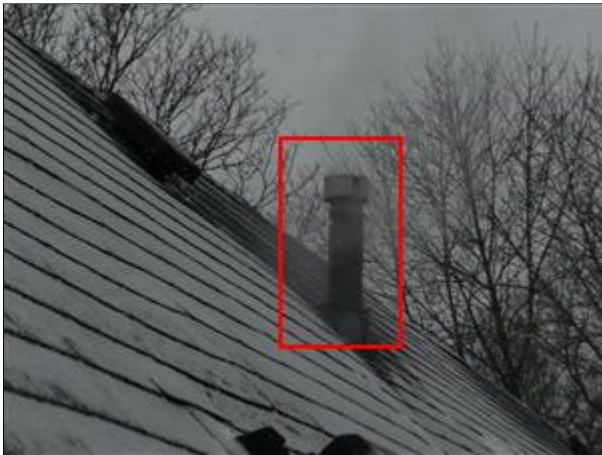
(9) The 2nd floor furnace (and kitchen fireplace chimney) exhaust vent does not meet the 2, 3, 10 rule which requires chimneys to terminate at least 3 feet higher than its roof penetration or be 2' higher than any building horizontal surface within 10'. If the furnace is to be replaced the proper clearances should be adhered to. Recommend repair of existing furnace vent.

E. Picture 21 2nd fl furnace vent

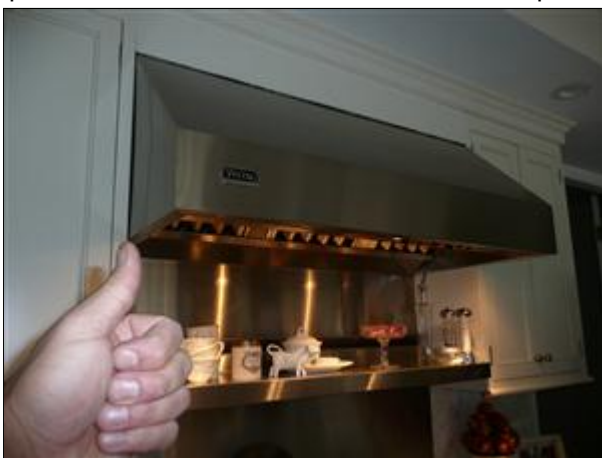
(11) The kitchen range hood is excessively loud during operation and should be serviced for acceptable sound levels while in operation. Commercial hoods such as these operate at higher than normal sound levels due to increased airflow.

E. Picture 24 loud hood operation

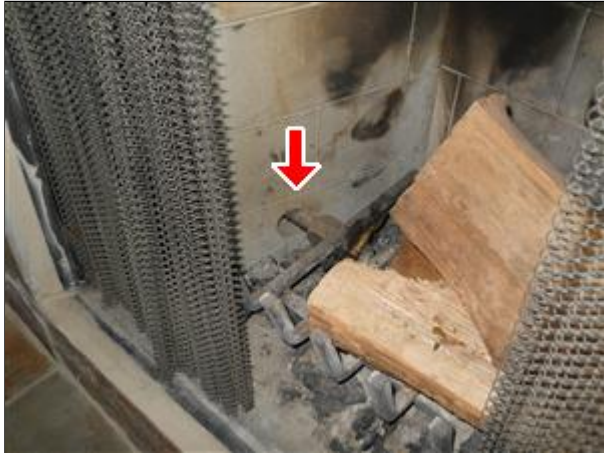
The gaps around the log lighter's penetration through the fireplace firebox should be sealed with intumescent caulk in order to prevent flames or superheated gases from entering the framing spaces.

F. Picture 1 seal all log lighter openings

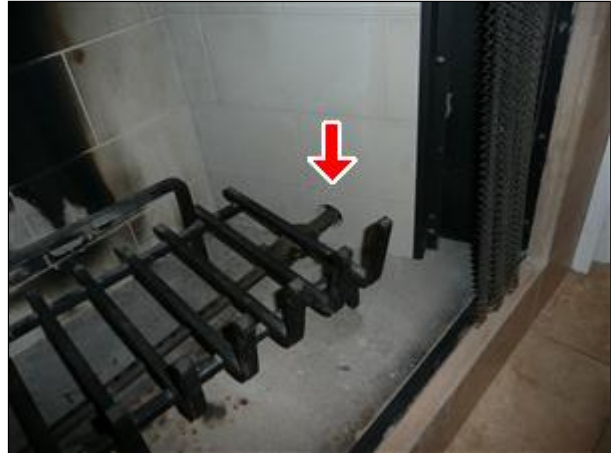
The metal wood burning fireplace is aged. The National Fire Protection Association recommends that all wood burning fireplaces be thoroughly inspected (known as a Level II inspection) by a certified chimney sweep when a home changes ownership. Evaluation of the chimney and firebox by a qualified contractor, preferably one who is a member of the Chimney Safety Institute of America (CSIA) is recommended.

F. Picture 2 master BR fireplace

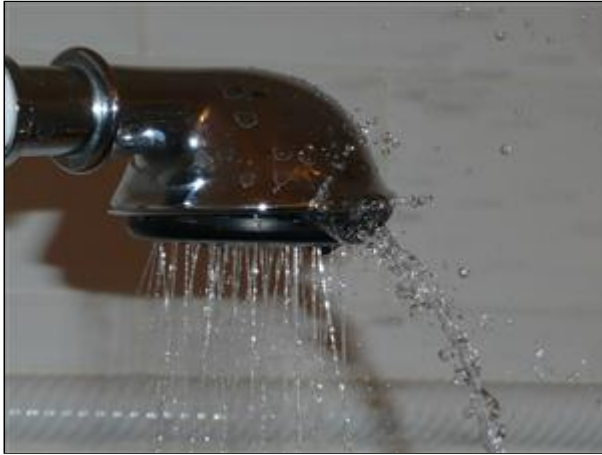
(2) Several plumbing deficiencies or repairs are required in the home. The following were noted and should be addressed by a qualified plumbing contractor or handyman should the repair be basic.

G. Picture 2 leaking 2nd fl showerhead

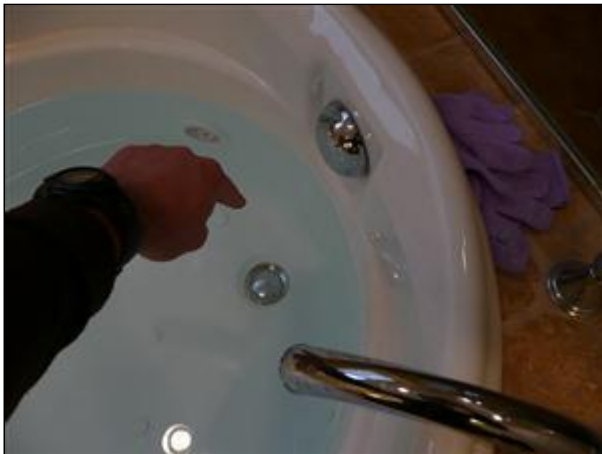
G. Picture 4 adjust master tub drain for full stoppage (water escapes in shut pos.)

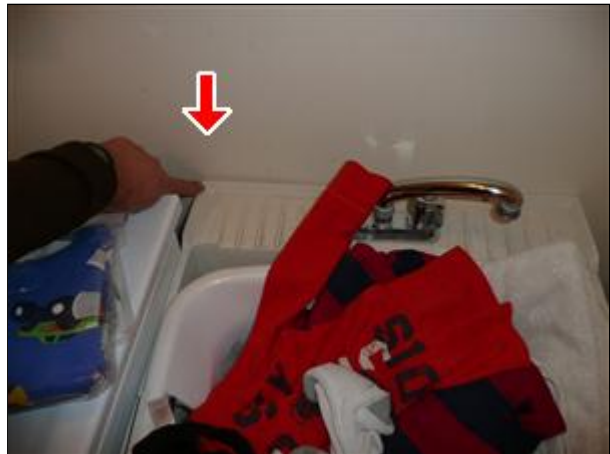
G. Picture 5 secure utility laundry sink to wall

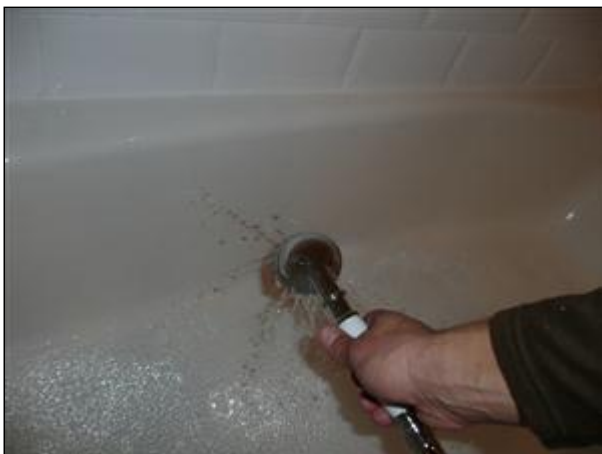
G. Picture 6 childrens' shower head

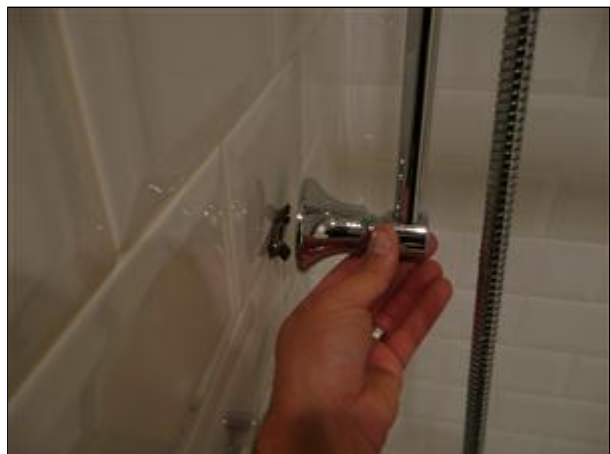
G. Picture 7 childrens' handheld sprayer bracket

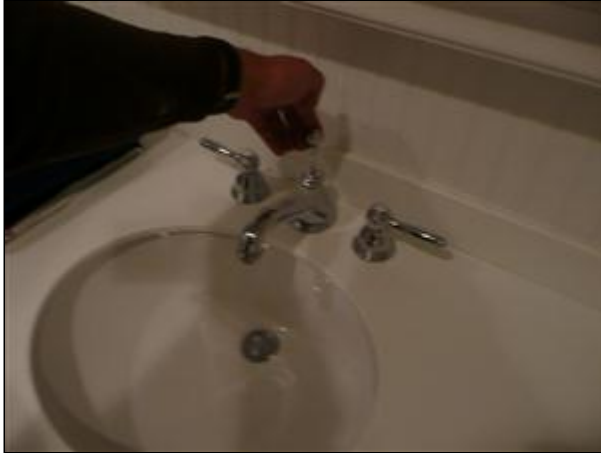
G. Picture 8 adjust childrens' bath pop-up and drain G. Picture 9 clean powder room aerator or replace

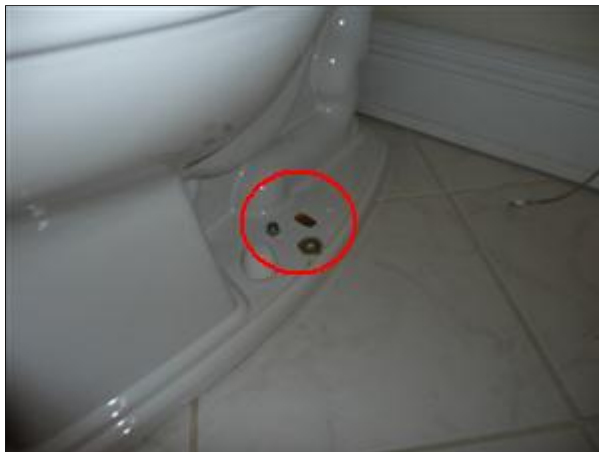
G. Picture 12 not seated toilet bolt

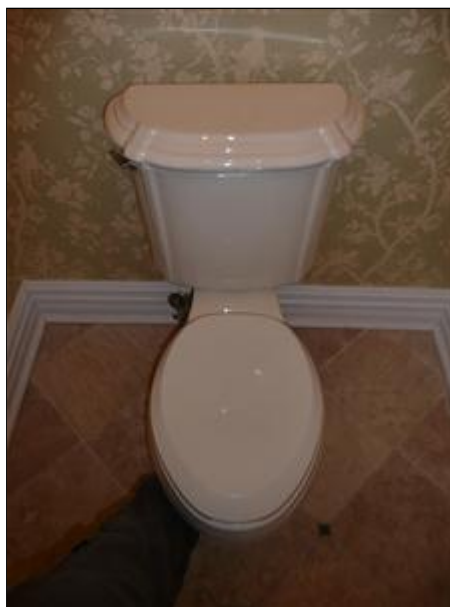
G. Picture 14 powder room toilet

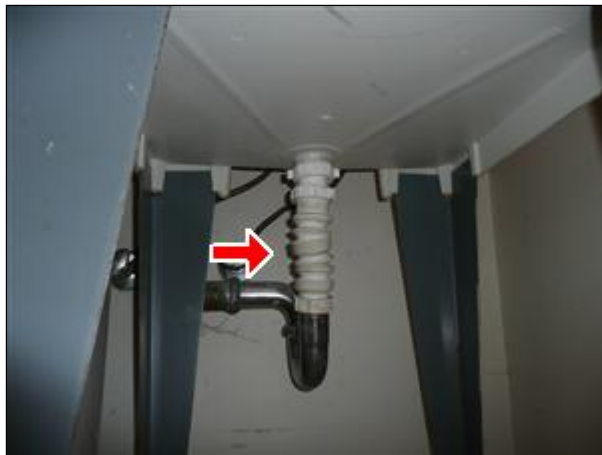
(4) The flexible and corrugated drain piping at the laundry sink should be replaced with rigid and smooth walled piping for optimal drain performance and clog prevention.

G. Picture 15 replace corrugated drain pipe

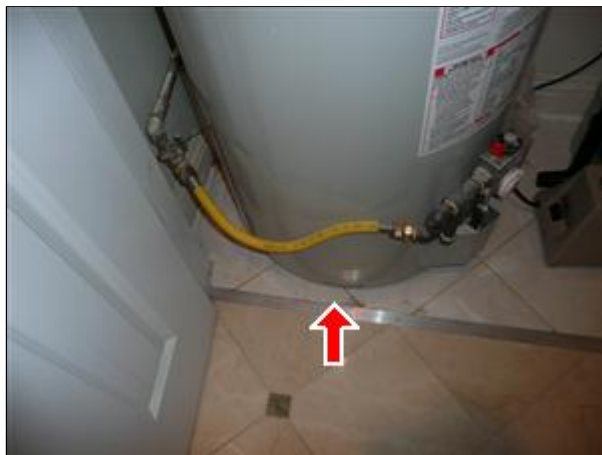
(5) A drain pan is required to be placed underneath the water heater when one is installed above living space. A drain pan should be installed and connected to the nearby floor drain in order to reduce the risk of leaking and damage.

G. Picture 16 install drain pan for HWH

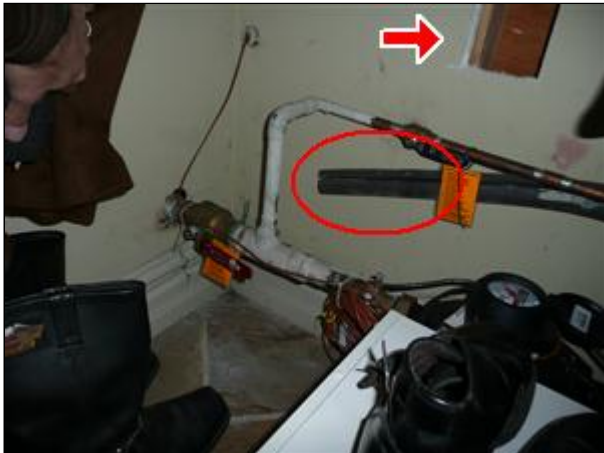
(8) The water supply piping should be insulated to reduce the risk of condensation and moisture leaks in the front foyer closet. All penetrations should be sealed to reduce drafts and energy losses.

G. Picture 20 install well fitted pipe insulation, seal gaps/openings

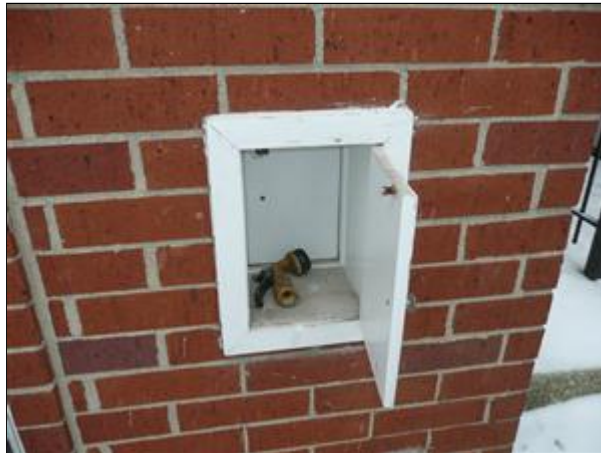
G. Picture 21 insulate access box with rigid foam

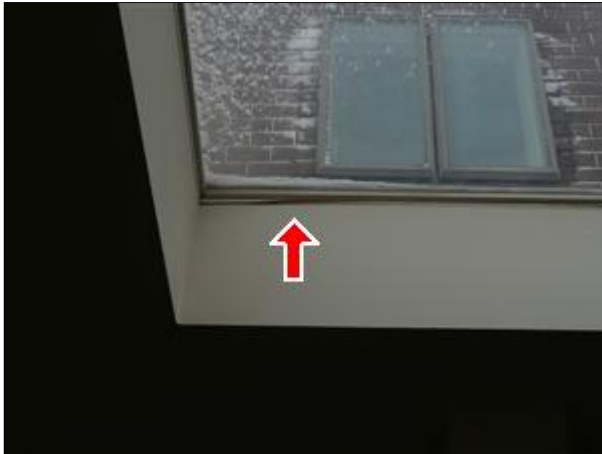
H. Picture 1 skylight trim buckling

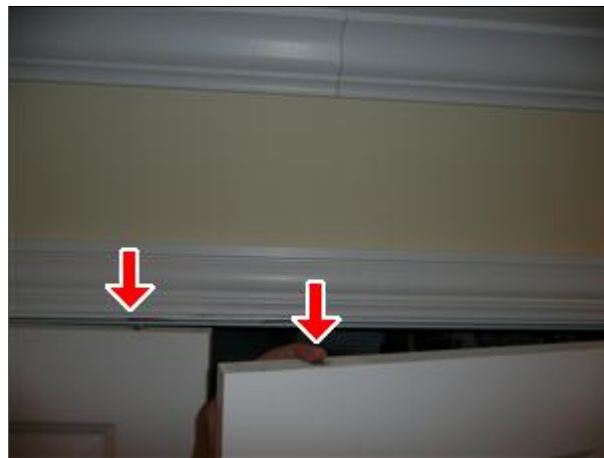
H. Picture 4 adjust closet ball catches for door fitment

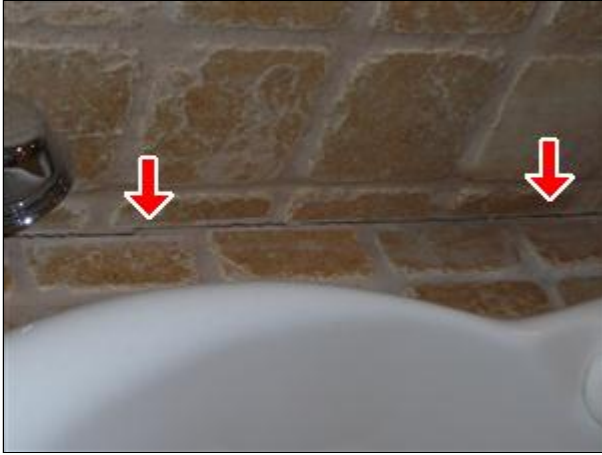
H. Picture 5 seal master tub surround junctions

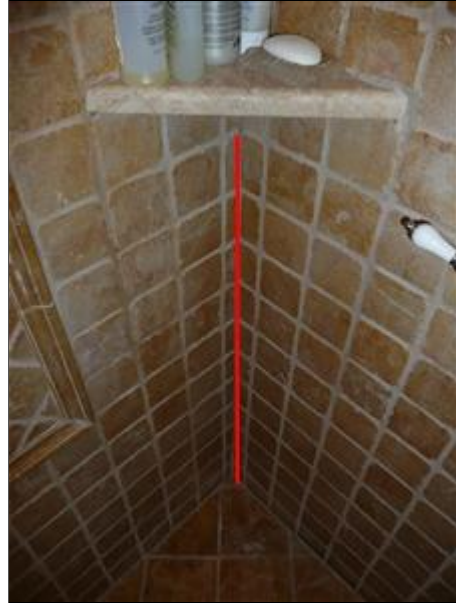
H. Picture 6 seal tile intersections, master shower

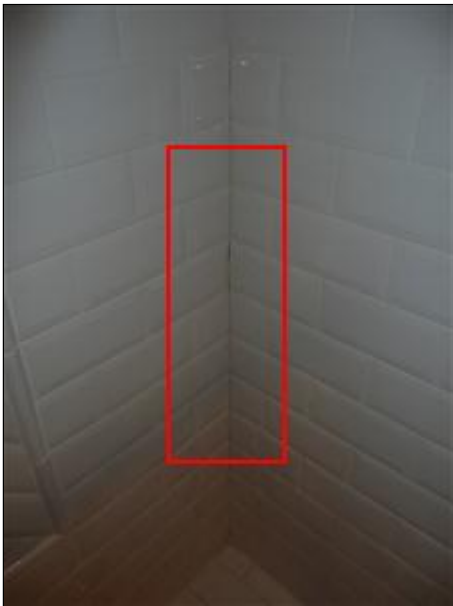
H. Picture 7 seal childrens' bath junctions

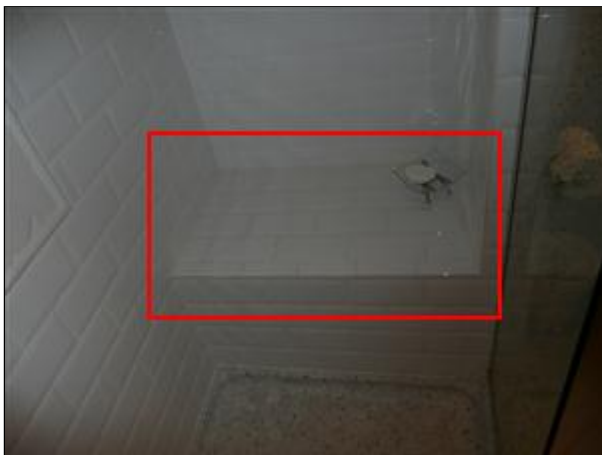
(3) INFORMATIONAL: It is poor practice to tile sills in wet locations. A monolithic piece of stone, tile, or manufactured stone (Corian, etc) is recommended to inhibit moisture intrusion and premature component failure.

H. Picture 10 recommend one piece stone or similar

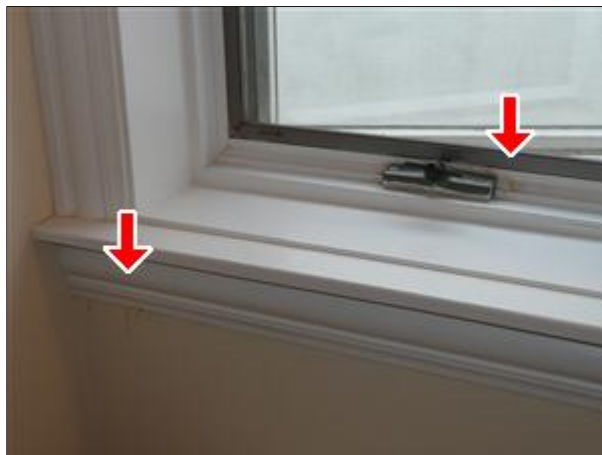
H. Picture 11 moisture staining at 2nd fl bath likely moisture control issue, not leaking

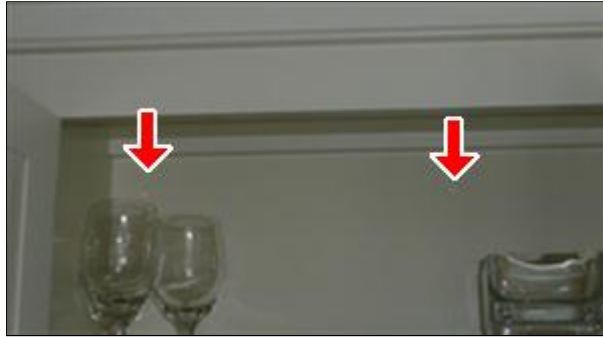
(5) The screws used to fasten the cabinets to the wall framing are not the recommended washer head screws. ALL non cabinet rated screws should be removed and replaced at ALL UPPER cabinets in order to reduce the risk of the cabinets pulling through the existing fasteners and loosening or becoming detached.

H. Picture 13 upgrade fasteners

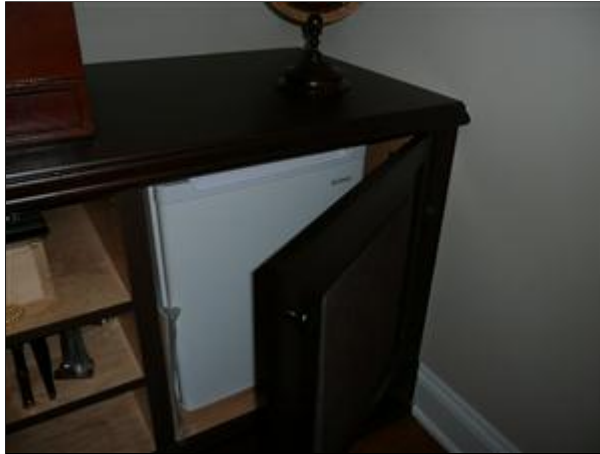
(1) The ventilation requirements of the office refrigerator may not be sufficient for optimum performance and efficiency. The manufacturer installation instructions should be consulted for accepted installation procedures.

I. Picture 1 confirm clearances and ventilation

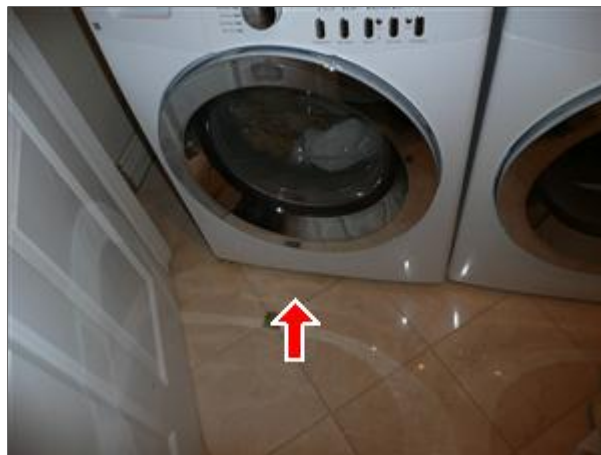
It is recommended that a pan be installed under the washer with no less than a 3/4 inch drain piped to the existing floor drain (if applicable) to prevent spills or moisture damage to the unit or unit below in the event of an accident or mechanical malfunction.

I. Picture 3 recommend drain pan

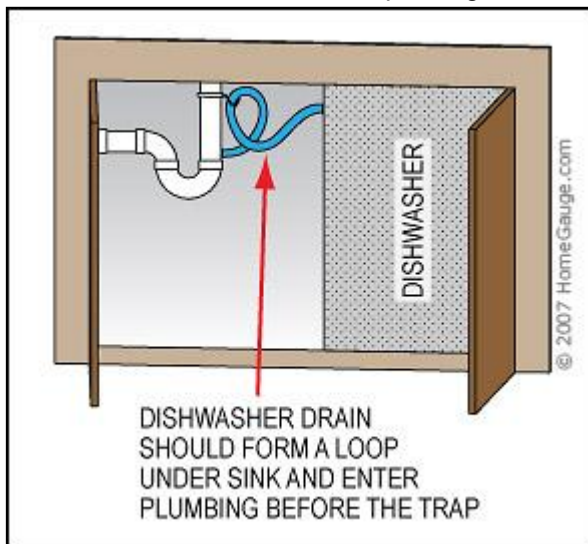
I. Picture 5

(5) The dishwasher drain hose should be configured into a 'high loop' position and secured at the underside of the counter in order to reduce the risk of drain water siphoning and cross contamination of the potable water system.

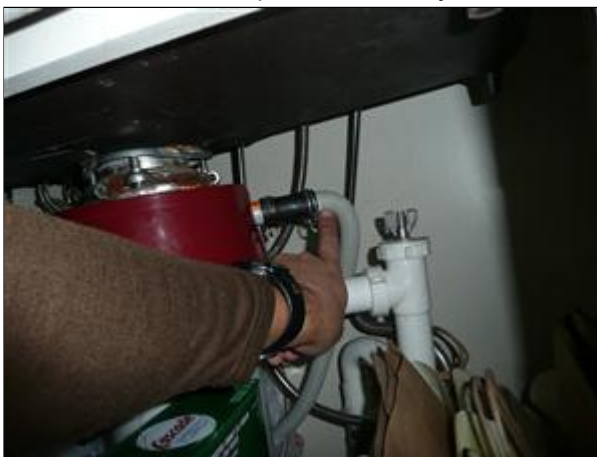
I. Picture 6 install DW drain in high loop

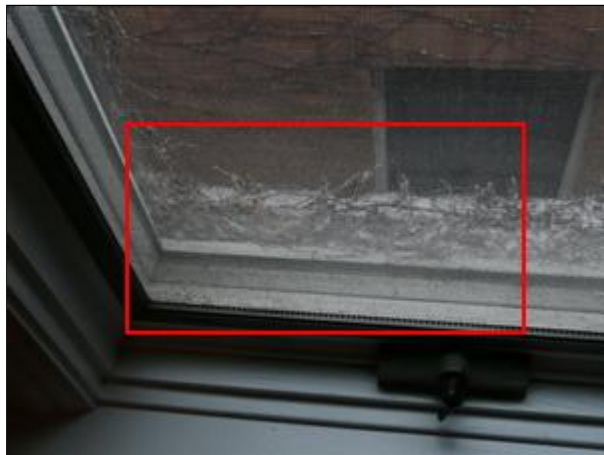
(3) Multiple windows require adjustment, repairs to hardware or glass, and overall maintenance to ensure easy operation and performance. A qualified repair contractor should evaluate.

J. Picture 7 ivy growth prevented safe operation, trim or remove

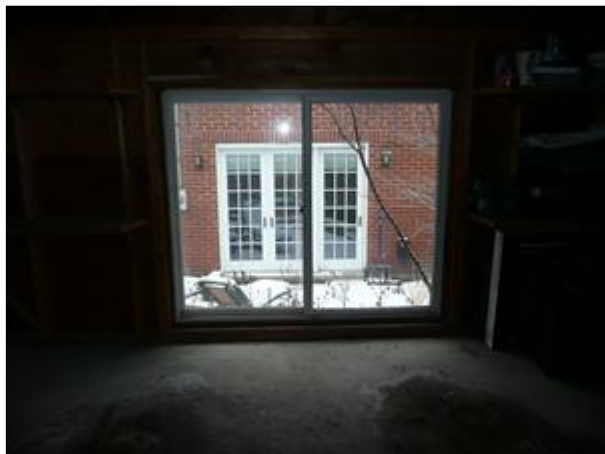
J. Picture 13 non tempered garage glass

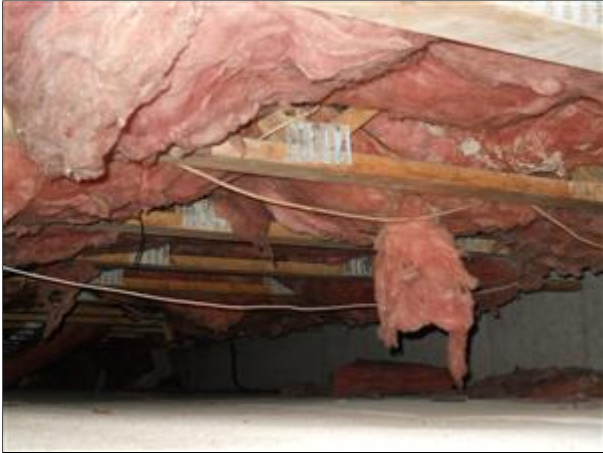
(1) The crawlspace does not conform to modern building and energy saving practices. The insulation is inadequate for our climate nor does it make contact with the "warmed" side of the joist cavity. The crawlspace should be thoroughly cleaned and the appropriate levels of insulation, as well as air sealing, installed to increase the comfort of the first floor which the Clients have indicated is often cold during heating efforts and winter-time exterior temperatures. Due to access limitations, the use of expanding spray foam at the exterior foundation walls and rim joist is recommended. All ductwork should be insulated to a minimum of R-8 as determined by the Department of Energy for our climate (can also be spray foamed AFTER duct revisions or repairs made). An adequate amount of supply air should also be added to the crawlspace to help condition the space and minimize moisture elevation and temperature differentials. The Client may reach the Inspector for more information. The crawlspace should be retrofitted by a qualified specialty or insulation contractor.

L. Picture 1 ineffective insulation

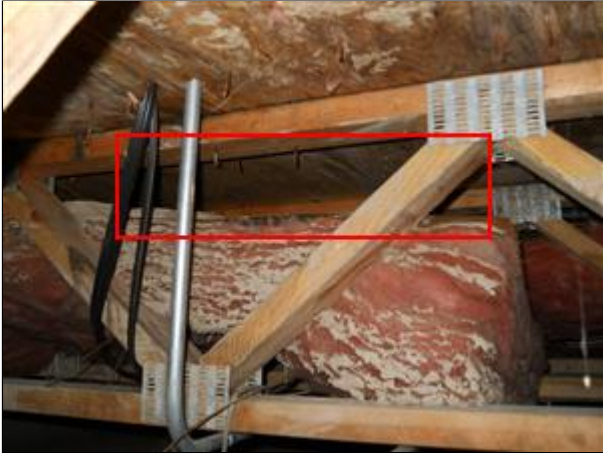
L. Picture 2 large gaps, no insulation contact

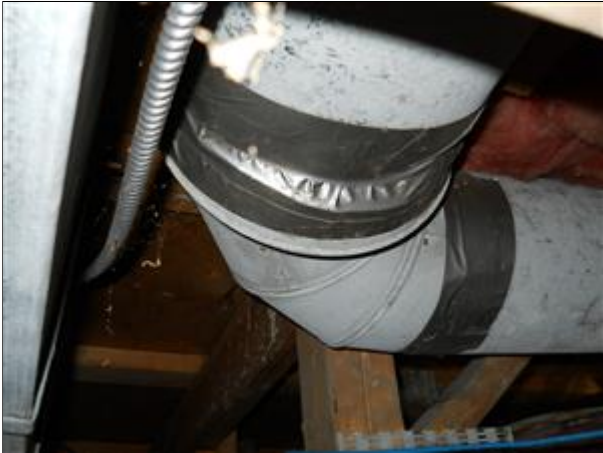
L. Picture 3 seal all duct joints with mastic or UL approved foil tape (spray foaming eliminates this step fyi)
