Inspection Report

Condominium Association

Property Address:
2468 Moldy Row
Chicago IL

This report reflects the findings of a limited scope moisture intrusion investigation performed at the request of the client named herein. The purpose of the investigation was to determine the cause of the moisture intrusion that has become evident in several areas of the interior condominium spaces. The inspection used only non-invasive techniques and therefore the concealed areas of the exterior wall assembly (wall cavities, wall framing, insulation, vapor retarders, etc.) could not be viewed. Bulk moisture can travel in unpredictable ways inside the space between the exterior wall cladding and the interior wall finishes. For these reasons, it is critically important to follow best construction practices regarding all exterior roof covering and wall cladding details so that the general risk for bulk moisture penetration into the wall assembly is reduced. This report is an attempt to compare the existing exterior wall and roof details against best practices in the industry and to make recommendations for repairs that will reduce the risk for ongoing moisture intrusion.

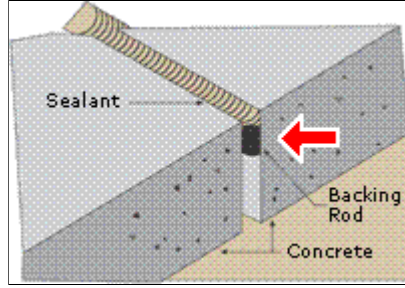
A. Picture 2 Aged and Deteriorated Caulking

(2) The application of the exterior sealants, a.k.a. caulking, was originally improper and is now also deteriorating. It is recommended that plans be made for a near-term removal and replacement of the exterior sealant joints. In order for the sealant joints to prevent drafts, repel moisture, absorb movement, and maintain durability high-quality materials inappropriate methods must be used. Please refer to the referenced article regarding exterior sealants.

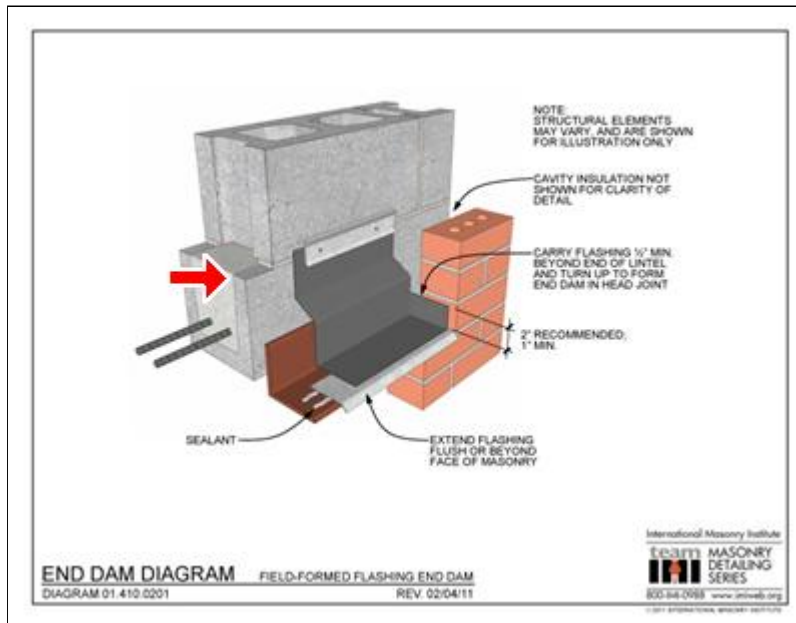
A. Picture 11 Missing Flashing

(9) The masonry wall flashings are either missing or improperly installed. The flashings should protrude from the wall by at least 1/4" at the following locations: the top of the foundation wall; above the masonry pockets where the floor joists are set into the concrete block; above and below every window and door. Missing or improperly installed wall flashing can

allow moisture to enter the home and cause rot, mold growth, and structural damage. The exterior masonry walls of this structure should be evaluated and repaired by a licensed and competent masonry contractor.

Since retrofitting of missing or improperly installed masonry wall flashing is both disruptive and expensive, it may be advisable for the condominium association to deal with this issue on a case-by-case basis. If and when bulk moisture intrusion becomes evident at the top or sides of the interior window openings then retrofitting of the missing flashings should be seriously considered.

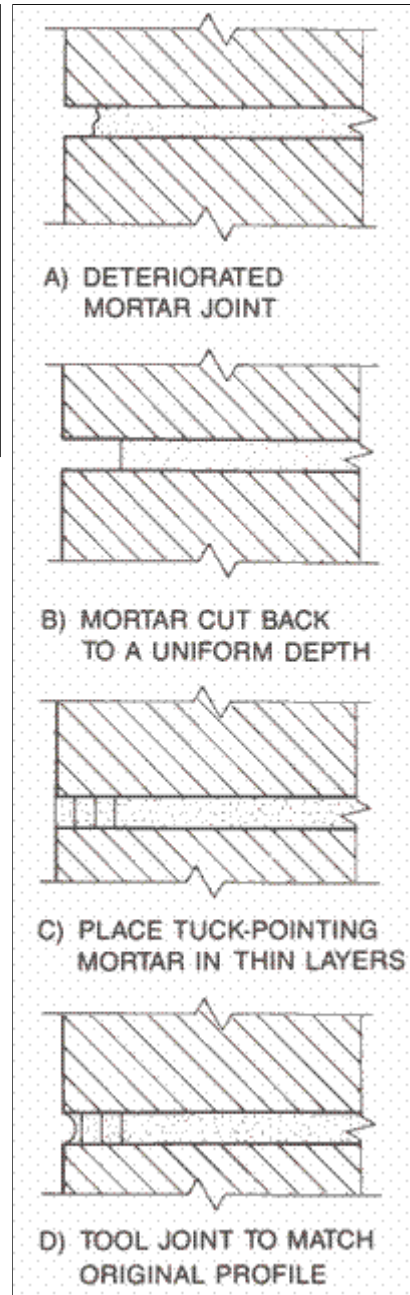
A. Picture 14 Mortar Gap

(10) The quality of the brick masonry mortar joints is substandard. Areas of the mortar appear to contain excessive amounts of sand and are not properly tooled; improperly or inadequately applied cement mortar in a brick masonry wall often leads to excess moisture saturation by the brick masonry units and, after prolonged or wind driven rains, leads to bulk moisture intrusion to the moisture sensitive interior wall components like insulation, drywall, and wood framing. It is

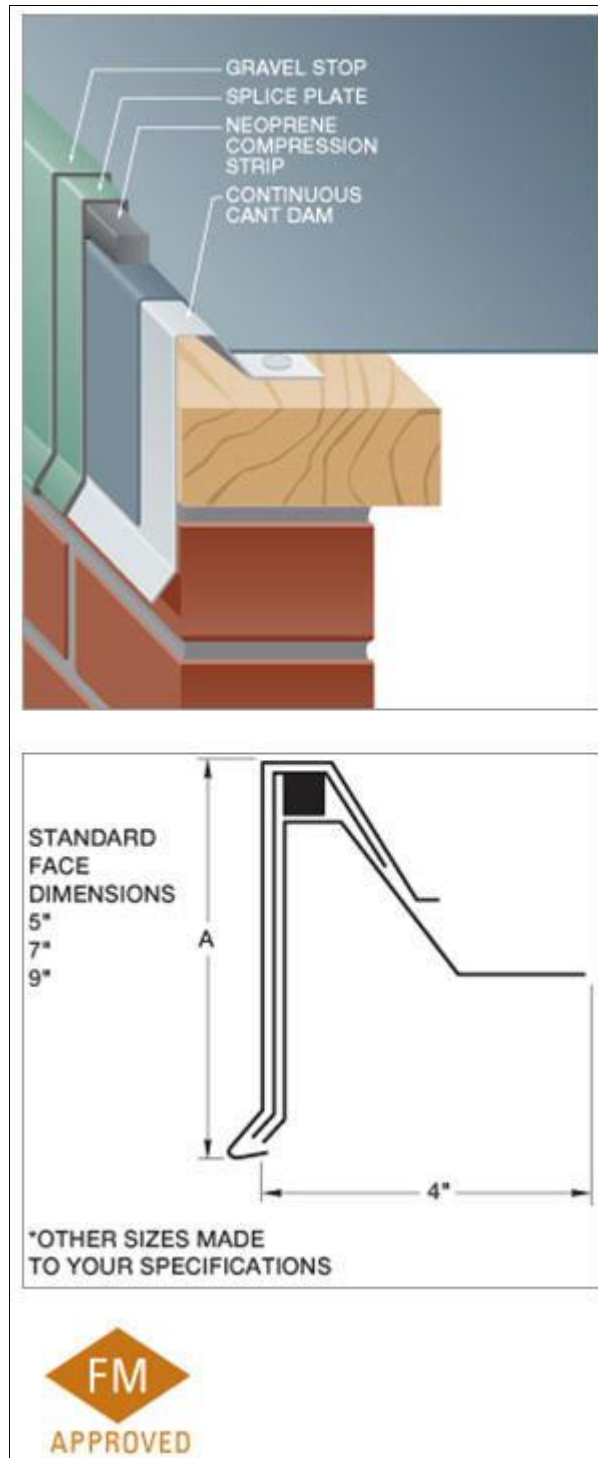
B. Picture 10 Improperly Detailed Edge Metal Flashing

(7) A number of defects were noted at the modified bitumen roof covering over the upper levels of units 3N and 3S. The failure to seal the modified bitumen roof covering at the gutter edge greatly increases the risk for moisture damage from ice damming. The material used as edge metal flashing is not approved for this use and is not properly installed. It is recommended that this roof covering be repaired as soon as possible and replaced as soon as practical.

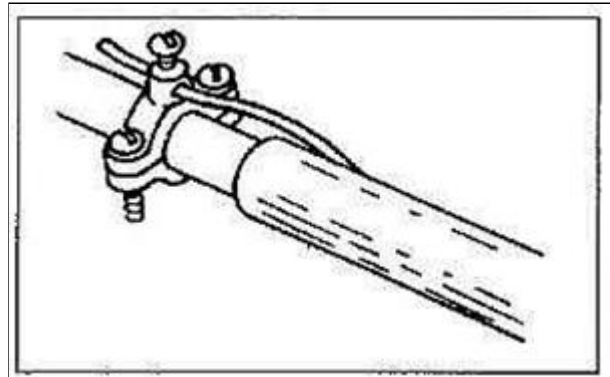
C. Picture 1 Improper Electrical Connection

The connection between the driven ground rod and the grounding electrode conductor at the rear basement is improper and unsafe. The grounding electrode conductor should be secured by the screw terminal and should not be squeezed between the clamp and the rod. Repair by a qualified electrician is recommended in order to help ensure the safe and effective bonding and grounding of the electrical system.
