# Inspection Report

**Property Address:**  
1945 W Butterfly Lane  
Chicago IL

**Domicile Consulting**

# I. Domicile Consulting Report

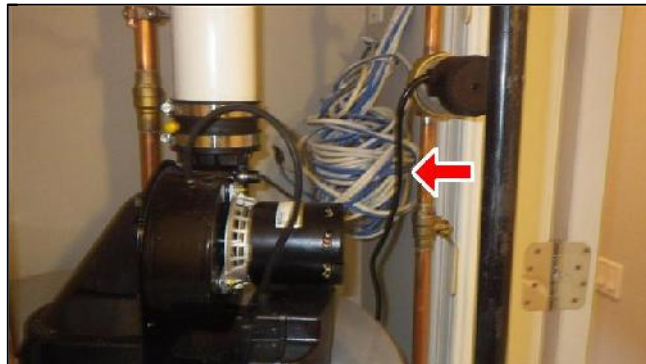
(2) The evaluation of the low-voltage equipment in the home: alarm, communication, audiovisual, etc., is beyond the scope of the home inspection and should be performed by a qualified low-voltage electrical contractor.

E. Item 4(Picture) Low-Voltage Wiring Should Be Organized and Secured

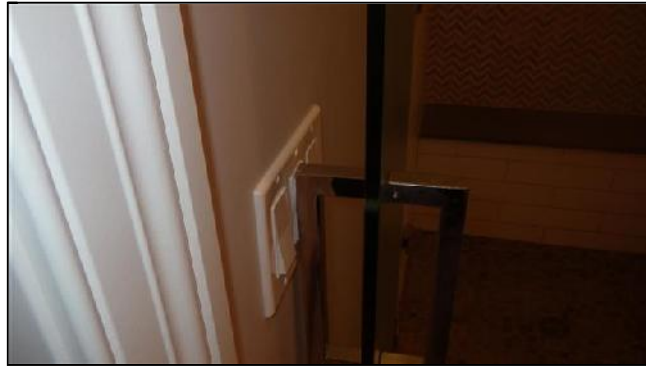
(3) The basement bathroom shower door should be provided with some means for preventing impact with the electric wall switch.

E. Item 5(Picture) Wall Switch Interference

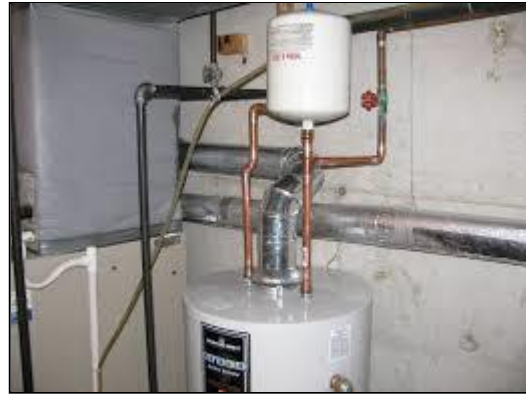
F. Item 2(Picture) Example of Expansion Tank Installation

(1) The plumbing code has long required that an expansion tank be installed adjacent to the water heater in order to prevent excessive piping pressure and leaking. A qualified plumbing contractor should install the required expansion tank.

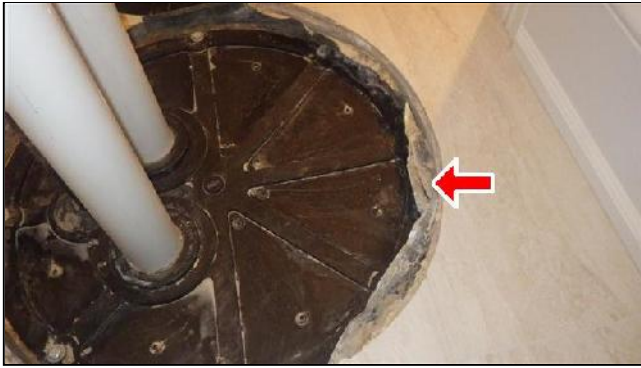
F. Item 5(Picture) Sloppy Installation

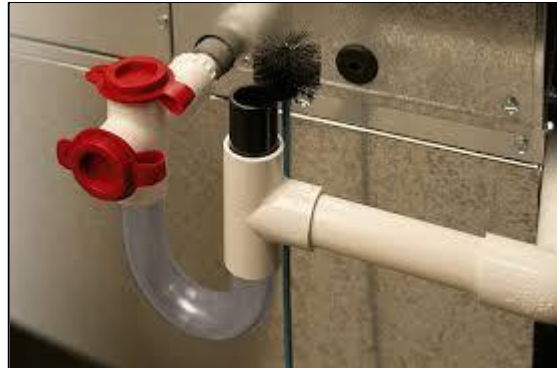
G. Item 4(Picture) Air Conditioning Condensate Drain Piping Trap

(2) The installation of a air conditioning condensate trap is recommended in order to reduce the risk for energy losses and for splashing and leaking at the evaporator drain pan. Repair by a qualified HVAC contractor is recommended.

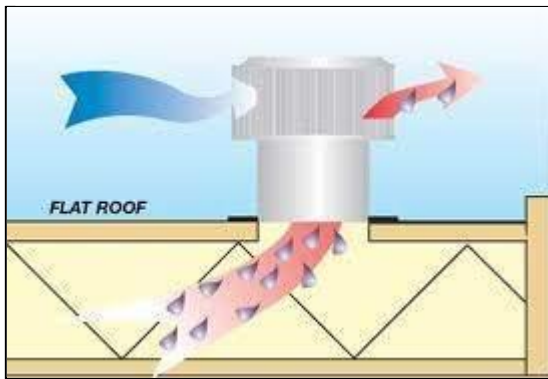
H. Item 1(Picture) High-Performance Passive Roof Venting

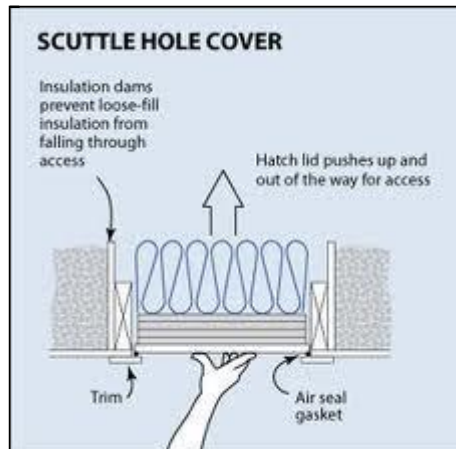
H. Item 6(Picture) Attic Hatch Insulation Diagram

(4) The attic hatch should be insulated to the same R-value as the surrounding attic floor and the hatch opening should be weatherstripped in order to reduce drafts and energy losses.

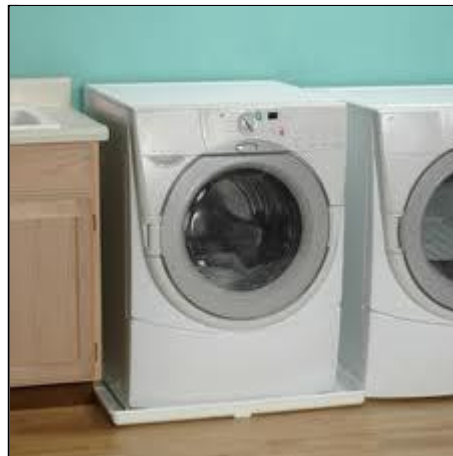
L. Item 6(Picture) Washing Machine Drip Pan

(3) The installation of a preformed drip pan is recommended underneath the washing machine in order to reduce the risk for leaking and damage in the event of an appliance malfunction.

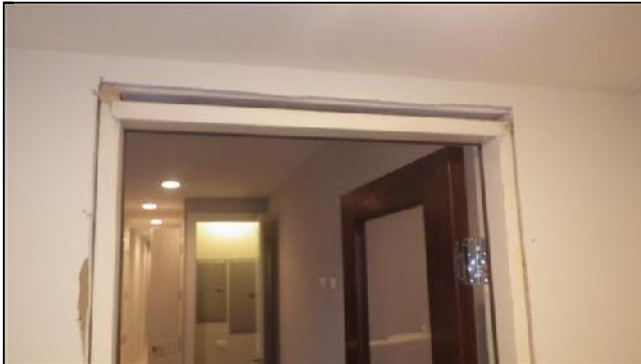
M. Item 4(Picture) Missing Interior Door Trim

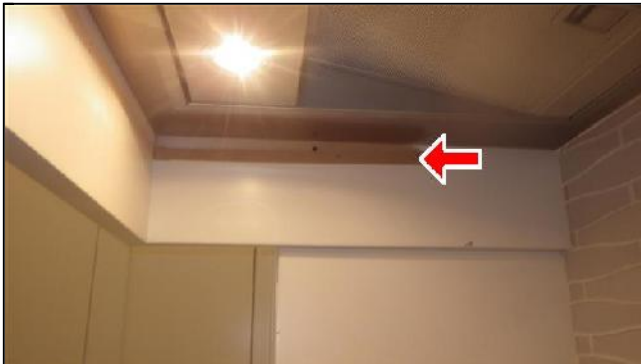
M. Item 6(Picture) Missing Paint Finish
