Inspection Report

Property Address:
1818 S Halcyon Drive
Chicago IL

Domicile Consulting

I. Domicile Consulting Report

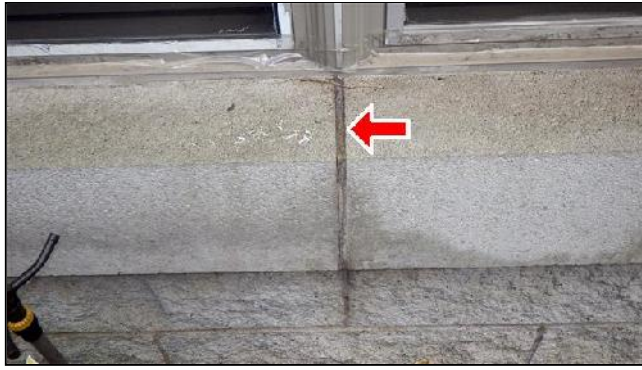
A. Item 3(Picture) Moisture Management Repairs Recommended

(3) The mortar joints at the corners of the stone window sills and between all limestone copings/sills should be raked out and sealed instead with a high-quality masonry caulking compound to reduce the risk of moisture saturation, moisture intrusion to the interior, and damage to the brick masonry below the sill.

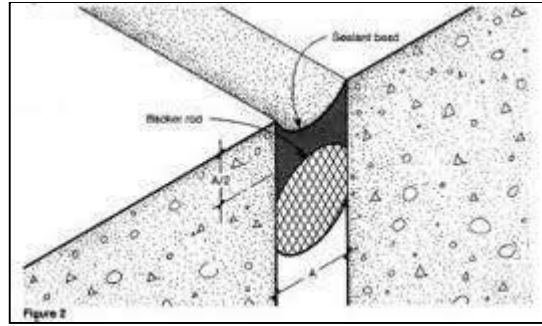
A. Item 4(Picture) Proper Configuration of Exterior Masonry Caulk Joint

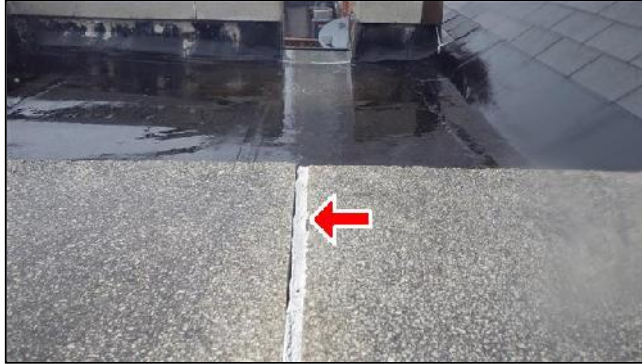
A. Item 5(Picture) Risk for Moisture Penetration and Moisture Damage

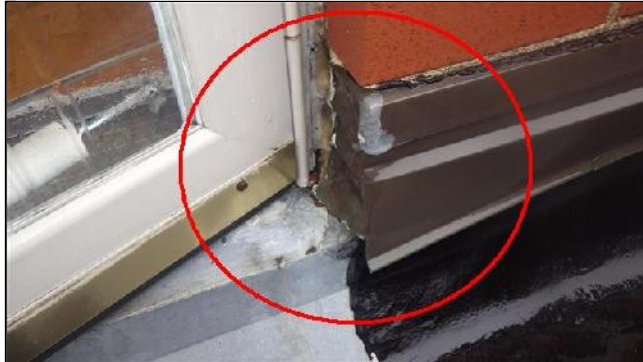
A. Item 9(Picture) Suspect Area

(5) Evidence of through-wall moisture penetration and hardwood flooring moisture damage was noted at the west balcony doorway. The door assembly as well as the adjacent masonry and flashing should be carefully evaluated and repaired as needed. The hardwood flooring damage should be addressed as part of the overall hardwood flooring repair recommended elsewhere in this report.

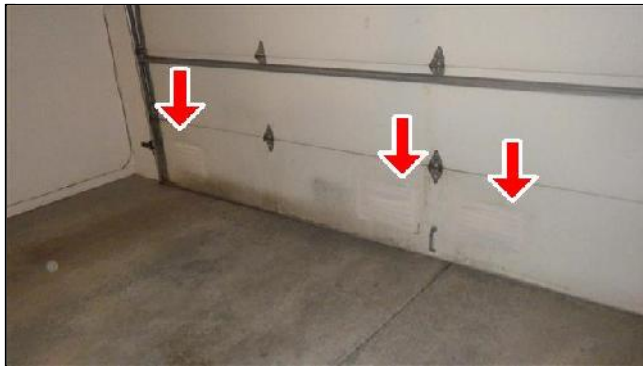
B. Item 2(Picture) Sealed Ventilation Openings

(2) Built-in garages such as the one at the subject townhome presented increased risk for contamination of indoor air with vehicle exhaust. This is why, at the time of construction, the overhead door required multiple ventilation openings. These openings have been sealed in an apparent attempt to reduce energy losses and to provide a warmer floor surface in the kitchen area during cold weather. The installation of the electric resistance garage heater was also likely intended to prevent cold floor temperatures during more extreme winter weather. The presence of the large HVAC return air grille just inside the personnel door between the parking garage and the lower-level family room creates a significant risk for vehicle exhaust and other indoor contaminants being drawn into the living space.

guided air sealing is recommended in order to find and eliminate all air breaches between the built-in garage in the living space thereby reducing the risk for indoor air contamination.

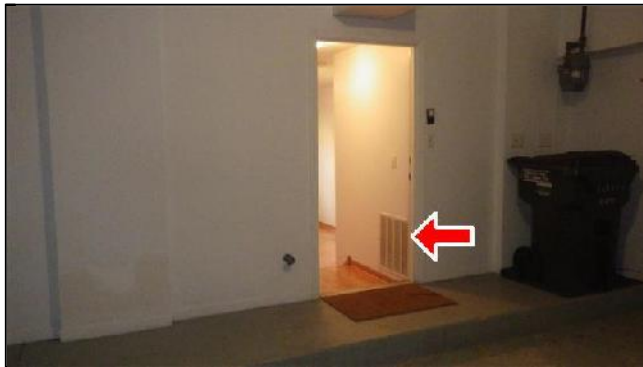
B. Item 3(Picture) Significant Risk for Indoor Air Contamination

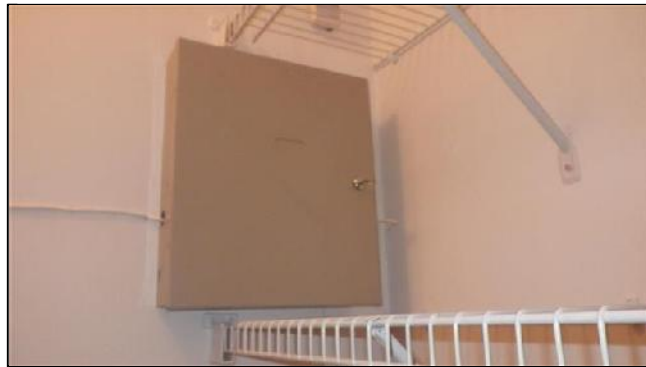
(1) The evaluation of the low-voltage equipment in the home: alarm, communication, audiovisual, etc., is beyond the scope of the home inspection and should be performed by a qualified low-voltage electrical contractor.

E. Item 1(Picture) Alarm Panel

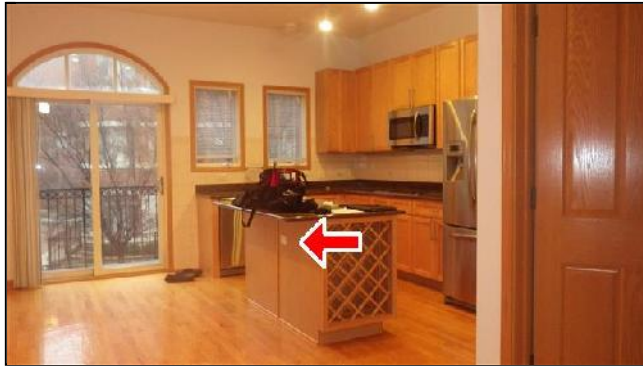
E. Item 12(Picture) Unsafe Receptacle Location

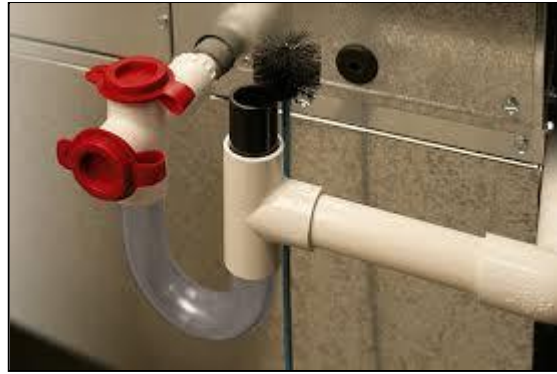
G. Item 3(Picture) Air Conditioning Condensate Drain Piping Trap

(2) The installation of a air conditioning condensate trap is recommended in order to reduce the risk for energy losses and for splashing and leaking at the evaporator drain pan. Repair by a qualified HVAC contractor is recommended.

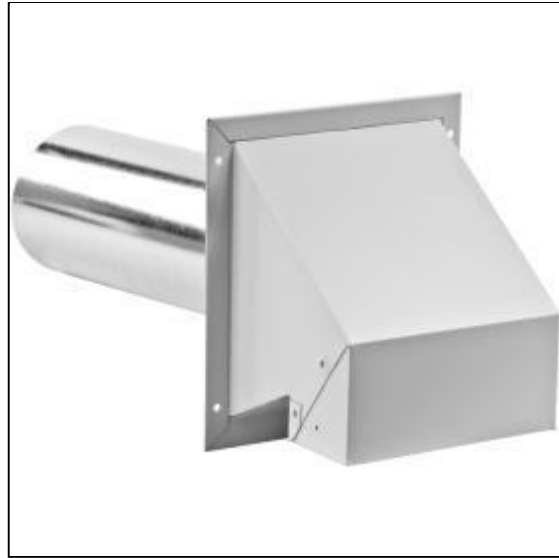
H. Item 2(Picture) High-Quality Vent Damper

The exhaust vent dampers on the exterior walls should be replaced with high-quality, gasketed, vent dampers in order to reduce drafts and energy losses.

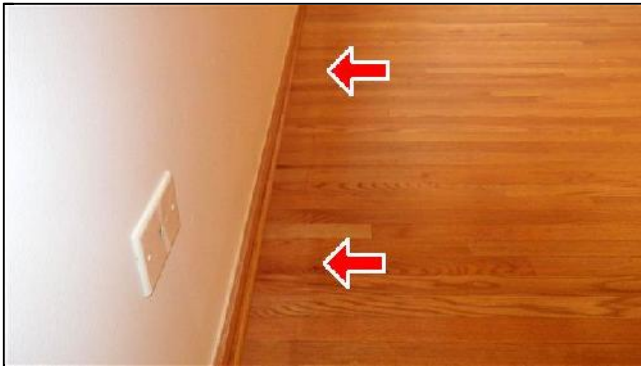
J. Item 2(Picture) Splotchy Color

(1) The refinishing of the hardwood flooring was not performed in a workmanlike manner. Splotchy areas, areas of inadequate floor finish, and areas of excessive floor finish accumulation will be noted. In addition, some portions of the hardwood flooring and hardwood stair treads exhibit excessive wear and were not refinished. It is recommended that a qualified hardwood flooring finishing contractor make all repairs needed to provide a uniform and properly protective finish on all hardwood flooring areas.

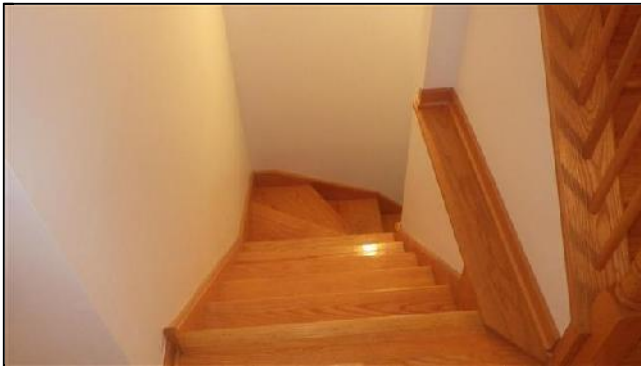
J. Item 5(Picture) Missing Railing

(3) Winding stairs presents an increased risk for falls and injuries. Therefore, secure, continuous, and graspable handrails should be installed along the wider portion of the winding stairs in order to reduce this risk. As currently configured, occupants are encouraged to walk the narrow or more dangerous portion of the stairway and do not have access to an easily grasped railing continuous from the top landing to the bottom landings as is required. Repair by a qualified carpenter or custom stair builder is recommended in order to reduce the risk for falls and injuries.

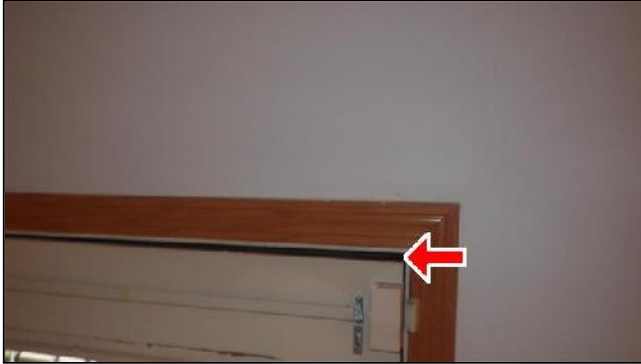
K. Item 2(Picture) Poorly Fitted Door

(1) The front entry door system is defective in multiple regards including but not necessarily limited to: defective storm door hydraulic closers; inadequate weatherstripping contact; and a poor fit between the door and doorjamb. A qualified contractor should make all necessary repairs for proper operation and draft prevention.

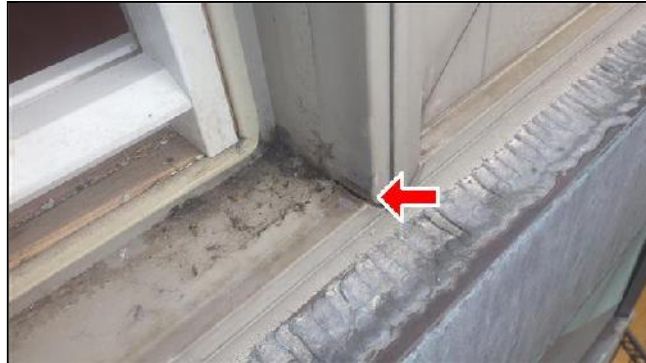
K. Item 5(Picture) Caulking Recommended

(4) It is recommended that the gaps and cracks on the exterior window cladding and exterior window frames be professionally sealed against ongoing moisture penetration.

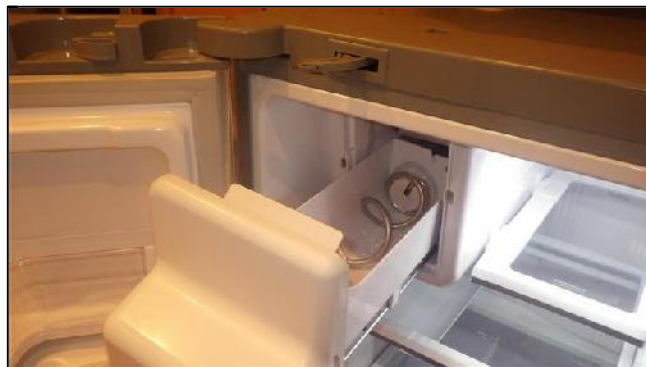
(4) The refrigerator icemaker was in the off position at the time of the inspection. It is recommended that the proper operation of the refrigerator icemaker be demonstrated at the time of the final walk-through prior to closing.

L. Item 4(Picture) Icemaker

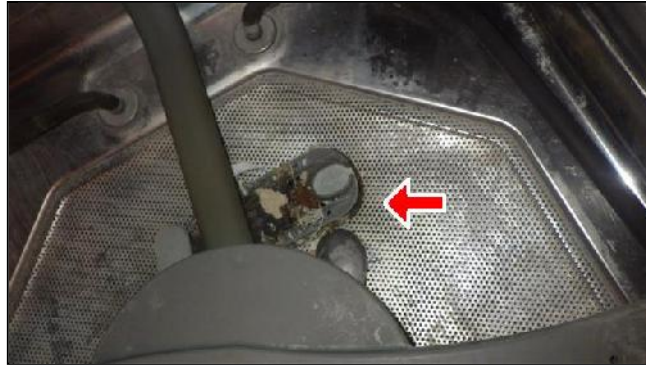
L. Item 6(Picture) Interior of Dishwasher

(6) Is recommended that the built-in dishwasher be cleaned according to the manufacturer's instructions prior to move-in.

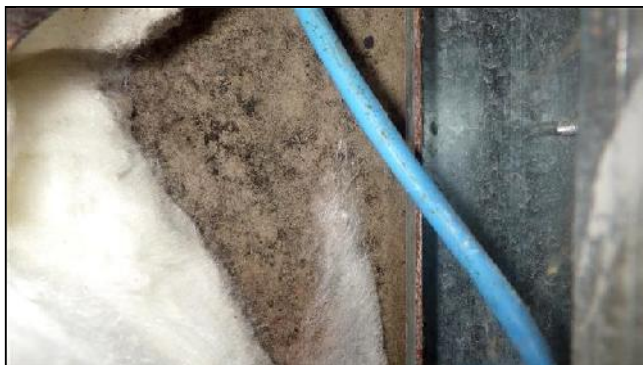
M. Item 2(Picture) Mold-like Material

(1) Evidence of mold growth was noted on the interior side of the exterior sheathing gypsum wallboard. The inspector was unable to determine the full extent nor the cause of this apparent moisture related condition.

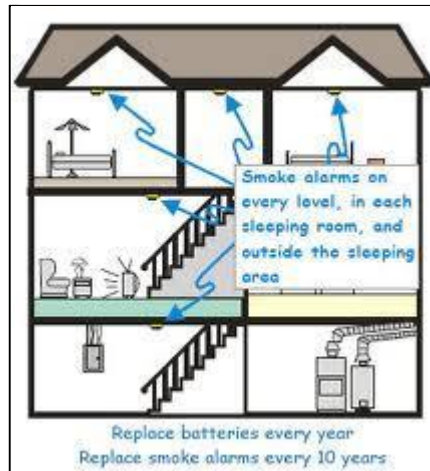
M. Item 4(Picture) Recommended Detector Placement

(2) Smoke and carbon monoxide detectors are relatively inexpensive considering the importance of their function. It is recommended that the smoke and carbon monoxide detectors be replaced with new units upon moving into the home. Each level of living space should have both types of detectors installed. The installation of hard-wired smoke detectors in each bedroom is recommended as is the inter-connecting of all smoke and CO detectors. This is recommended so that an alarm in one area of the home would be able to alert occupants at all areas of the home.
