Inspection Report

Property Address:
1632 S Poinciana #603
Chicago IL

Domicile Consulting

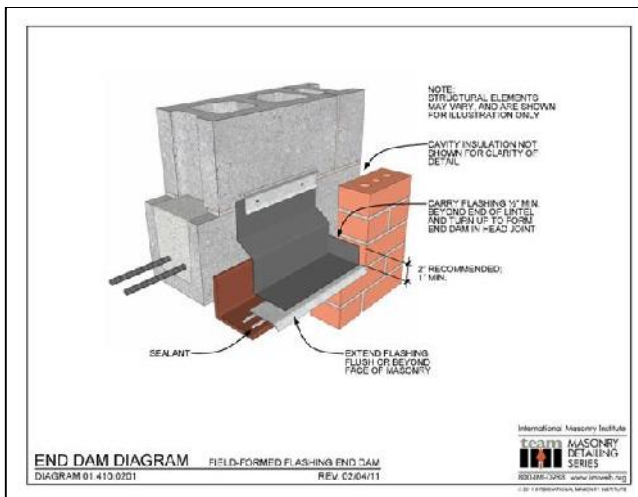
A. Item 5(Picture) Flashing over Lintel Diagram

(2) The masonry wall flashings are either missing or improperly installed. The flashings should be used in conjunction with stainless steel drip edge, should be 'end dammed' and should be present at the following locations: the top of the foundation wall; above the masonry pockets where the floor joists are set into the masonry wall; above and below every window, door, and all lintels/beams. Missing or improperly installed wall flashing can allow moisture to enter the home and cause rot, mold growth, and structural damage. The exterior

masonry walls of this structure should be evaluated and repaired by a licensed and competent masonry contractor.

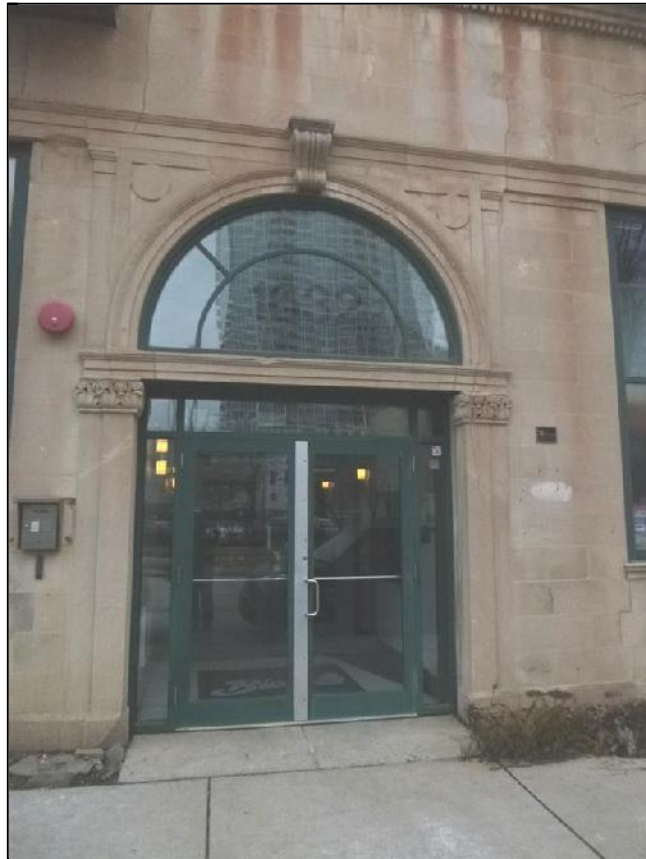
M. Item 1(Picture) Further Due Diligence Recommended

(1) It is strongly recommended that the buyer request a copy of all pertinent documentation regarding the financial condition of the HOA. This documentation should include a copy of the declarations and bylaws, a copy of the meeting minutes going back at least one year, and a copy of the latest reserve study if one exists. Failure to maintain a current (updated within the last five years) reserve study could indicate a lack of diligence on the part of the condominium board.

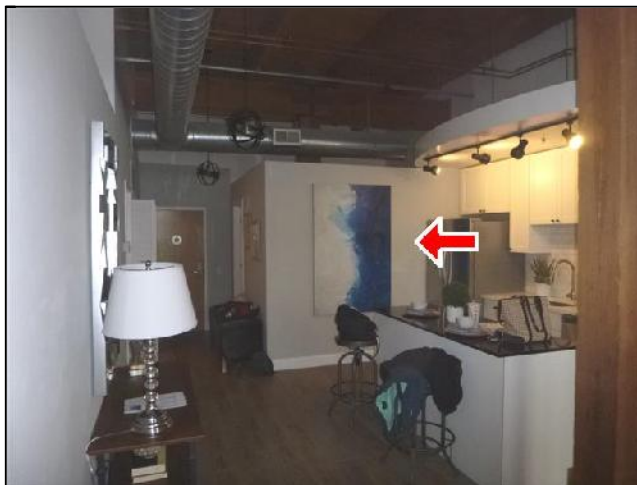
M. Item 2(Picture) Second Bedroom

(2) The inspector makes no judgment or opinion regarding the legality of the recently configured second bedroom in this condominium unit. It is recommended that the seller provide all documentation regarding suitability of the unit for the installation of a second bedroom, the building permit necessary to make this alteration, architectural drawings, etc.
