Inspection Report

Property Address:
9999 S. Garden Path
Chicago IL

Domicile Consulting

I. Domicile Consulting Report

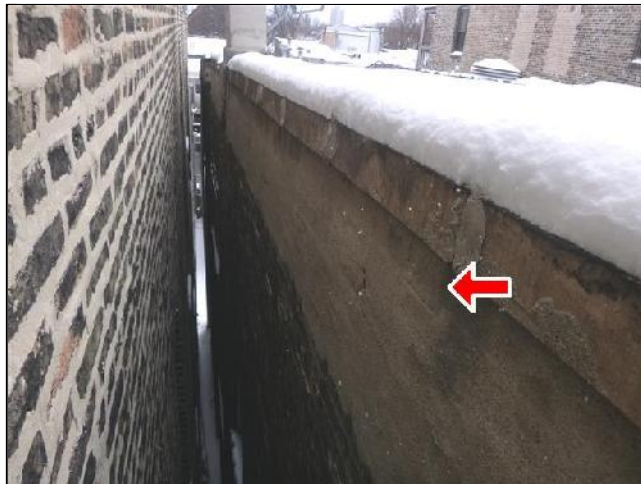
A. Item 5(Picture) parapet wall parging

(2) Portions of the exterior masonry walls have been covered with a cement parging. The cement parging is splotchy and appears to have been patched a number of times. This thin cement coating which has been applied over deteriorated brick masonry will require regular upkeep and patching. The cement parging at this home is lacking several features that would be present on a high-quality cement parging job. These include a stainless steel mesh screen behind the cement parging it reduces the risk for delamination; corrosion resistant metal beading at the top and sides terminations of the cement parging; and a proper movement joint at the base of parging. The parging on the exterior masonry walls would ideally be composed of lime mortar and not Portland cement in order to allow for the best performance and optimal protection of the brick masonry walls. The application of a clear masonry sealant over the existing cement parging may extend its service life and may reduce its maintenance requirements. The homeowner should engaged the services of a qualified masonry restoration contractor with extensive experience in historic masonry repair in order to develop a plan and budget for ongoing maintenance/repair of the cement parging.

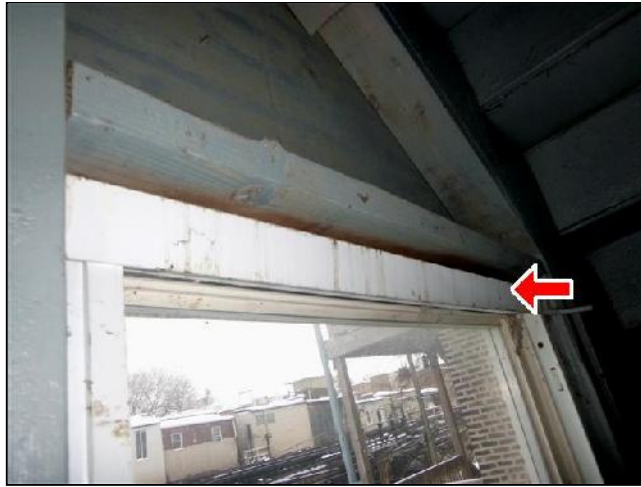
A. Item 12(Picture) evidence of ongoing water penetration

(4) Evidence of ongoing moisture penetration through the vinyl siding was noted at the enclosed rear porch. It is possible and even likely that this ongoing moisture penetration has resulted in significant damage to the siding substrate. The extent of the installation defects and ongoing deterioration indicate that removal and replacement of the siding is the appropriate option. A qualified siding specialty contractor should evaluate the vinyl siding and ancillary components on the enclosed rear porch exterior walls in order to develop a plan and budget for the needed repairs.

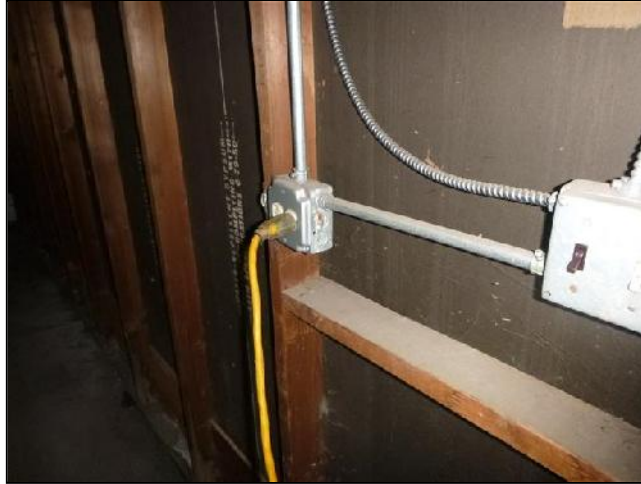
B. Item 1(Picture) Missing Shock Protection

(1) The electrical receptacles in the garage should be provided with GFCI protection in order to reduce the risk for electrocution.

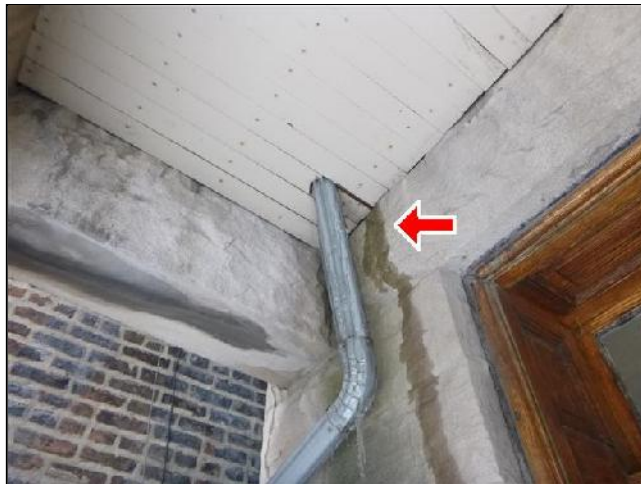
C. Item 1(Picture) leaking gutter/downspout

(1) The gutter at the second floor front balcony is leaking then should be repaired by a qualified specialist in order to prevent wood rot of the front entry soffit ceiling.

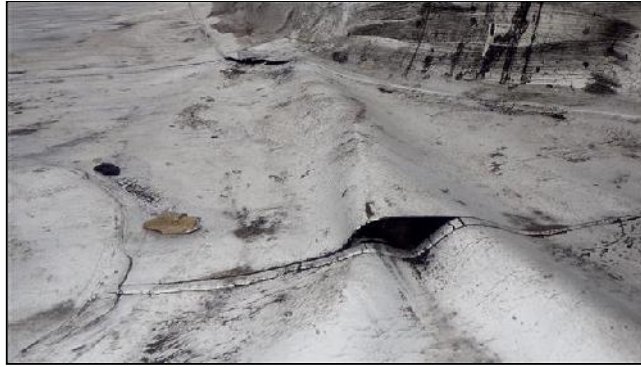
C. Item 3(Picture) extreme blistering/buckling of modified bitumen roof covering with resulting seam failure

(2) The inspector made a return visit to the property in order to better evaluate the conditions of the roof covering after significant snowmelt had occurred. With regard to the composition shingle roof covering over the front of the building, the shingles are significantly deteriorated and appear to be at the end of their useful life. Removal and replacement is recommended. With regard to the modified bitumen roof covering over the low slope portion of the building, it also is significantly deficient and exhibited extreme buckling as well as delamination from the underlying substrate. It is strongly recommended that plans be made for the near-term removal and replacement of the modified bitumen roof covering over the entire low slope area of building. It is the inspectors firmly held opinion that the existing roof coverings need to be removed and replaced as soon as practical in order to reduce the risk for leaking and damage to the underlying components.

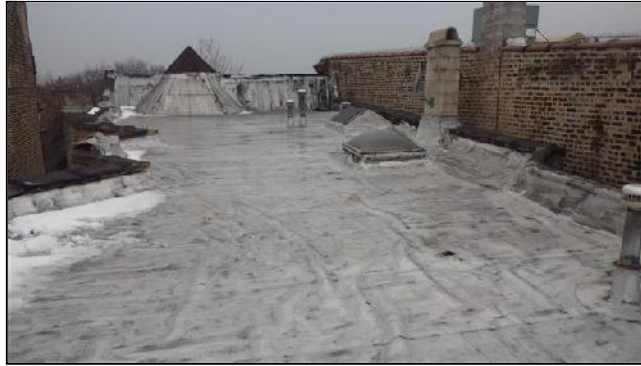
C. Item 4(Picture) widespread blistering/buckling

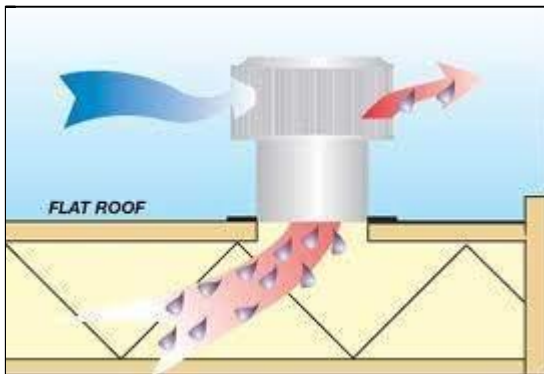
C. Item 5(Picture) High-Performance Low Slope Roof Vent

(3) The failure to properly ventilate a conventionally insulated roof/ceiling plenum can result in condensation, mold growth, wood rot, and eventually....sheathing and framing failure. It is strongly recommended that a qualified roofing contractor install high-performance passive roof vents in order to reduce these risks and to also allow moisture and mold and easy way out of the living space.

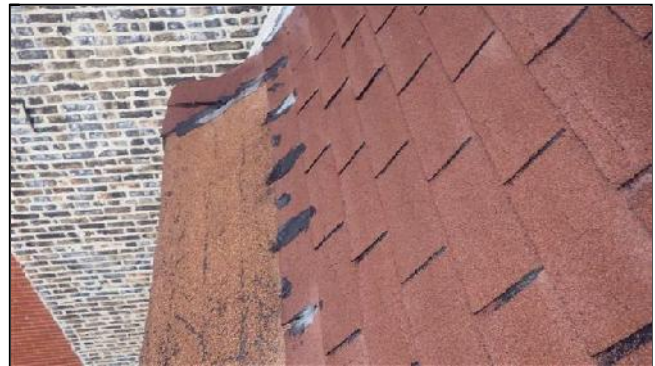
C. Item 6(Picture) badly deteriorated and heavily patched shingle roof covering

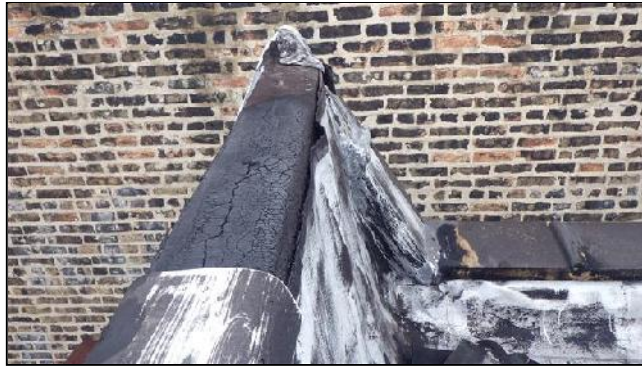
C. Item 7(Picture) failed/displaced area of modified bitumen roof covering

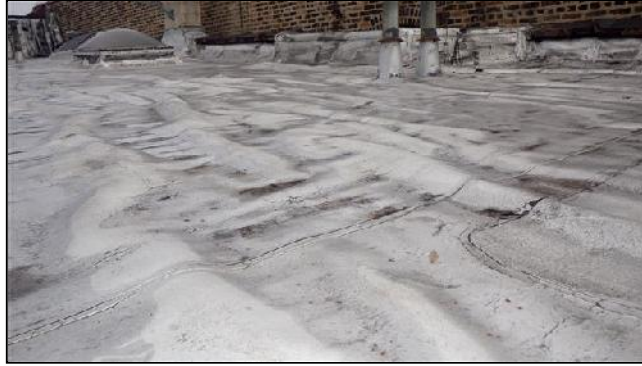
C. Item 8(Picture) the modified bitumen roof covering is no longer adhered to the substrate

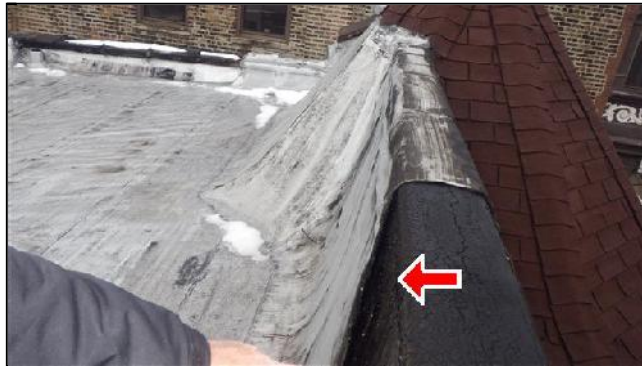
C. Item 9(Picture) missing/failed modified bitumen roof covering at front parapet

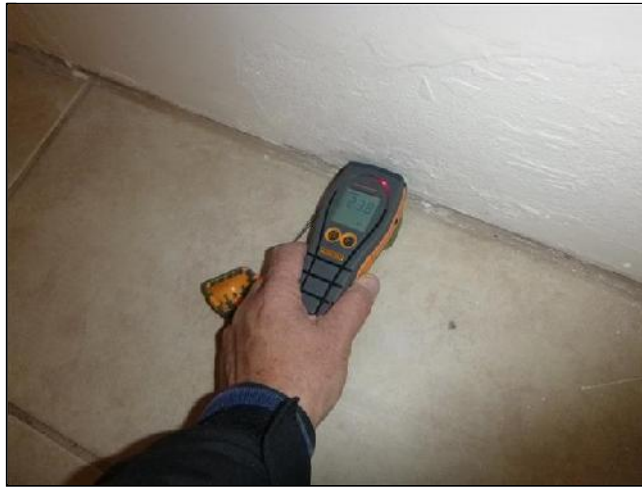
D. Item 5(Picture) wet wall

(2) Several areas of wet wall finishes and moisture damaged walls were noted in the basement. This condition is indicative of basement seepage and/or condensation within the basement wall finish cavities. It is recommended that the basement wall finishes be gutted and that a full complement of finished basement moisture management details be installed including but not necessarily limited to; foundation perimeter drainage tubing, sump pit and pump assembly, and a moisture impermeable membrane installed over the interior side of the foundation.

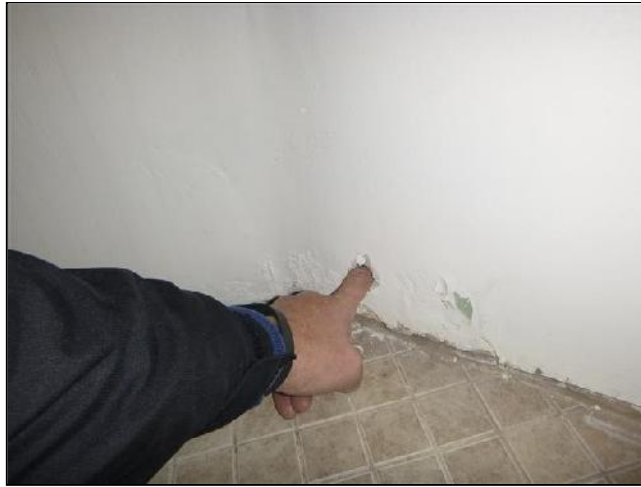
D. Item 6(Picture) mushy gypsum wallboard

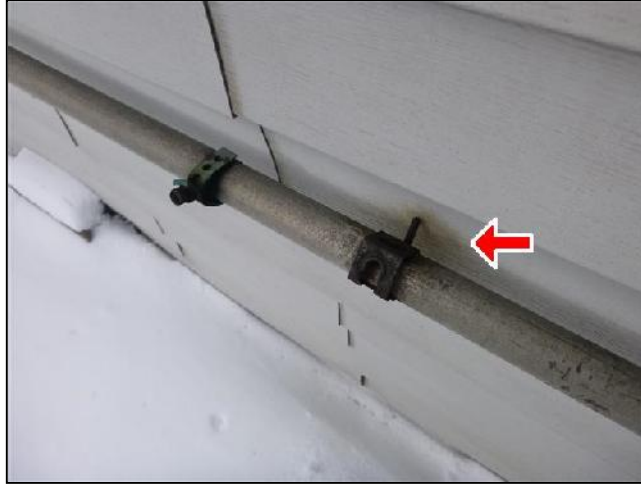
E. Item 1(Picture) in adequately secured conduit

(1) The electrical service mast at the rear wall of the building is not properly secured and is at risk for excess movement, arcing/sparking, fire, shock, and interruption of electrical service. Also, the overhead electrical service wires do not have adequate clearance from the nearest window of the enclosed rear porch. It should be repaired or replaced as soon as practical.

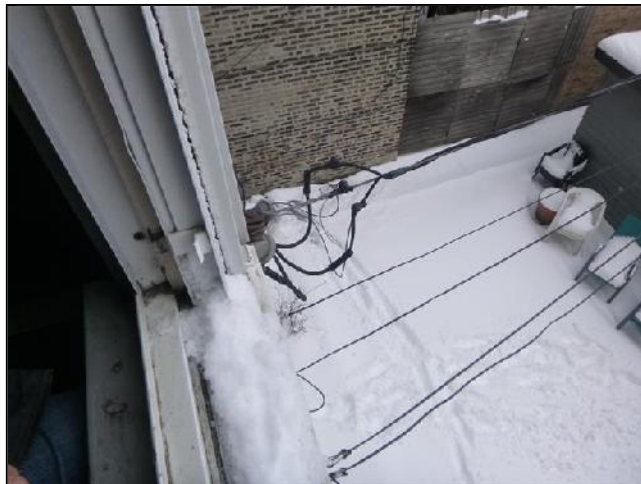
E. Item 3(Picture) inadequate safety clearance

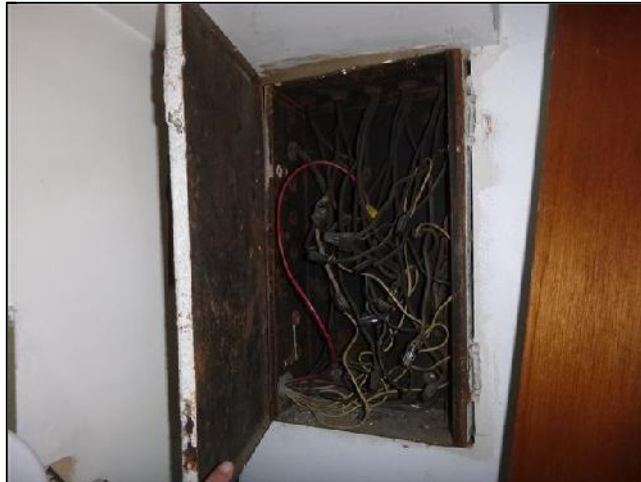
E. Item 5(Picture) extensive cloth insulated wiring

(3) The existence of cloth insulated branch wiring was noted in the home. Older cloth insulated wiring is often degraded and may have to be replaced during remodeling of the electrical system. This condition presents another indicator of the need to perform a full gut remodel of the building. It is strongly recommended that a qualified electrical contractor provide a plan and budget for removal and replacement of the cloth covered wiring.

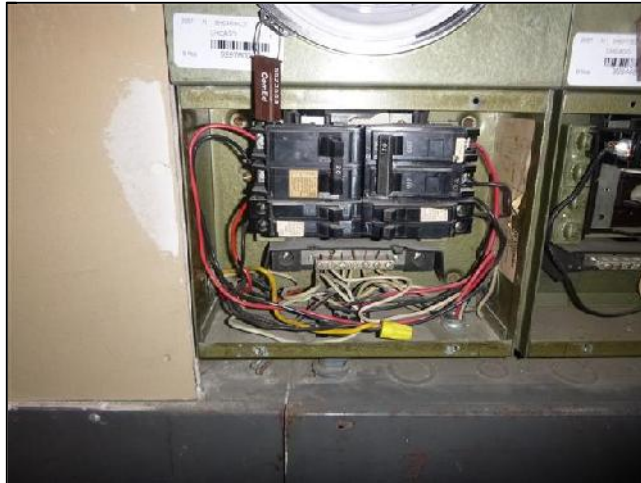
E. Item 7(Picture) half-size breakers

(4) The six position electrical breaker panels for the individual apartments are seriously undersized according to today's electrical demands. Also, a significant number of individual safety defects were noted in relation to the electrical panels including but not necessary limited to; the use of prohibited half-size breakers, the presence of prohibited wire splices within the electrical panels, over fused conductors, and defective nonconductive bushings at the feeder conduit terminations inside the panels. In addition, the 200 amp electrical service coming into the building is woefully inadequate and is likely nonconforming with regard to the current electrical code. Once again, the extent of the inadequacies, defects, and deterioration regarding the electrical service/supply components indicates that a full gut remodel is warranted and appropriate.

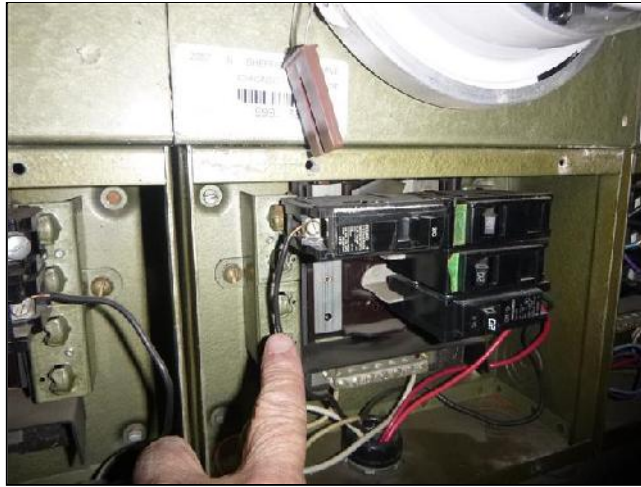
E. Item 8(Picture) over fused circuit

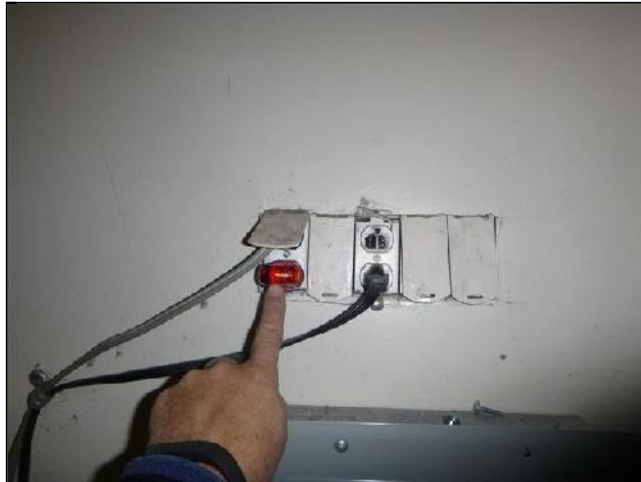
E. Item 11(Picture) defective electrical receptacle

(6) Ungrounded electrical receptacles, inoperative electrical receptacles, loose electrical receptacles, and mis-wired electrical receptacles were noted in various areas of the home. All of these conditions represent significant electrical safety defects. All the electrical receptacles in the home should be evaluated and repaired or replaced as necessary by a licensed and competent electrical contractor.

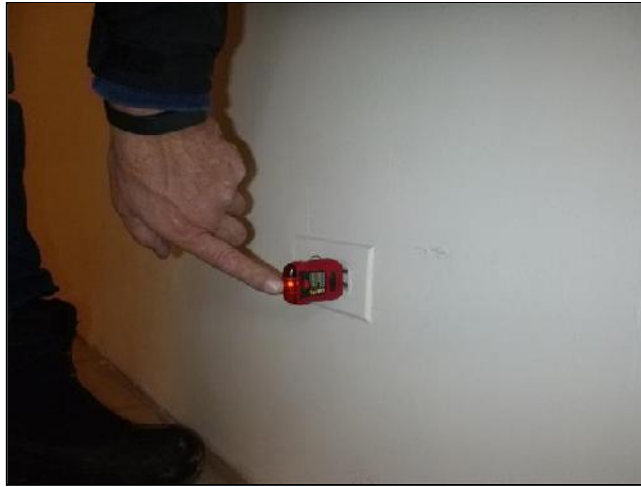
E. Item 13(Picture) ungrounded electrical receptacle

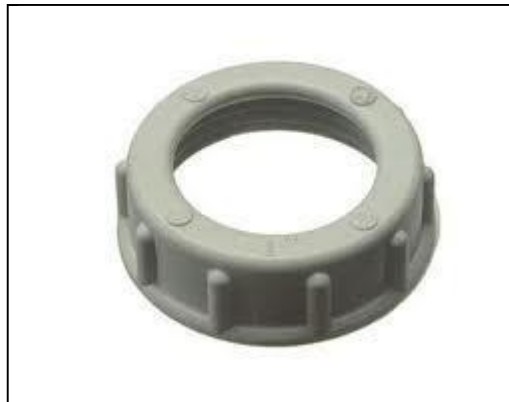
E. Item 17(Picture) Nonconductive Conduit Bushing

(7) Larger electrical conductors are required to be protected at conduit terminations with a non-conductive bushing in order to reduce the risk for arcing/sparking, shock, fire, etc. These bushings are missing in both the furnace closet subpanel as well as the main distribution panel in the master bedroom. It is strongly recommended that the electrical panels be evaluated and repaired as needed by a qualified electrician prior to closing.

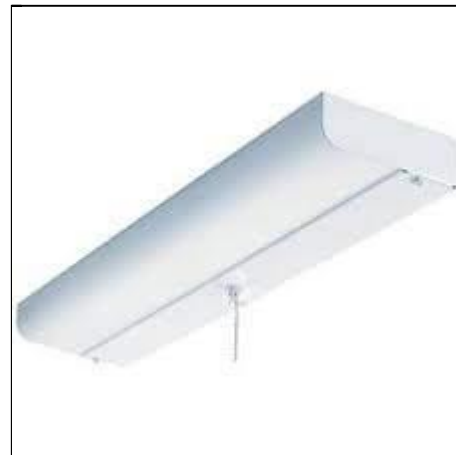
E. Item 23(Picture) Preferred Closet Lighting Fixture

(11) The bare bulb light fixtures in the closets should be replaced with low-profile fluorescent fixtures or their equivalent in order to reduce the fire hazard associated with their hot surfaces and also in order to reduce the risk of bulb breakage.

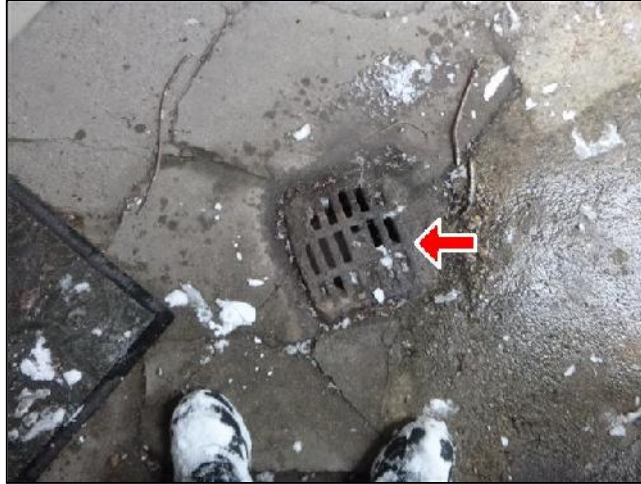
F. Item 1(Picture) blocked drain

(1) The drain at the front exterior basement landing is at least partially blocked and should be cleared or otherwise repaired by a qualified plumbing contractor prior to closing.

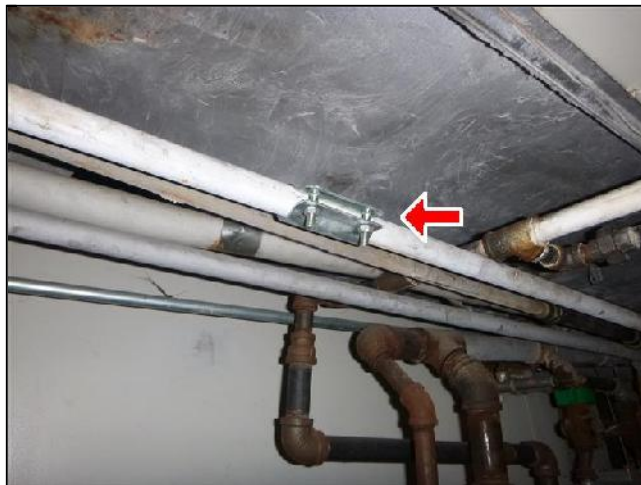
F. Item 6(Picture) galvanized water supply piping patch

(6) The water pressure and flow at the plumbing fixtures is marginal. It is recommended that the remaining galvanized water supply piping be removed and replaced with copper piping for optimal flow and pressure during the use of multiple fixtures.

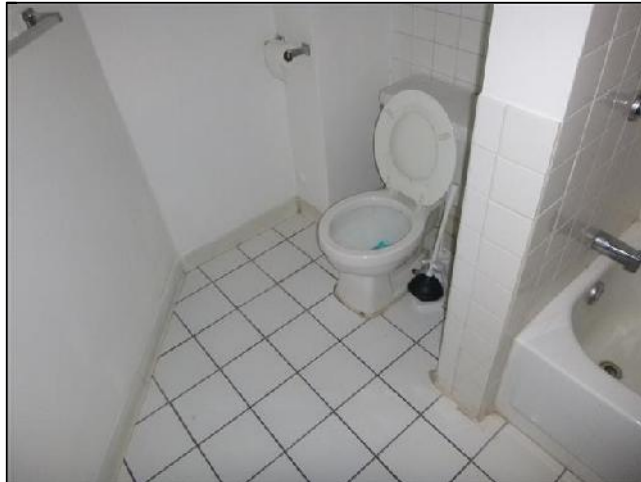
F. Item 9(Picture) basement bathroom gravity drain

(7) The plumbing fixtures in the basement drain to the city sewer via an underground gravity drain pipe system. This is far inferior to the preferred method of any injector pit and pump assembly draining into an overhead sewer. It is strongly recommended that a qualified plumbing contractor provide a plan and budget for the installation of such a plumbing drain system for the basement plumbing fixtures. This improvement would provide a significant safety margin against sewer backup into the basement.

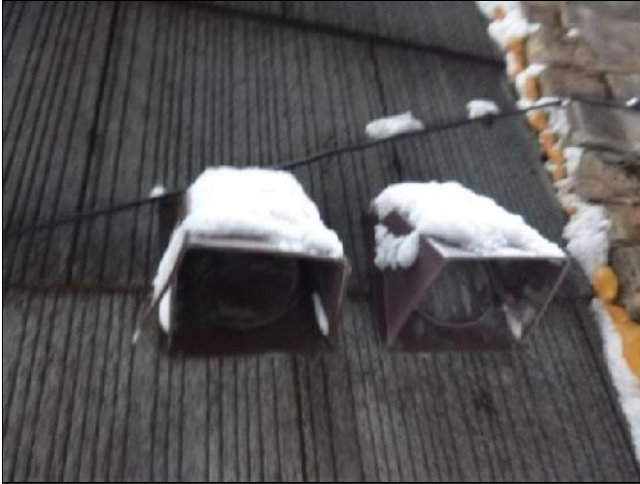
H. Item 1(Picture) dryer vent terminations

(1) The exhaust vent dampers on the exterior walls should be replaced with high-quality, gasketed, vent dampers in order to reduce drafts and energy losses.

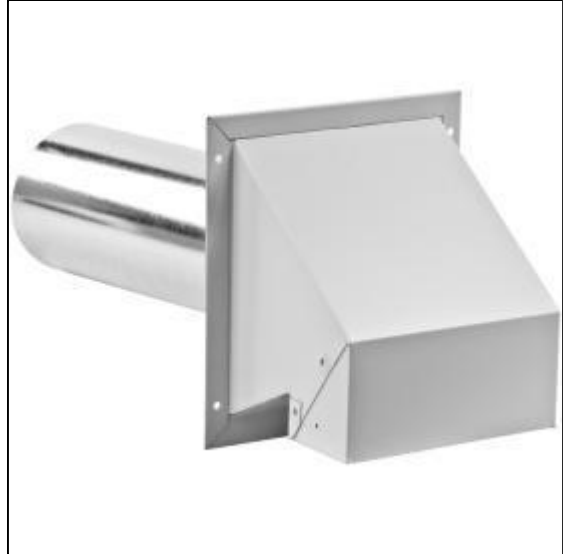
H. Item 2(Picture) High-Quality Vent Damper

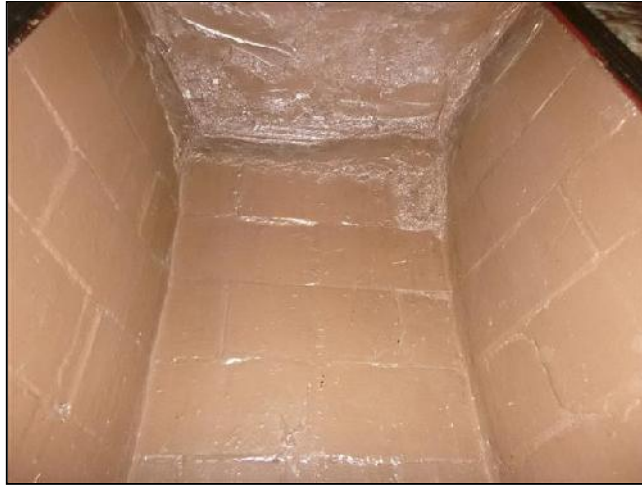
I. Item 1(Picture) Interior of 1st Floor Fireplace

The fireplace in the first floor apartment living room is for decorative use only.

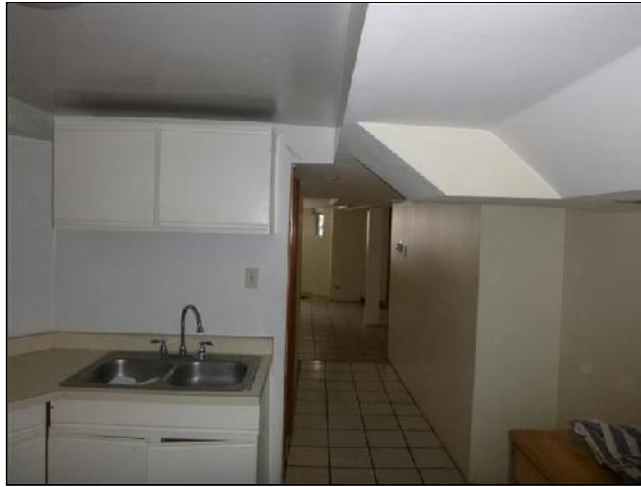
J. Item 8(Picture) Low Ceiling

(4) As currently configured the basement living space doesn't conform to the local code authority's existing requirements. Typically, a minimum of 7 feet of ceiling height is required with some allowance made for soffits. The buyer should perform further due diligence regarding the legality of the basement living space as part of the due diligence process.

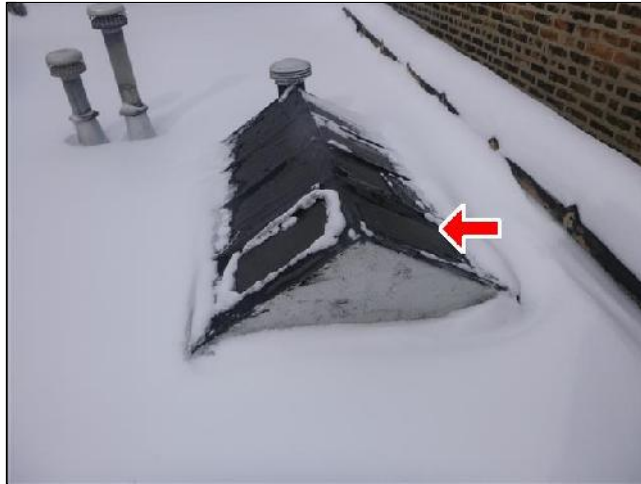
K. Item 1(Picture) aged and deteriorated skylight

(1) The skylight which has, in the past, provided natural daylight to the front interior stairway has been tarred over and is no longer operating as intended. The skylight is significantly deteriorated. It is recommended that the skylight be replaced in conjunction with the recommended upcoming roof covering replacement

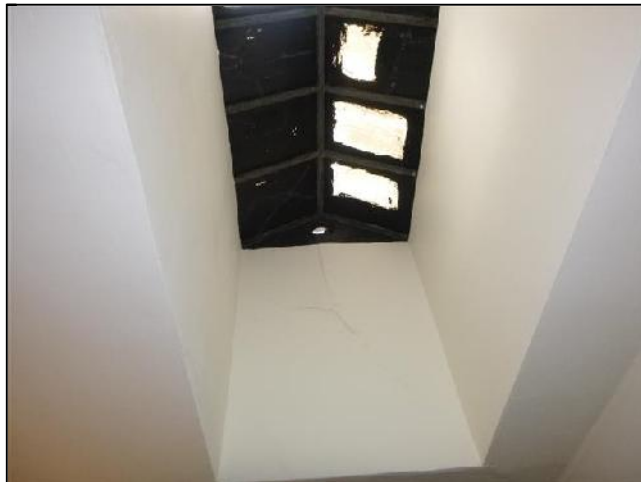
K. Item 2(Picture) front stairway skylight

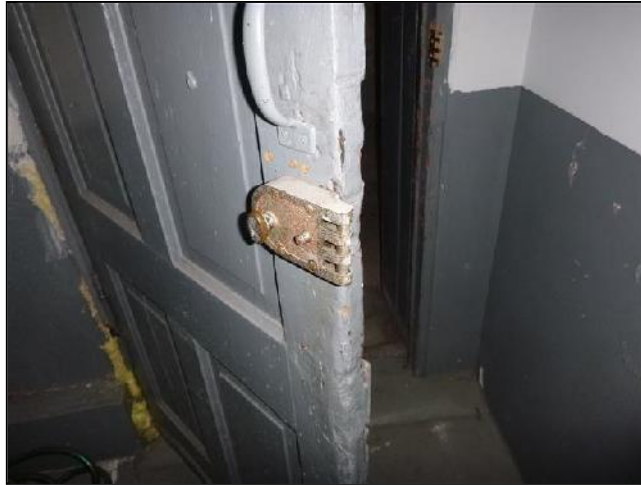
K. Item 3(Picture) antiquated door

(2) All of the exterior doors and unit entry doors are aged, deteriorated, drafty, easy to force, and in need of replacement. It is strongly recommended that all of the exterior and unit entry doors be replaced with the

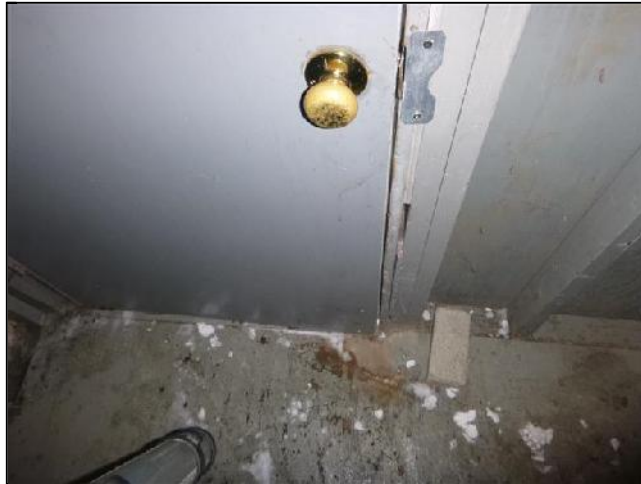
K. Item 4(Picture) drafty door

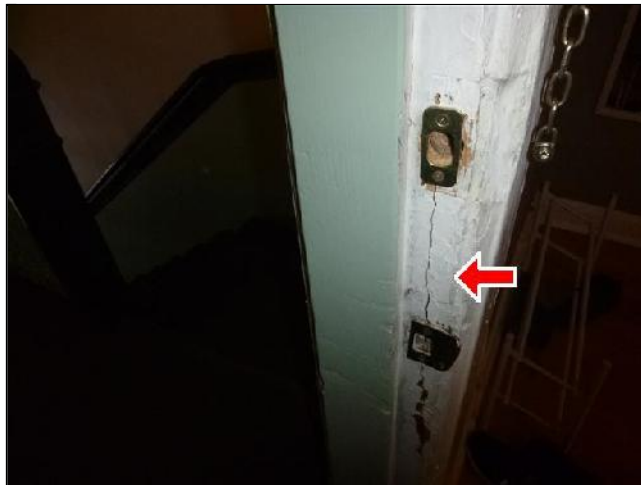
K. Item 5(Picture) Damaged Door Jamb

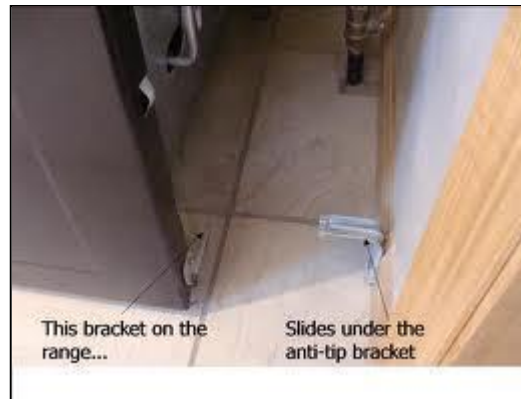
L. Item 2(Picture) Kitchen Range Anti-Tipping Bracket

An anti-tipping device (Federally mandated and shipped with all ranges) should be installed at the kitchen range for the prevention of scalds and burn injuries.

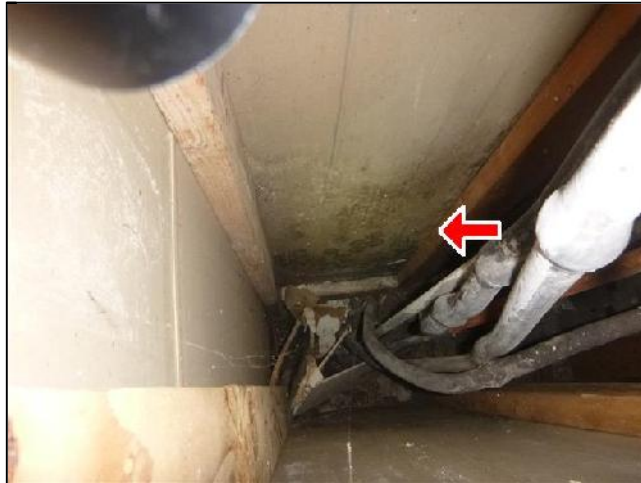
M. Item 2(Picture) moldy drywall

(2) Mold-like substances were noted on surface/s of this building. Mold growth results from moisture on organic strata and is first and foremost a moisture problem. The source of the moisture that is the proximal cause of the mold-growth should be found and eliminated before final remediation is performed. Initial remediative steps may be advisable in order to reduce the release of mold spores, fungal fragments, and mycotoxins during the moisture investigation and repair process. Small areas of mold (10 square feet or less) can be remediated by the homeowner successfully. An EPA approved mildewcide with residual mold inhibiting properties (Concrobium Brand) can be found at major home improvement stores. Relatively non-porous surfaces such as tile, laminate, concrete, etc. should be surface cleaned with this type of product and kept dry. Semi-porous surfaces such as wood framing and sheathing can also be cleaned in this manner if fungal growth hasn't degraded the material significantly. Porous surfaces such as paper-faced gypsum drywall, cellulose insulation, etc. should be removed and replaced.

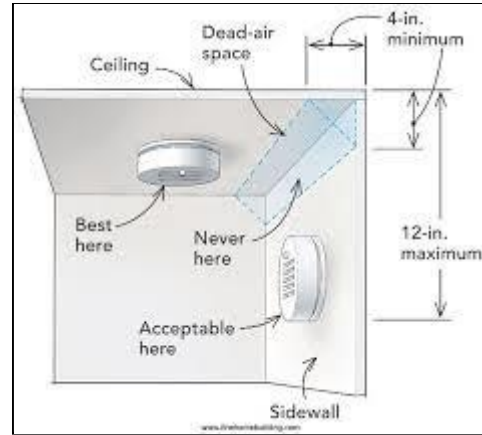
M. Item 6(Picture) Detector Placement Standards

(5) Smoke and carbon monoxide detectors are relatively inexpensive considering the importance of their function. It is recommended that the smoke and carbon monoxide detectors be replaced with new units upon taking ownership. Each level of living space should have both types of detectors installed. The installation of hard-wired smoke detectors in each bedroom is recommended as is the inter-connecting of all smoke and CO detectors. New smoke detectors are available that have 10 year batteries and which combine ionization and photocell functions thereby detecting both slow smoldering fires as well as quickly developing fires.
