Inspection Report

Strip Mall
Anytown IL

Domicile Consulting

I. Domicile Consulting Report

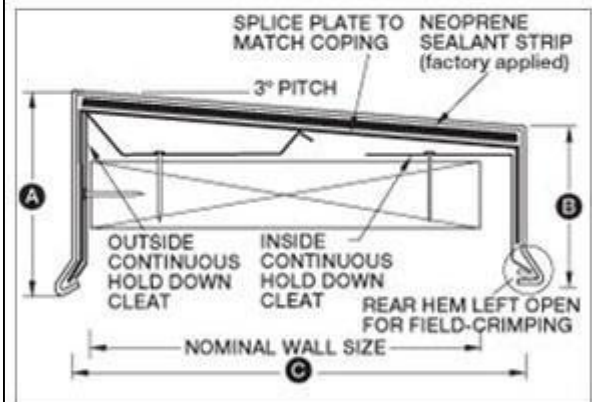
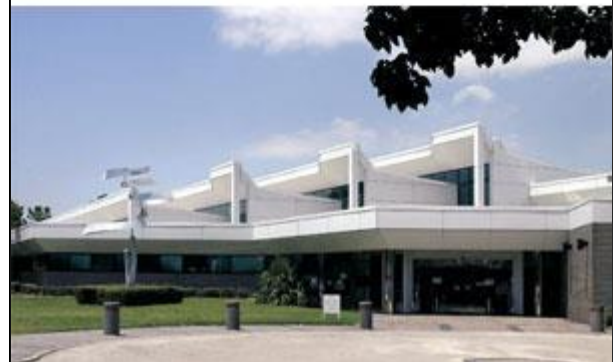
Aluminum Parapet Capping

(10) The aluminum parapet capping at the top of the masonry parapet walls does not conform to industry standards as published by the Sheet-Metal and Air Conditioning Contractors National Association (SMACNA). The aluminum wall cap does not promptly shed moisture; does not have sleeved and gasketed overlaps; and is composed of relatively thin aluminum which will expand and contract significantly from temperature changes. These defects greatly increase the risk for moisture penetration into and through the underlying masonry walls. It is recommended that plans be made for the near-term replacement of the existing parapet wall cap with one that reflects industry standards and best practices.

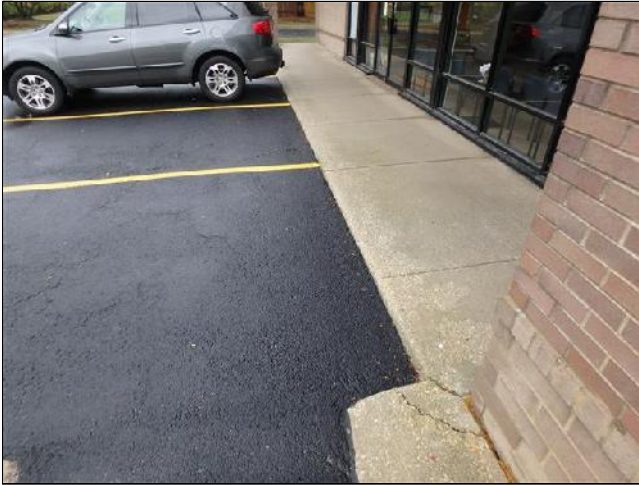
Missing Safety Devices

(11) The missing curb stops should be furnished and installed in order to reduce the risk for vehicles causing property damage or personal injury.

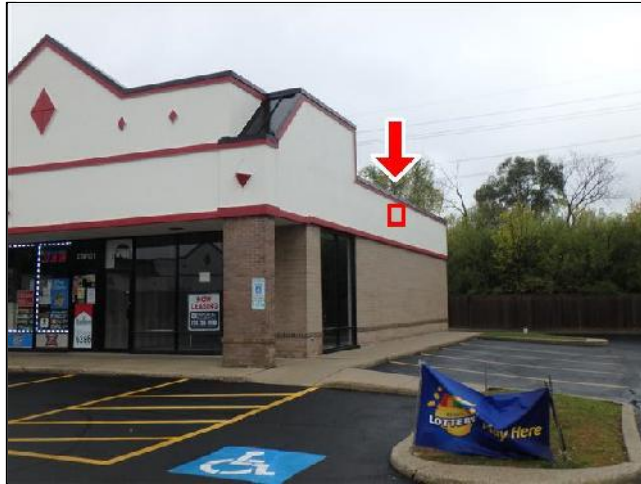
Additional Lighting Recommended

(1) Some areas of the parking lot are not adequately illuminated for safety and security. It is recommended that the exterior lighting around the building and parking/driveway areas be thoroughly evaluated by a qualified electrician so that the existing light fixtures can be maintained and/or upgraded for reliability and energy efficiency. It is further recommended that areas of inadequate lighting be provided with high-efficiency lighting controlled by automatic timers or photo sensors.

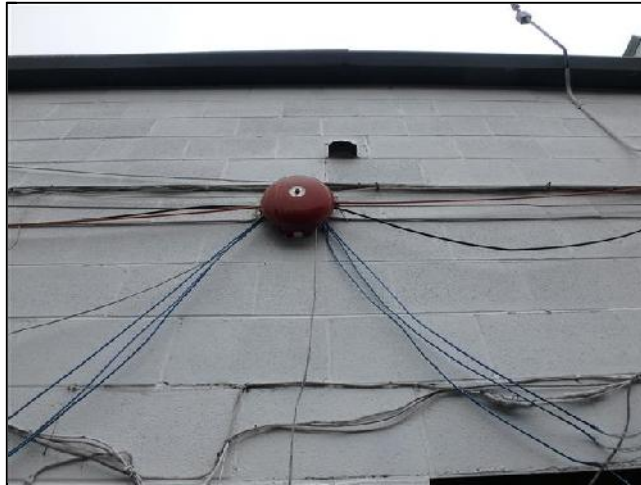
Risk for Snagging, Damage, Etc.

(4) The evaluation of the low-voltage equipment in the home: alarm, communication, audiovisual, etc., is beyond the scope of the home inspection and should be performed by a qualified low-voltage electrical contractor. Nevertheless, as a courtesy to the buyer, it is recommended that the low voltage wiring both inside and outside the individual business occupancies be evaluated, organized, secured, and concealed as needed.

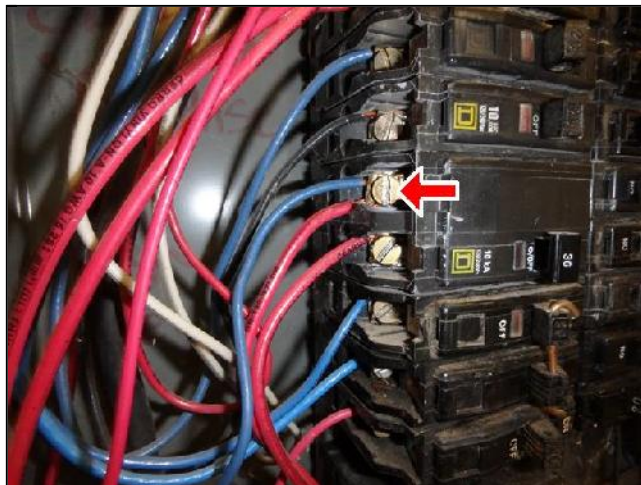
Dangerous Electrical Condition

(5) A significant number of dangerous electrical conditions were noted at the electrical panels within the former Winfield Waffle occupancy. It is strongly recommended that a qualified electrical contractor evaluate and repair the dangerous electrical conditions such as the improper double pole breaker handle tie, the double tapped and over-fused conductors inside the electrical panel, and the improperly secured grounding conductor at the neutral busbar. Also, the lighting inside this commercial occupancy is currently controlled, in large part, by the individual breakers at the electrical panel. A qualified electrician should install wall switches in order to provide for safe and convenient lighting.

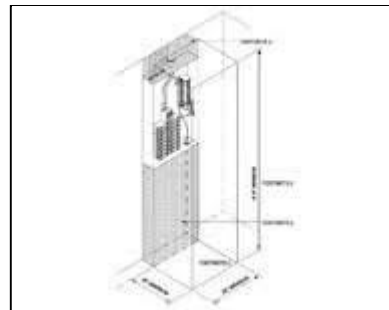
(6) The electrical service panel at the Jake's Pizza occupancy has not been provided with the required working clearances. This creates an increased risk for injury to individuals performing repairs or maintenance to the electrical panel and precluded the inspector from examining the interior components of the panel. It is strongly recommended that proper access be provided and that the electrical panel be further evaluated prior to closing.

Required Working Clearance at Panel

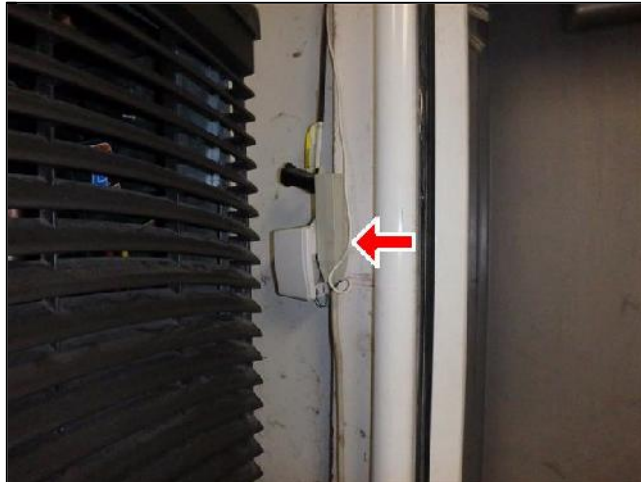
Piggyback Extension Cords

(8) There is an inadequate number of electrical receptacles in areas of the interior spaces. Additional receptacles should be added by a qualified electrician in order to reduce the risk for over-loading of circuits, the risk associated with the excessive reliance upon extension cords, and for convenience in the use of electrical appliances.

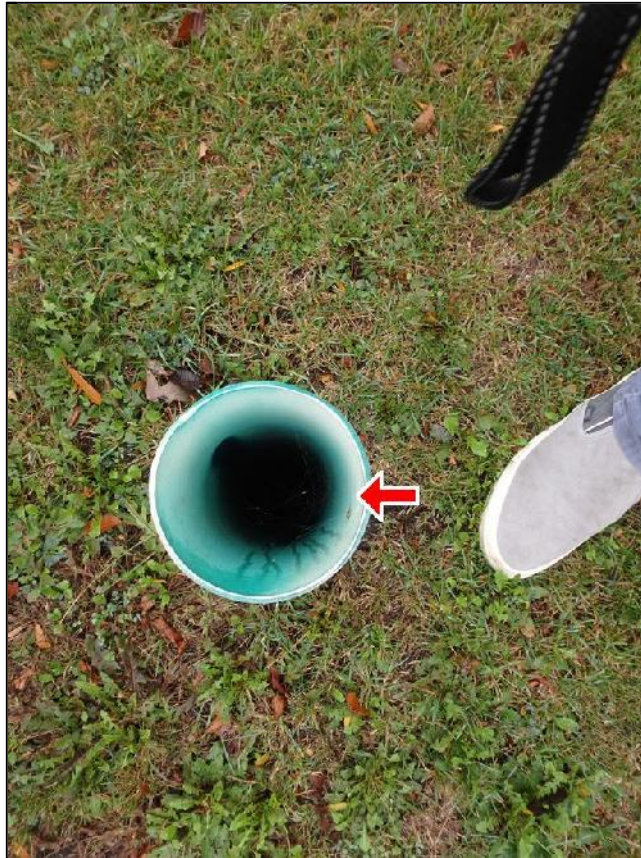
Unknown Function

(1) The inspector was unable to determine the function of the projecting vertical plastic piping at the grassy island at the southwest corner of the building. The current building management personnel should describe the function of this component to the buyer.

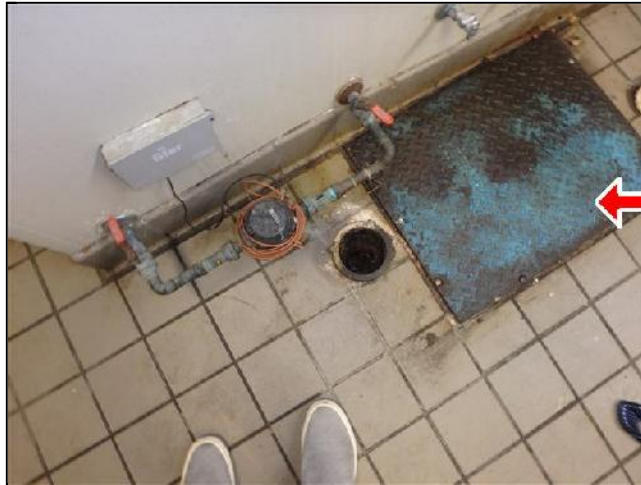
Grease Interceptor Cleaning Recommended

(2) Due to the age of the structure a fiber-optic evaluation of the subsurface sewage drains should be performed to determine their current condition. Subsurface drain repairs can be quite expensive and due diligence requires a fiber-optic evaluation. In addition, the current and former food preparation occupancies should have their grease interceptors and subsurface drain piping evaluated and cleaned as needed.

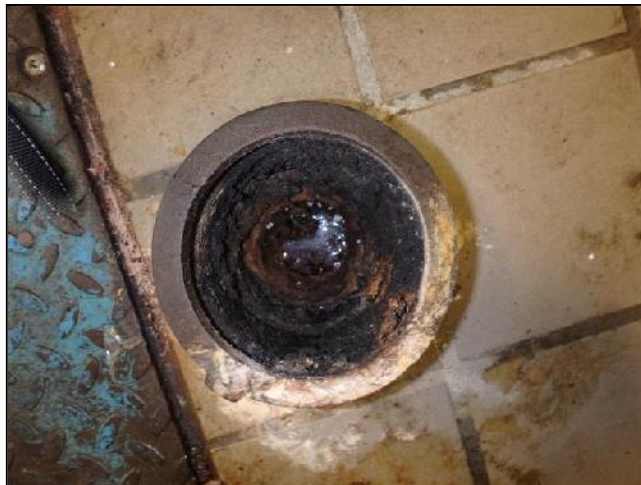
Caked On Grease at Floor Drain

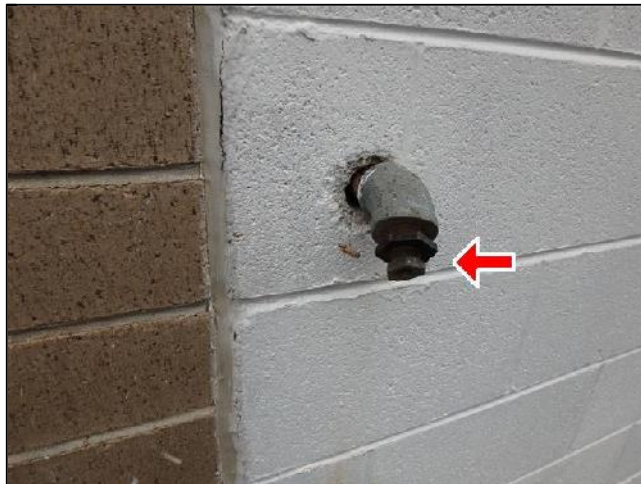
Plugged Piping

(1) Any abandoned or unnecessary mechanical components should be removed from the premises or properly terminated in order to reduce the risk for accidental energizing, leaking, or other failure.

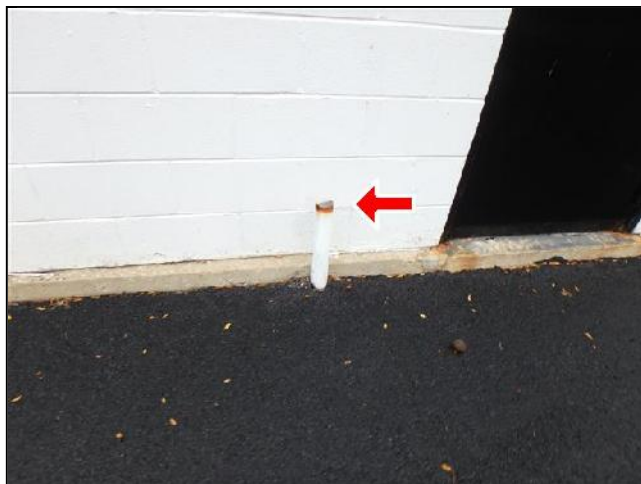
Open Piping

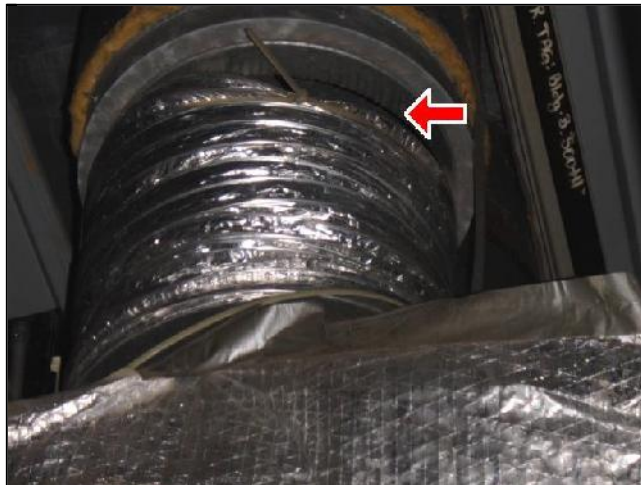
Partially Disconnected Duct Connection

(3) Flexible ductwork should be carefully stretched and properly configured at connections to the rigid metal duct in order to allow for proper airflow and equipment performance. It is recommended that the flexible ducts in the attic be repaired by a qualified HVAC contractor so that they conform to the applicable standards.

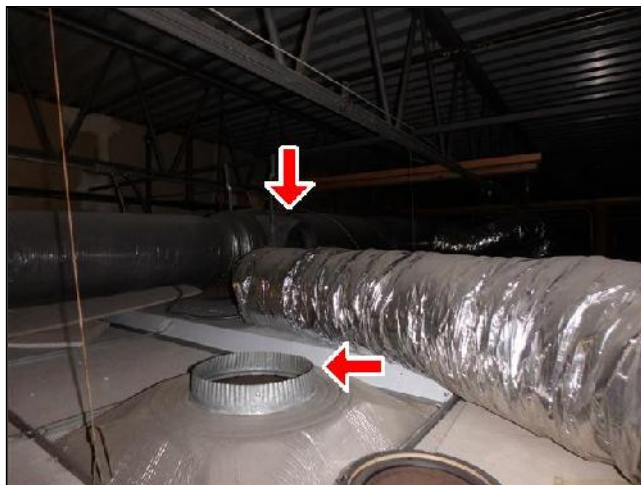
Disconnected Duct

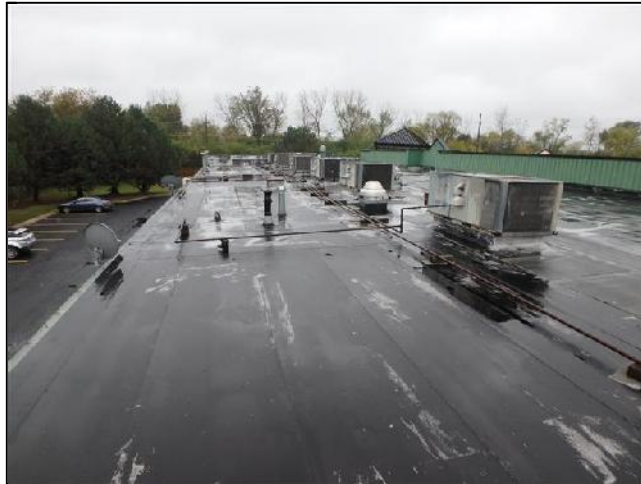
Packaged Rooftop HVAC Units

(4) The inspector found 14 individual packaged HVAC units on the rooftop. Six of the units are approximately 27 years old and therefore well past the typical useful life for such equipment; plans should be made for their near-term replacement. Four of the units are approximately 18 years old and are nearing the end of their typical service lives; major repair expenditures should not be made to these aged units. The other four packaged rooftop units date from 2007 (2), 2014, and 2015.

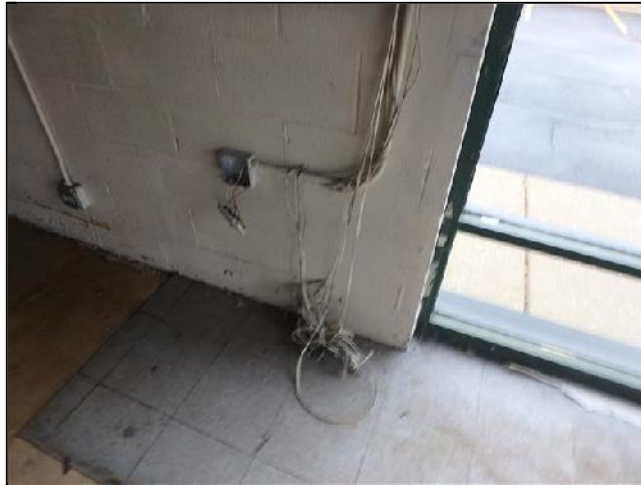
Defective Wiring

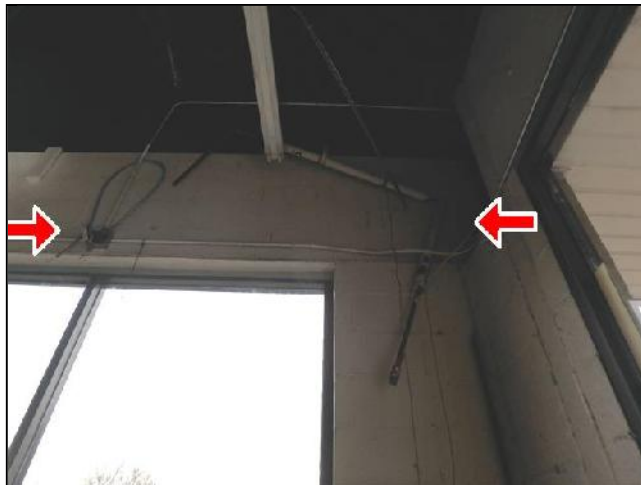
General Deterioration

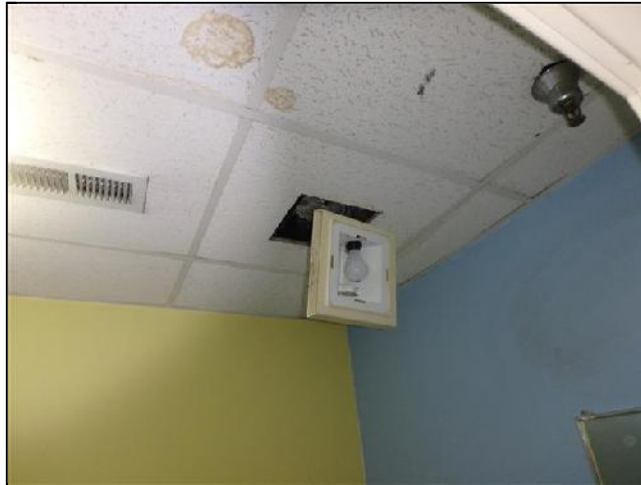
Significant Neglect

(2) The interior wall, floor, and ceiling finishes are aged and deteriorated. The interior trim and millwork is aged, defective, and damaged in multiple locations. Some of the kitchen and bathroom cabinetry, fixtures, and appliances are also aged, deteriorated, and neglected. Extensive remodeling of the home's interior is required in order to elevate it modern standards of safety, convenience, and appearance. Further evaluation by a qualified remodeling contractor is recommended in order to assist the buyer's in developing a plan and budget for these repairs/upgrades.

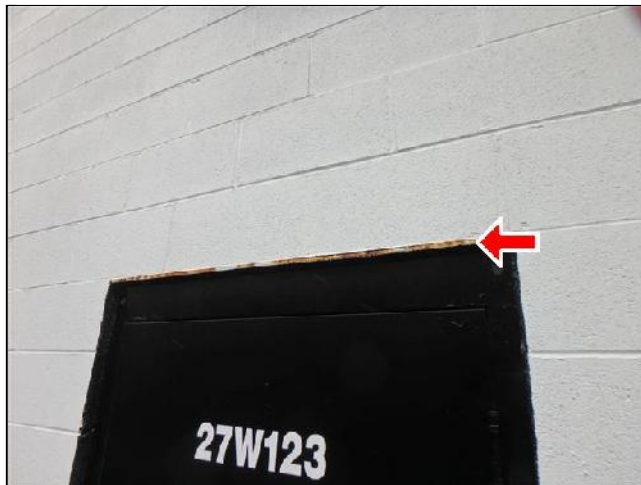
Lintel Corrosion from Moisture Exposure

(2) It is recommended that any exterior doors which are not currently provided with drip cap flashing have such flashing installed in order to reduce the risk for wind driven rain blowing through the gap along the top of the entry door and to also reduce the risk for ongoing and accelerating lintel corrosion.

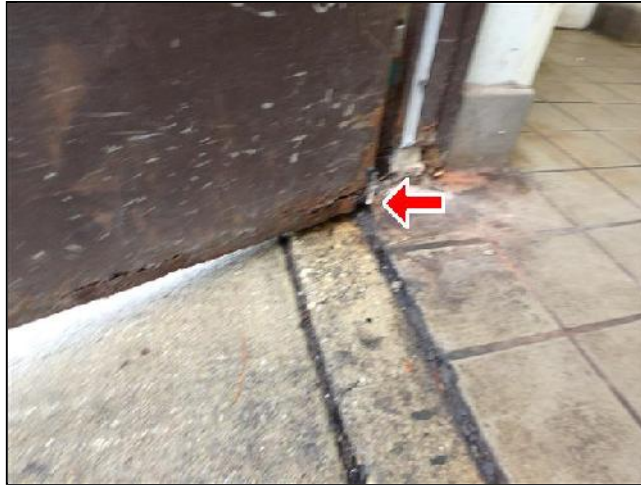
Badly Corroded Exterior Door

(3) Several of the rear exterior doors are badly corroded and need to be replaced.

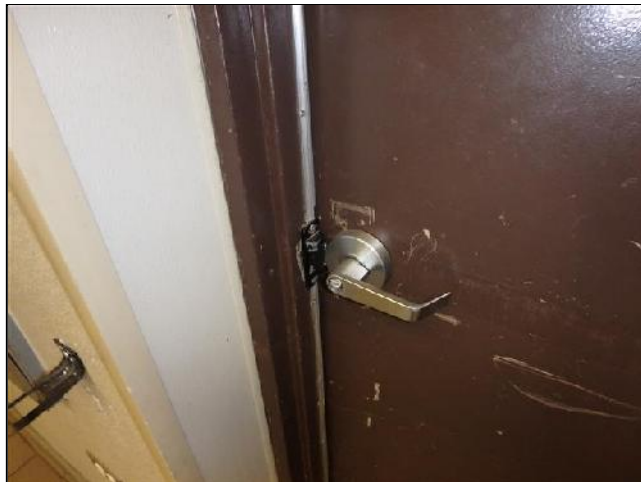
Missing Panic Hardware

(4) Few, if any, of the rear exterior doors are provided with panic hardware. Rear exterior doors in business occupancies are typically required to have panic hardware at the secondary emergency egress doors in order to reduce the risk for occupant entrapment in the vent of a fire or other emergency. It is strongly recommended that all required emergency egress safety devices be furnished and installed by a qualified contractor as soon as practical.

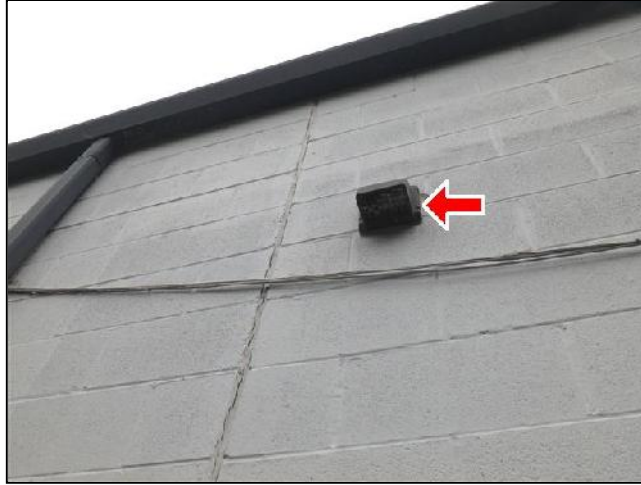
Lint Build up

Heavy lint build-up was noted inside the vent passages of the clothes dryer. Regular cleaning is recommended in order to reduce drying times, increase equipment service life, and reduce the risk of a dryer fire.

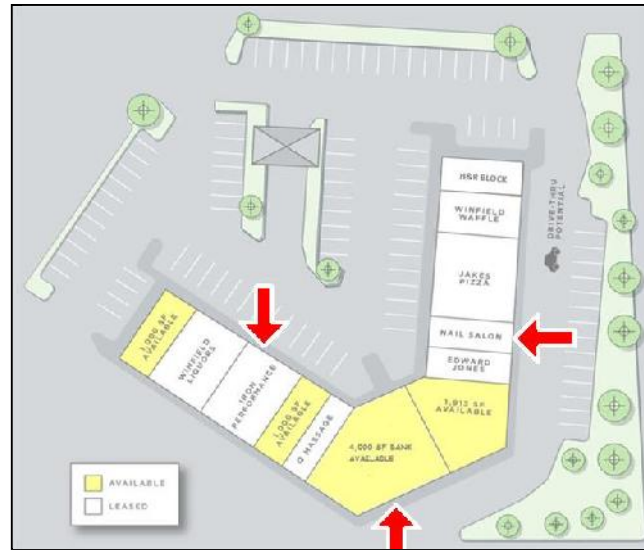
Units Not Entered

(4) FYI: Several of the individual business occupancy interiors within the stripmall were not entered during the inspection.
